Due Diligence Study Scituate Town Hall Buildings

CODE EVALUATION & MEP/FP SYSTEMS NARRATIVE

June 3, 2014

**R.W. Sullivan
Engineering**

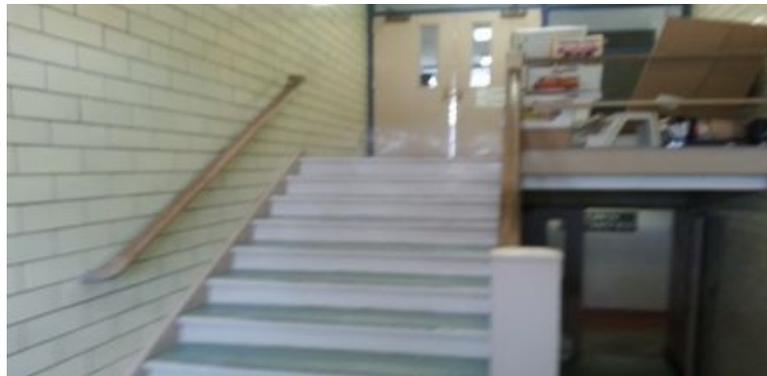
- b. **Egress:** In general, the means of egress capacity appeared to be sufficient for the anticipated number of occupants within the building. The main floor has sufficient egress lighting and exit signs. However, the Basement requires additional egress lighting and exit signs coverage. In addition the exit stair contains storage and the door closer is broken.

Storage in Town Hall Exit Stair

Town Hall		
1. Short Term		Cost Estimate
a.	Remove storage from the exit stair.	N/A – Completed in house
b.	Replace boiler room door.	System Cost: \$1,000 Installation Cost: Needs Study

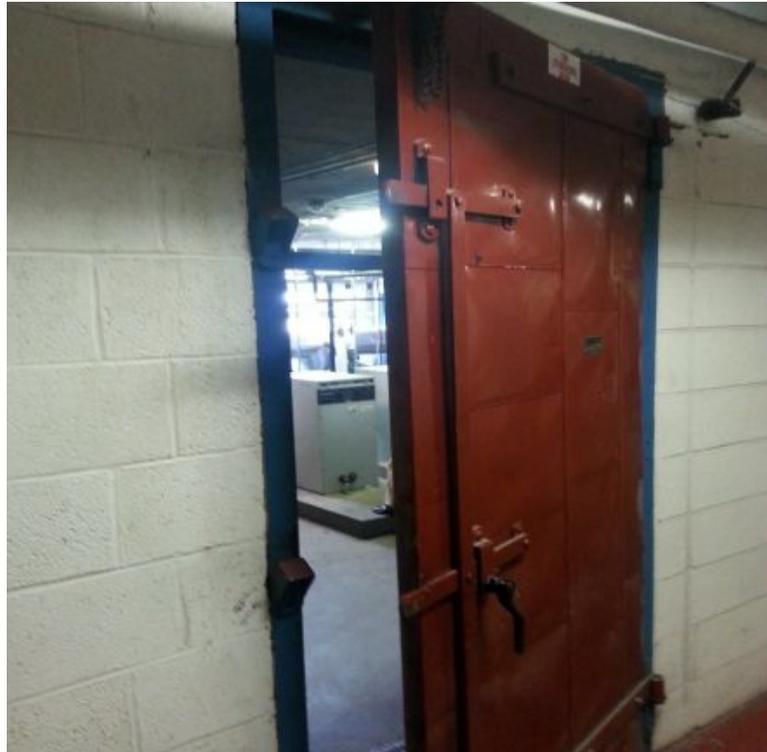
- c. **Fire Resistance Ratings:** Also, the boiler room door separating the space from the corridor is outdated and does not close or latch properly.

Boiler Room Door

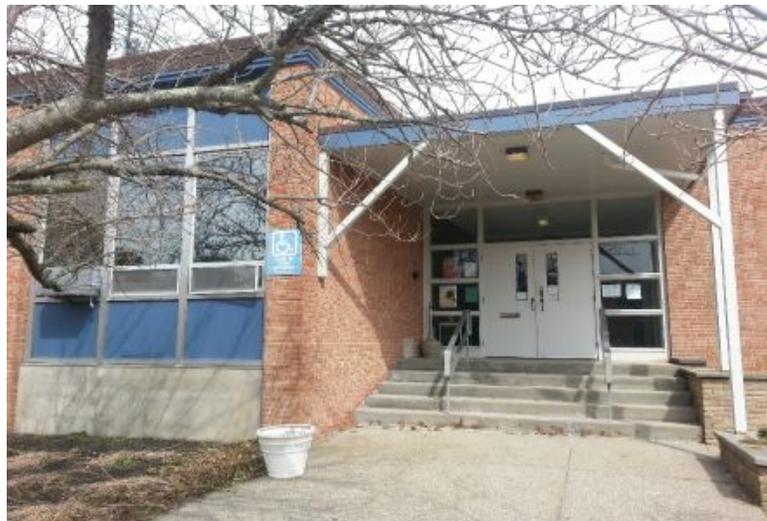
- d. **Handicap Accessibility:** The main floor of the building is generally usable by persons with a disability. However, the following major building elements are not accessible:
- 1) The main entrance to the building is not provided with a ramp (521 CR 25.1).

Town Hall Main Entrance

j.	Increase IT capability.	Needs Study
2. Long Term		Cost Estimate
a.	Make main entry accessible.	Needs study
b.	Replace existing entry ramp at accessible entrance	Needs study

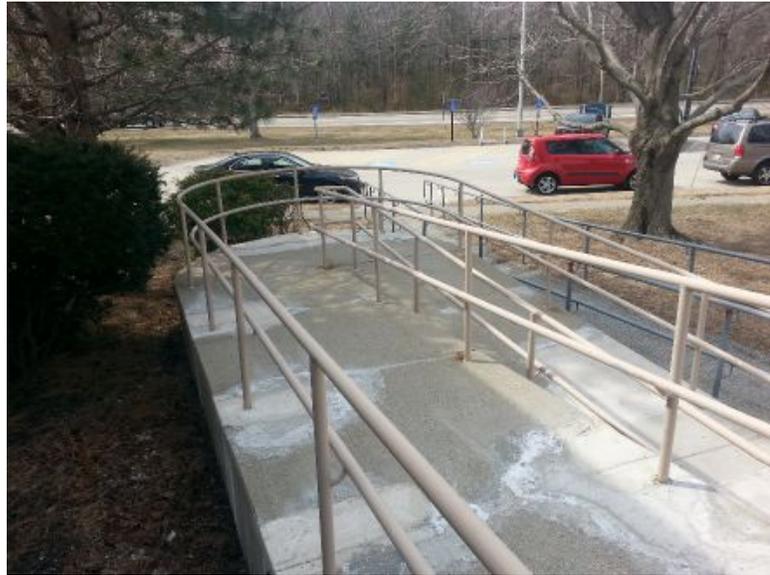
- 2) The accessible entrance ramp is not compliant due to the landing, which cannot be curved (521 CMR 24.4). In addition, the exterior walkways including the path from the accessible parking to the building entry door including the stair contains cracks, uneven surfaces, and handrails that are not compliant.

Town Hall Accessible Entrance

c.	Repair / replace all exterior walkways on site.	Needs study
d.	Replace all building signage	N/A – Completed in house
e.	Replace stair handrails.	Needs study

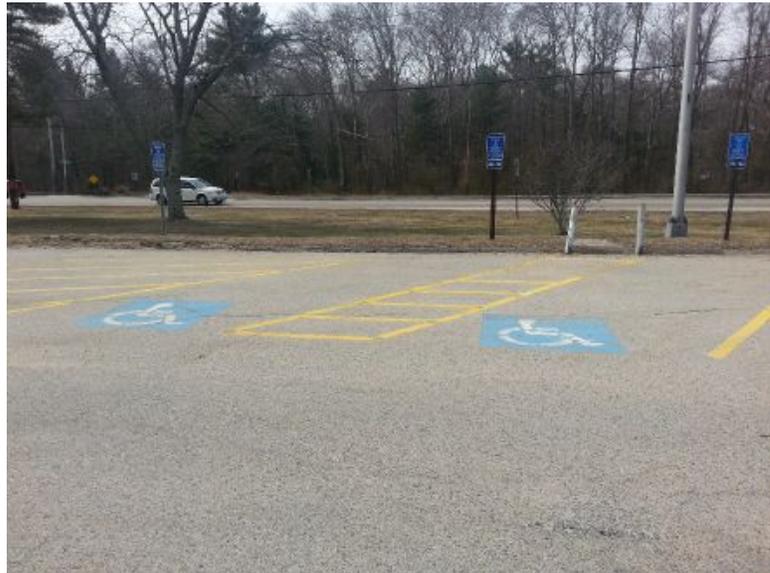
- 3) The accessible parking is not provided with a 5' access aisle (521 CMR 23.4.6).

Accessible Parking Spaces

c.	Restripe parking lot to create compliant accessible parking spaces	N/A – Completed in house
d.	Retrofit door knobs with lever hardware.	N/A – Completed in house

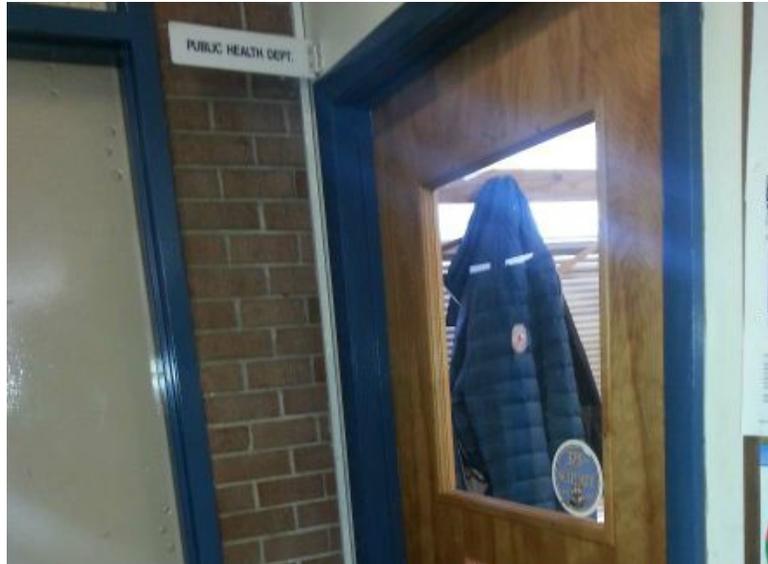
Door to Public Health

- 4) The building signage generally does not contain Braille or other accessible features (521 CMR 41.1.1).

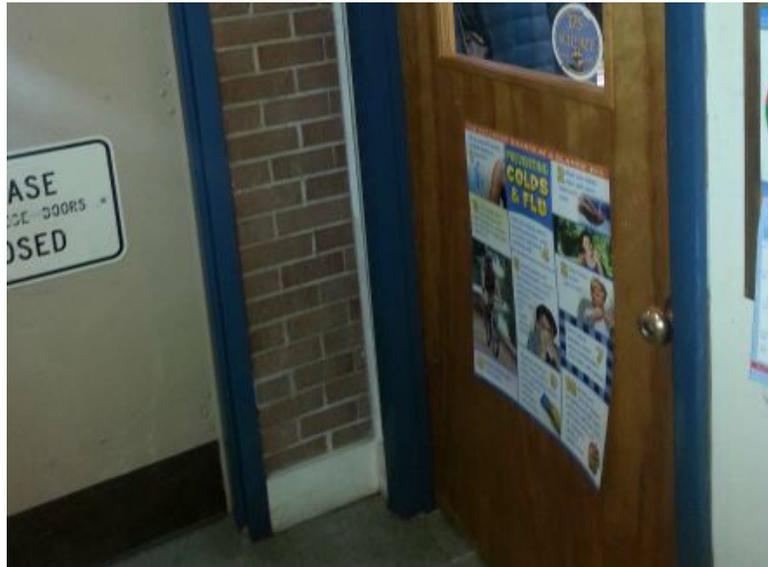
Door to Public Health

- 5) The building contains a mix of retrofitted lever hardware and door knobs. The door knobs are not compliant since they require tight grasping and twisting of the wrist (521 CMR 26.11.1).

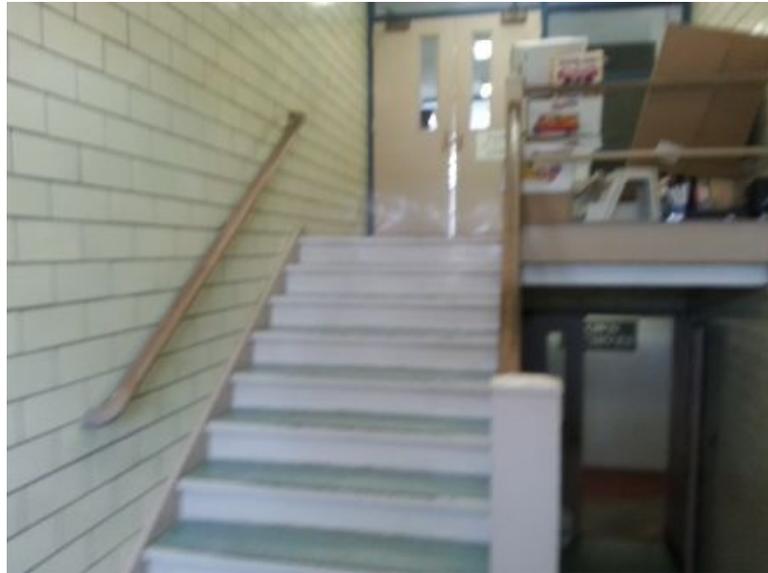
- 6) The stairs contain abrupt nosings and noncompliant handrails (521 CMR 27.3 & 27.4).

Stair in Town Hall

f.	Make stair nosings compliant.	Needs study
g.	Provide elevator so basement can be available for use.	Needs study
h.	Renovate building to incorporate larger meeting spaces and office in the basement.	Needs study

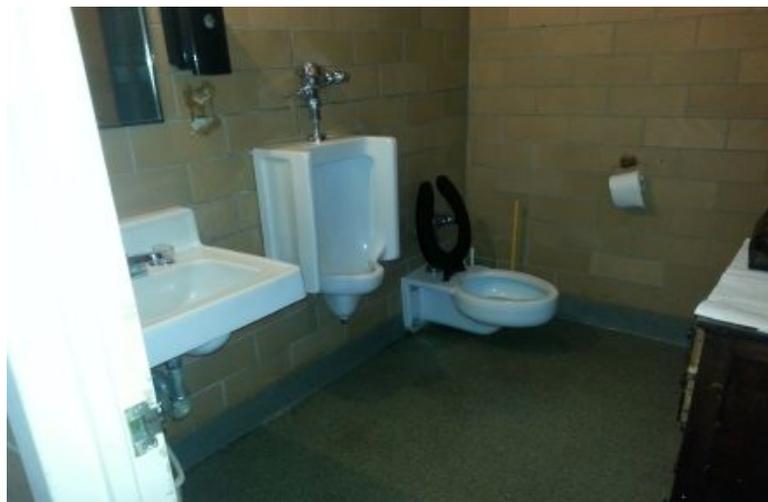
- a. **Use Classification:** The building currently contains the following use:
 - 1) Use Group B – Fire Station
 - 2) Use Group R – Living Quarters
 - 3) Use Group S-1 – Storage
- b. **Egress:** In general, the means of egress capacity appeared to be sufficient for the anticipated number of occupants within the building. The building size is such that a single means of egress from the public areas as well as the living quarters is sufficient.
- c. **Handicap Accessibility:** The building is generally not usable by persons with a disability.

Toilet Room in Fire Station

d.	Replace lighting.	Installation Cost: \$10/ ft ²
2. Long Term		Cost Estimate
a.	Create accessible toilet room if the building will be used for public education / tours.	Needs study

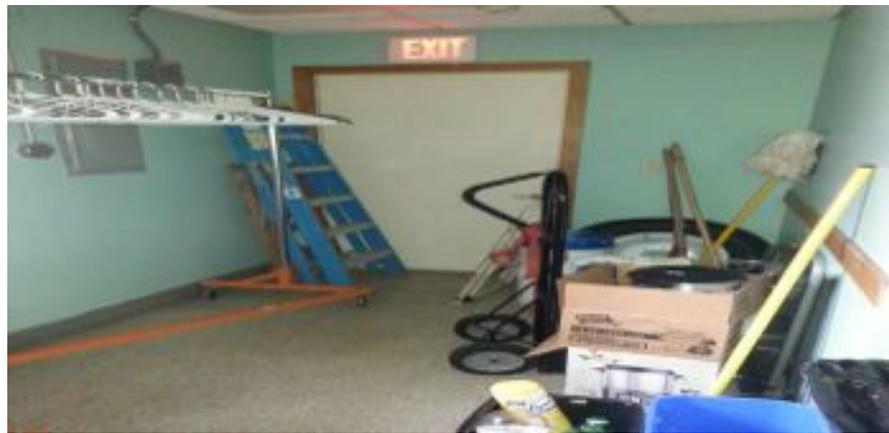
b. **Egress:** In general, the means of egress capacity appeared to be sufficient for the anticipated number of occupants within the building. The building has sufficient egress lighting and exit signs. However, the exit from the kitchen was blocked with storage.

Blocked Kitchen Exit

1. Short Term		Cost Estimate
a.	Remove storage blocking kitchen exit.	N/A – Completed in house
b.	Restripe parking lot to create compliant accessible parking spaces	N/A – Completed in house

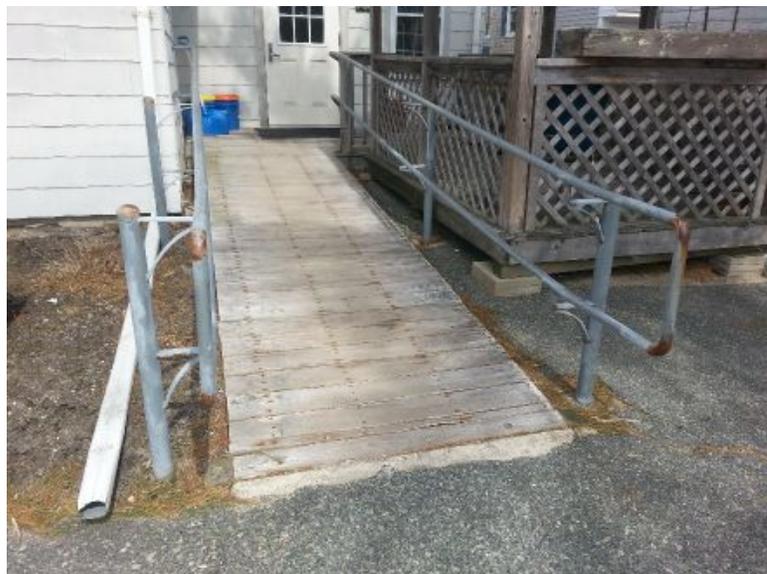
- 1) The accessible entrance ramp is not compliant due to the slope and handrails (521 CMR 24.4).

Rear Accessible Entrance

f.	Increase ventilation.	Installation Cost: \$10 / ft ²
g.	Upgrade lighting.	Installation Cost: \$10/ ft ²
2. Long Term		Cost Estimate
a.	Replace rear entry ramp.	Needs study

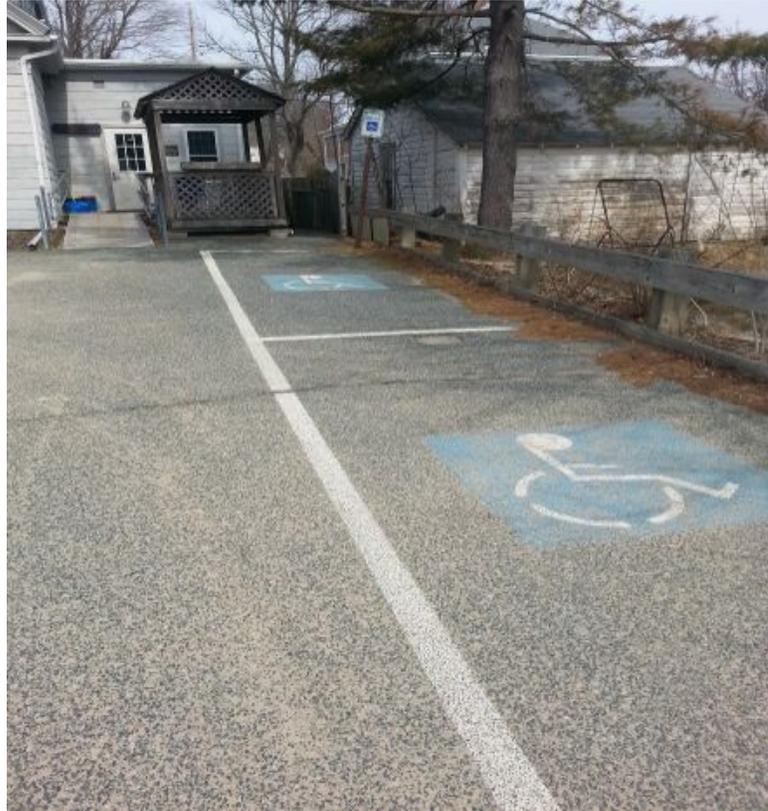
- 2) The accessible parking is not level or provided with a marked 5' access aisle (521 CMR 23.4.6).

Accessible Parking Spaces

b.	Regrade accessible parking spaces.	Needs study
c.	Renovate building to create consultation rooms.	Needs study
d.	Improve building envelope including roof and windows to be more energy efficient.	Needs study

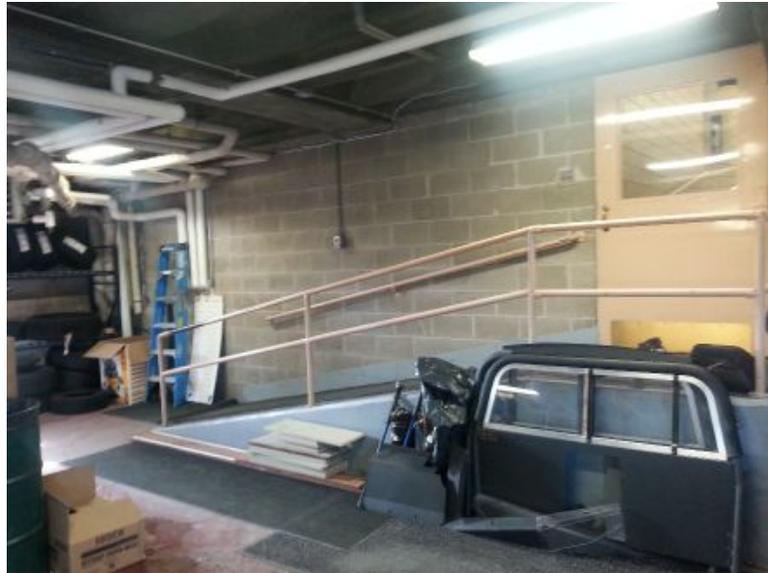
- a. **Use Classification:** The building currently contains the following uses:
 - 1) Use Group B – Offices
 - 2) Use Group I-3 – Cells
 - 3) Use Group S-1 – Record Storage
- b. **Egress:** In general, the means of egress capacity appeared to be sufficient for the anticipated number of occupants within the building. The addition has sufficient egress lighting and exit signs. However, the original building is lacking in exit sign coverage.
- c. **Handicap Accessibility:** The building is not compliant, not usable by persons with a disability including the following major building elements:
 - 1) The ramp from the garage to the cells is not compliant due to the slope and handrails (521 CMR 24.4).

Ramp from Garage

h.	Create accessible and DPH compliant cells by enlarging and replacing finishes.	Needs study
i.	Replace ramp in garage	Needs study
j.	Replace all building signage	N/A – Completed in house

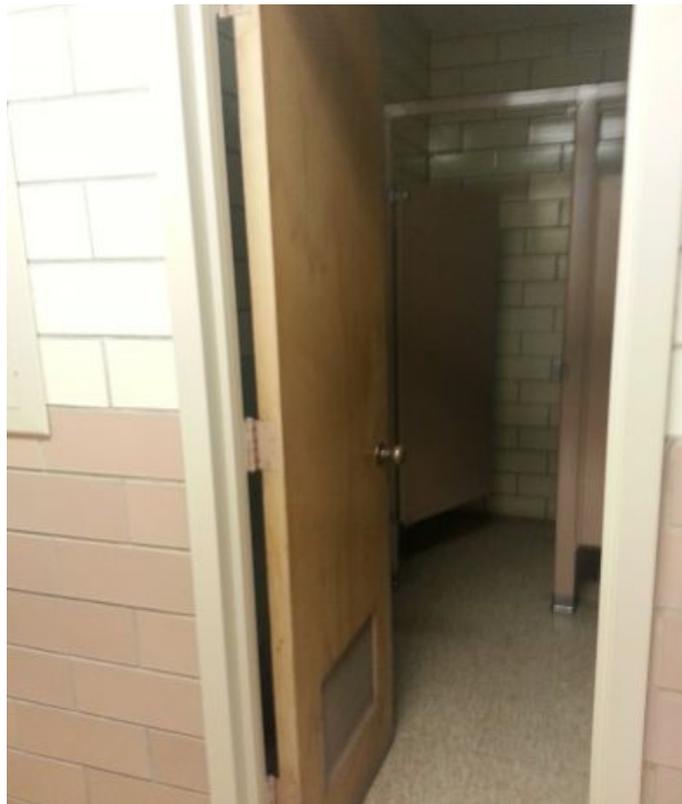
- 2) None of the adult cells contain any accessible features (521 CMR 15.1).
- 3) The building signage does not contain Braille or other accessible features (521 CMR 41.1.1).
- 4) The door hardware throughout the building consists of door knobs. The door knobs are not permitted since they require tight grasping and twisting of the wrist (521 CMR 26.11.1).

Door to Toilet Room

b.	Retrofit door knobs in areas open to the public with lever hardware.	N/A – Completed in house
c.	Provide increased ventilation throughout the original building.	Installation Cost: \$15 / ft ²

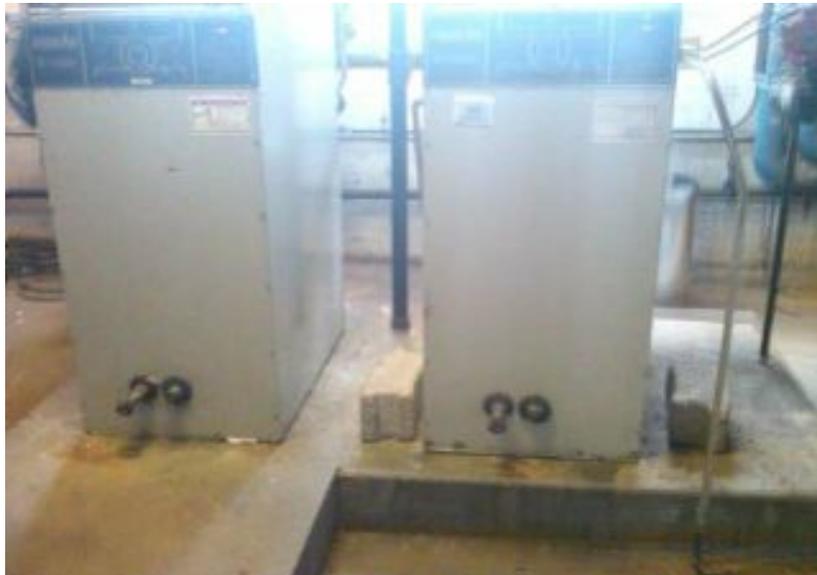
- a. The building is heated by two (2) gas-fired hot water boilers manufactured by Lochnivar. The boilers are rated for 750 mbh input and 660 mbh output. Hot water is circulated by the use of inline circulator pumps to the town hall, police station and fire station. Piping is routed underground to these buildings. The physical condition of the buried piping is unknown.

Boilers at Town Hall

e.	Provide new gas fired boilers.	System Cost: \$50,000 Installation Cost: \$15 / ft ²
f.	Provide new energy management system.	System Cost: \$250,000
g.	Increase ventilation throughout the building.	System Cost: \$30,000 Installation Cost: \$10 / ft ²

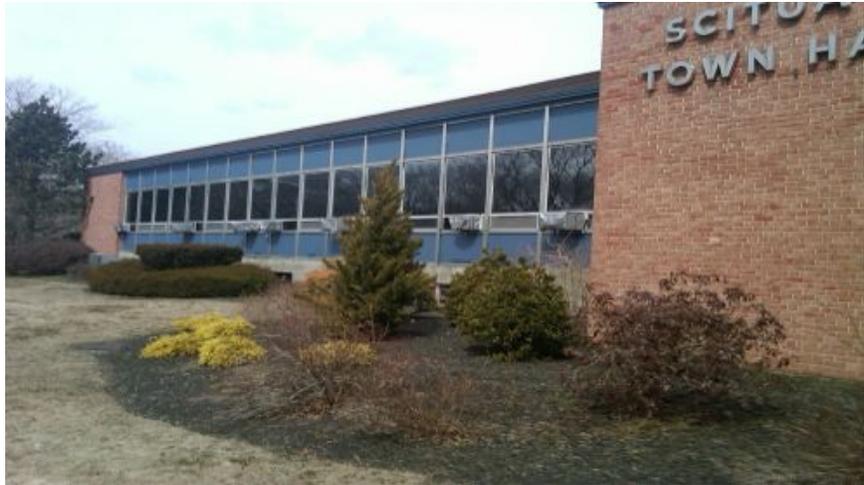
- b. The offices are heated utilizing fan coil units. The units are controlled manually. Controls are integral to the unit. This results in the offices being overheated. No ventilation is provided at the fan coil units.
- c. Window AC units provide air conditioning. Fresh air is provided by operable windows. They do not interfere with fresh air or heating. (PHOTO)

Window Air Conditioners

k.	Provide air conditioning through the building with a central system.	Installation Cost: \$15 / ft ²
l.	Upgrade electrical system.	Installation Cost: \$20 / ft ²

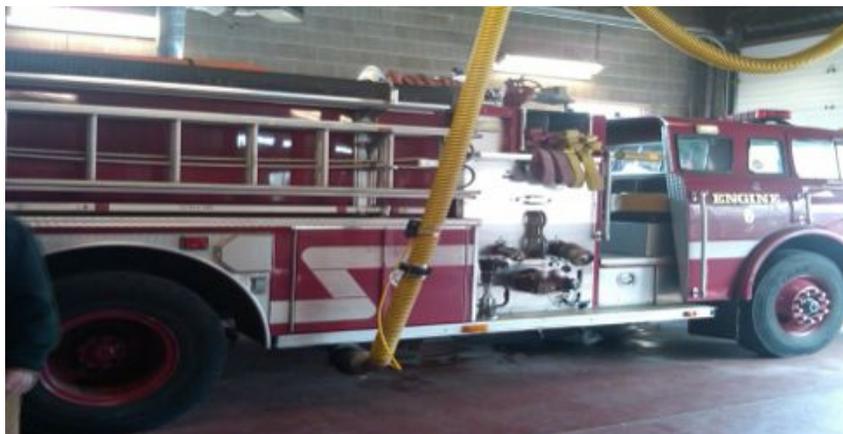
- a. Heating to the building is provided by hot water generated at town hall. Heating piping enters the building through an exterior wall and then feeds hot water unit heaters in the bay area.
- b. Ventilation is provided by operable windows. An overhead carbon monoxide system provides an exhaust hookup for the fire trucks. Fresh air is brought back into the building via a supply fan and "duct sock".
- c. There is no air conditioning in the building.

Flex Exhaust for Engine

p.	Unplug floor drain.	System Cost: \$500
Fire Station		
1. Short Term		Cost Estimate
a.	Fix broken SCBA filling station	Needs study
b.	Improve ventilation in bay area.	System Cost: \$20,000

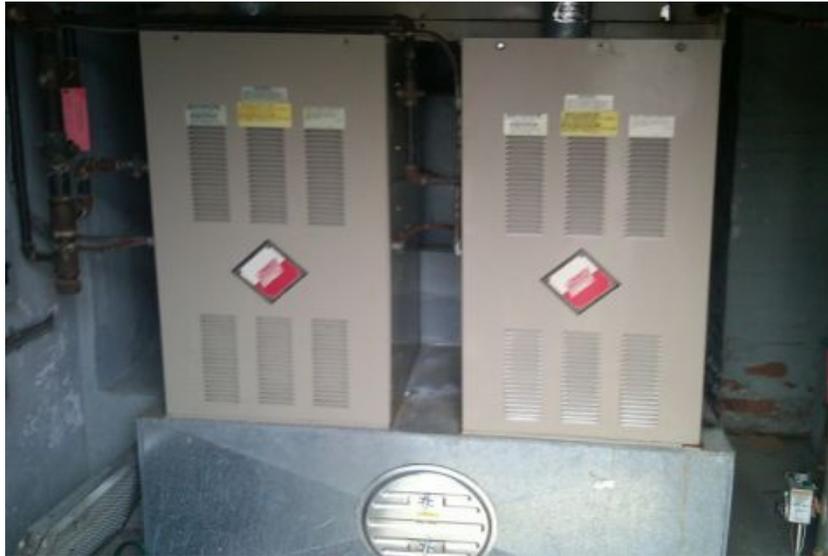
- a. Heating and air conditioning is provided by a single zone, split system gas fired air handler. Air is circulated by the use of ductwork above the ceiling. A wall mounted thermostat controls the unit.

Furnaces at Senior Center

- b. According to the town, the second floor is not habitable. There are complaints from occupants about being too hot or cold.
- c. The kitchen does have an exhaust hood with internal suppression system over the cooking area.

c.	Improve HVAC system.	Installation Cost: \$20 / ft ²
d.	Upgrade electrical service.	Installation Cost: \$20 / ft ²
e.	Provide low flow plumbing fixtures.	System Cost: \$200 each Installation Cost: \$300 each

e.	Replace HVAC system in its entirety.	Installation Cost: \$20 / ft ²
f.	Replace kitchen exhaust hood and provide make up air in kitchen.	System Cost: \$50,000 Installation Cost: \$50,000

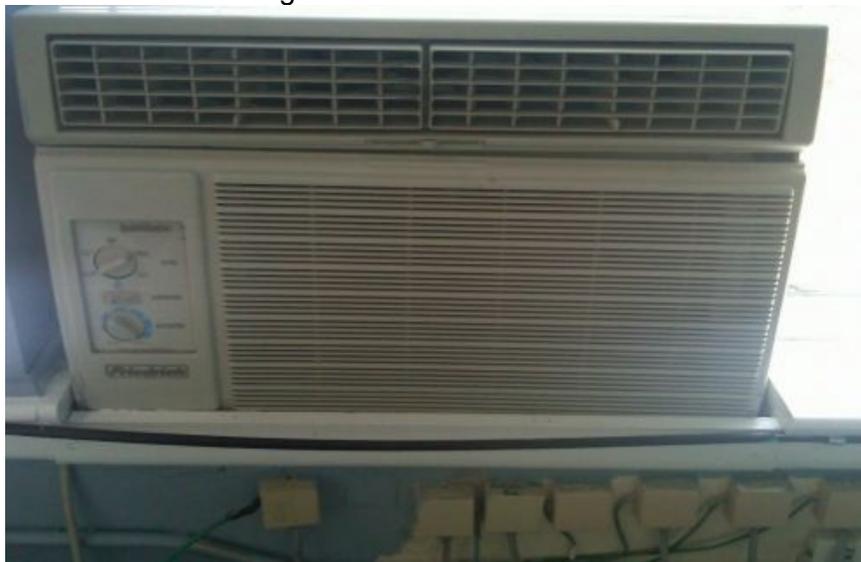
- a. The original building is heated by hot water generated at Town Hall. Hot water is circulated to perimeter fin tube radiation. There is no central air conditioning. Some rooms have window air conditioners.

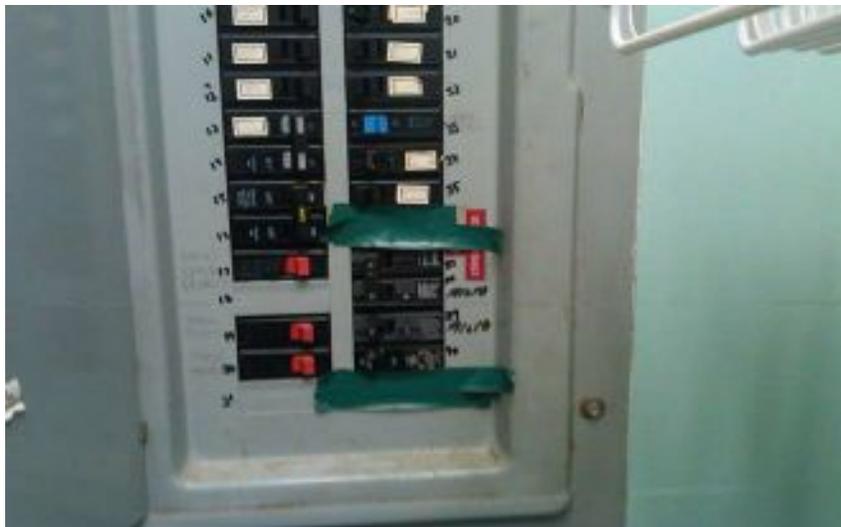
2. Fire Station
 - a. The existing electrical service is 200 amps.
3. Senior Center
 - a. The existing electric service is 200 amps. The panel is in poor condition. Breakers are taped, which suggest problems with the breakers and potential safety hazards and the panel appears to be at maximum capacity.

Senior Center Electric Service

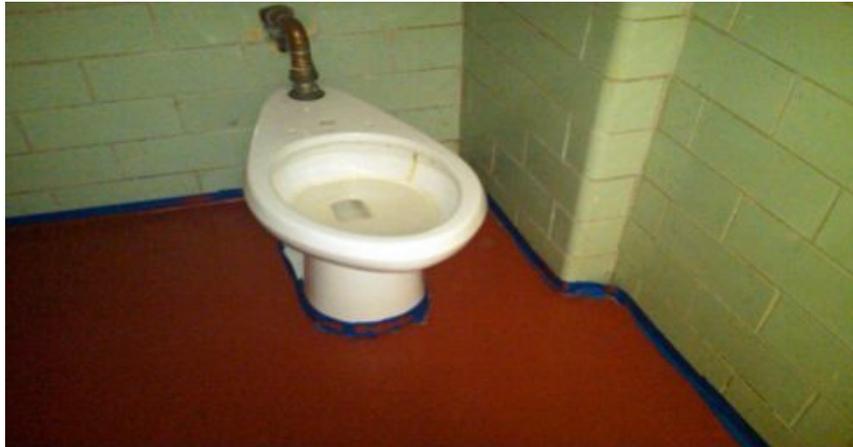
- a. Plumbing fixtures in general areas are in good condition. However, plumbing fixtures within the cell areas are porcelain and cracked. They can be used as a weapon. Stainless steel, correctional type fixtures should be used in cell areas.

Cell Area Toilet

f.	Increase fire alarm system to provide complete coverage throughout the building.	Installation Cost: \$5 / ft ²
g.	Replace toilets in cell area with new correctional type fixtures.	System Cost: \$1,000 each Installation Cost: \$1,000 each

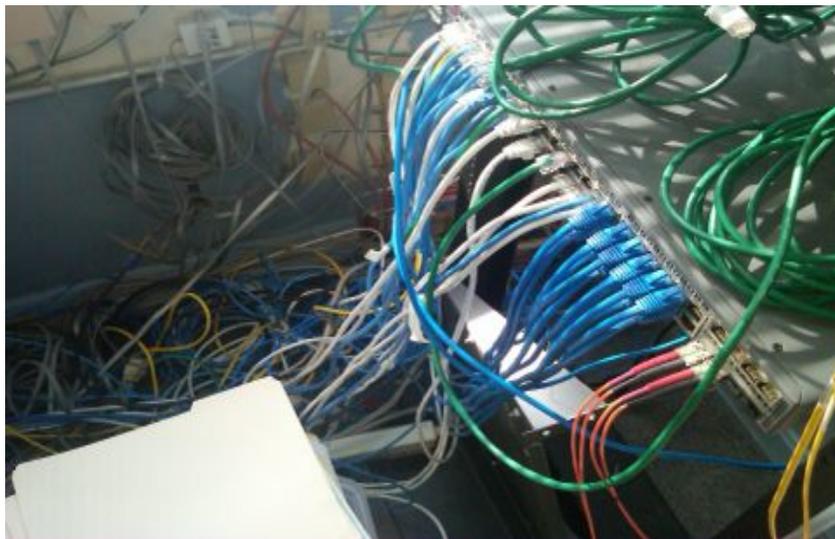
- a. General – Cabling is a mess in all buildings and much of it is unsecured. There should be a town wide study undertaken to evaluate the town's current and future needs for all buildings. Some general observations during the walk through included the following:
 - 1) Service room in the town hall had insufficient air conditioning in the main (server?) room.
 - 2) 911 server rack in police station next to sump pump pit.
 - 3) All buildings should have dedicated server rooms with temperature and humidity control.

IT Cabling
