46 OCEANSIDE DRIVE OUTFALL REPAIR
NORTH SCITUATE BEACH REVETMENT DESIGN (19-FS-53)
SCITUATE, MASSACHUSETTS

Photographic Log – Oceanside

Scituate Foreshore Protection Repairs

North Scituate Beach

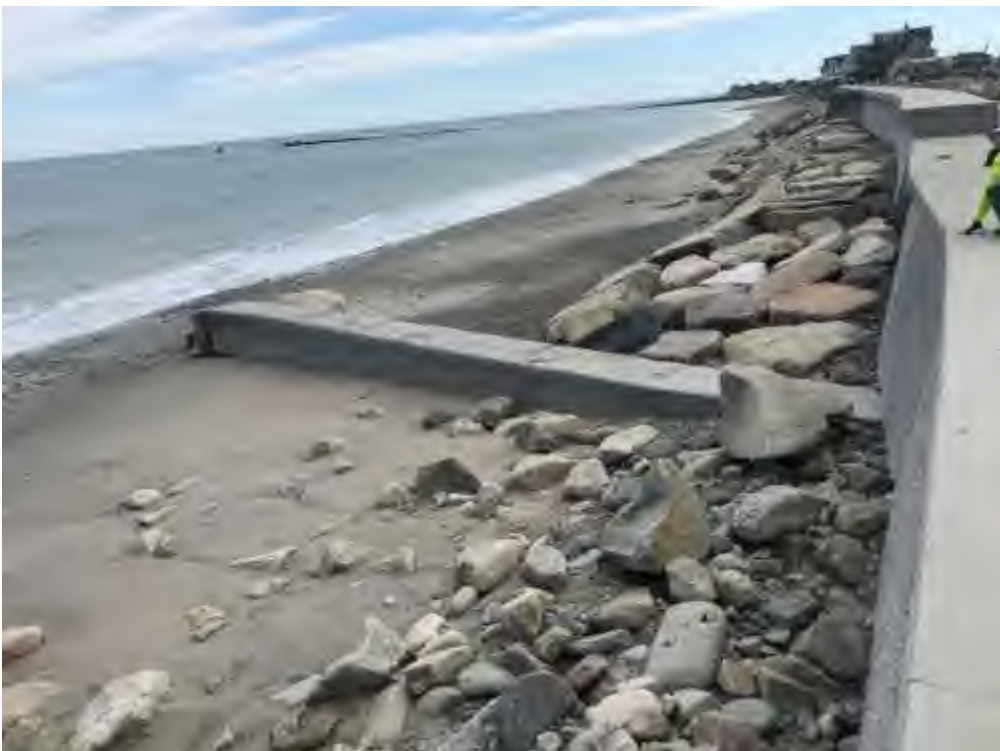
Photo No. 2	Date: 4/14/20

Direction Photo Taken: East		
Description: An overview of the outfall structure along its west face. Note the damaged and displaced precast outfall head structure and undermining of the concrete-encased poly pipe.
