SCITUATE FORESHORE PROTECTION REPAIRS

SITE NO. 2: 91 SURFSIDE ROAD SCITUATE, MASSACHUSETTS

COVER SHEET

Photographic Log

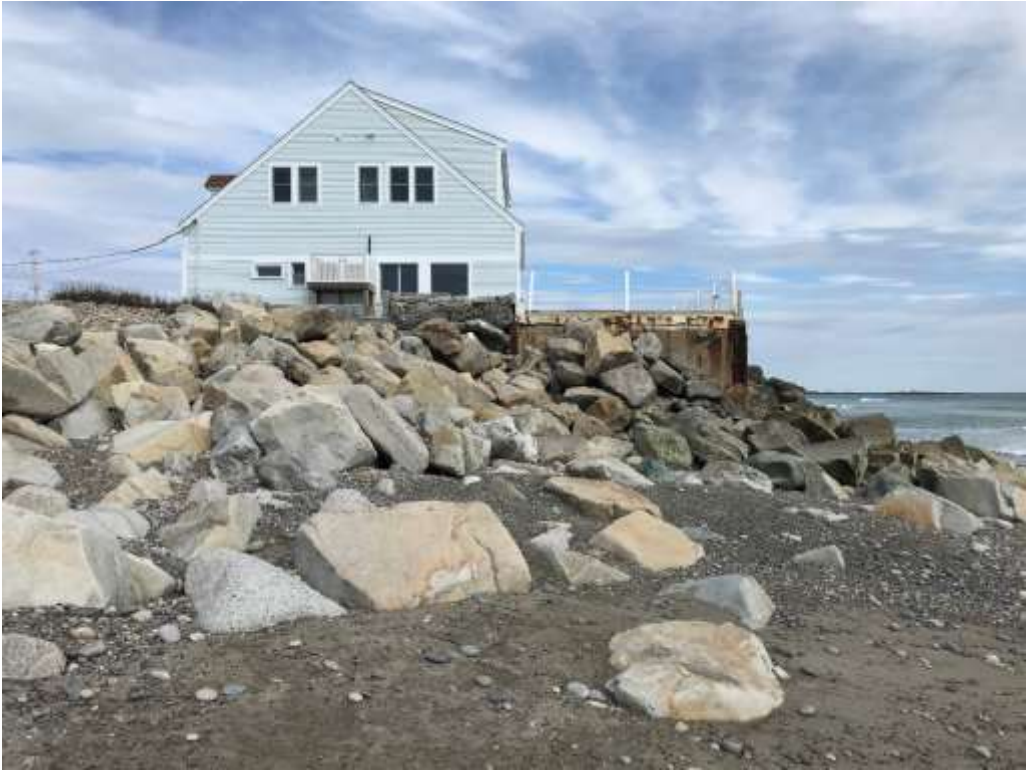
Client Name: Town of Scituate		Site Location: 91 Surfside Road Scituate, MA	Project No. 18.0174547.02
Photo No. 1	Date: 4/14/20

Direction Photo Taken: Northwest			
Description: Typical displaced revetment toe and slope along the southern return wall.

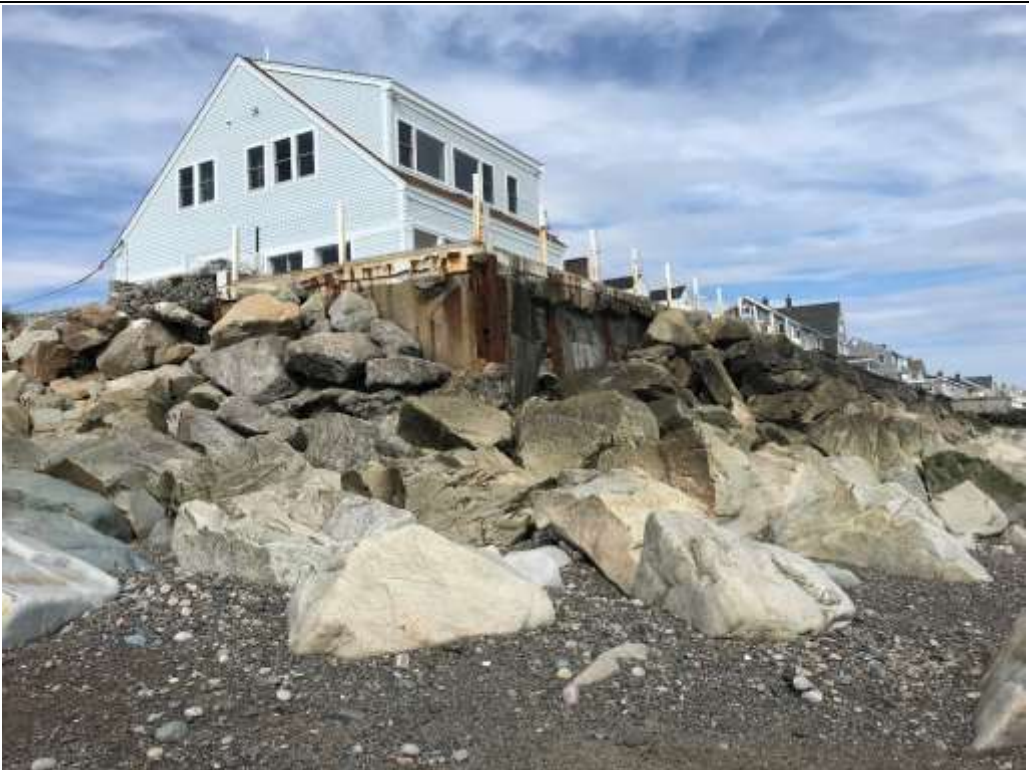
Photo No. 2	Date: 4/14/20

Direction Photo Taken: West		
Description: Overview of displaced revetment toe and slope along deteriorated steel H-pile and concrete panel seawall.
