**MASSACHUSETTS DEPARTMENT OF ENVIRONMENTAL PROTECTION
SOUTHEAST REGIONAL OFFICE
DRINKING WATER PROGRAM
SITE INSPECTION SUMMARY**

Public Water System (PWS): Scituate Water Division
Old Oaken Bucket Surface Water Treatment Plant
4 Old Oaken Bucket Road, Scituate, Massachusetts

SUBJECT: Inspection Of Old Oaken Bucket Surface Water Treatment Plant

INSPECTION DATE: Wednesday, August 17, 2022

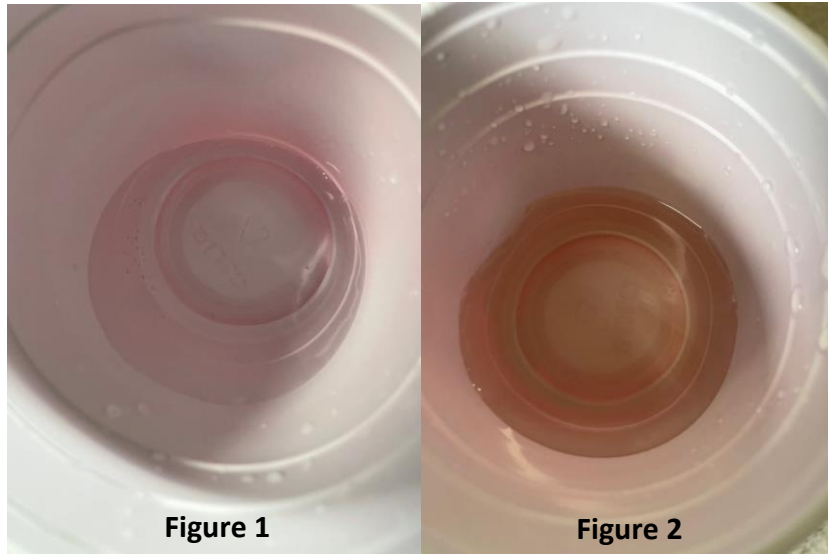
- The clearwell is divided into two sections, the first beneath the carbon filter, and the second beneath the sand filter. The first section is not accessible and has never been inspected or cleaned. It is likely filled with precipitated manganese, filter media and other sludge and should be cleaned to reduce the level of manganese in the finished water.

- The effluent from the carbon filter (Figure 1) is clear and colorless in appearance. After chlorination, the clearwell effluent (Figure 2) has a noticeable yellow color. The color of the post chlorination sample is from manganese precipitating out of solution. The operators report that the degree of discoloration is variable and is sometimes much worse than pictured. Post chlorination for disinfection is required by the surface water treatment rule (SWTR) and cannot be eliminated.

- The temporary greensand filtration vessels housed in the shop area and formerly used to treat the groundwater from Well 17A may be of use to further treat the effluent from the OOB Plant. That would require changing the media and may limit the flow rate of the plant. The post chlorination from the plant may enhance this filtration, and should the system achieve contact time post-filtration, it would be able to use contact time through the filters and the associated piping for that purpose.
