## *Scituate Lighthouse Restoration Project - Project Update*

*July 11, 2023*

# SCITUATE LIGHTHOUSE: JULY 07, 2023 CONDITIONS UPDATE

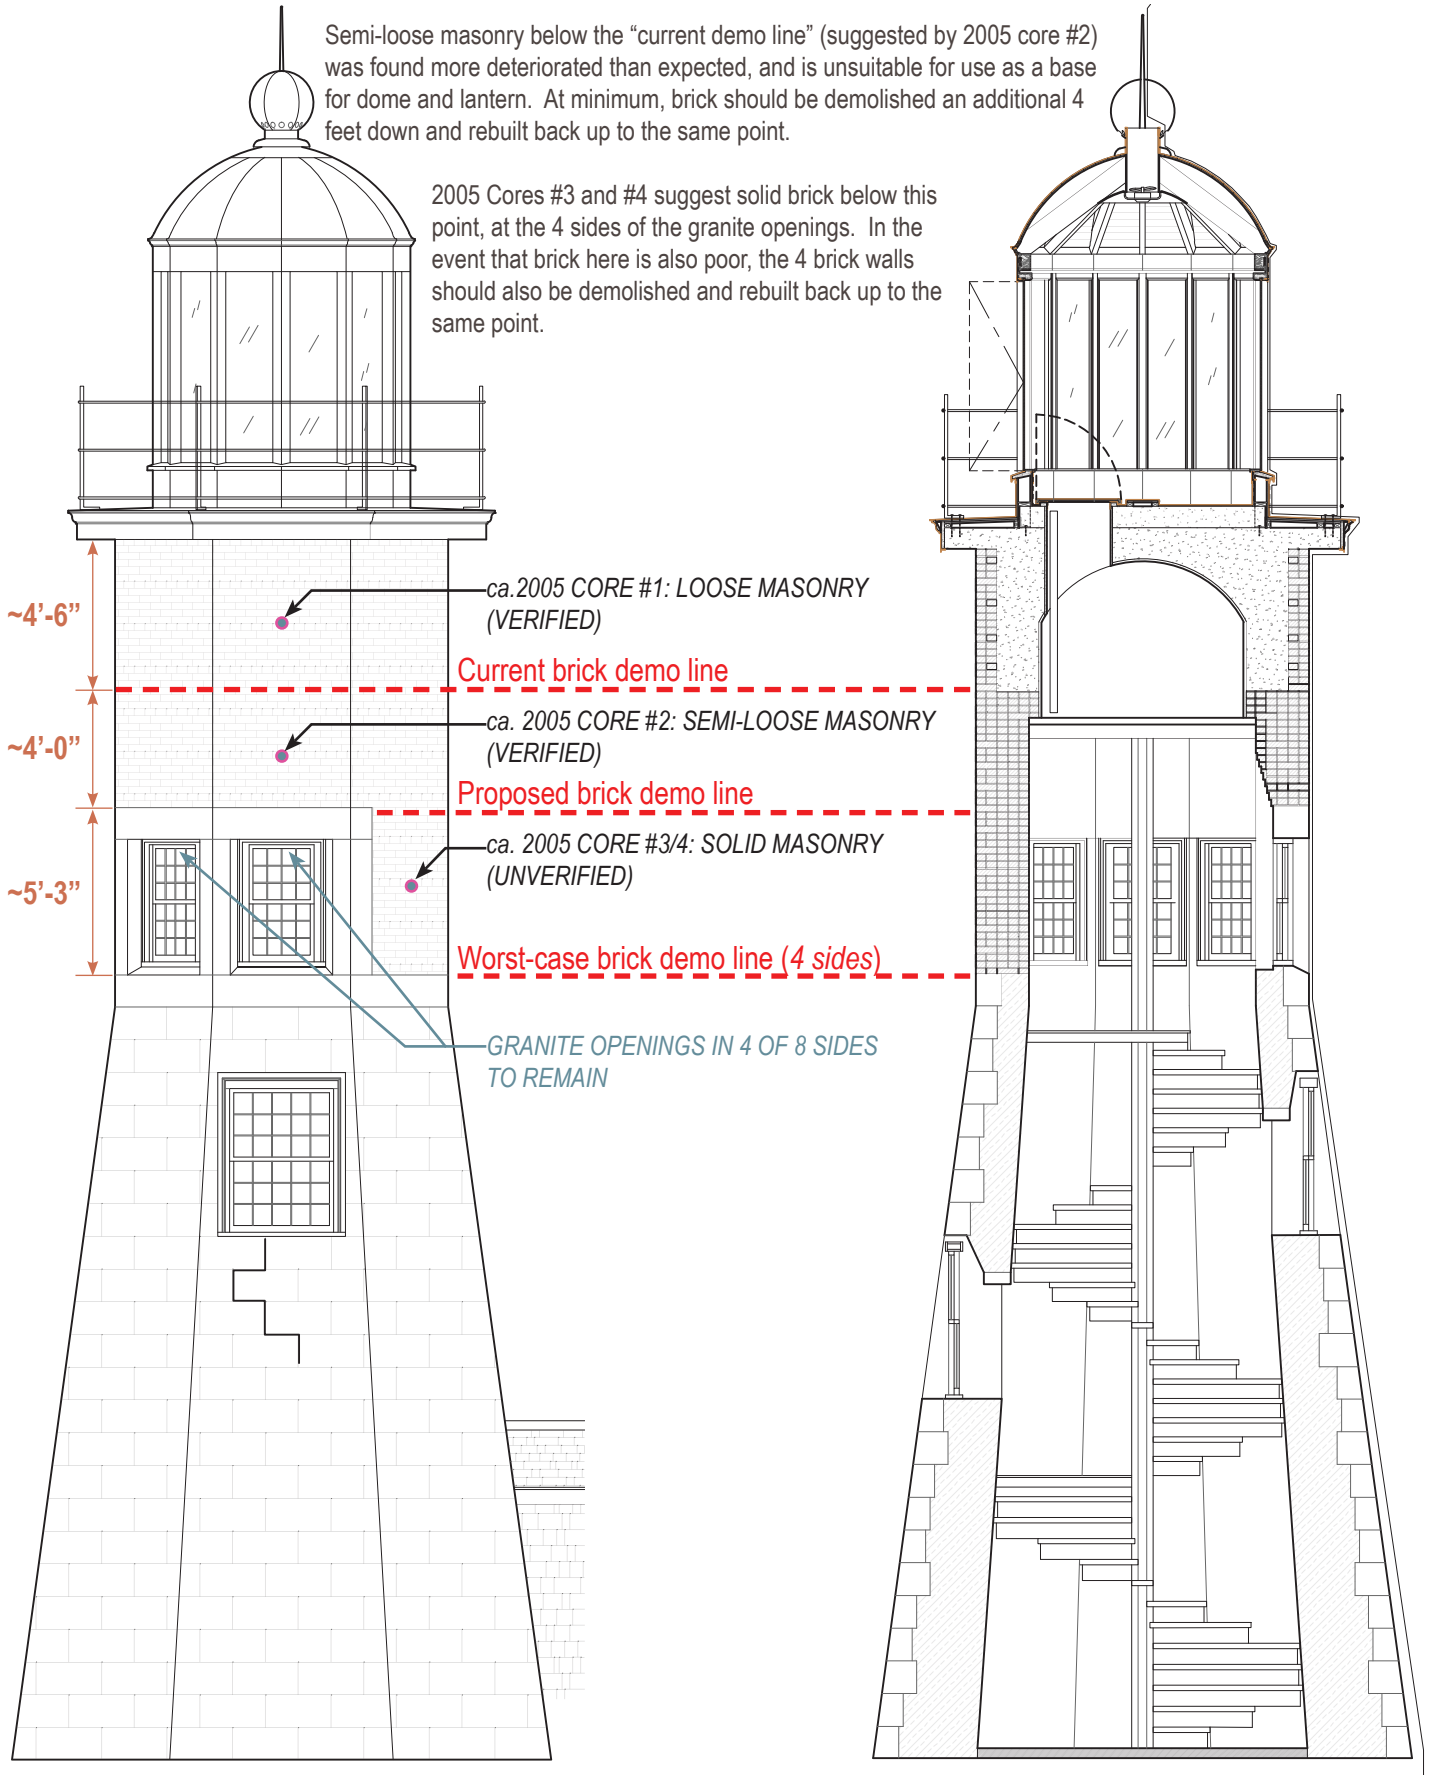
- 1. Demolition/Existing Conditions** – The demolition/rebuild process has been delayed due to the poor condition of the masonry infill within the tower. The original design intent was to remove the existing cap structure, leave the existing brick “2 wythe” veneer installed in 2005 and re-build the inner wall assembly down approximately 4’-6” with cast in place concrete. When the cap assembly was removed, it was obvious that the internal/core masonry conditions and the construction of the 2005 brick veneer were not suitable to support the intended re-build. Therefore, the contractor was directed to remove the top 4’-6” +/- of masonry tower in its entirety to just above the internal platform section of the lighthouse for further evaluation with the hopes that the condition of the internal/core masonry improved. This additional demolition was completed the week of June 25<sup>th</sup> and the contractor installed several helical type ties into masonry internal/core for testing purposes which were not favorable. The structural engineer and architect reviewed the results and existing conditions and recommend continuing removal down an additional 4’-0” +/- to the level of the existing window heads for future evaluation and it may be necessary to continue the removal down an additional 5’-3” +/- down to the point where the granite base transitions into the brick tower. Attached is a diagram which better illustrates the condition.

Loose masonry (expected from 2005 Core #1) at the top of the brick tower was verified and demolished in anticipation of interior concrete dome. Brick was removed down 4'-6" to "current demo line".

Semi-loose masonry below the "current demo line" (suggested by 2005 core #2) was found more deteriorated than expected, and is unsuitable for use as a base for dome and lantern. At minimum, brick should be demolished an additional 4 feet down and rebuilt back up to the same point.

2005 Cores #3 and #4 suggest solid brick below this point, at the 4 sides of the granite openings. In the event that brick here is also poor, the 4 brick walls should also be demolished and rebuilt back up to the same point.

The contractor is currently assembling the costs for the additional demolition aspect and the team recommends proceeding with the demolition/exploration while the architect develops the drawings for the reconstruction of the brick tower and for contractor pricing.
