Existing Conditions Survey & Feasibility Study

Gates Middle School
327 First Parish Road
Scituate, MA

August 7, 2012

DURKEE BROWN
VIVEIROS WERENFELS
ARCHITECTS
111 Chestnut
Street Providence, RI 02903
tel: 401.831.1240
www.durkeebrown.com

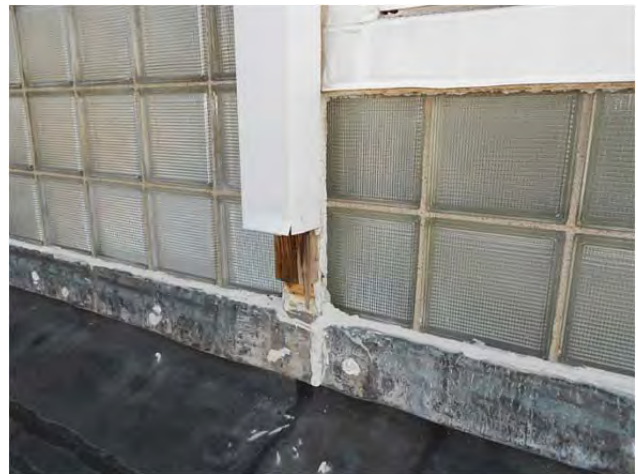
Extensive sealant & missing pilaster at gym

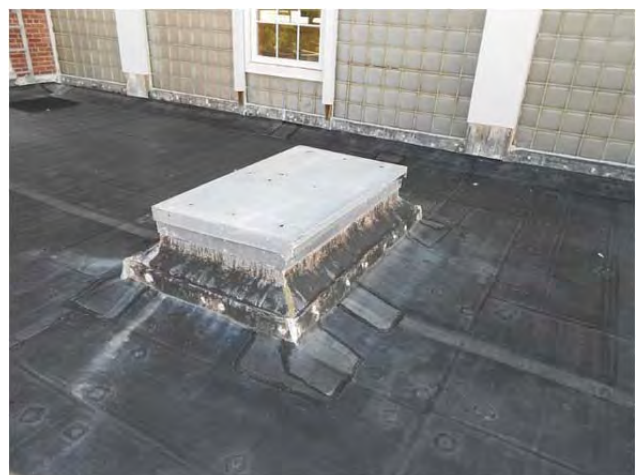
Failing roof curb and hatch adjacent to gym

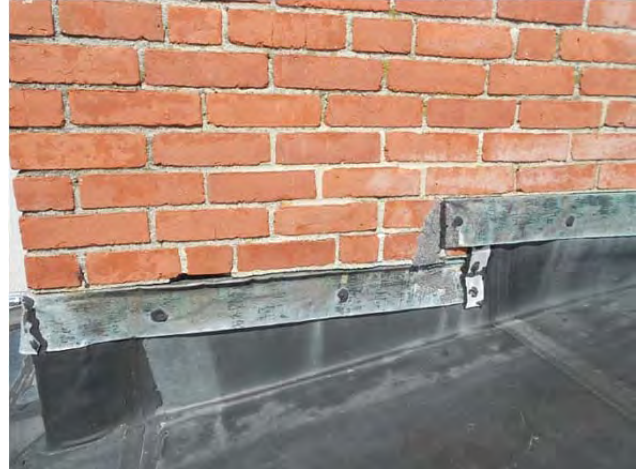
Bent flashing @ mechanical gym mechanical

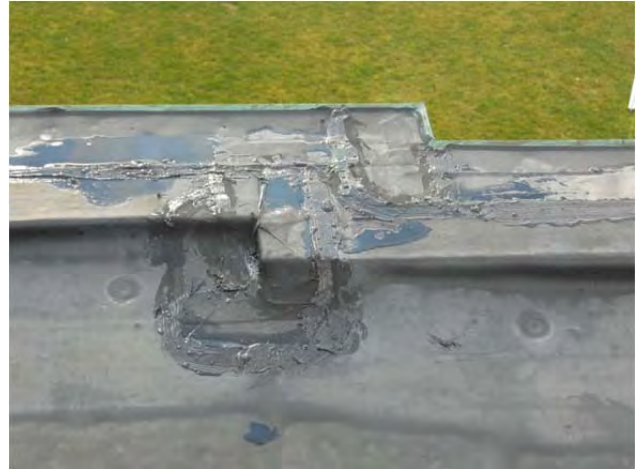
Coping at the flat roof with EPDM seam on top of metal coping and demonstrating past maintenance

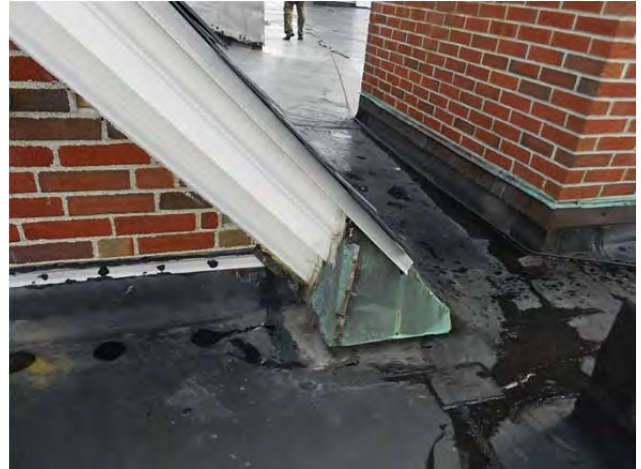
Remaining original copper flashing at area near elevator where spongy insulation was noted

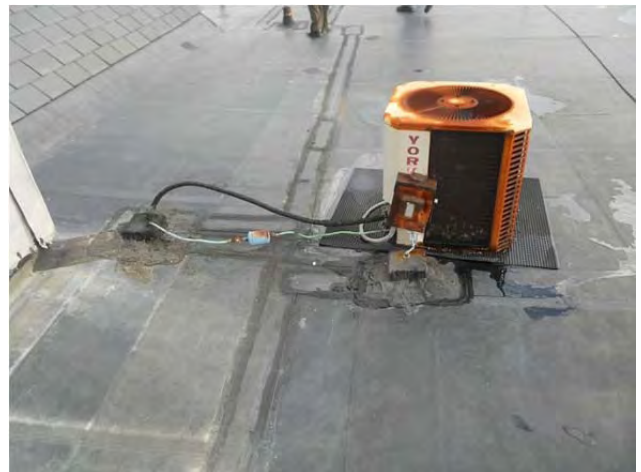
Corroded roof top equipment beyond its useful life

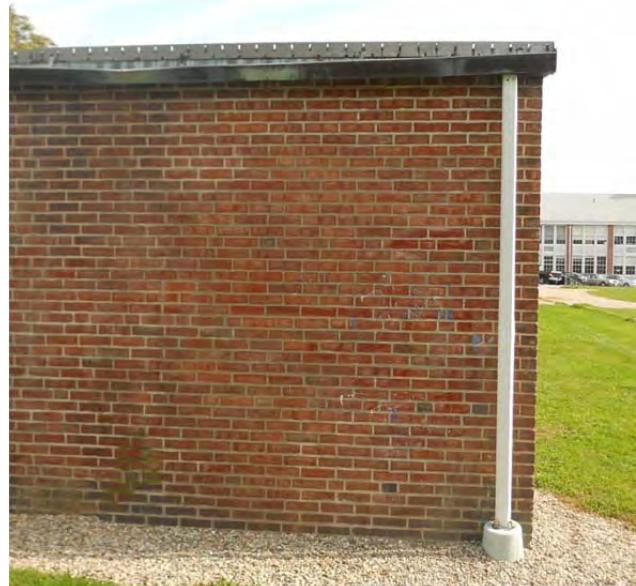
C wing gutters, where they exist at all, have been damaged by ice and snow

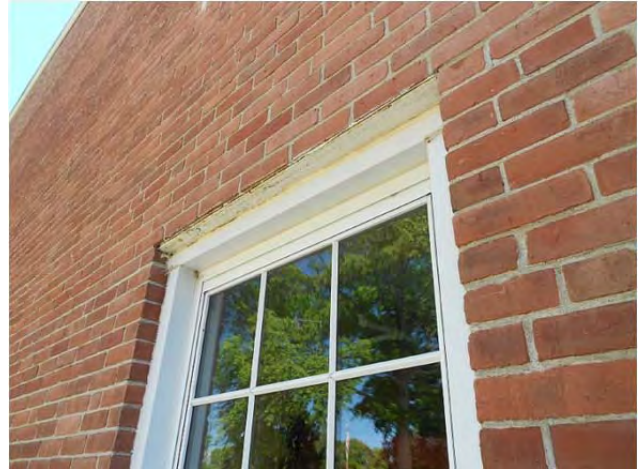
Lintels in A wing are rusting and require prep and repaint before deterioration accelerates

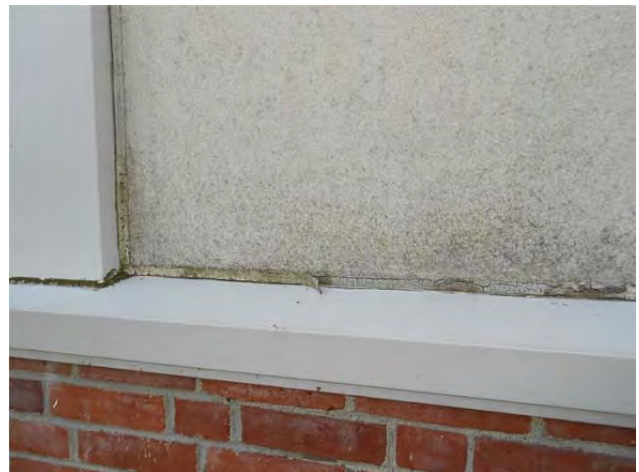
Sealant joints at the stucco are dirty and failing

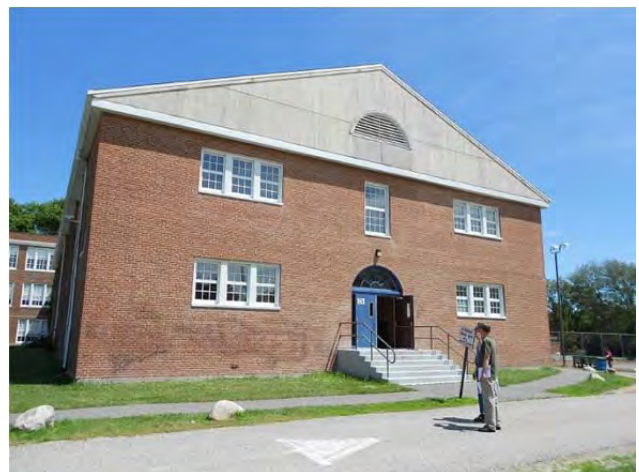
Stucco along the gable ends may conceal the original gable end

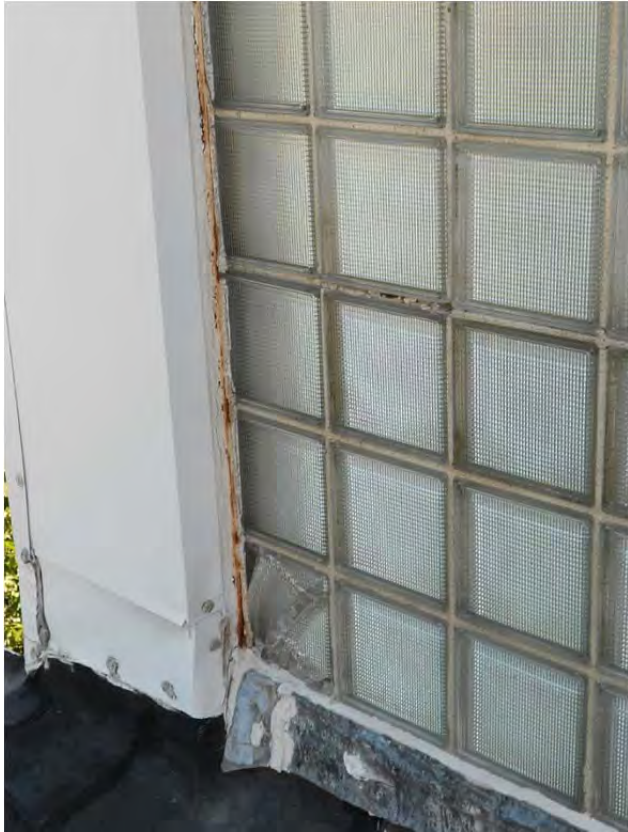
The glass block is located around the entire upper perimeter of the gymnasium. Although subject to damage from projectiles from both inside and out, the glass block is actually failing from other causes. The portland cement mortar joints between the glass block have failed, allowing water penetration to the surrounding steel frames as well as into the glass block units themselves. Years of moisture-induced freeze-thaw, as well as crumbling mortar have caused several blocks in each panel to crack, split, shift, and/or shatter. The glass block in its entirety is beyond repair. Left alone, the mortar joints and glass blocks will experience rapid acceleration of decay and failure. The further the panels decay, the more susceptible the adjacent structural steel components will be to damage.

Failed glass block wall through crumbling mortar joints, rusting reinforcing, and shattered glass units

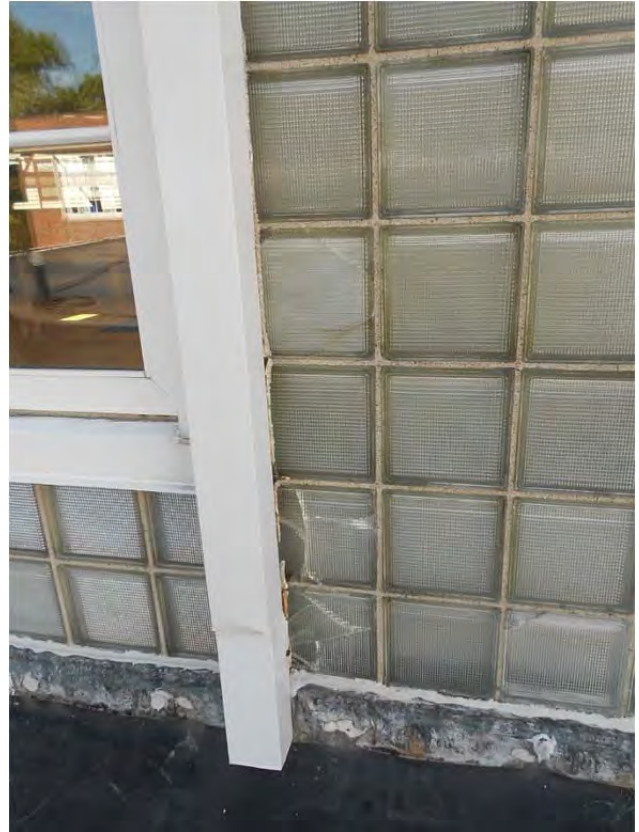
Water intrusion is possible through failed sealant joints at aluminum panning

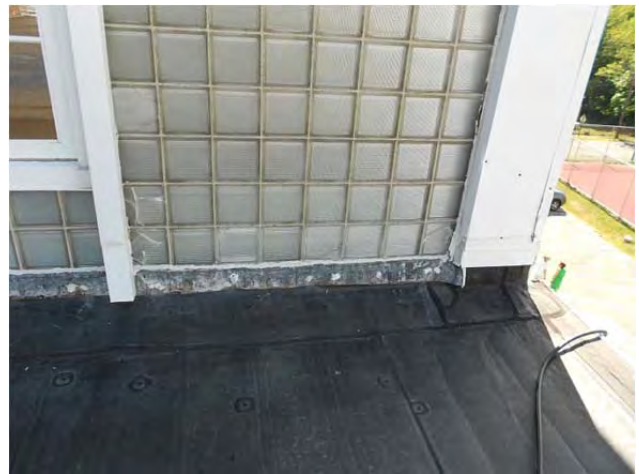
Failed glass block at southwest corner of gym

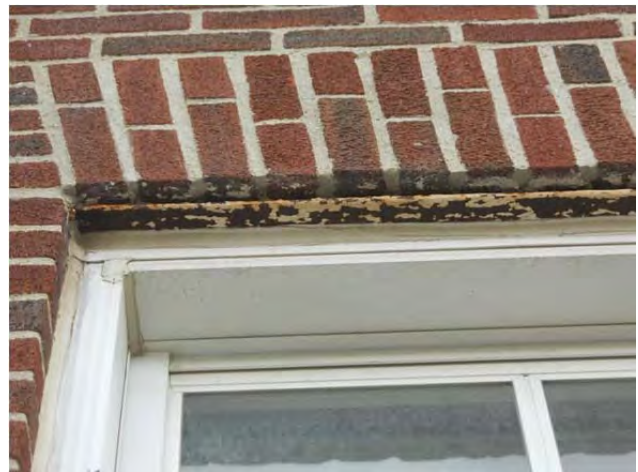
During the 2007 work, many of the steel lintels at window openings were replaced; however 25 of them were not. The remaining steel lintels do exhibit signs of rust. During this work, original terra cotta keystones were

Corroded steel lintels at B wing require cleaning and repainting.

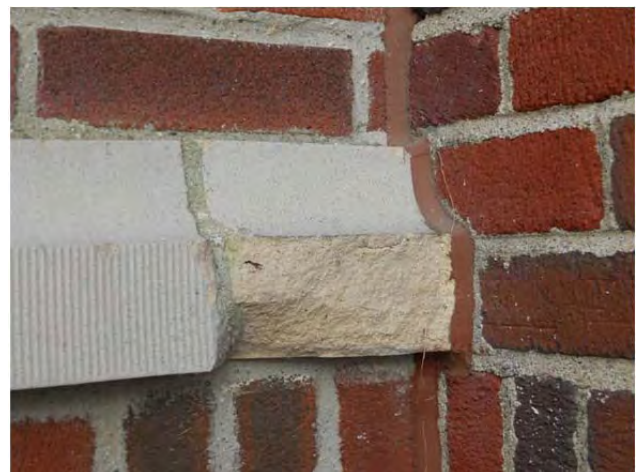
Broken piece of terracotta stone on B wing.

replaced with cast concrete replicas; these appear to be in good condition. There is one piece of original terra cotta at the west side of the original building that is broken.

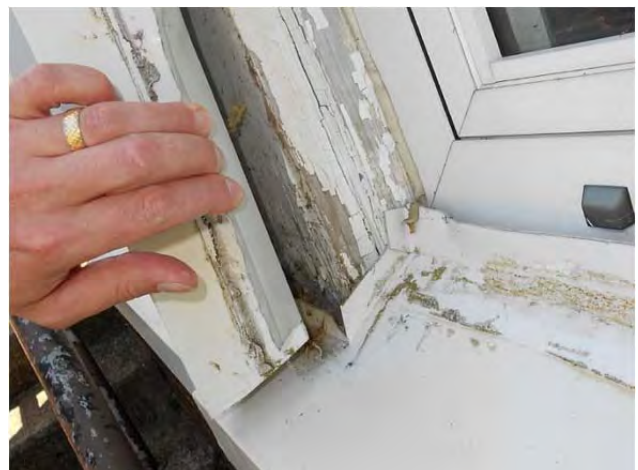
Loose panning around original trim at A wing can compromise existing substrate(s)

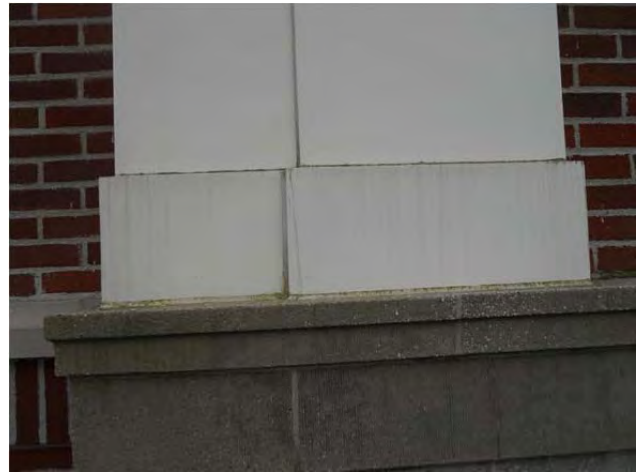
Sealant joints at GFRP pilasters with vegetation and staining.

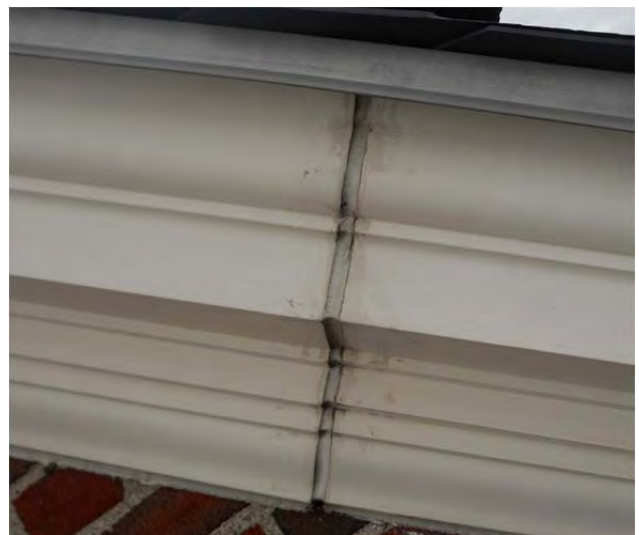
Large sealant joint at butt seam of GFRP raking eave

These larger butt joints may be more susceptible to failure.

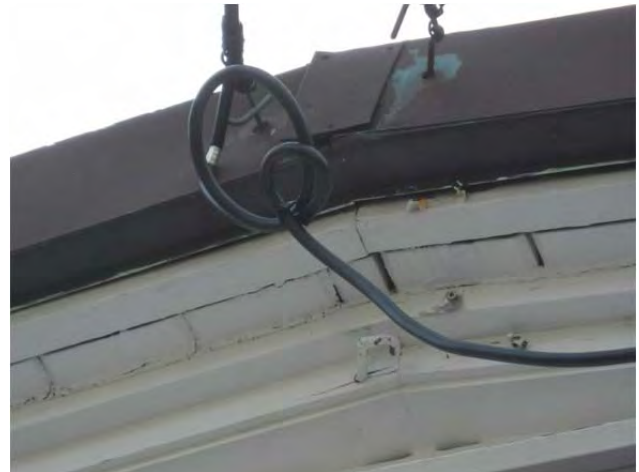
In addition, along the gable wall rakes, areas of the structural roof deck are exposed as soffits. These areas show signs of water infiltration, wood shrinkage, and end-grain rot from exposure.

Exposed structural deck at the gable end of C wing is showing signs of exposure to moisture

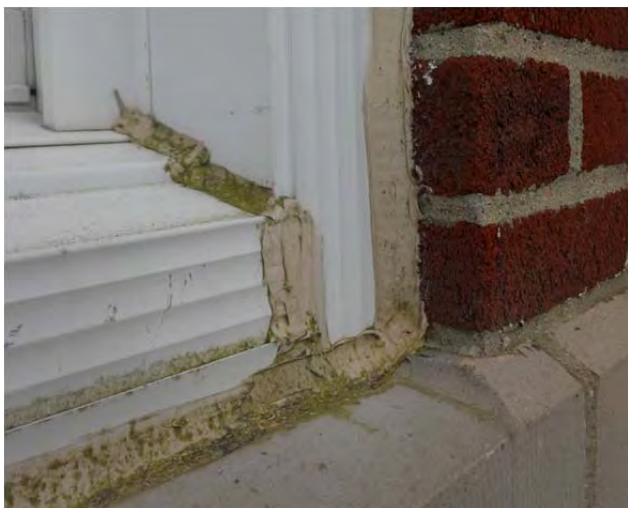
Poor sealant installation, mold accumulation, and staining at sealant joints

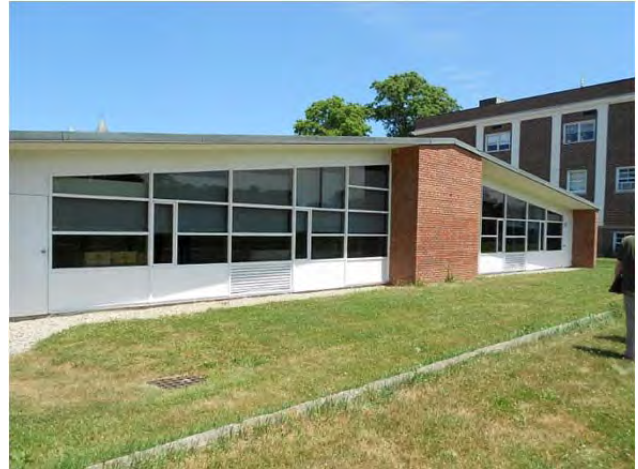
Original wood window system at C wing with non-tempered plate glass facing ball fields

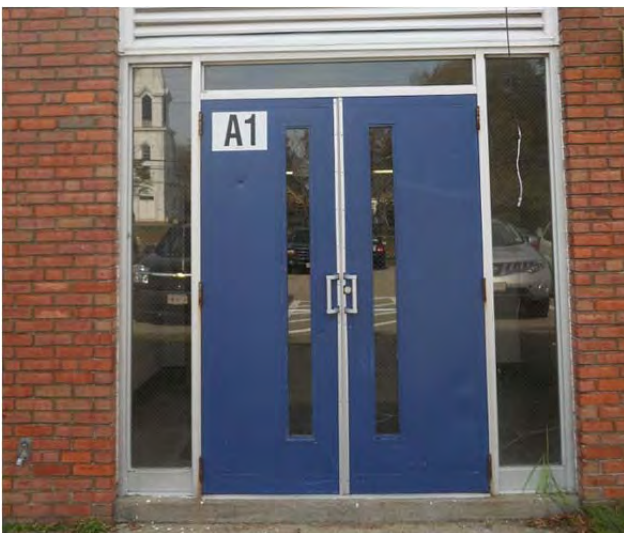
Antiquated hardware and plate glass mean the doors should be replaced

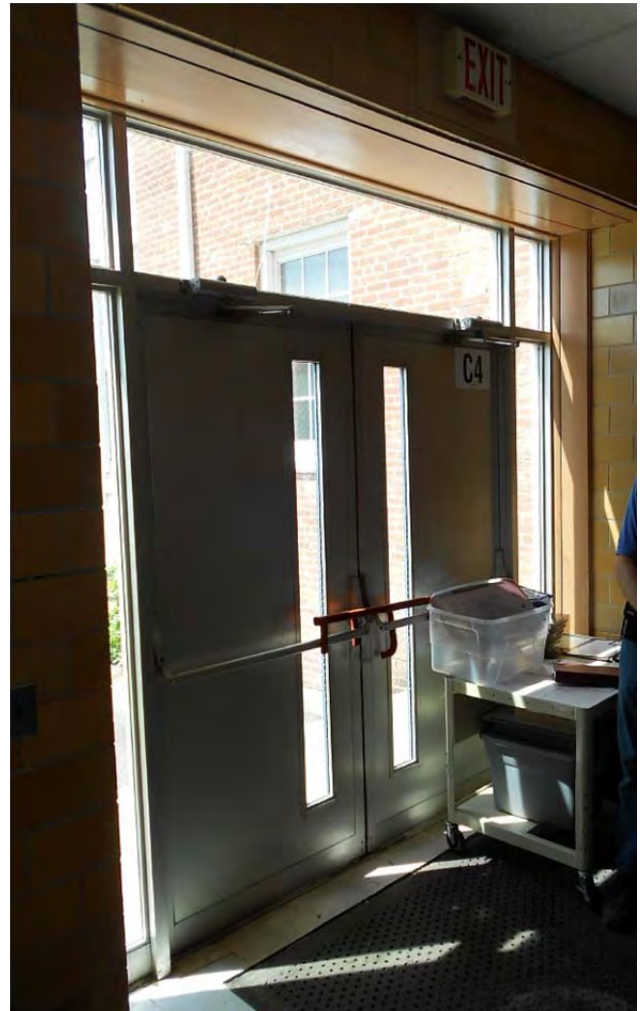
Interior locking bars at egress doors are against Code

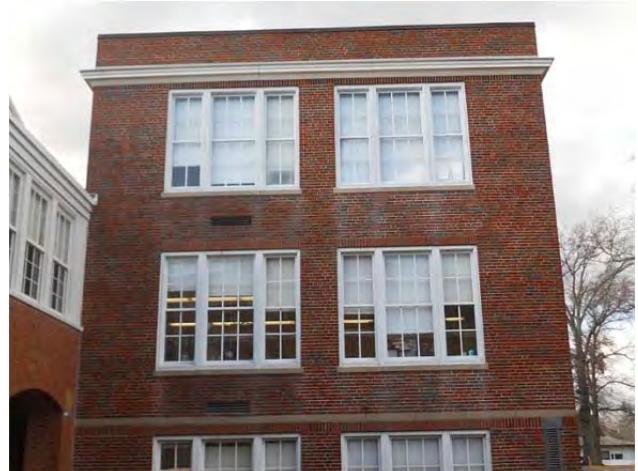
Thin metal thru-wall louvers for unit ventilators are not stormproof and could allow water infiltration.

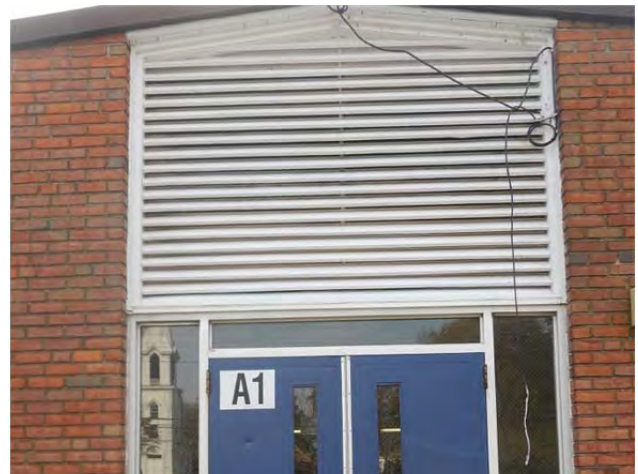
Wood louvers are straight bladed with no provisions to stop water infiltration.

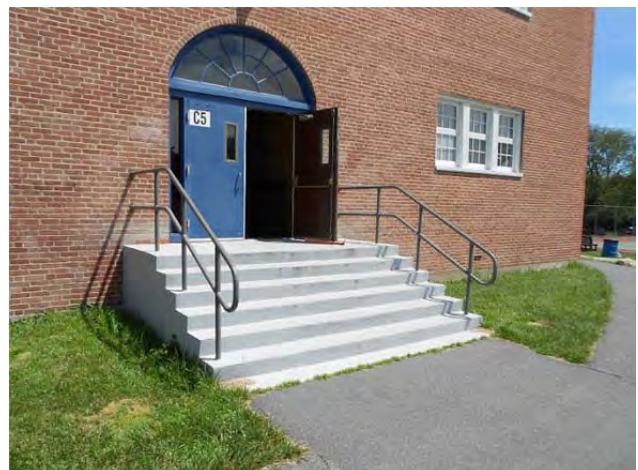
Egress stairs are close to compliant. This stair in A wing only lacks compliant guardrails.

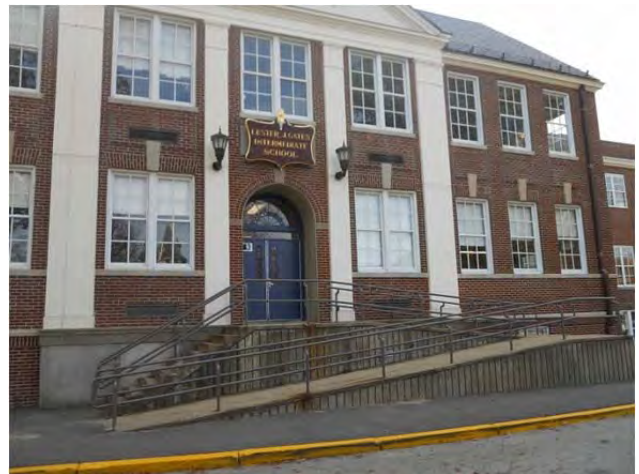
Main entrance stair and ramp at B wing has significant compliance issues.

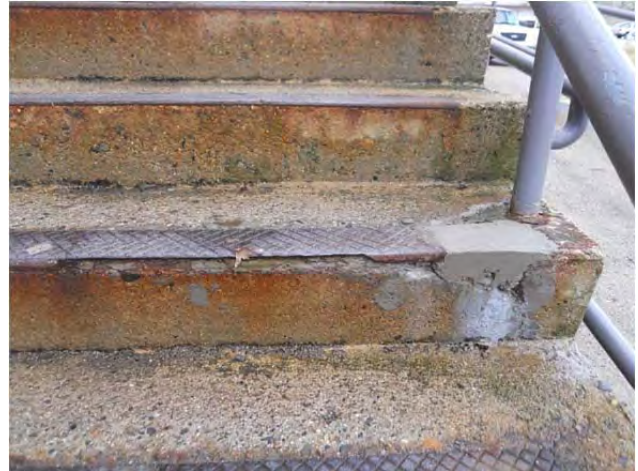
At the main entrance, the concrete ramp and stairs with metal railings are in poor condition due to age and water damage. The concrete is heavily degraded and metal components such as railings and treads have caused rust jacking. The concrete has been patched several times to repair the spalled concrete, but these repairs are also now failing. The ramp is the required 48" wide, with a slope of greater than 1:12 but still is not fully compliant with the Massachusetts Architectural Access Board ("MAAB"). It has a vertical rise of greater than 30 inches between landings, lacks edge protection and does not have the required 60 inch turning radius at the area in front of the main entry doors. Also, the guardrails do not meet current building code requirements. The top of the guard is only 2'-9" high where 3'-6" high is required.

Main entrance stairs and ramp at B wing have rust jack and patch failures.

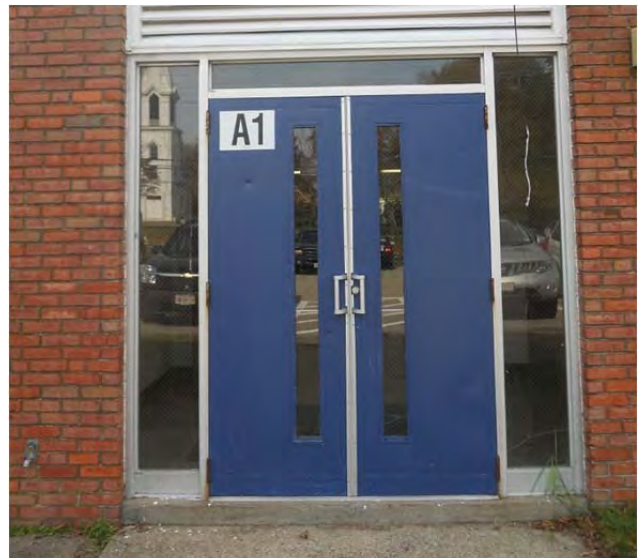
Although the building sits nearly flush with grade, there are still deficiencies with vertical access. The north egress doors have a single step down immediately upon exiting the building. This is a tripping hazard and a non-accessible doorway, neither of which are permissible by code.

Even on-grade C-wing isn't handicapped compliant with a step down at the egress door.

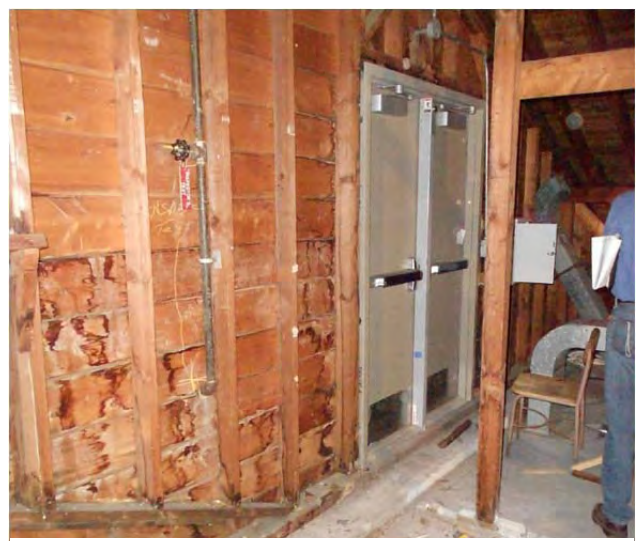
New roof access doors in A wing's attic. Note the old water staining to the left.

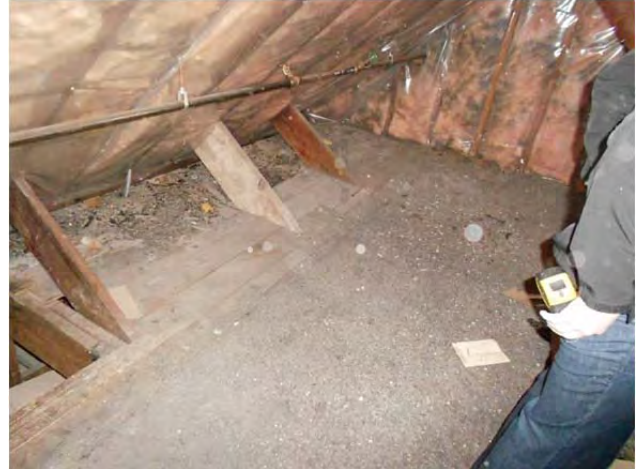
The original tar and gravel roof remains in place in the B wing attic.

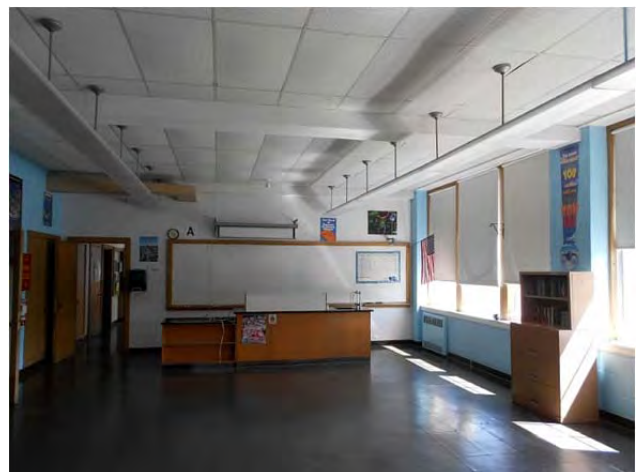
2x4 ceiling tiles are sagging between the grid, showing signs of humidity and age.

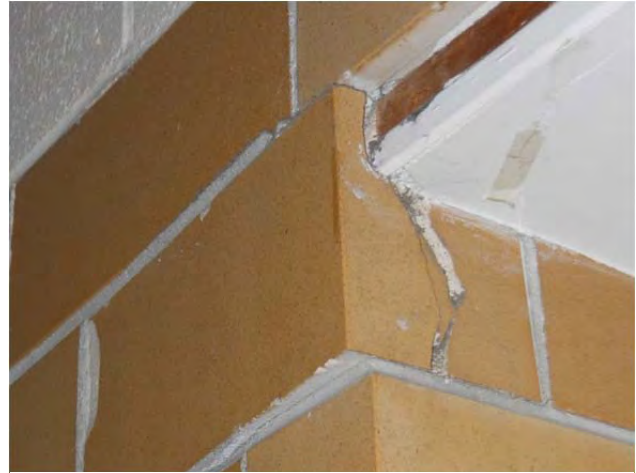
Cracking of the glazed block walls in A wing

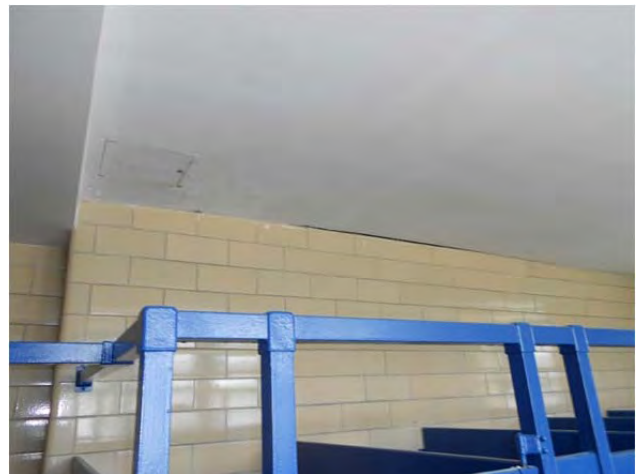
Subsidence of the glazed block walls in A wing

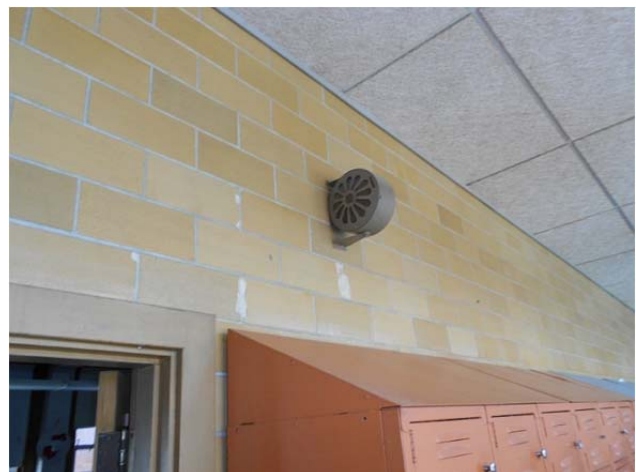
Spalling of the glazed block face appears throughout A wing, although the locations and extent are random.

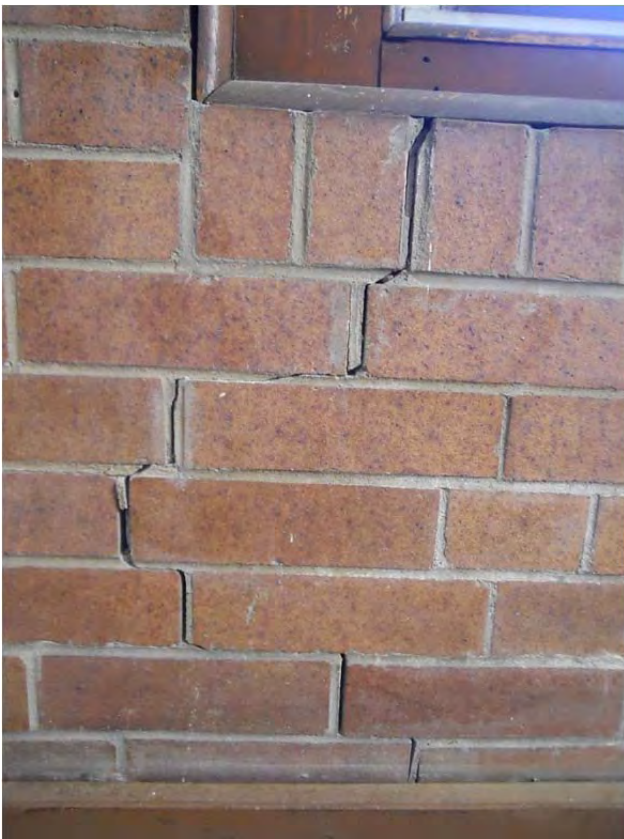
Crack above the door head, west elevation of the southwest stair in B wing.

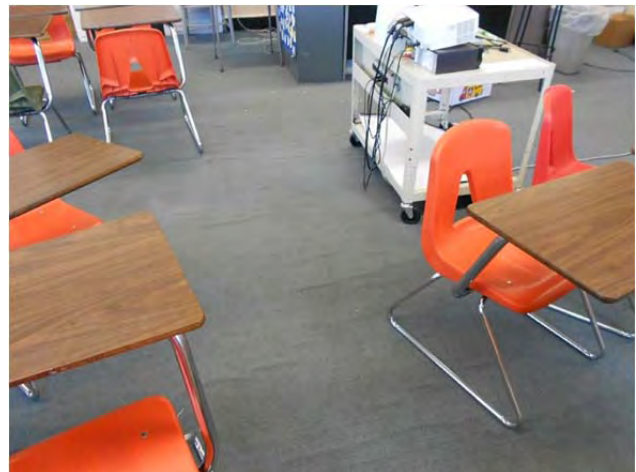
Classroom carpets are stretched, causing ripples, tears, pulls, and tripping hazards.

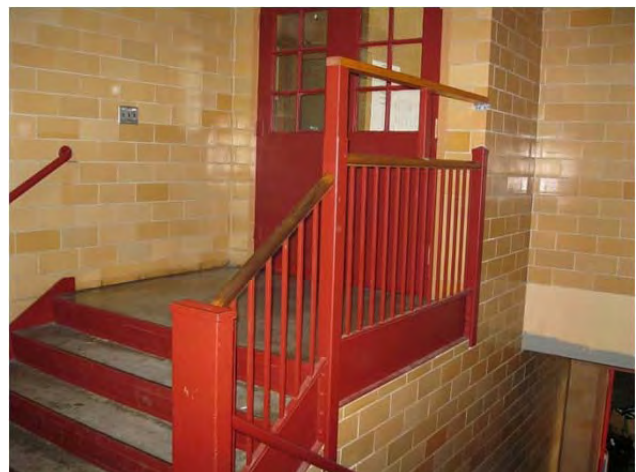
Non-compliant stair guardrails and handrails

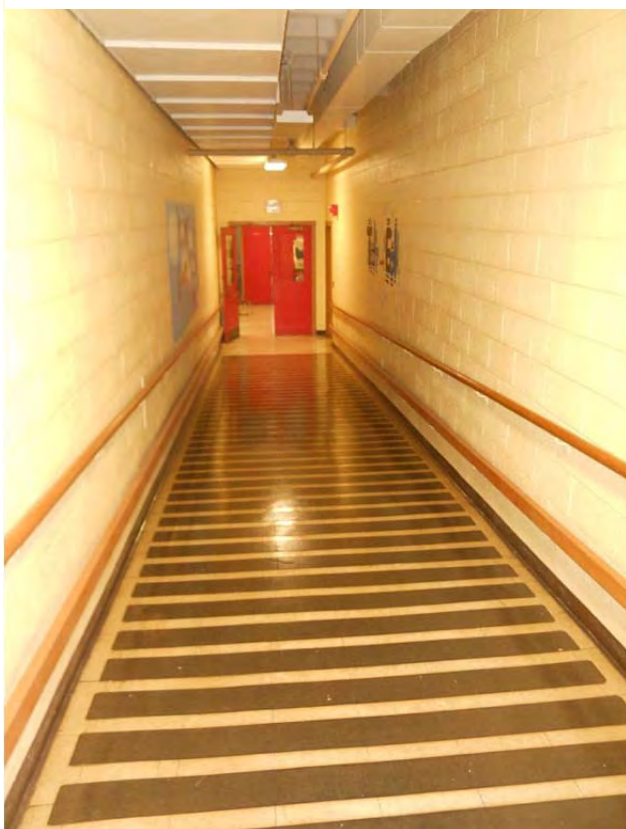
Many ramps are missing one or both required landings

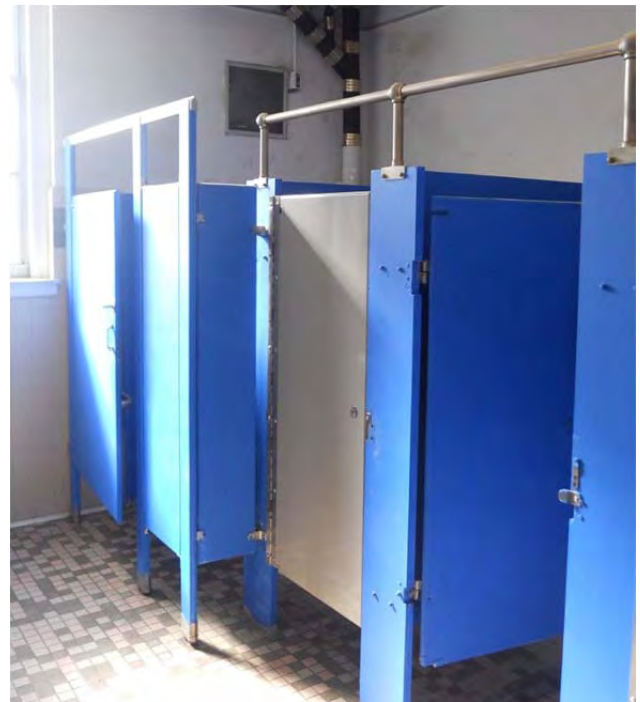
Modified restrooms are not in good condition and need to be renovated in their entirety.

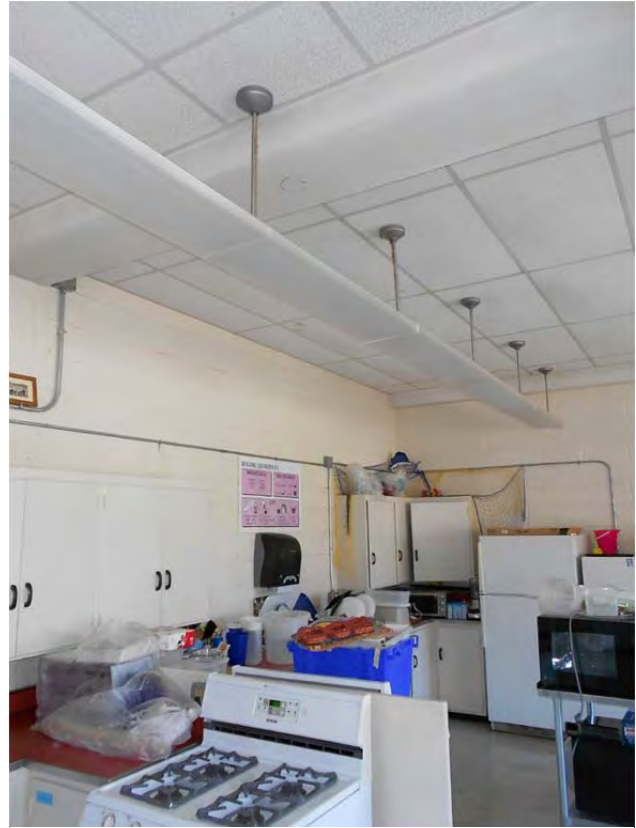
No ventilation hoods over cooking appliances

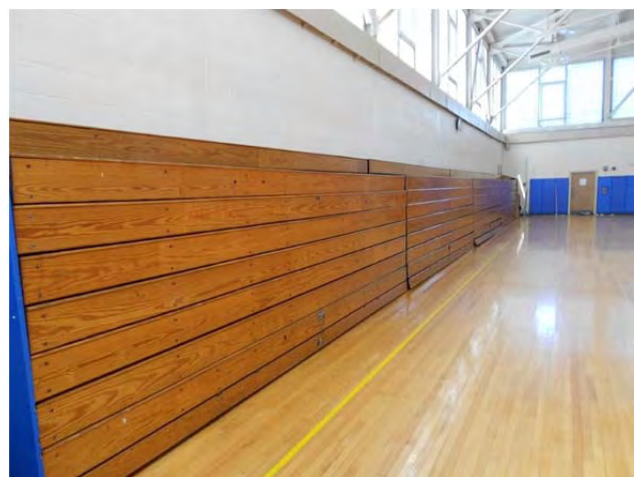
The gymnasium bleachers are in good shape but lack proper aisles, handrails, and guardrails.

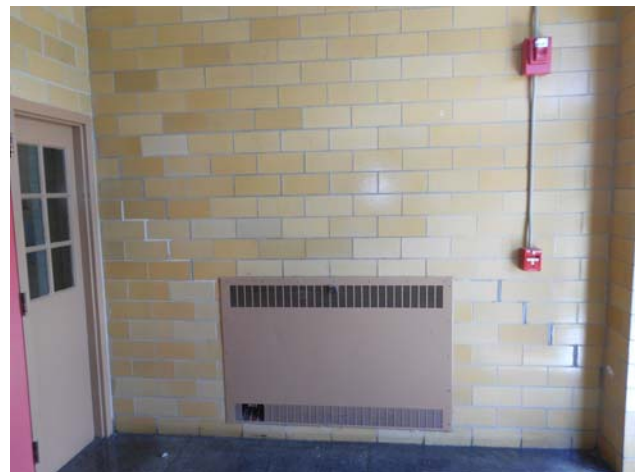
Cracks in glazed block caused by building movement (floor deflection).

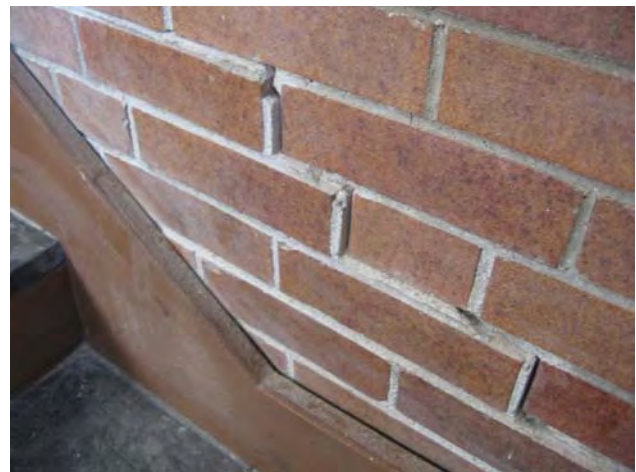
Out of plane cracks adjacent to southwest stair (B-Wing).
