## PART ONE – EXISTING CONDITIONS (STRUCTURAL)

### A. GENERAL STRUCTURAL OBSERVATIONS

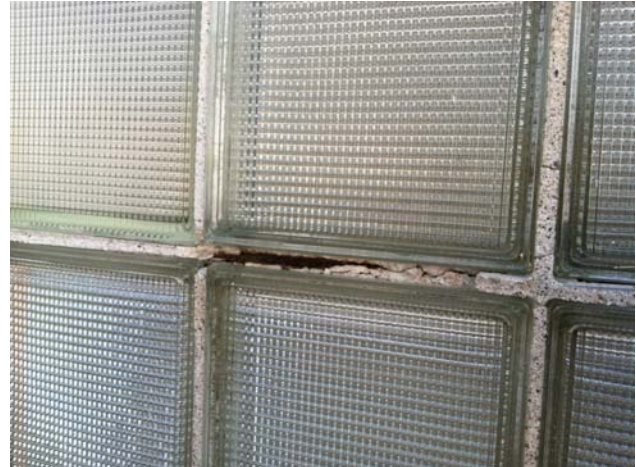
Rusting steel supports in glass block mortar joints at upper gymnasium wall (A-Wing)

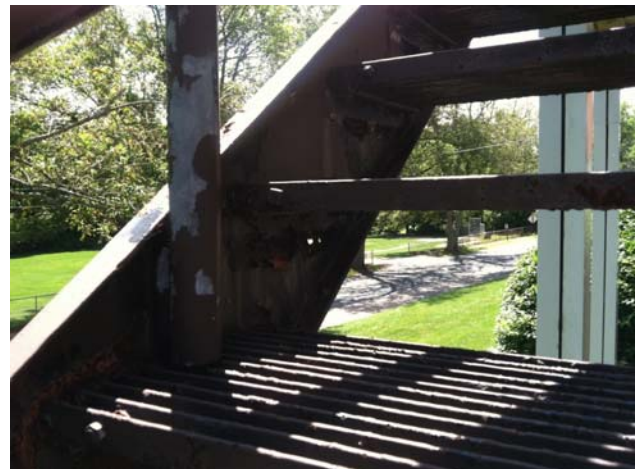
Deteriorated steel stringers and treads at gymnasium east egress exterior stairs.

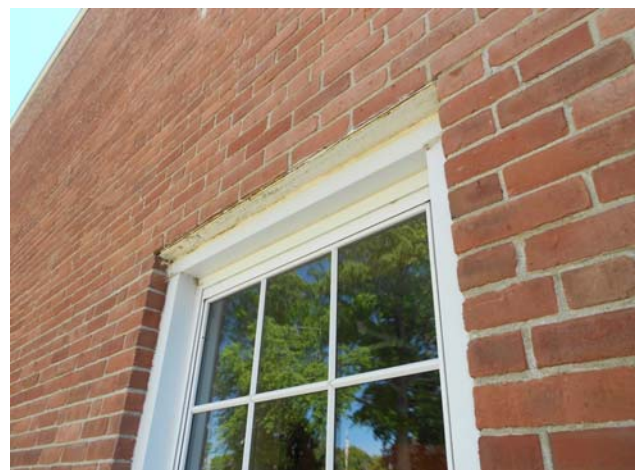
Peeling paint and rusting lintel at A-Wing.

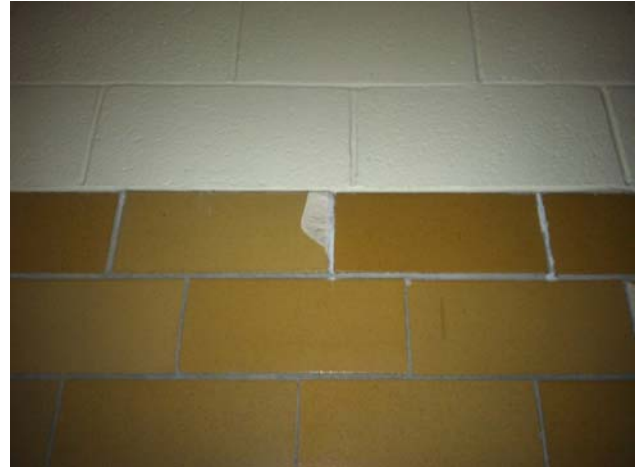
Random spalling of interior face of glazed block.

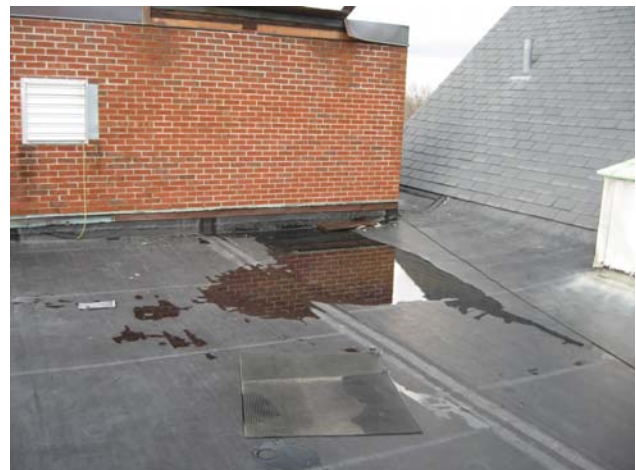
Vertical roof projection – added snow drifting.

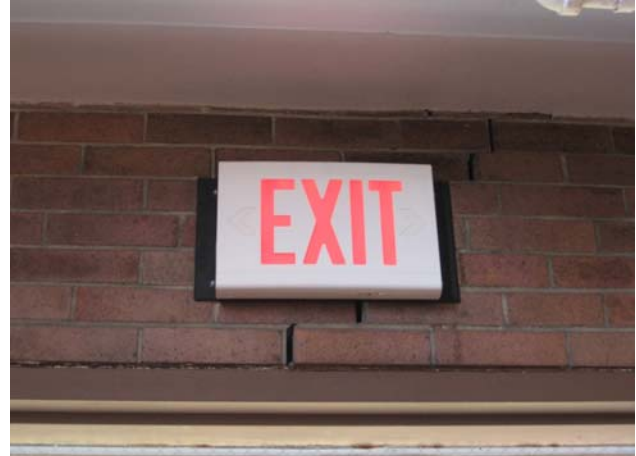
In-plane cracks over door in southwest stair (B-Wing).

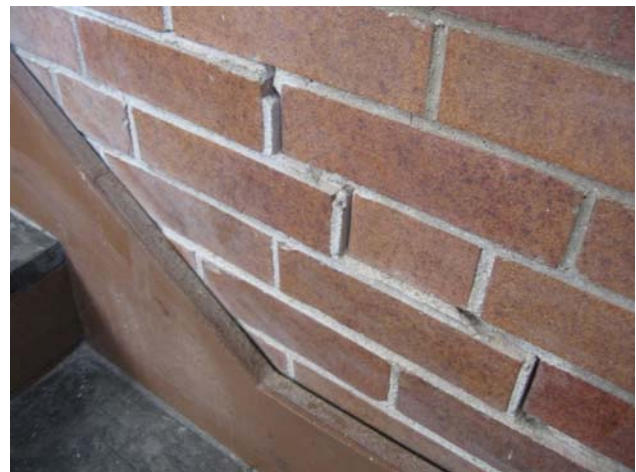
Out of plane cracks adjacent to southwest stair (B-Wing).

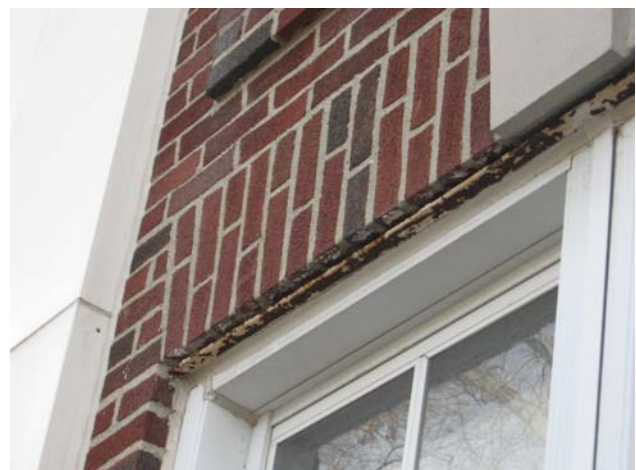
Deteriorating lintel at B-Wing.

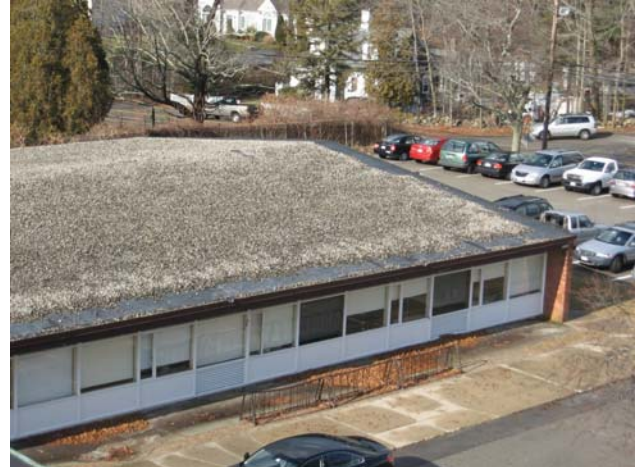
Missing roof ballast along roof edges (C-Wing).
