## Attachment 5 Wampanatuck School - Current Playground

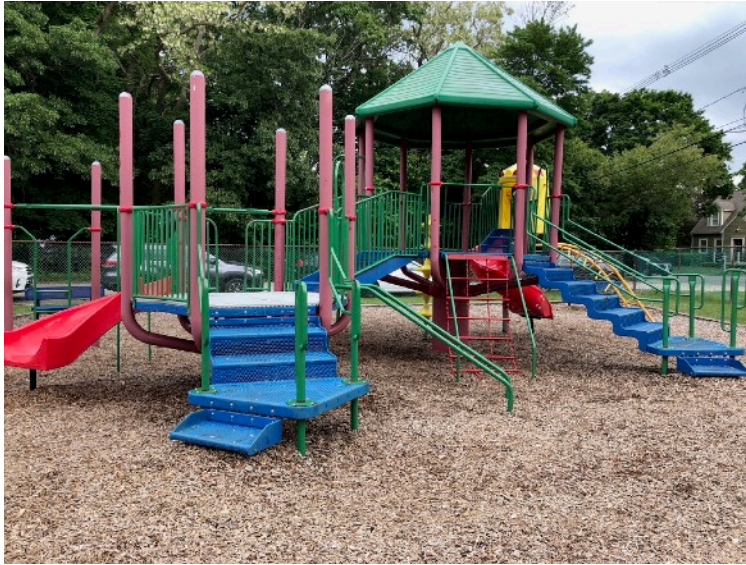
Current play structure is nearly three decades old, is deteriorating, and does not meet current playground safety standards. We have explored the possibility of repairing this structure, but repairs would be costly, not be compliant with current safety regulations, and could create additional hazards and liability. We explored replacing components, but due to its age this equipment is no longer available (nor are its replacement parts).

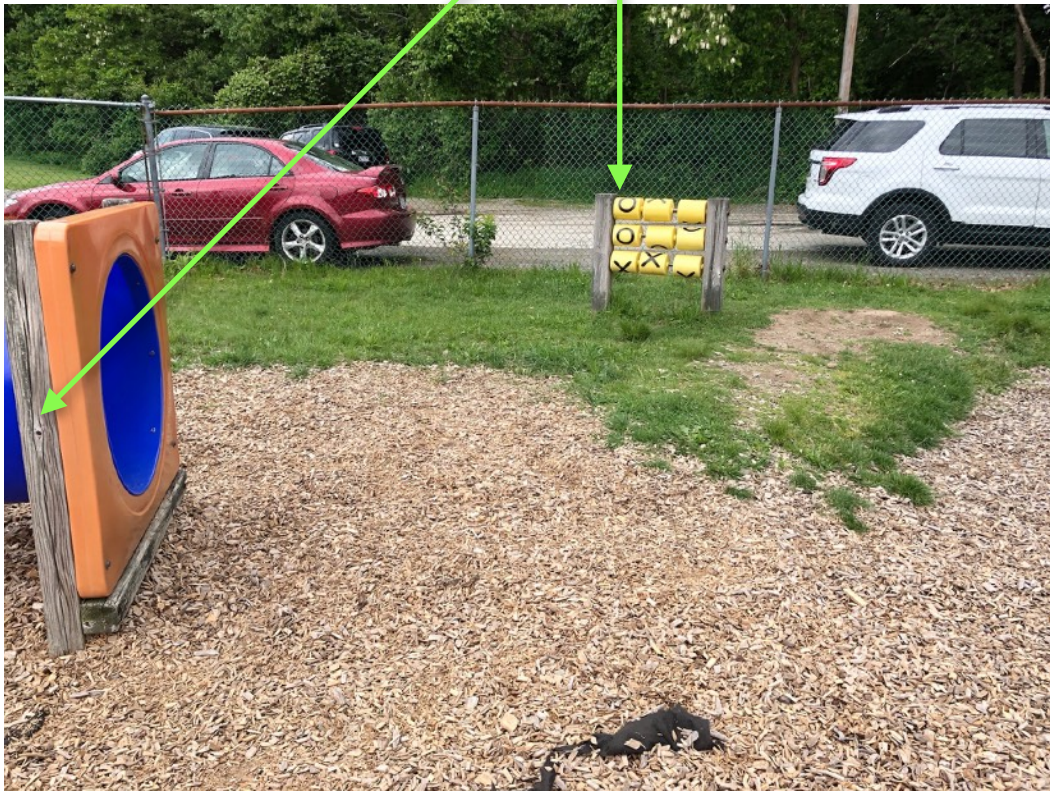
Single low level / 'inclusive' tic-tac-toe element is minimal and also not ADA accessible. This as well as the accessory 'blue tube' piece are supported by outdated/cracking wooden post elements that do not meet current playground safety regulations.

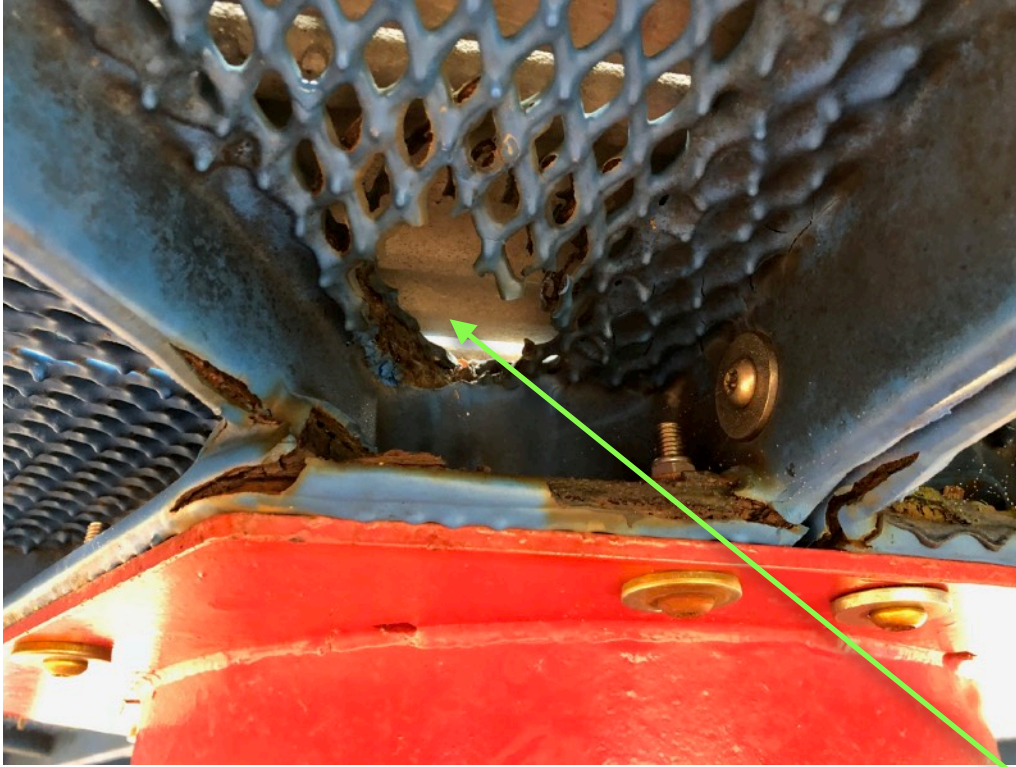
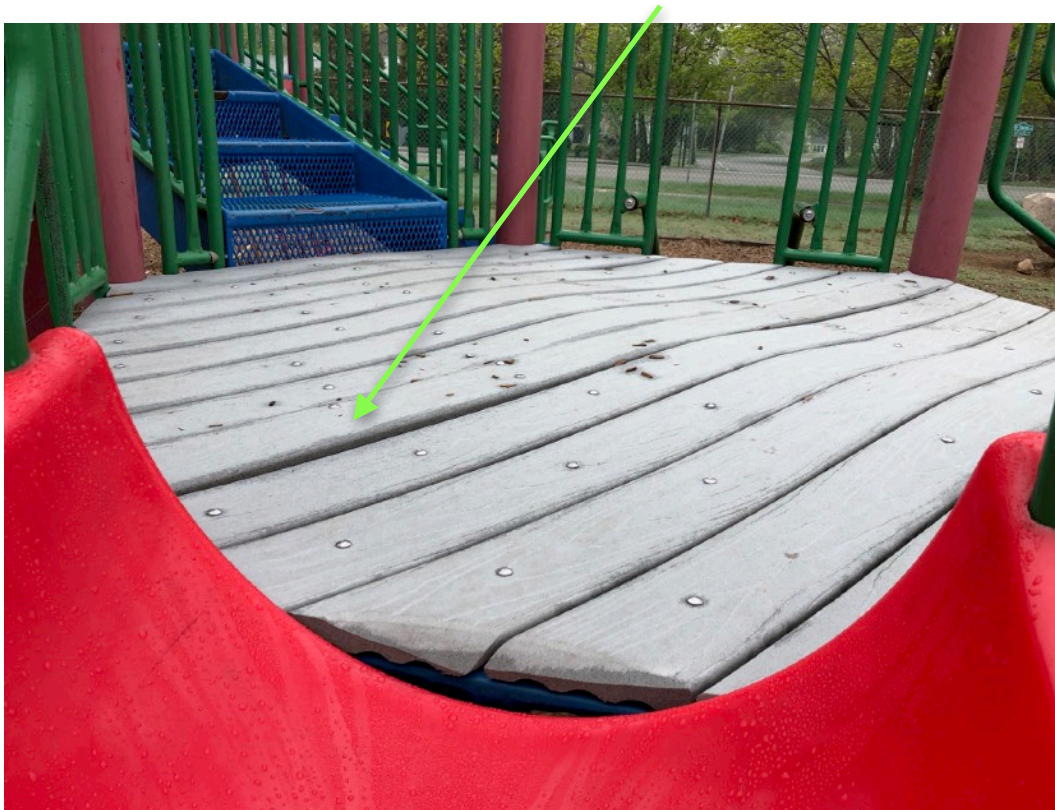
Metal mesh of the main deck of the structure is deteriorating/rusting and has holes (seen here exposed on the underside), which caused a severe safety issue as they have protruding metal pieces and were large enough for a child's foot/leg to go through. As this was a serious risk, it was addressed by covering with composite decking material after plywood patches (a previous fix) came loose and became a tripping hazard. Unfortunately, the decking is uneven/wavy as it is bolted to an uneven surface, and safety/tripping is still a concern.

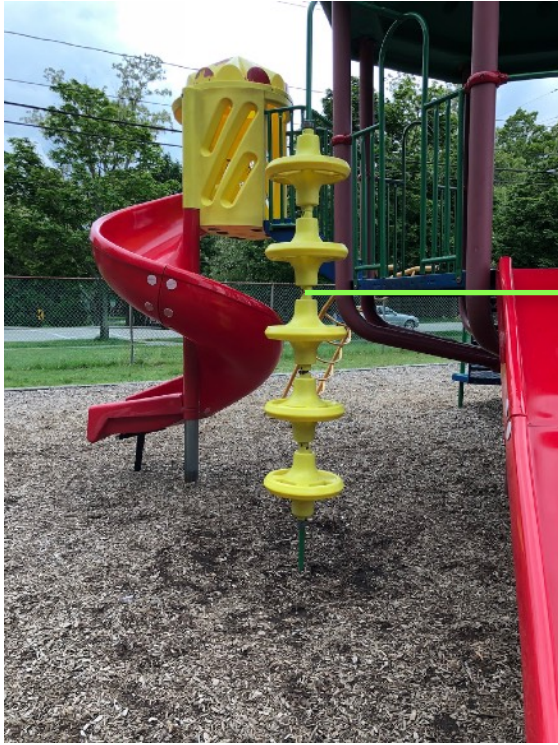
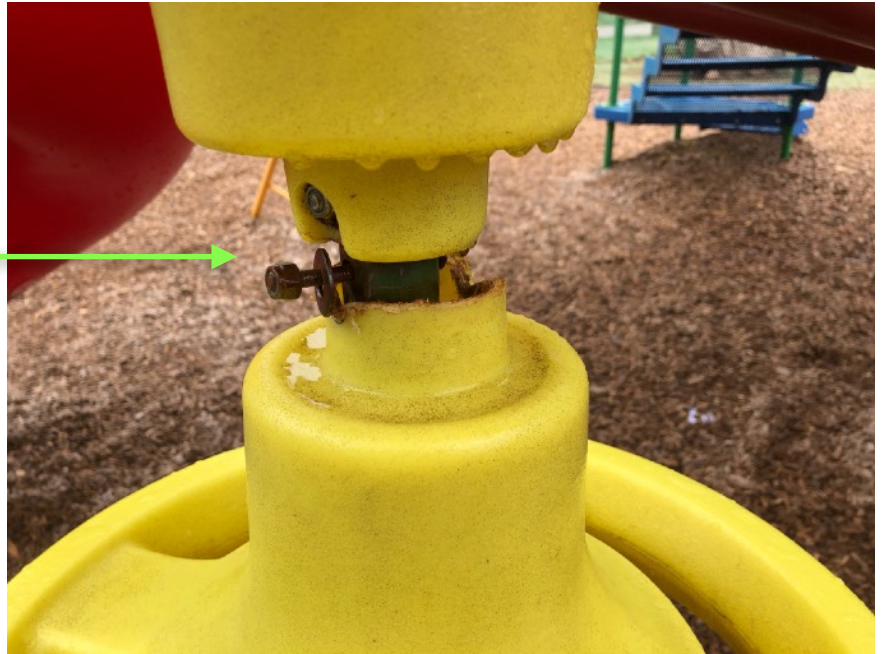
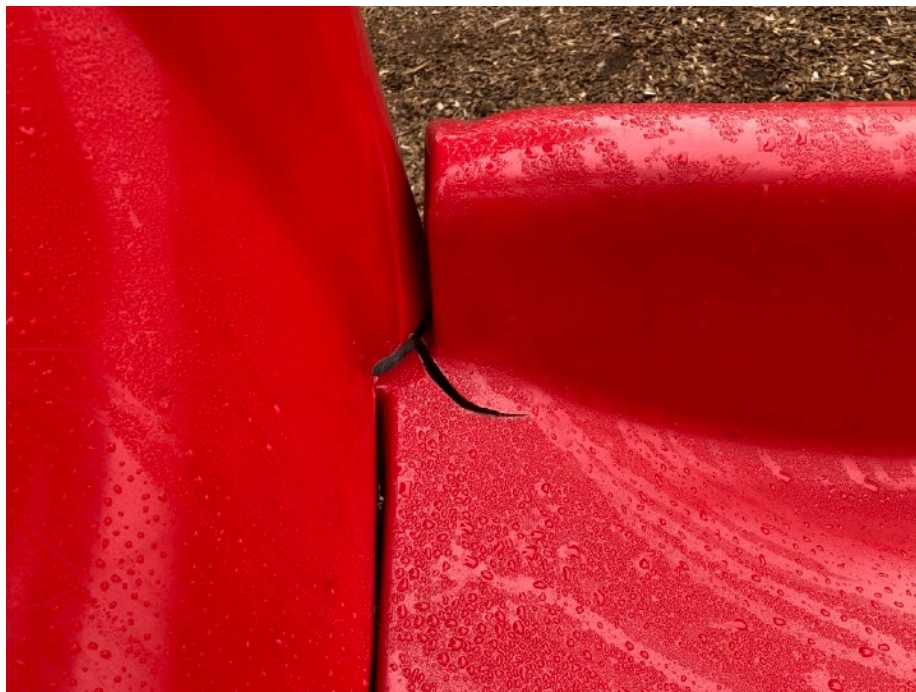
Equipment is deteriorating and structures are loose due to broken bolts and fasteners causing equipment to move/spin where they should be stationary, causing a significant safety issue. The Town has reviewed for possible repair, but can only remove these outward structures - they cannot be repaired or replaced (as parts are not available). This was not advised by playground experts as removing these outward structures could compromise the integrity of the main structure. Slides are cracking causing risk of injury especially in areas that are along the slide hold rails.

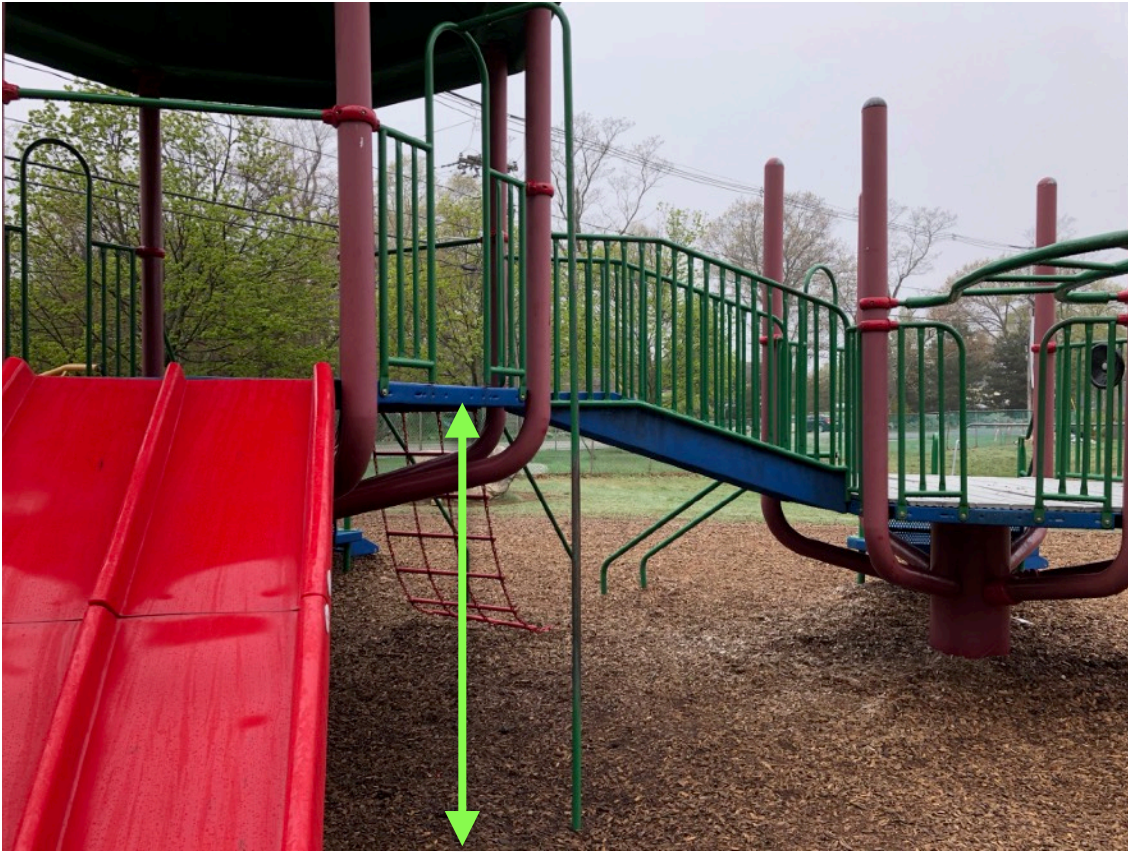
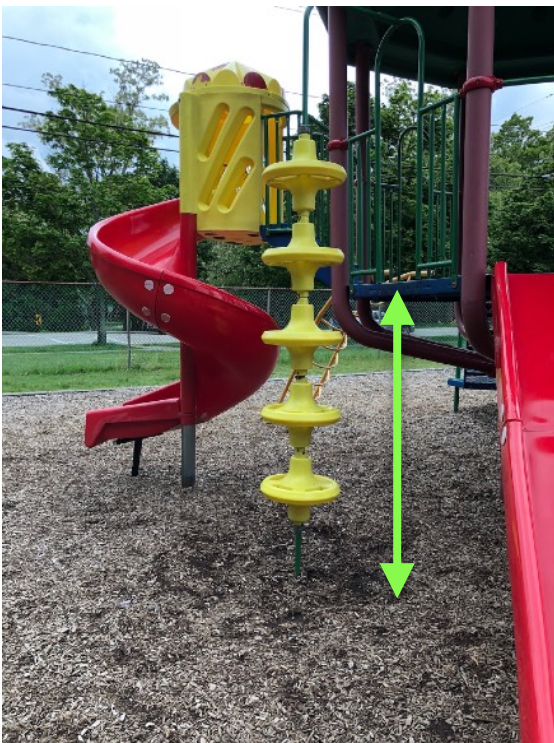
Regular replenishment of wood-chip surfacing to the safe required 12" depth is a challenge (this is very costly for the Town and the chips biodegrade rapidly), and as such it has compacted to a low, unsafe depth that does not meet fall height safety requirements.

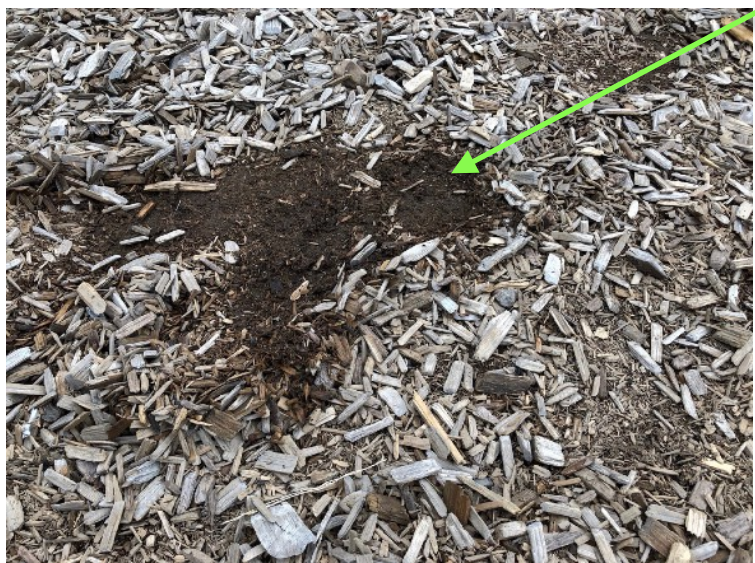
Wood chips should be 12" uncompressed per current playground safety codes. Current uncompressed area of wood chip surface is just a few inches deep, causing higher risk of fall injuries. We are recommending poured-in place surfacing to minimize this annual maintenance and cost to the Town and address fall safety issues.

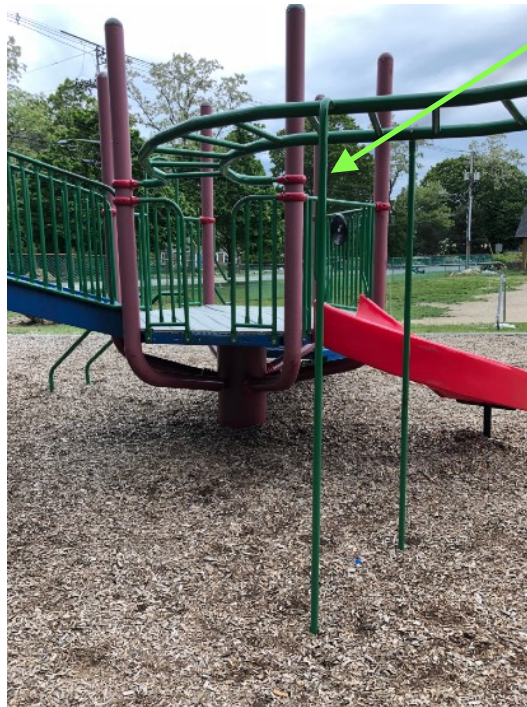
Monkey bar side supports are loose — these have been repeatedly tightened but continue to come loose with use of the equipment as the bolts no longer hold a tight connection.

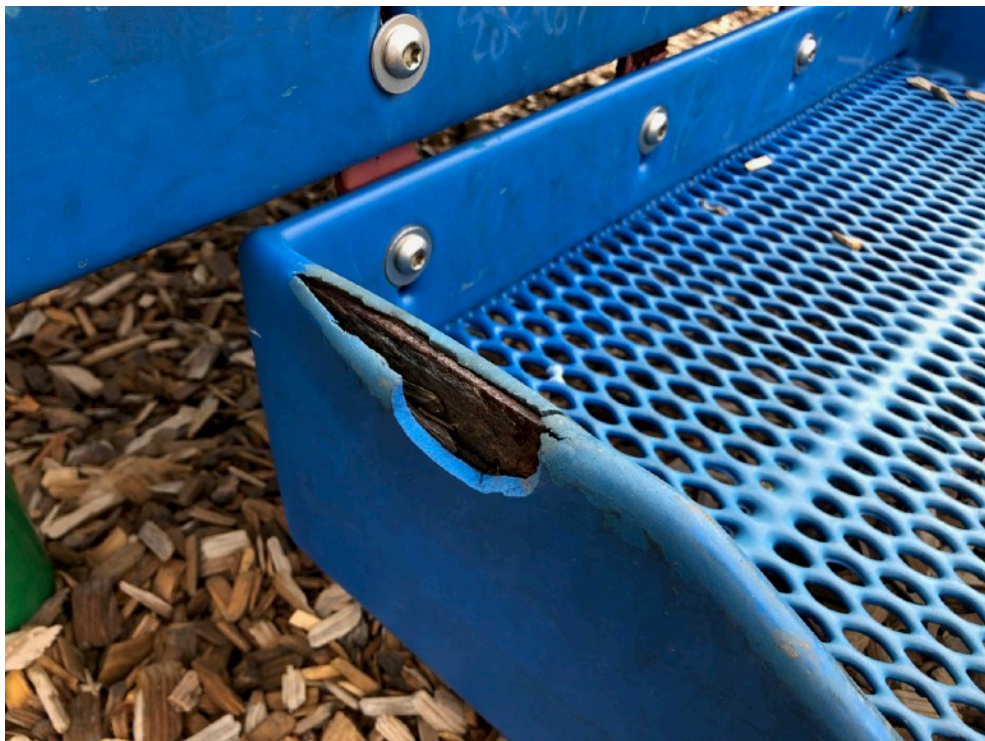
Equipment coating is deteriorating causing exposed, rusted metal surfaces.
