SCITUATE PUBLIC SAFETY

FEASIBILITY STUDY

FINAL REPORT

May 22, 2014

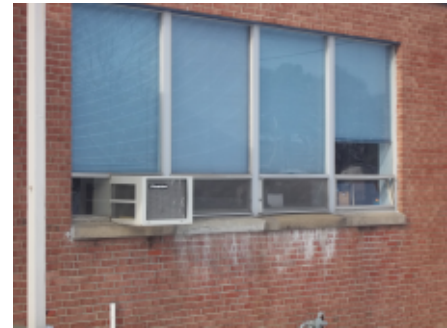
- There are some areas where brick is showing efflorescence which indicates moisture in the walls. Re-pointing is required especially above the Garage Doors
- Instances of stained precast window sills due to moisture
- Instances of rusted steel lintels

Efflorescence at Window Sills

- If possible, increase insulation at exterior walls to improve thermal envelope to insulation values of between R11.5 and R13 continuous insulation. This is very difficult with this type of construction
- Repair and re-point brick veneer at locations indicated
- Determine if moisture is seeping into precast sills and make necessary corrections
- Wire brush, clean and paint steel lintels where rusting occurs

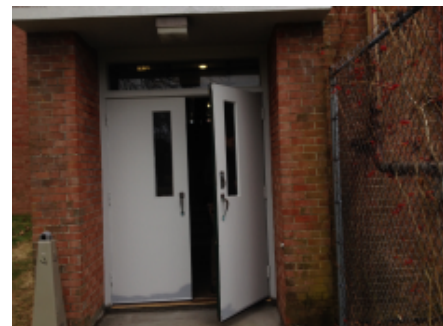
- The Public Entrance is single pane glazing with wood doors. This area is not energy efficient
- The doorway, stairs and ramp railings are not ADA compliant
- The Public Entrance is not a secure entrance and lacks bullet proofing
- Other doors appear to be non-insulated hollow metal doors. They function properly but are not energy efficient
- Doors are not ADA compliant
- The second story fire escape coming from the Detention area is unsafe.

Typical Exterior Doors

- Replace public entrance doors with energy efficient, ADA compliant security doors and sidelights.
- Replace all other doors with insulated energy compliant doors
- Review the use of proximity or keypad type locks for access into the building
- Provide safety rails at fire escape

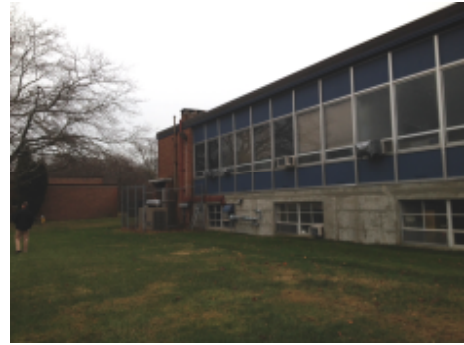
- Water infiltration has been reported through the aluminum storefront window panel system
- The spandrel storefront window system is not energy efficient. We suspect the spandrel panels have a low insulation value

Typical Exterior Wall with Storefront

- Replace window spandrel panel system with more energy efficient system
- Replace window spandrel panel system using energy efficient insulated glazing with low “E” and argon gas filled air space and solid infill insulated walls instead of spandrel panels.

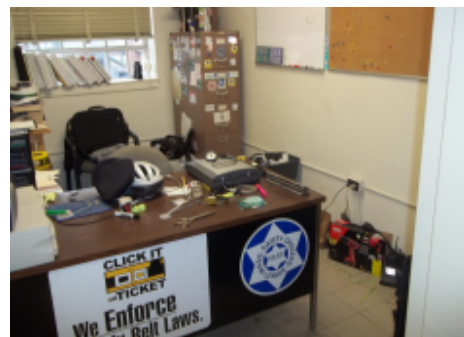
Overcrowded Office Space

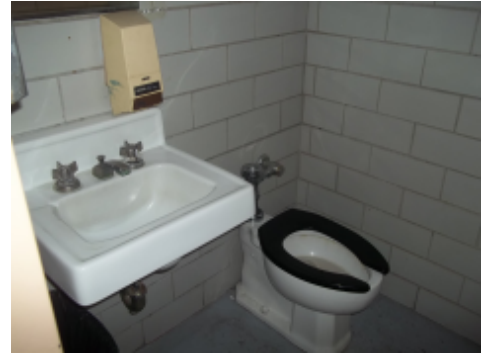
Non ADA Compliant Toilet

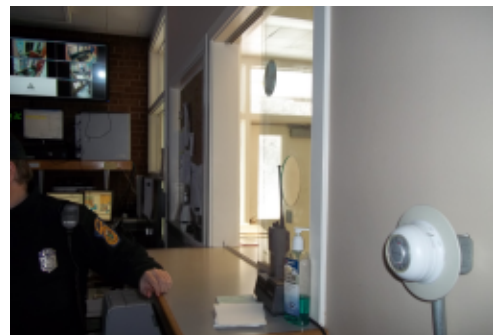
Non-secure Reception Window at Dispatch

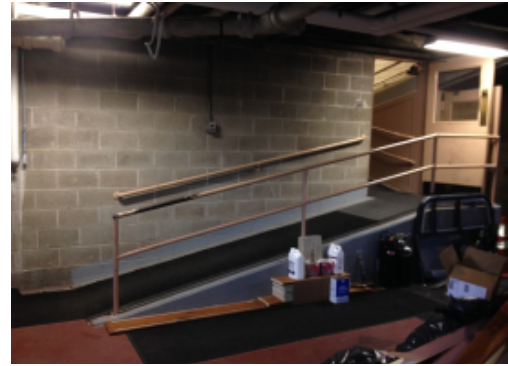
Steep ramp from Sallyport to Booking

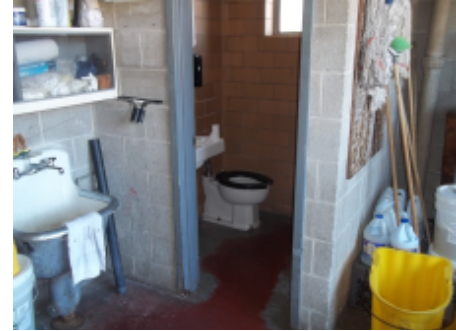
Dirty Restroom

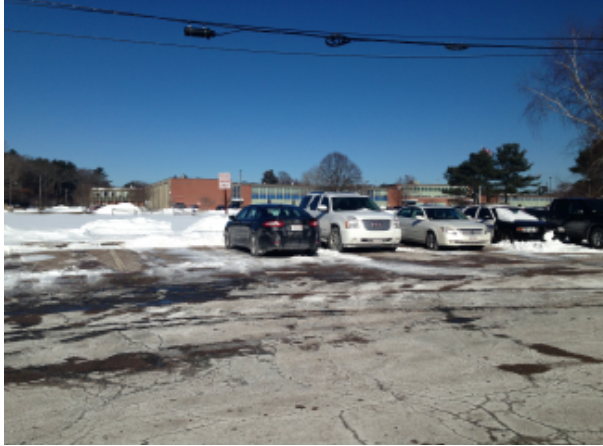
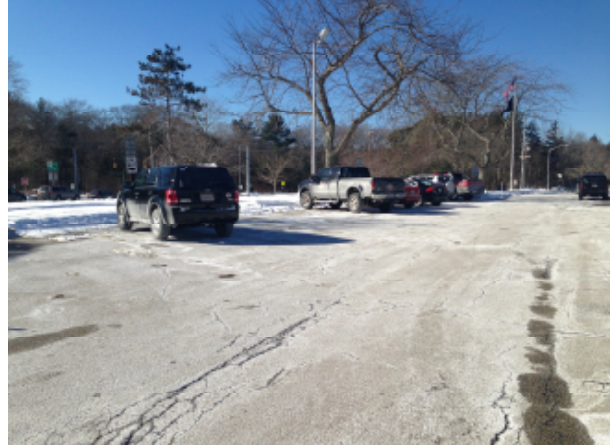
The asphalt pavement in parking lots, service drives, and walkways adjacent to the site were observed to be in fair to poor condition. Pavement within the north parking lot was observed to be in poor condition with severe cracking and degradation. Pavement within the south parking lot was observed to be in fair to poor condition with cracking throughout. Due to a recent storm, some walkways were covered with snow, thereby making it difficult to determine the condition of pavement.

Figures 4 & 5: Cracked and degraded pavement in north parking lot and cracked pavement in south parking lot.

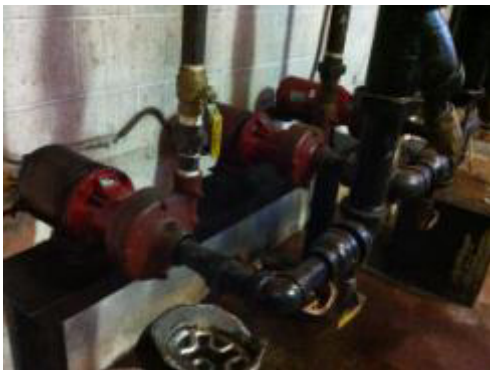
Each building is served by a single dedicated base mounted pump located in the Town Hall boiler room. The pumping system did not appear to have backup or redundancy. If a pump fails the building serviced by the pump will lose its heating hot water. Heating hot water is pumped to the Police Station and Fire Station via buried piping. The condition of the underground piping is unknown.

Base Mounted Pumps

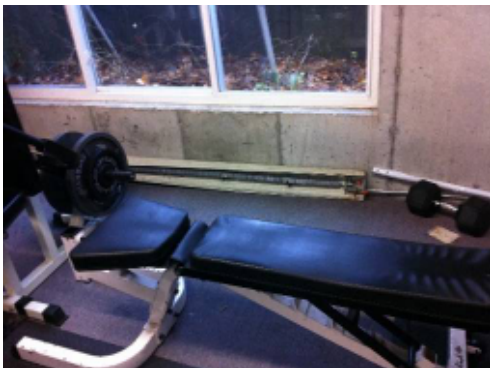
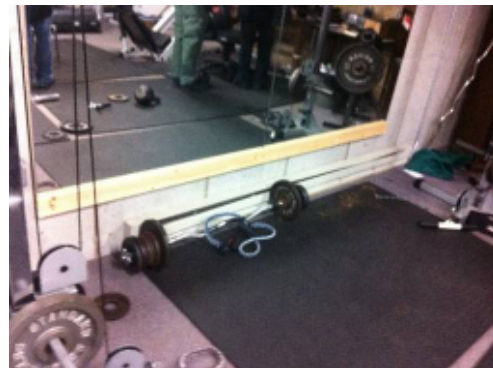
The lower level of the addition consists of the gym and storage rooms. The gym is heated by electric baseboard which is damaged. The gym is not cooled and only means of ventilation is through the use of operable windows. The gym does not have a means to exhaust the space. The storage area is heated by ceiling mounted unit heaters.

Electric Baseboard

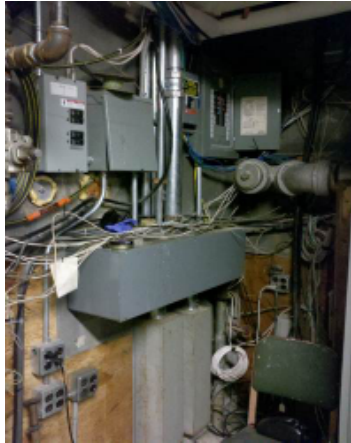
Sewer pipes exit the basement in the same corner as the electric panels, and along with water pipes over and under the panels, violates the required panel working space.

Electrical Panels & Sewer Lines

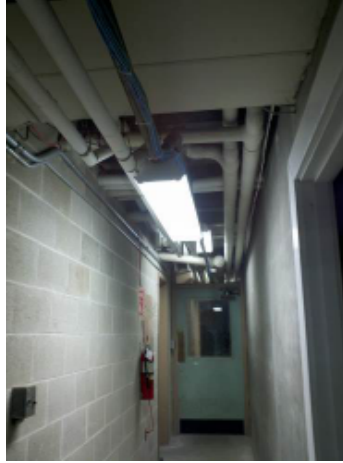
In general the condition and density of branch circuits and receptacles is inadequate. Extension cord usage due to lack of receptacles appears to be prevalent. The use of extension cords as a substitute for permanent wiring is a code violation. The facility does not have computer grade panelboards with surge protective devices and double neutrals.

Plug-In Extension Cords

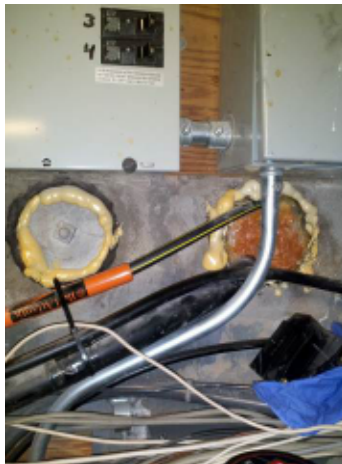
The telephone, cable TV and fiber run in one 4" underground conduit plus one 4" spare between utility poles and electric room. CAT 5 tel/data cabling are generally improperly supported from other trade's utility pipes.

Incoming Fiber & Telephone
