Facility Analysis and Assessment Plan

Gates Middle School
327 First Parish Road
Scituate, MA

February 22, 2012

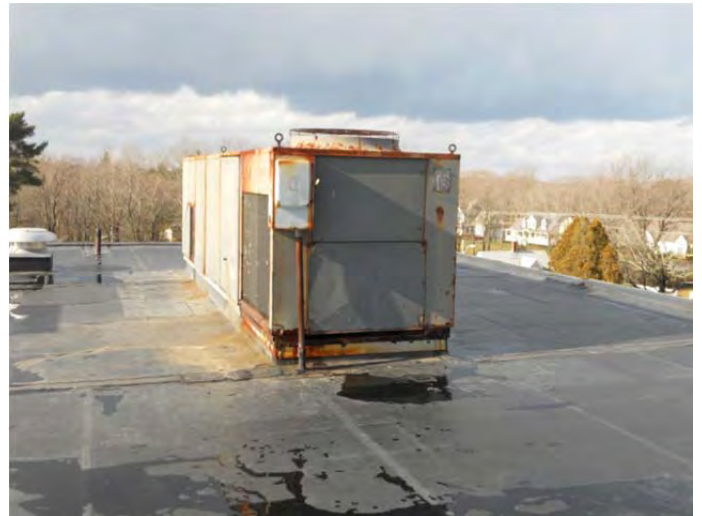
Corroded roof top equipment.

Replace metal sheds housing mechanical equipment. **PRIORITY A**

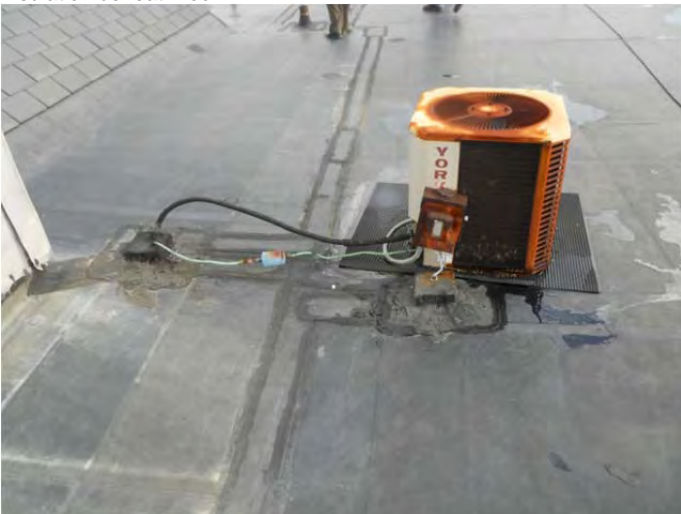
Corroded roof top equipment.

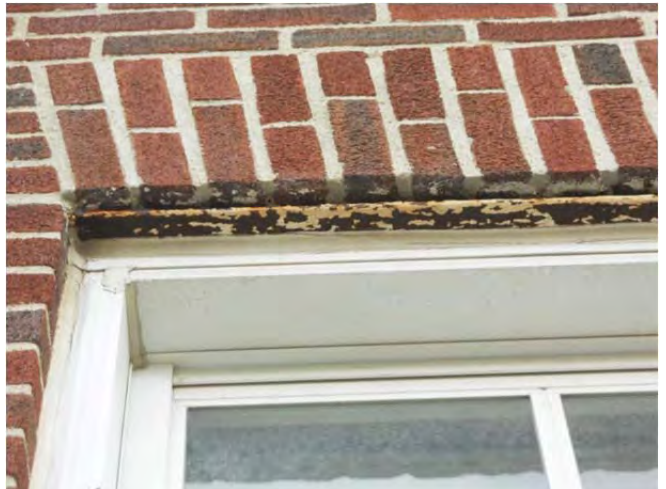
During the 2007 work, many of the steel lintels at window openings were replaced; however 25 of them were not. The remaining steel lintels do exhibit signs of rust. During this work, original terra cotta keystones were replaced with cast concrete replicas; these appear to be in good condition. There is one piece of original terra cotta at the west side of the original building that is broken.

Corroded steel lintel

Blast and paint the remaining 25 steel lintels not replaced under the 2007 campaign.

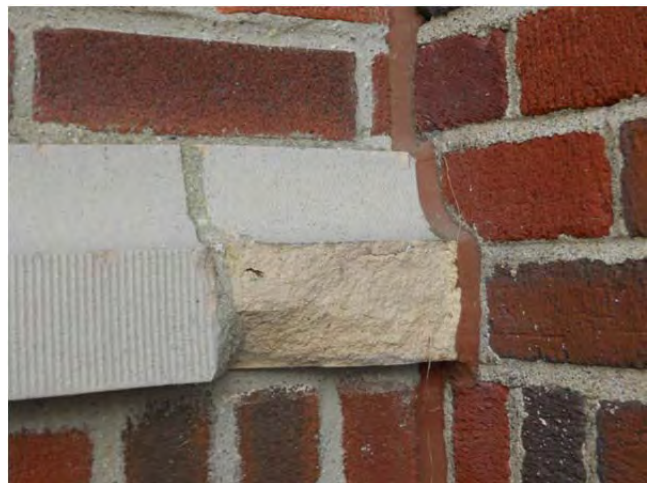
Broken piece of terra cotta

Provide Dutchman repair to the broken terra cotta string course element.

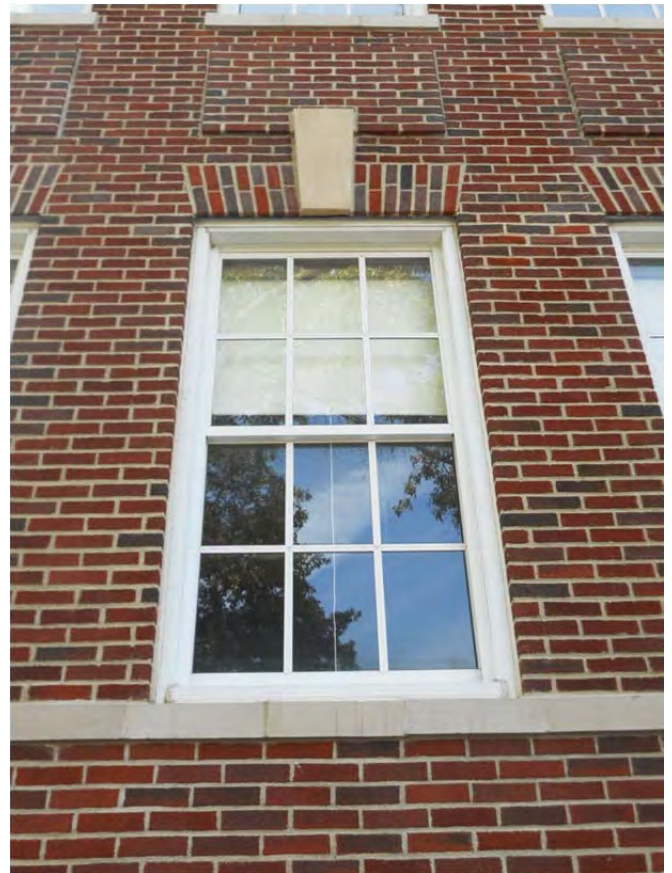
All existing metal replacement windows are not in satisfactory condition due to heavy weight, improper balancing, difficult operation, air leakage and water leakage. Many of the windows that can be opened do not remain in the open state and fall shut when not supported by alternate means.

Typical metal replacement window.

Replace all existing metal windows with aluminum clad wood windows to meet all current code requirements. See Code section of this report for additional information.

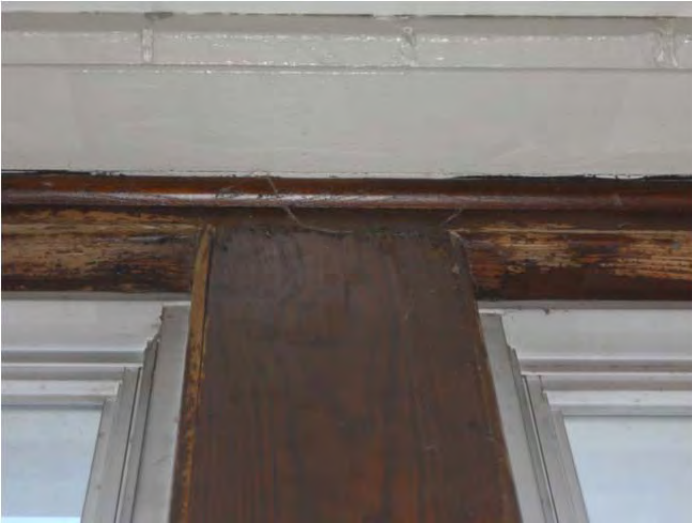
On the exterior, sealants were poorly installed and are covered in mold. On the interior, wood casings, trims and moldings demonstrate signs of peeling paint, water damage and ultra violet degradation.

Wood window trim with water damage.

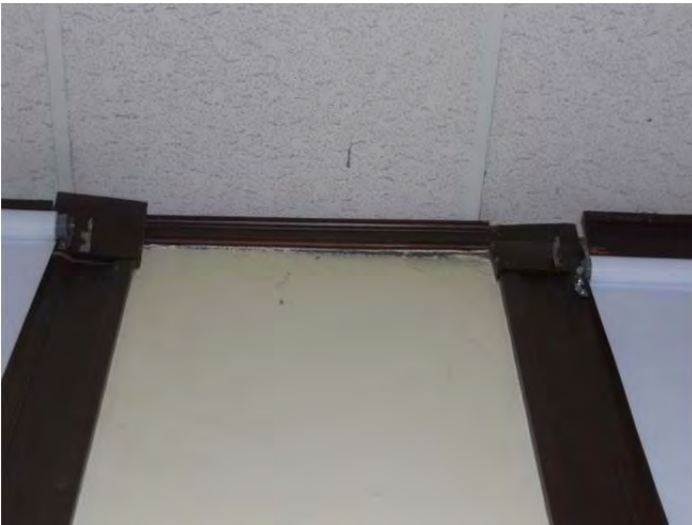
Wood window trim with water damage.

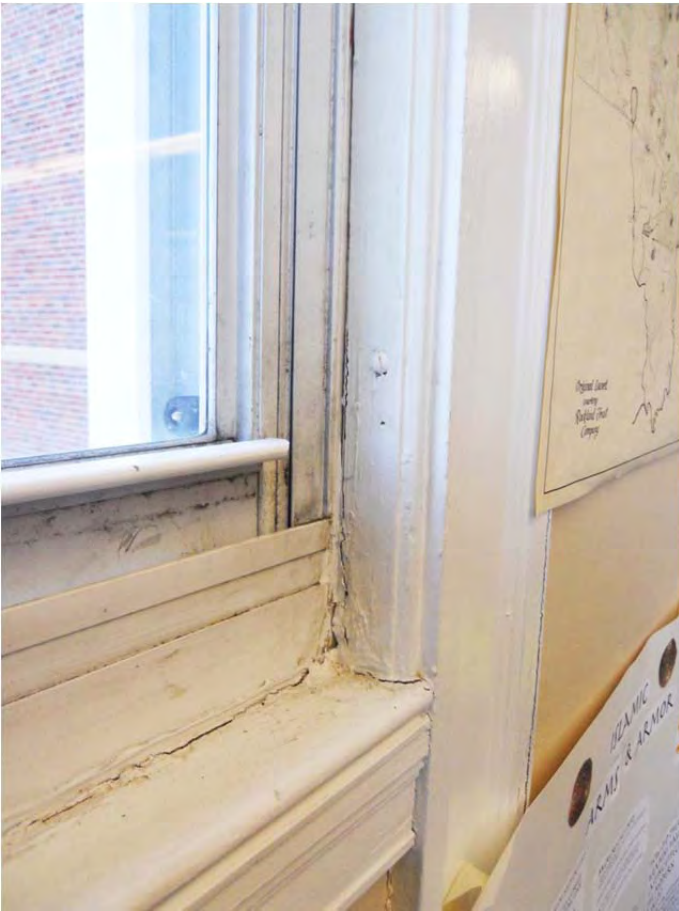
Paint failure at window frame interior.

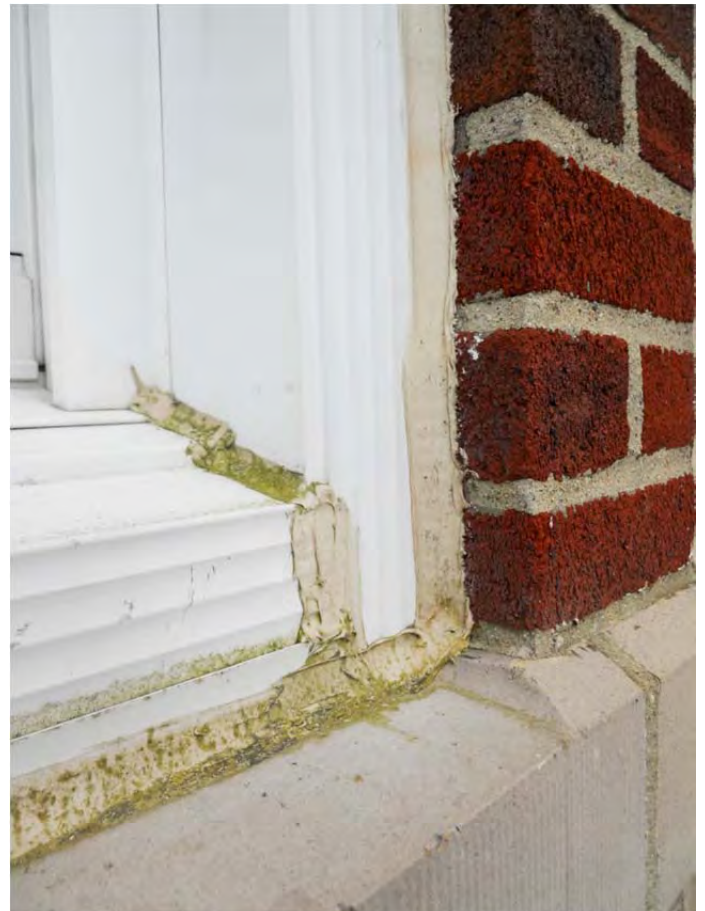
Poor sealant installation and mold accumulation at sealant joints.

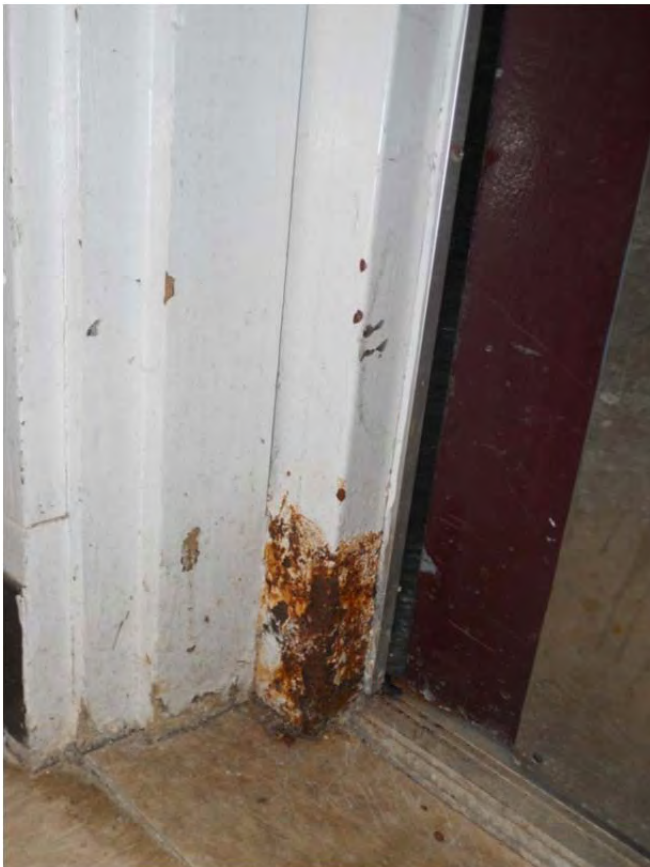
Rusted metal frame, typical condition at all exterior doors.

All exterior metal doors and metal frames are in poor condition due to rust and age.

Replace all metal doors and frames with new metal doors and frames?
PRIORITY A

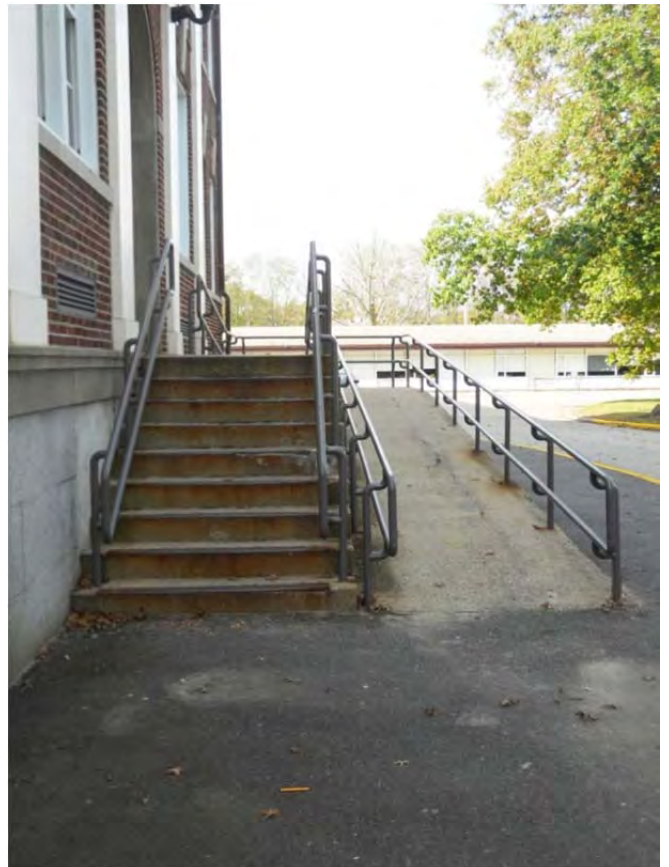
Deteriorated accessibility ramp and stairs at main entry.

At the main entrance, the concrete ramp and stairs with metal railings are in poor condition due to age and water damage. The concrete is heavily degraded and metal components such as railings and treads have caused rust jacking. The concrete has been patched several times to repair the spalled concrete, but these repairs are also now failing. Additionally, a number of code violations exist relative to this construct; see the Code section of this report for additional information.

Remove and rebuild the main entry stairs and ramp, the west stair at the west elevation and the stair at the south elevation. See Code section of this report for more information.
PRIORITY A

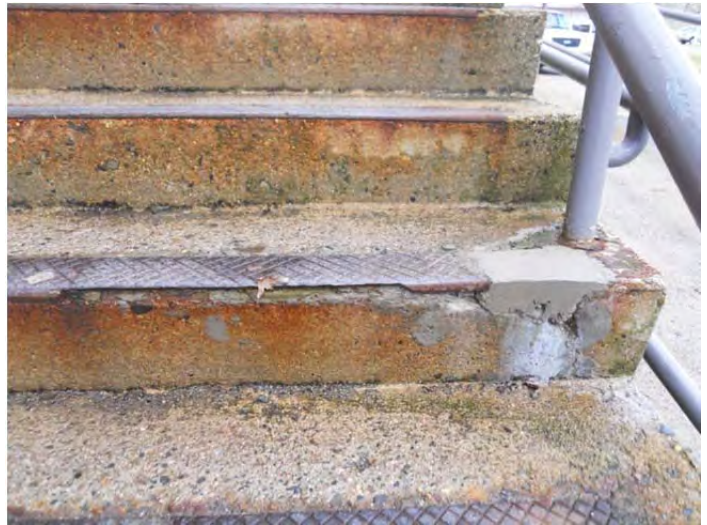
Deteriorated accessibility ramp and stairs at main entry.

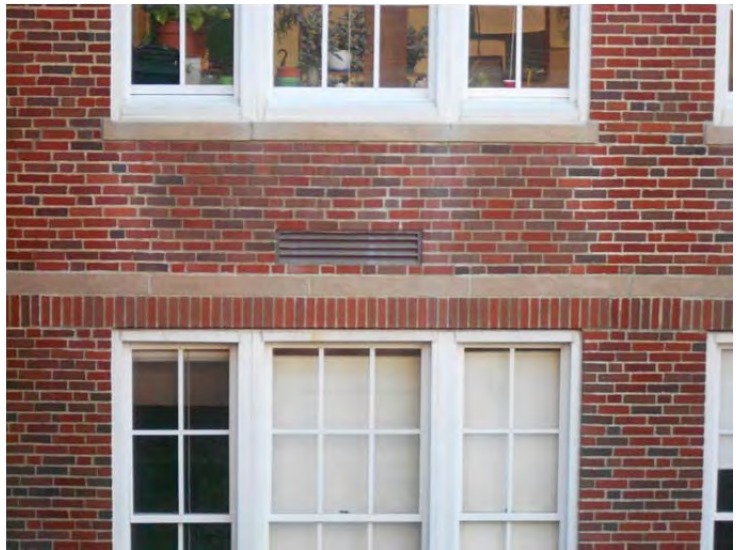
The louvers themselves are in good condition, but the lack of storm blades allows the possibility for wind driven rain to enter the building walls.

Louver at east elevation of east wing.

Replace all existing metal louvers with new metal louvers featuring storm blades to meet all current code requirements. See Code section of this report for additional information.

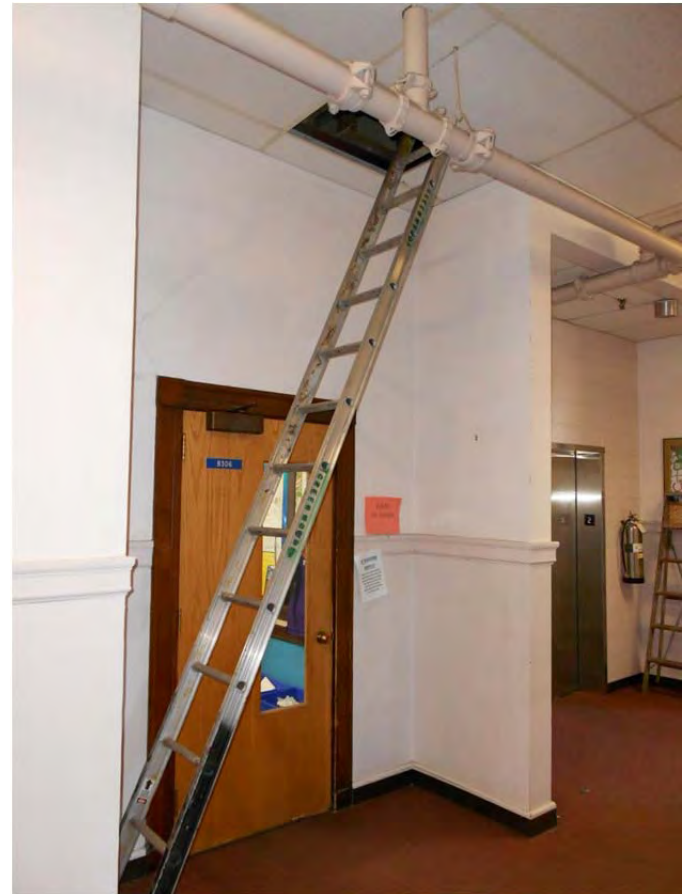
The attic access is not a safe condition due to its location directly outside of a classroom door. This is a hazard for maintenance technicians in the attic, technicians on the ladder and occupants of the classroom. The actual scuttle into the attic is small and difficult for those carrying tools. Within the attic, there is widespread mold on batt insulation in both the attic walls and roof rafters.

Unsafe attic access.

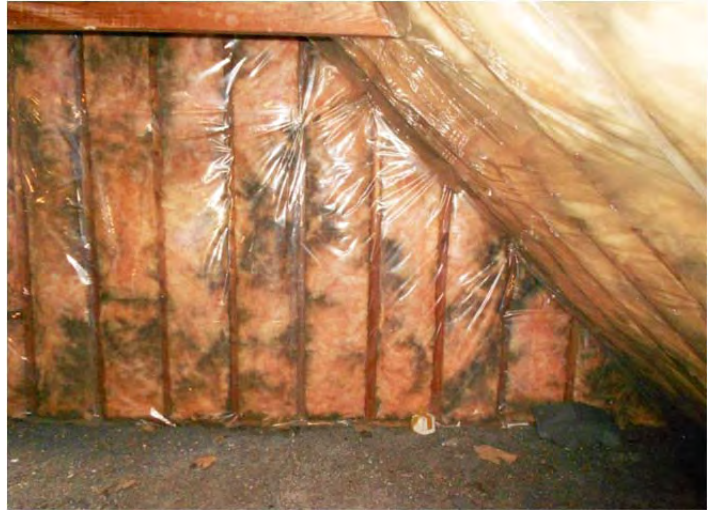
Attic insulation covered in mold.

Remove batt insulation and replace with new insulation and vapor barrier. **PRIORITY A**

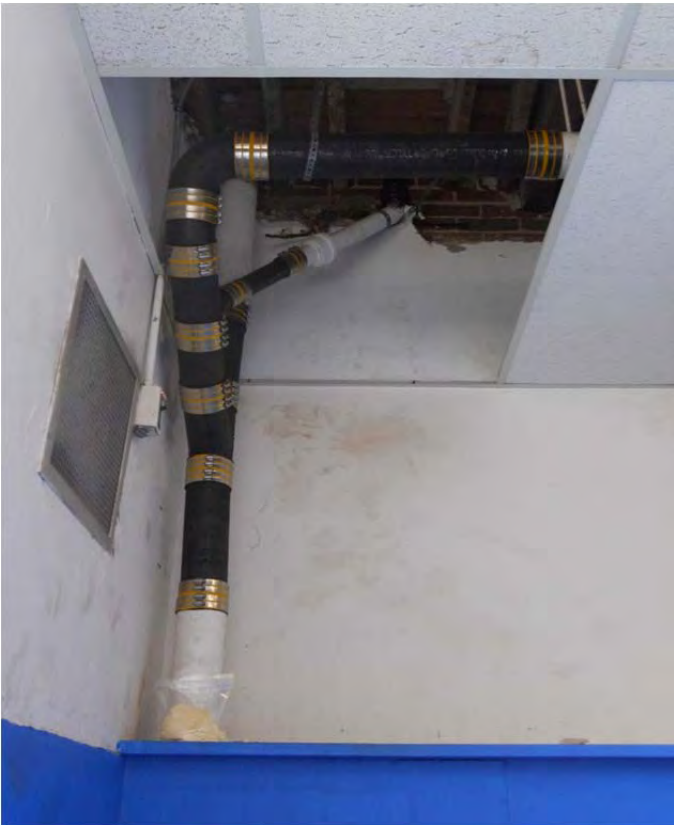
Missing ceiling panel in restroom due to pipe leak and repair.

Remove and replace all existing suspended ceiling grids and panels throughout. **PRIORITY A**

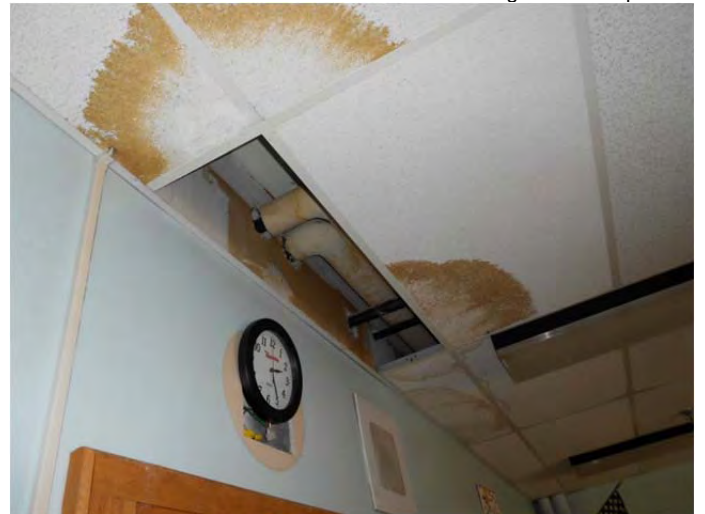
Water leaks visible in ceiling panels.

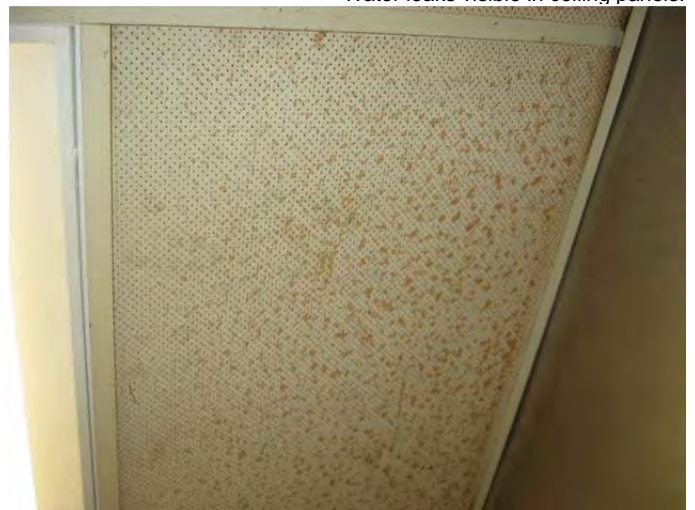
Close-up of metal panel with kitchen splatter.

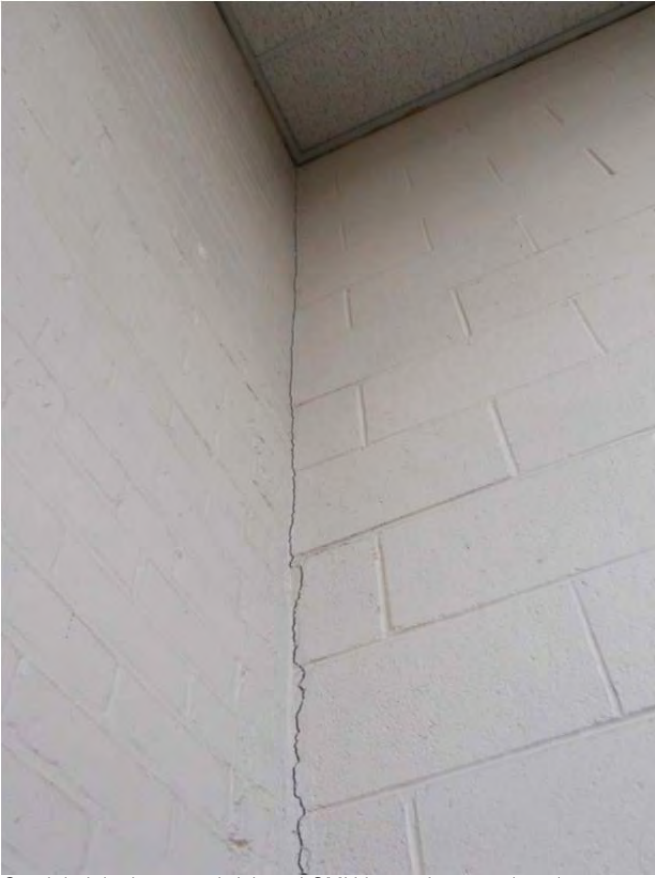
At the southwest egress stair, masonry cracks exist above the exterior door head, at the intersection of a CMU and brick wall, and at a brick intersection in the southeast corner. At the northwest stair, significant efflorescence exists behind the paint. Efflorescence indicates that there is or once was water in the masonry wall. The paint is peeling off the wall in these areas and the efflorescence sheds piles of white dust on the floor on a continuous basis.

Crack in joint between brick and CMU in southwest exit stair.

Repair cracks in masonry walls. **PRIORITY A**

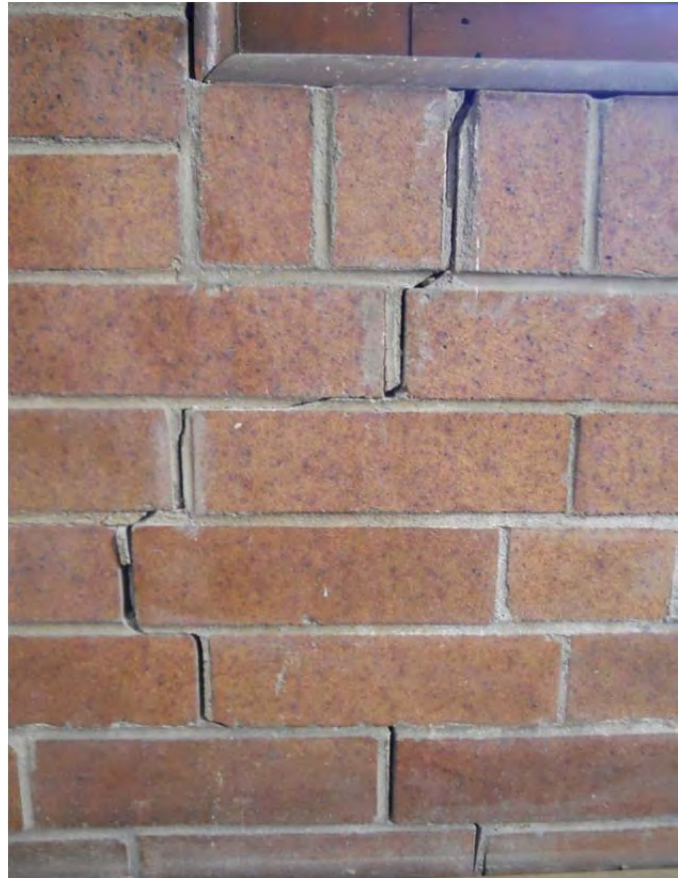
Crack above door head at west elevation in southwest exit stair.

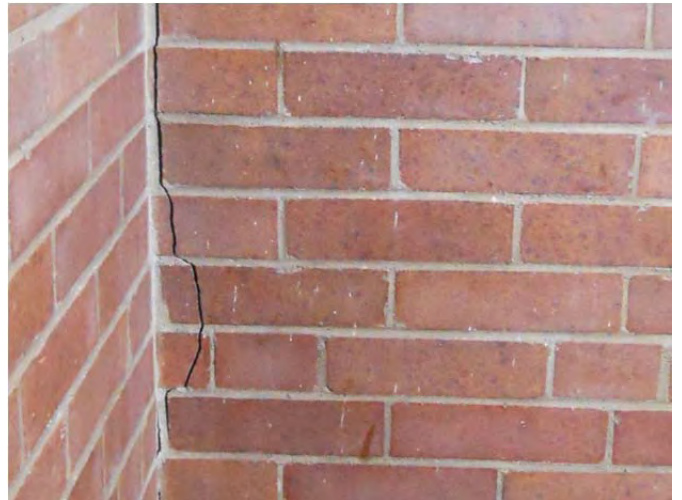
Crack in brick wall at southeast corner of southwest stair.

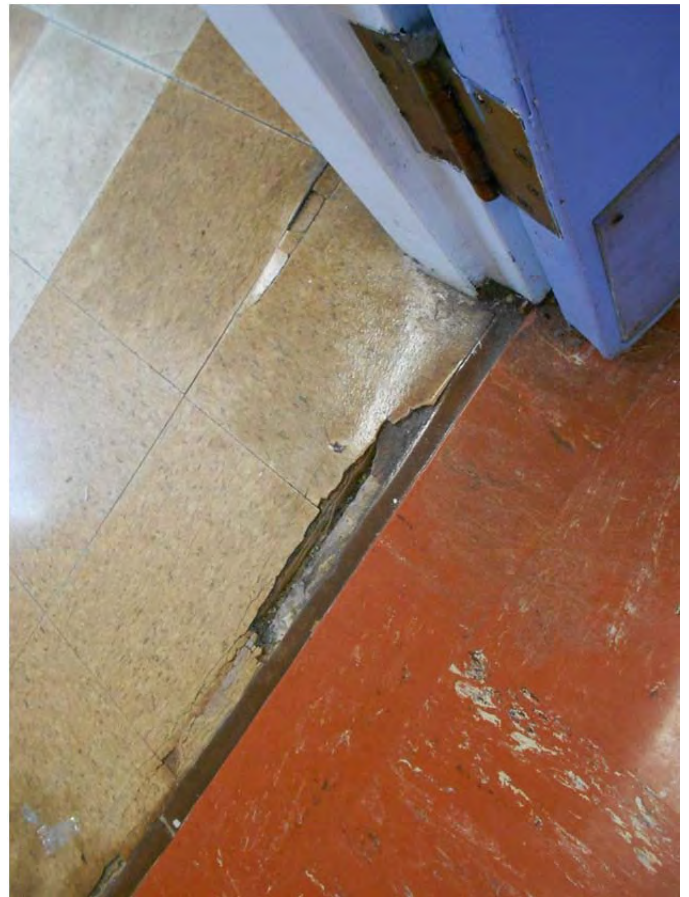
Worn VCT at threshold, evidence of wood beneath VCT.

Replace all existing floor finishes new resilient flooring.

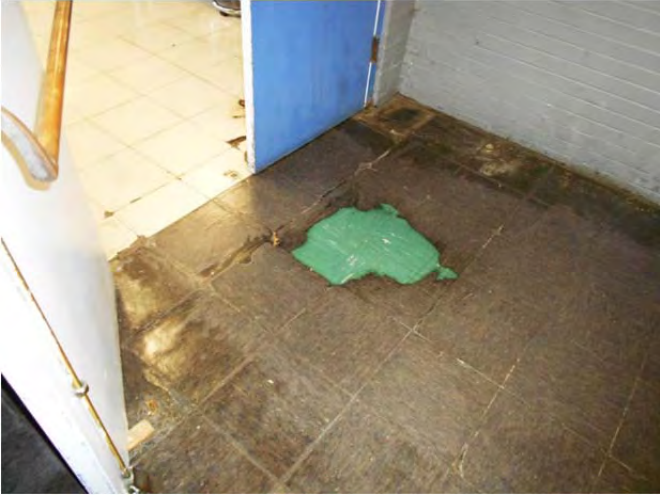
Worn VCT at exit stair, evidence of another layer of VCT beneath.

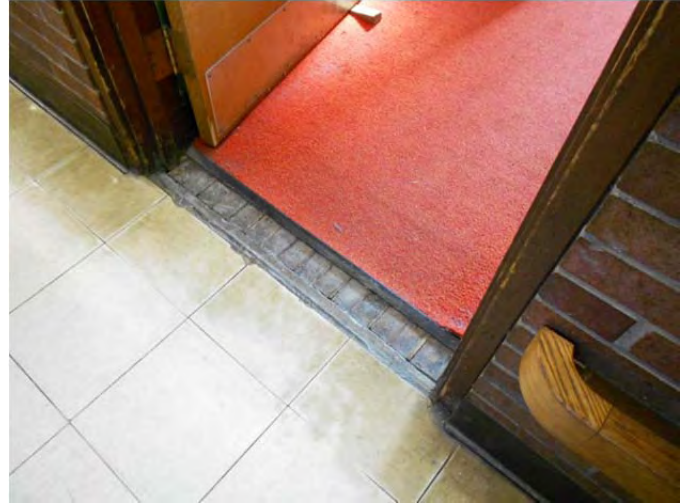
Missing threshold between VCT and carpet, evidence of original wood floor beneath carpet.

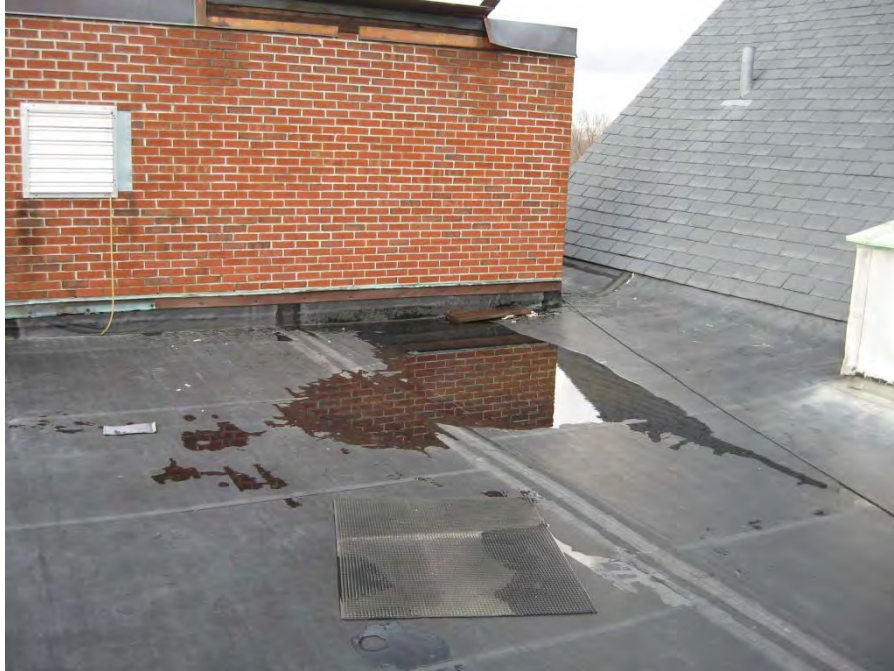
Photo 2.1 – Snow Drifting caused by Sloped Roof and Elevator Mechanical Room

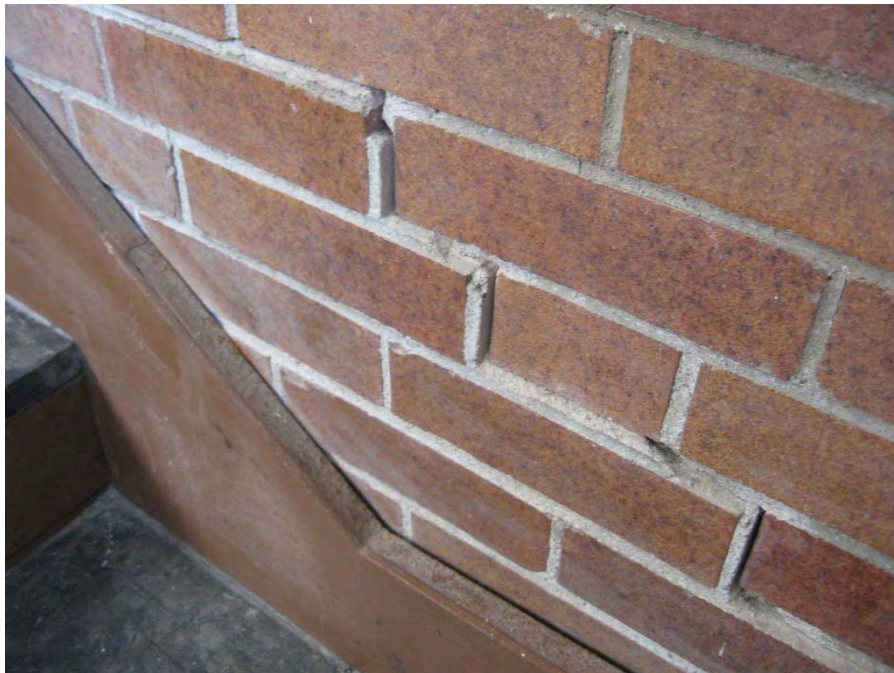
Photo 2.2a – Out of Plane Crack in Southwest Stair Wall

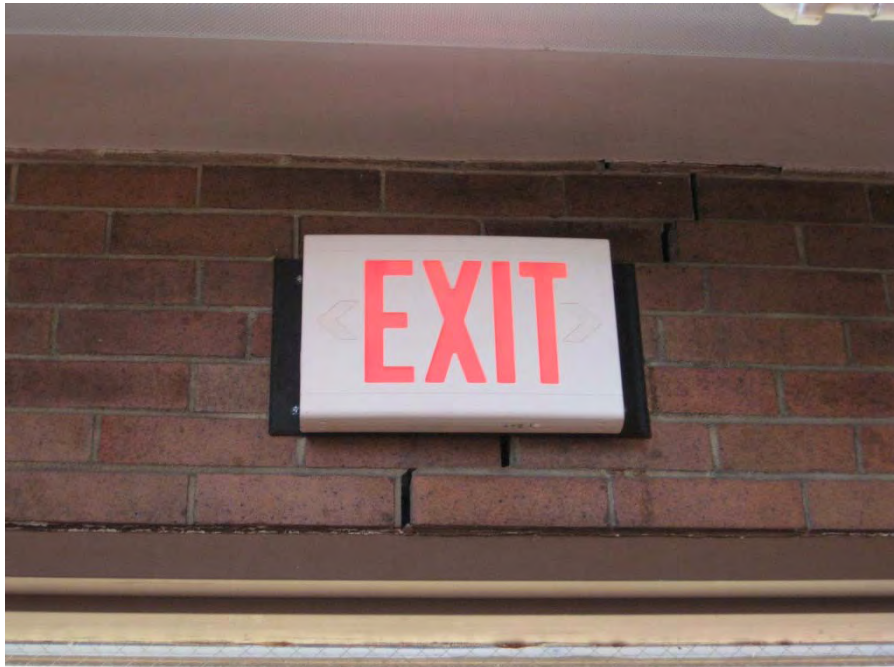
Photo 2.2b – Out of Plane Crack in Southwest Stair Wall

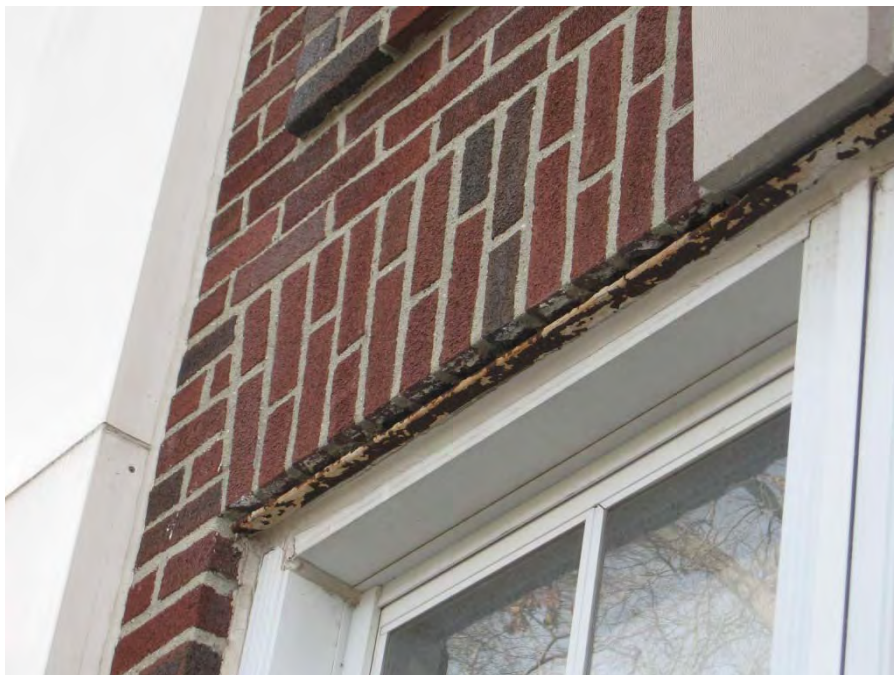
Photo 2.3 – Unpainted Lintel
