SCITUATE LIGHTHOUSE – LANTERN STRUCTURE  
PHOTOS OF EXISTING CONDITIONS

**RIVERMOOR ENGINEERING, LLC**  
 146 FRONT STREET, SUITE 211  
 SCITUATE, MASSACHUSETTS 02066  
 TEL: (781) 545-2848  
 FAX: (781) 544-7729

TITLE:  
**SCITUATE LIGHTHOUSE**  
 100 LIGHTHOUSE RD, SCITUATE, MA 01908  
 EXISTING LANTERN FRAME

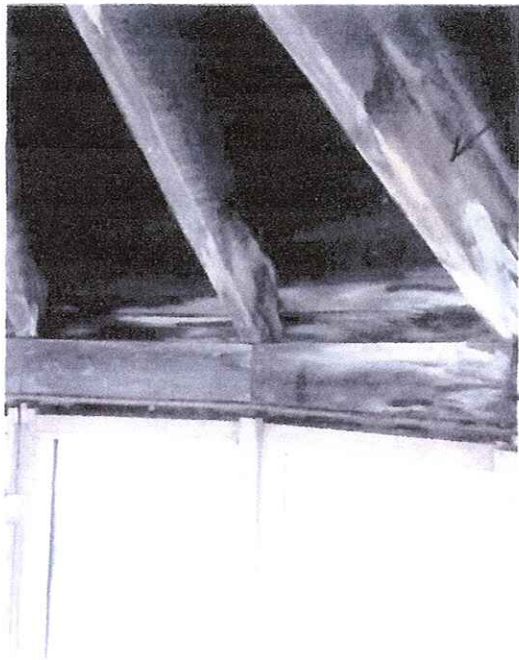
Interior view Lighthouse lantern windows and roof framing

DETERIORATED WOOD ROOF RATTERS

DETERIORATED TIMBER BEAMS

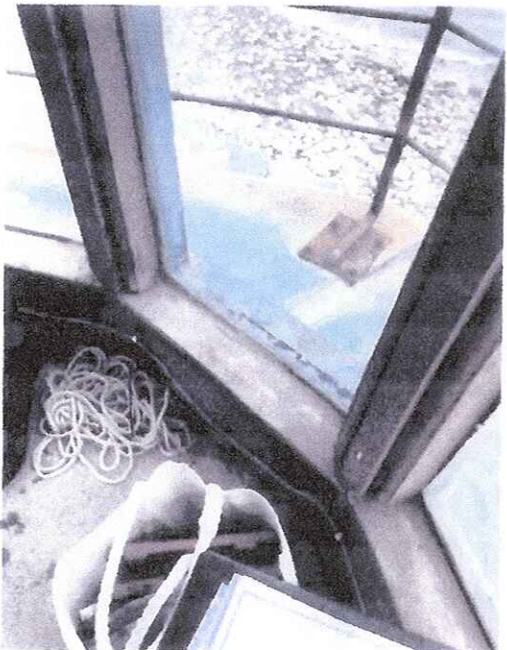
Interior view Lighthouse lantern windows and concrete floor slab

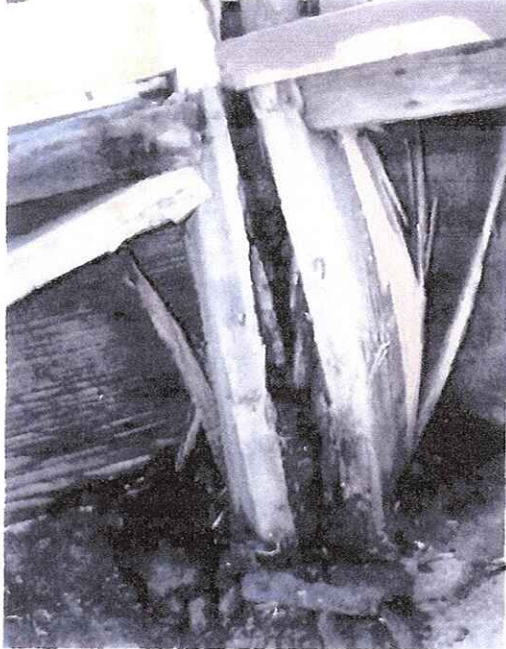
4)

Wrought Iron (W.I.) columns severely deteriorated.

W.I. POST & DEBRIS

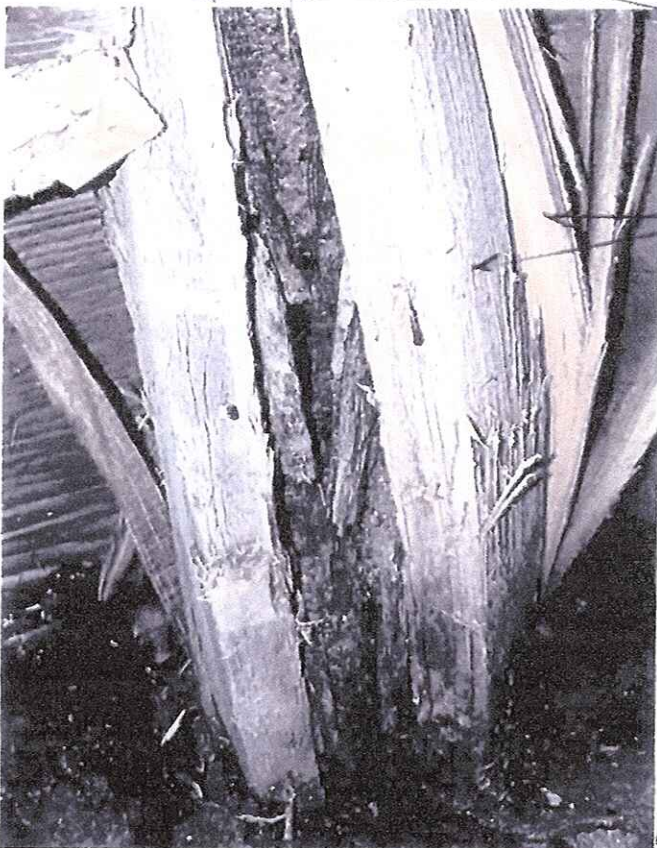
5)

WROUGHT IRON  $\frac{1}{2}$ " CRUMBLING COLUMN.

WOOD TRIM DETERIORATED  
& BUCKLING E.S. OF # COLUMN TYP.

Close-up view of the severely deteriorated column- no capacity remaining.

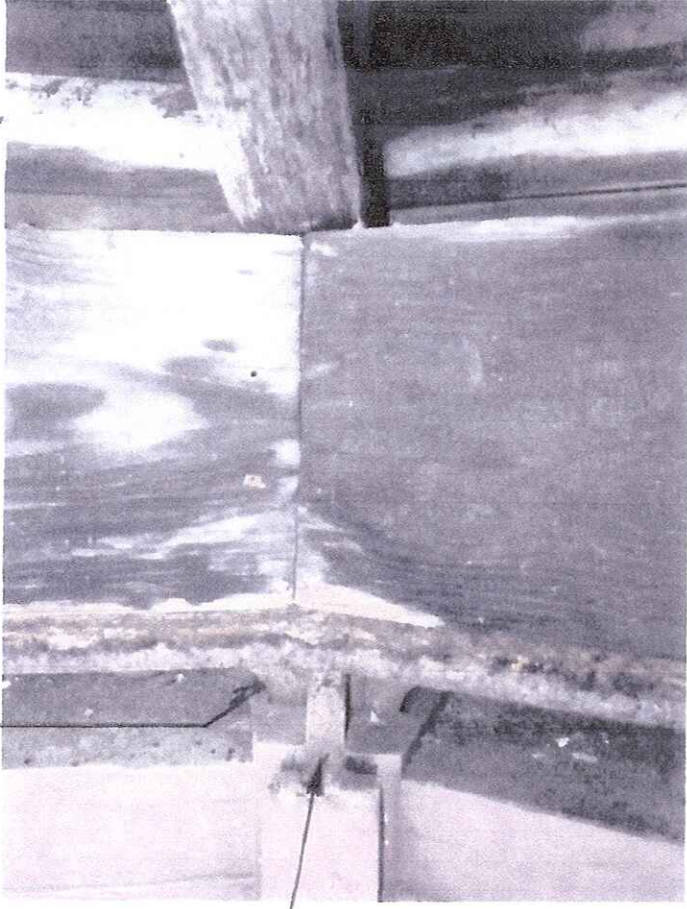
6)

WOOD ROOF PLANKS W/ WATER STAINS

TIMBER R BM WATER STAINED  
W/ INTERNAL DRY ROT

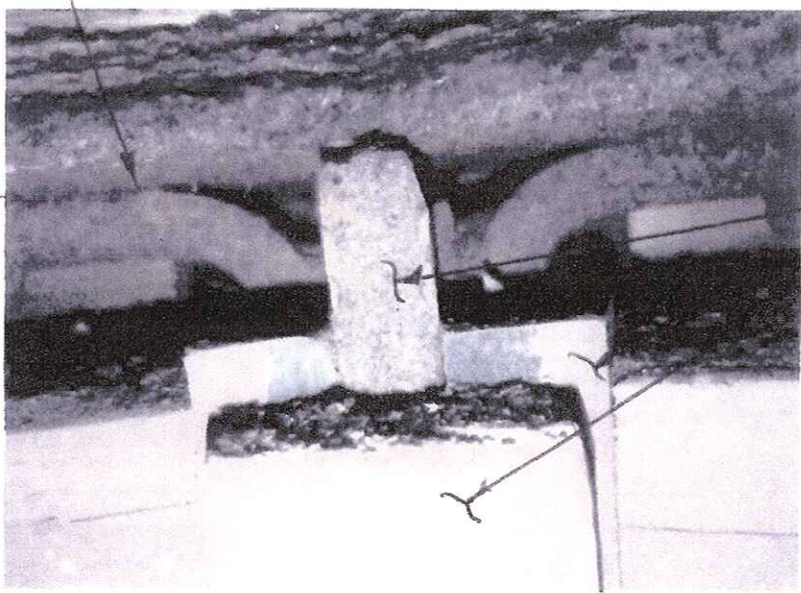
7)

TOP CONTINUOUS RING & RITE W.I.  
DETERIORATED, RUST PUSHING UP  
ON TIMBER BM

BENT W.I. CONNECTION W/ THREE BOLTS

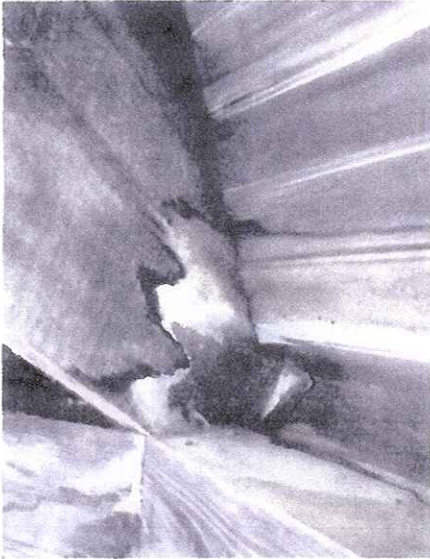
8)

Roof wood framing members – deterioration.

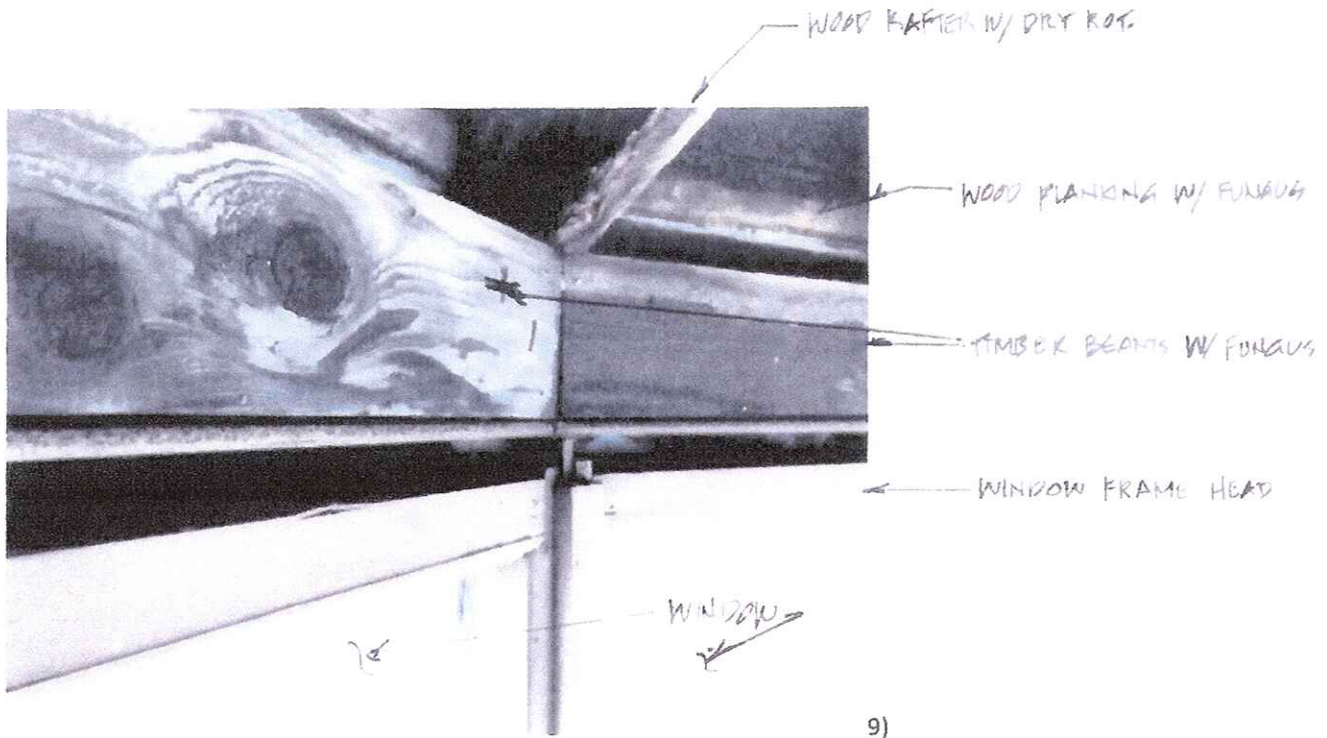
9)

Roof wood framing members – deterioration.

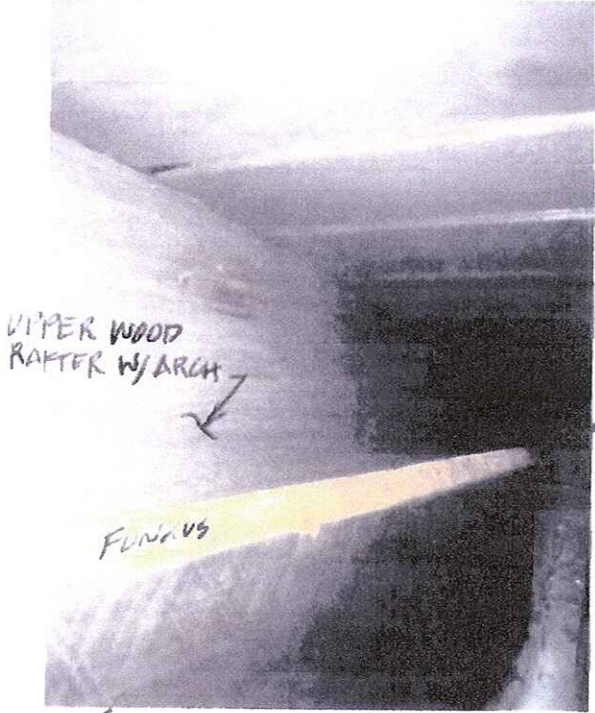
10)

FUNGUS

WOOD RAFTERS STACKED W/ FUNGUS GROWTH DETERIORATING & TWISTING RAFTER

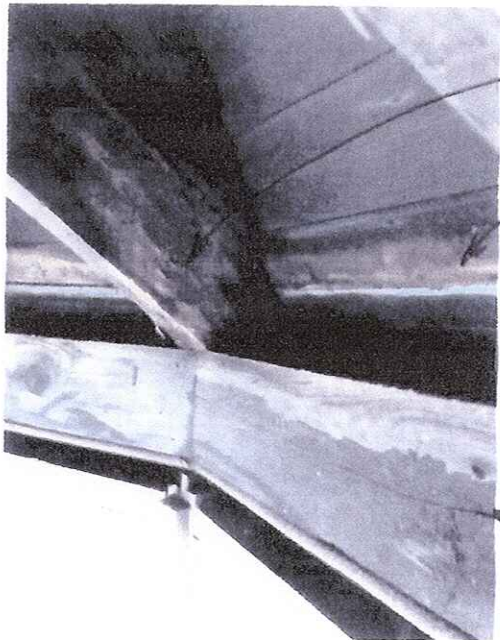
11)

TIMBER BEAM W/ WATER STAINS

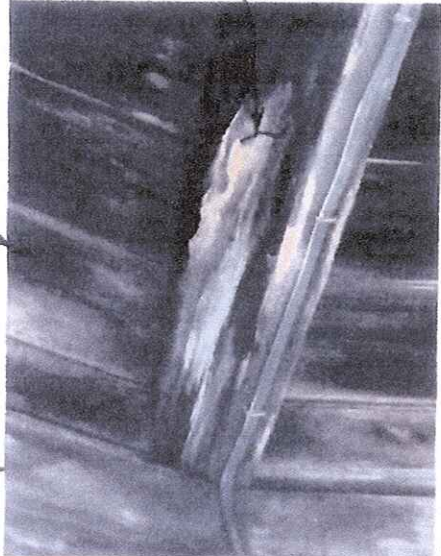
12)

RAFTER W/ DRY ROT

WOOD ROOF PLANKING W/ WATER STAINS & FUNGUS

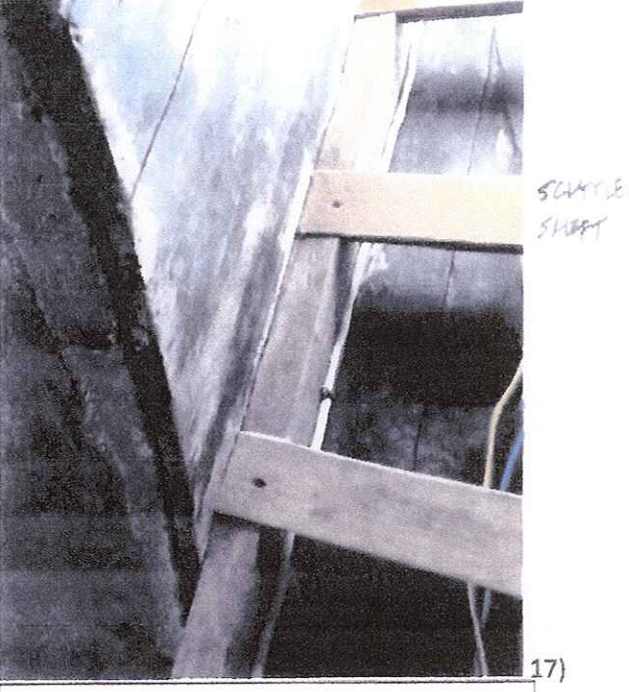
Photos of scuttle - interior side of scuttle shaft, showing crack thru the concrete dome structure.

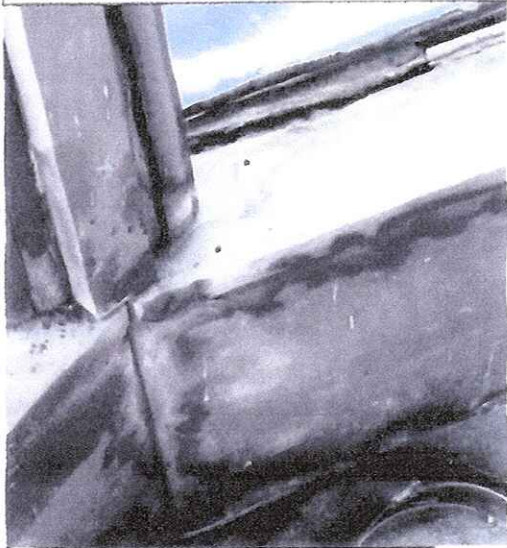
19)

Interior window wood sill and column trim deteriorated

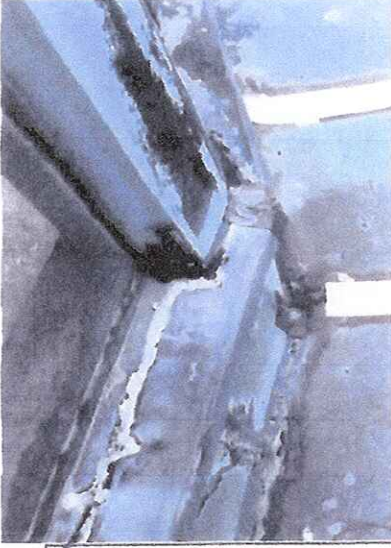
20)

Exterior window sill and column copper cladding deteriorated.

*DETERIORATED COPPER CLADDING  
THIN WOOD SILL W/ DRY ROT*

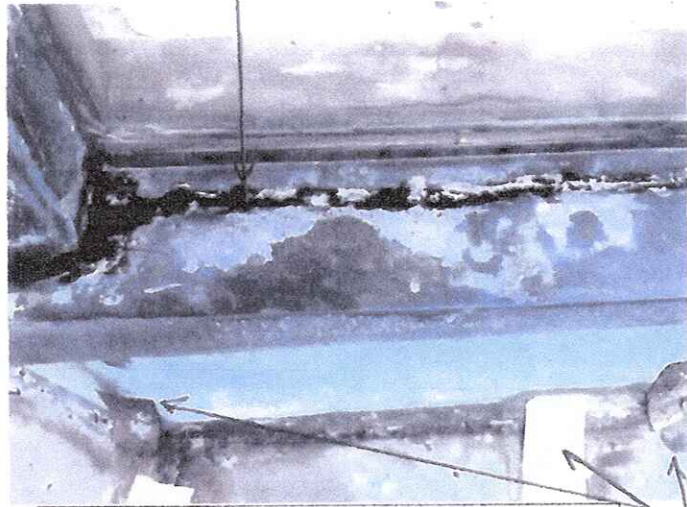
21) Exterior window sill copper cladding deteriorated

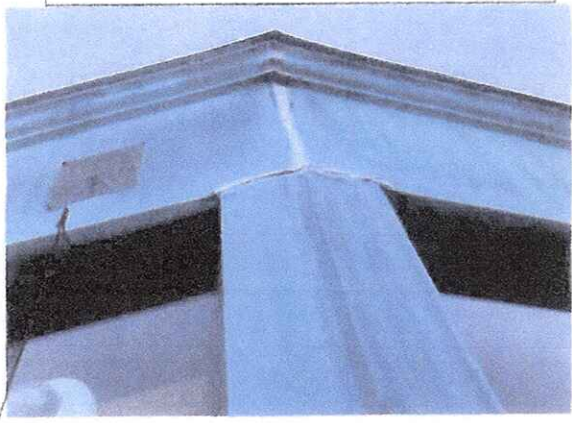
22) Exterior view of roof fascia copper cladding- which leaks and caused deterioration of the roof framing and wrought iron structural framing seen inside

*PATCHING OF DETERIORATED COPPER CLADDING*

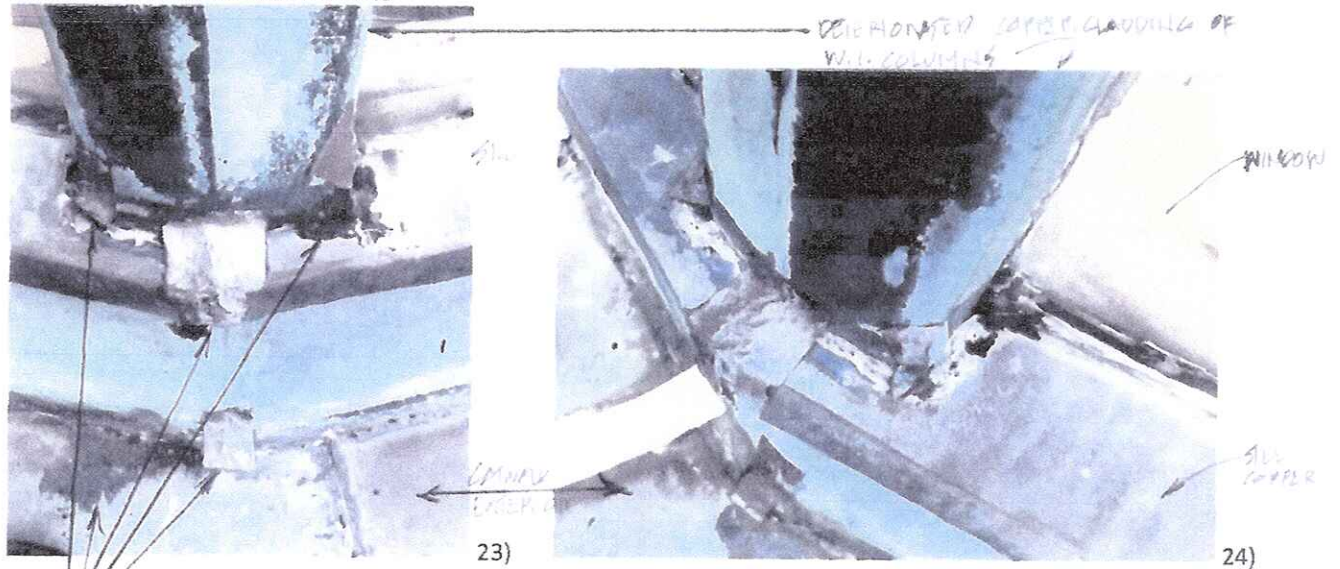
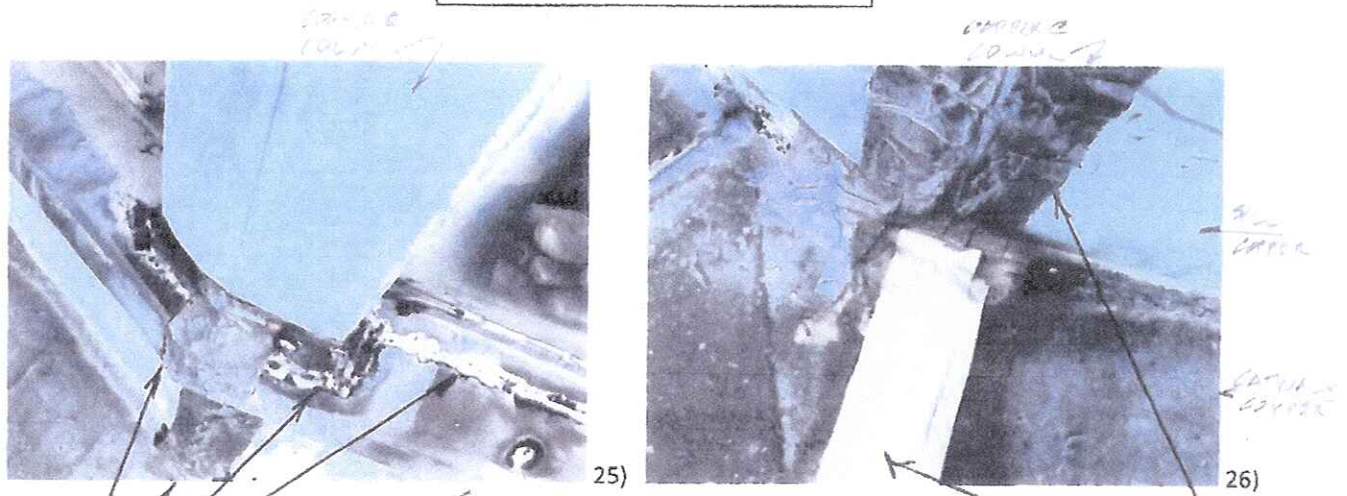
Exterior views of copper cladding of columns, sills and utility catwalk – severe deterioration of copper and deterioration of the copper repairs & patches visibly seen.

DETERIORATED COPPER CLADDING & DETERIORATED PATCHES & PREVIOUS REPAIRS OF COPPER CLADDING

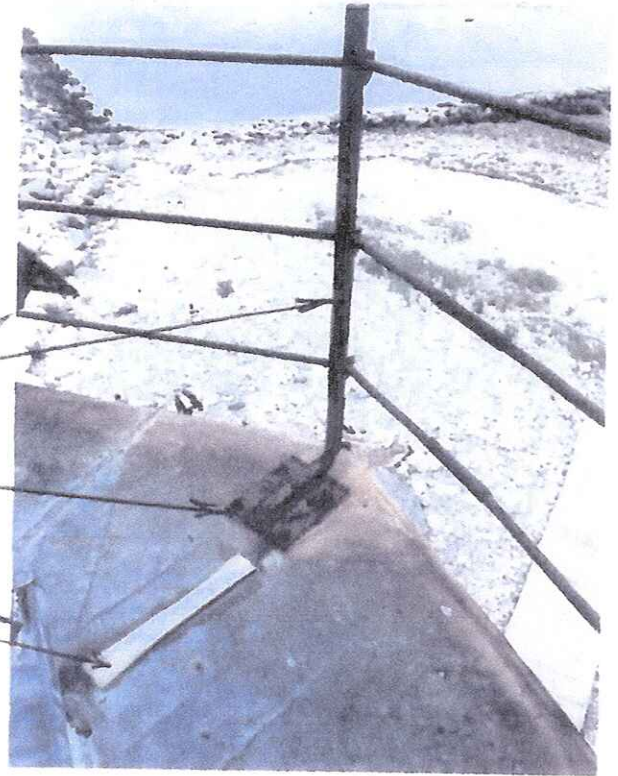
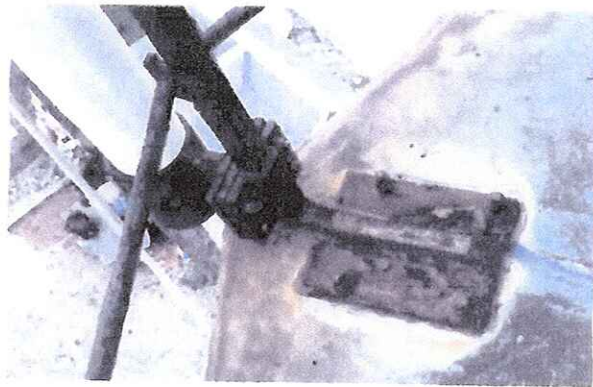
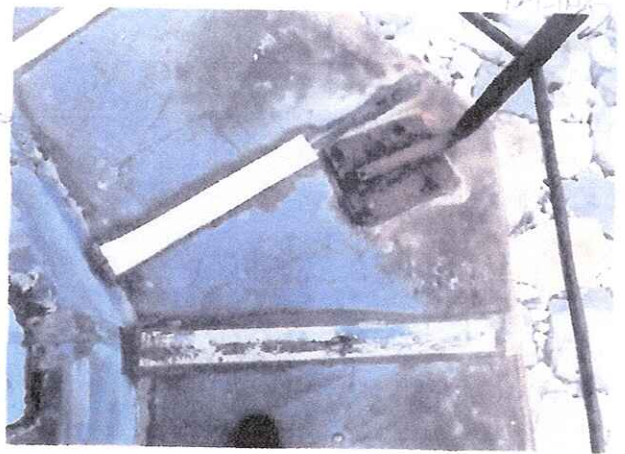
27, 28, 29)

Utility catwalk exterior photos – severely deteriorated copper cladding of the catwalk and wrought iron railing system and its connection to the cantilevered catwalk. Catwalk framing and condition unknown

W.I. RAILING SYSTEM  
BRITTLE & RUSTED

RUSTED BASE PLATE & BOLT HEADS,  
RAILING SUPPORT

DETERIORATED COPPER  
CLAD CATWALK WITH  
DETERIORATED FITTINGS
