Re: Gates Middle School – Scituate, MA  
Structural Observations on 1-13-2012

At your request, I met with you on January 13, 2012 to make a structural assessment of the existing building located on First Parish Road in Scituate, Massachusetts. The building currently serves as the Middle School for the Scituate School Department. The focus of this structural assessment is on the three central portions of the building. This includes the original building constructed in 1917, the adjacent east classroom wing constructed in 1931, and the west gymnasium/auditorium wing also built in 1931. This west wing was renovated in 1974 and the gymnasium was converted to the current Resource Center and a second floor added to create the current Learning Center and additional classrooms. My assessment consisted of a walkthrough of the building, including attic and basement spaces, and visual observation of any exposed structural conditions. I have also reviewed the construction drawings from the 1931 additions as well as the 1974 renovation. No drawing information was available for the original 1917 building. The following report summarizes the results of my observations, identifies the primary str

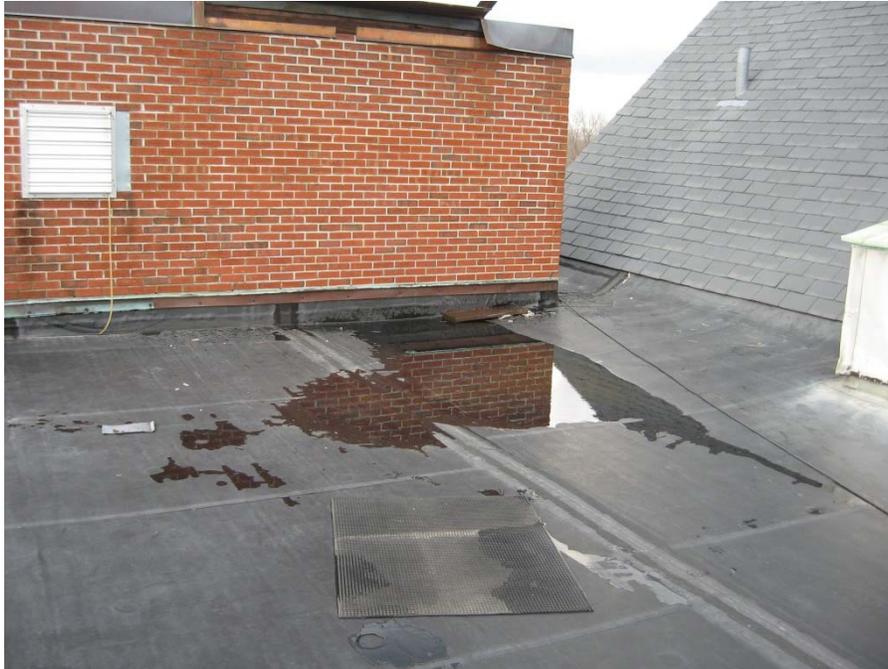
When the gable roof was constructed over the existing flat roof in 1931, it created a significant potential increase for drifting snow load on the adjacent existing flat roof joists on the south side of the building. Along the west edge of this roof there is also a vertical projection created by the elevator mechanical room that was added with the 1974 renovation (See Photo 2.1). This vertical wall also creates the potential for significant localized drifting snow. Based on my observation of existing conditions and my review of the structural drawings for the 1931 and 1974 renovations, the additional drifting caused by these two conditions does not appear to have been addressed. In many cases, older codes did not address drifting conditions at all. Based on the current code, the additional drift potential is approximately 50 pounds per square foot above and beyond the base design snow load requirement of 35 pounds per square foot. This creates an increase in stress on the existing flat roof rafters of nearly twice the allowable in the area immediately adjacent to the mechanical room projection.

**Photo 2.1 – Snow Drifting caused by Sloped Roof and Elevator Mechanical Room**

This condition is very significant structurally and so it is my recommendation that this portion of the roof framing be reinforced by sistering each of the existing rafters with 2x12 LVL's. This work should be done regardless of any future renovation to the building. Until this work has been completed, the snow should be removed from the lower roof during the winter so that the depth of snow on the existing flat roof never exceeds 12 inches.

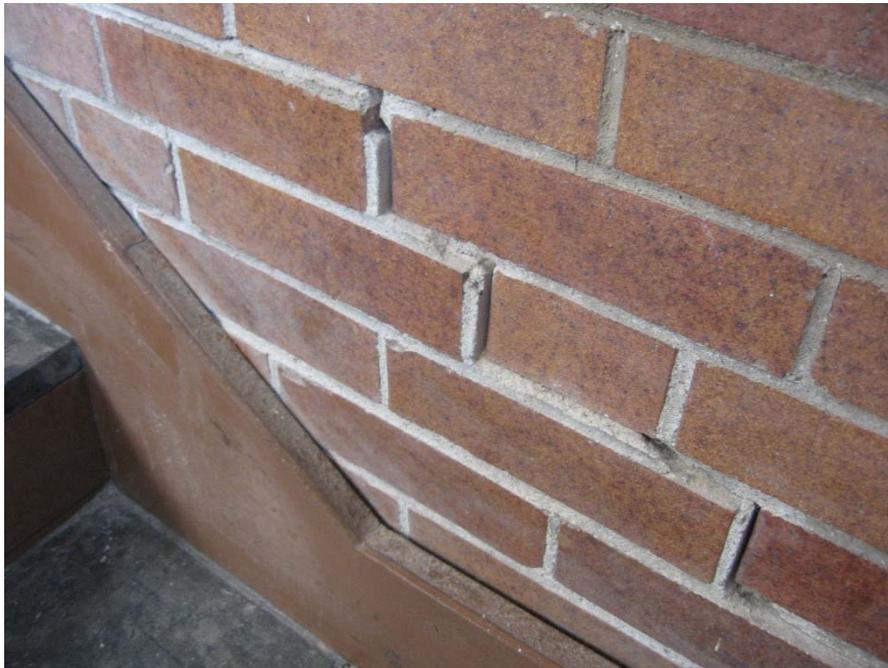
Several significant cracks were observed in the interior masonry walls of the southwest stair. The cracks varied in thickness from hairline to approximately 1/4" in thickness. In some areas, there has been out of plane movement on opposite sides of the crack (See photos 2.2a and 2.2b). There are a couple of possible causes for these types of cracks. The diagonal cracking could be the sign of differential settlement. However, there do not appear to be any other typical indicators that settlement is a problem in the building. Also, settlement typically occurs early in the life of the building and these cracks appear to be much more recent. Settlement cracks also are not typically out of plane. Based on this, it is my opinion that the more likely cause of these cracks is that they are result of water infiltration into the wall. With this type of solid masonry wall, water infiltration can cause severe damage. If the water gets trapped and freezes, it causes the walls to crack and push out resulting in out of plane movement. It appears that the most likely entry point for water getting into the walls was with the original belt course detail near the top of the wall. This was removed and replaced during the most recent façade renovation and so it is likely that previously deteriorated belt course was allowing water into the wall. The cracks above the entry door are most likely related to failure of the flashing over the entry canopy roof which was also repaired during the 2006 façade renovation.

**Photo 2.2a – Out of Plane Crack in Southwest Stair Wall**

It is my recommendation that the masonry walls in this stair be repaired by removing localized portions of the cracked interior face and reconstructing. These existing conditions do not represent a severe structural deficiency, but something that should be addressed within the next couple of years.

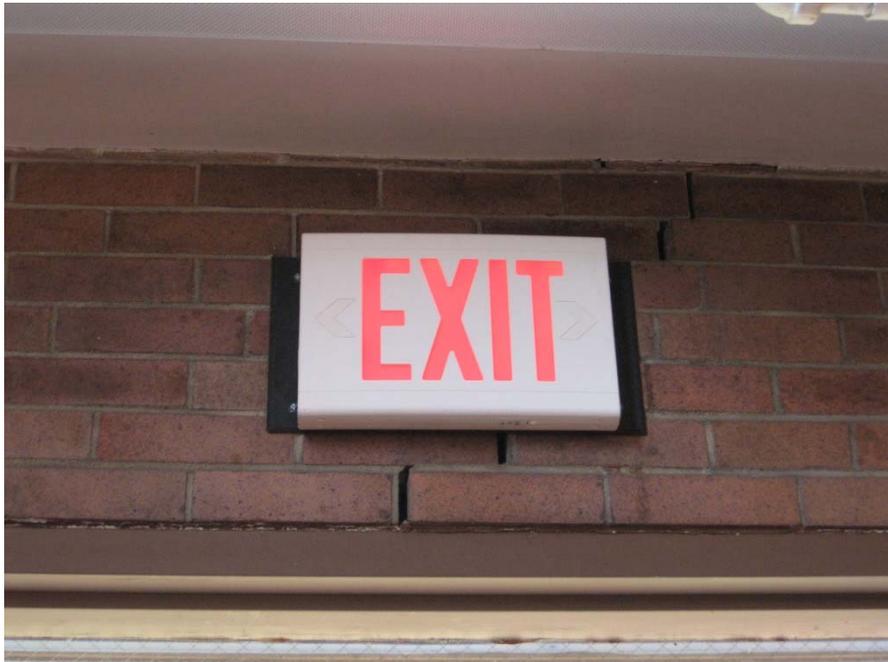
**Photo 2.2b – Out of Plane Crack in Southwest Stair Wall**

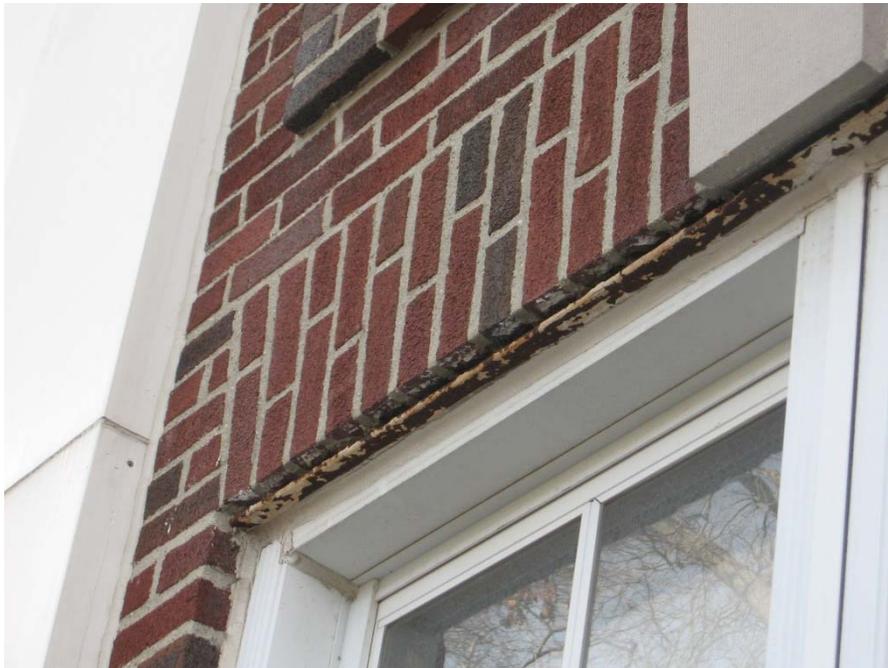
During the 2006 exterior renovations that were made to the building, many of the original exterior lintels over windows were replaced with new galvanized lintels. However, it was noted during my site visit that there were many existing lintels that were not replaced as part of this work. The original lintels are not galvanized nor painted (See photo 2.3). The lintels over these windows are currently exposed bare steel and will deteriorate over time if left unattended.

**Photo 2.3 – Unpainted Lintel**

It is my recommendation that these lintels at the very least be cleaned and painted. Eventually, they will need to be replaced with galvanized steel angles. The existing lintel conditions do not represent an immediate structural deficiency, but something that should be addressed within the next couple of years.
