Elevating Roadway Improvements and Dune/Beach Nourishment along North Humarock for Improved Coastal Resiliency

North Humarock, Scituate, Massachusetts

June 2017

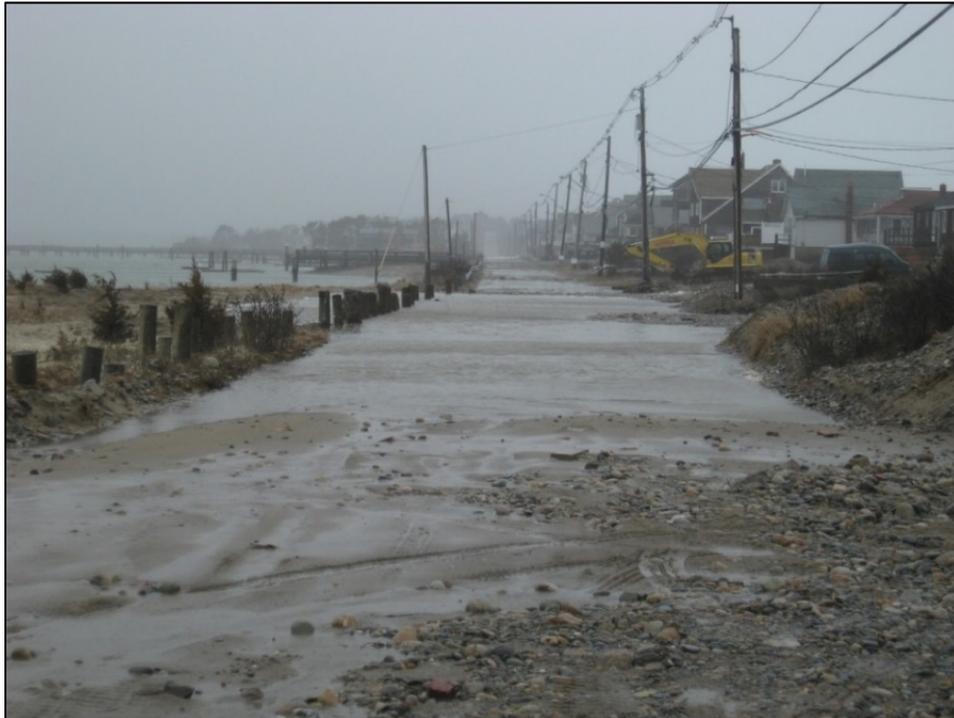
Figure 2.1 Overtopped and ponding water along Central Avenue prevents emergency access. (Image source: Jason Burtner on March 7, 2013)

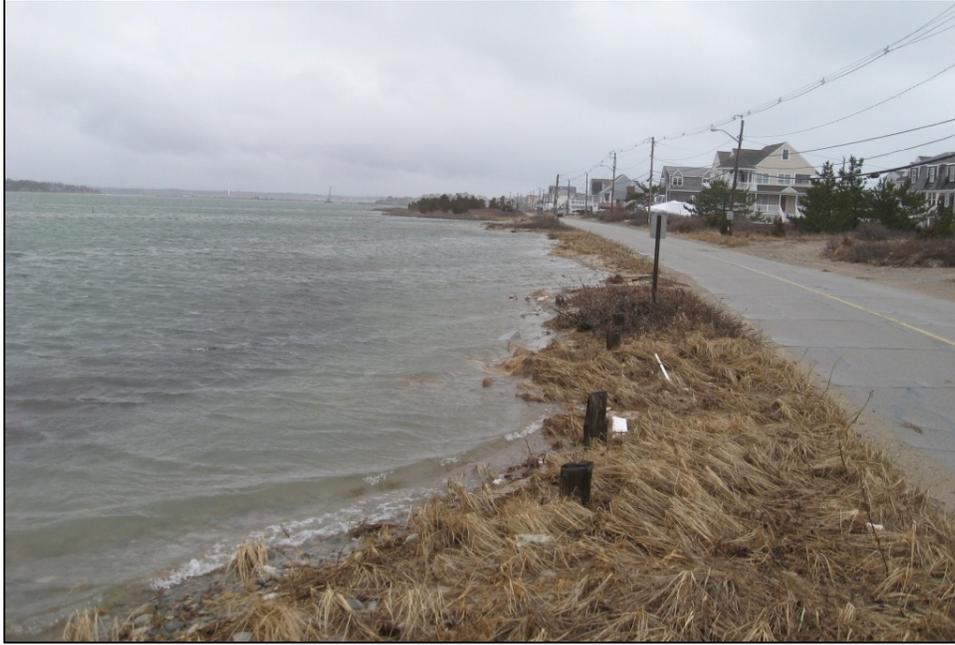
Figure 2.6 Near-flooding conditions at Central Avenue on where the water level is approximately 6.5 feet NAVD88. (*Image source: Jason Burtner on March 31, 2014*)

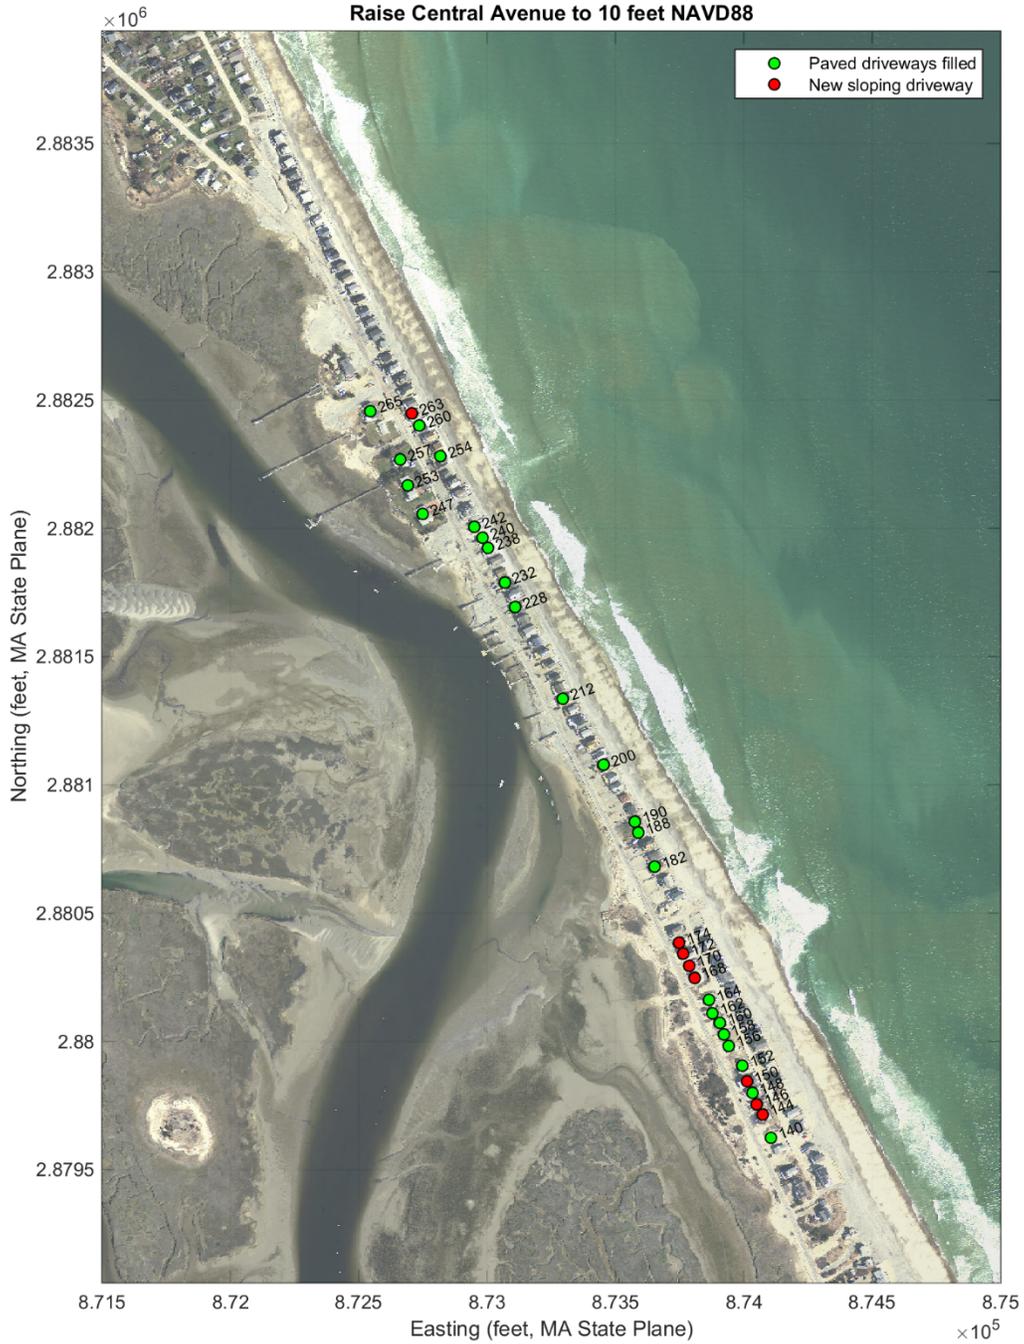
Figure 3.11 Potential issues identified during preliminary assessment of elevating Central Avenue where the road is raised to 10 feet NAVD88 throughout.

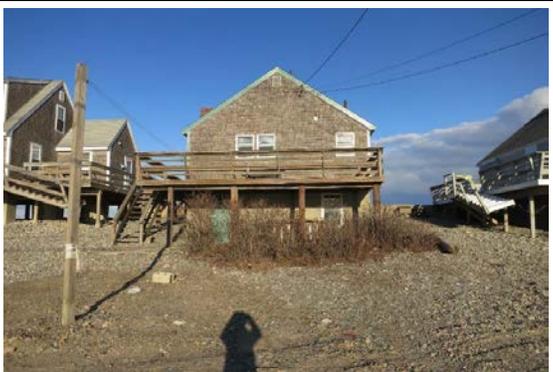
Road Elevation	7.15 feet NAVD88	
Ease of Construction	Challenge, but could be okay because of distance from road	
Notes	Older home on solid concrete foundation Door and window in basement ~8' deck overhand Slab looks to be ~1' above road	
Address	294 Central Avenue

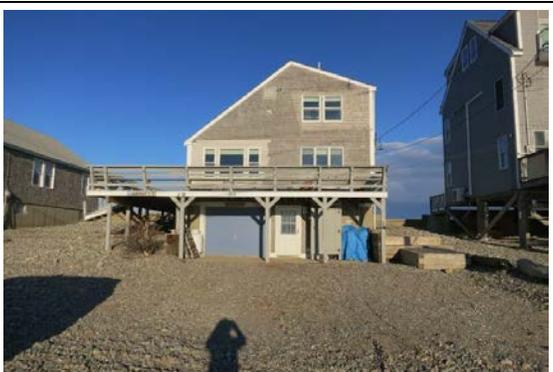
Road Elevation	7.49 feet NAVD88	
Ease of Construction	Challenge, but could be okay because of distance from road	
Notes	Older home on solid concrete foundation with garage and side door ~6' deck overhand Slab looks to be ~0.5' above road	
Address	292 Central Avenue

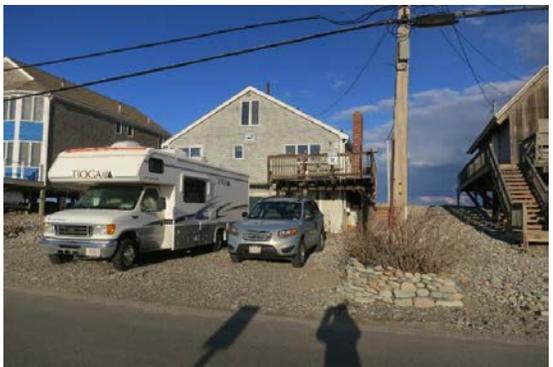
Road Elevation	7.57 feet NAVD88	
Ease of Construction	Challenge	
Notes	Home rehabbed on solid foundation Slab at roadway elevation Living space in basement Brick chimney	
Address	282 Central Avenue

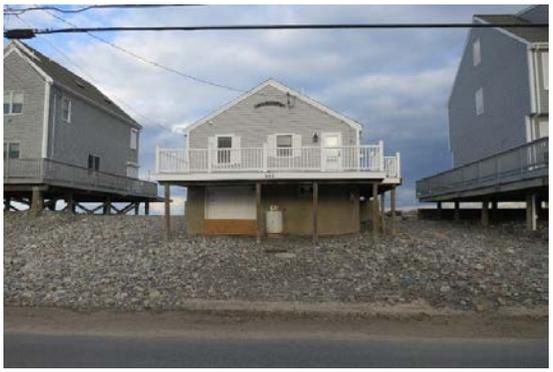
Road Elevation	7.98 feet NAVD88	
Ease of Construction	Challenge	
Notes	House on solid concrete foundation with garage Slab elevation ~1' above road	
Address	262 Central Avenue

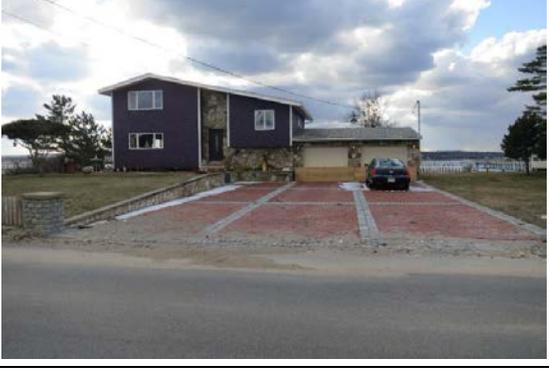
Road Elevation	9.28 feet NAVD88	
Ease of Construction	Problem	
Notes	Brick driveway could be costly Solid foundation Road slope could redirect flood into house	
Address	244/246 Central Avenue

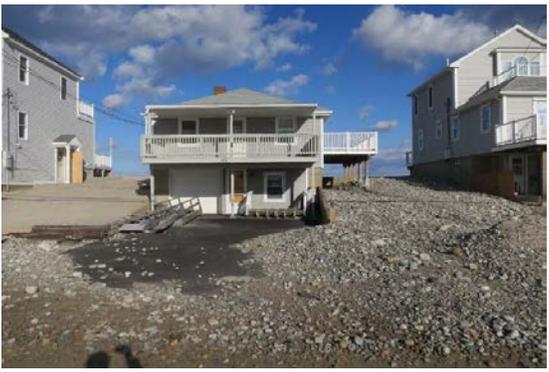
Road Elevation	7.90 feet NAVD88	
Ease of Construction	Acceptable, slab at road elevation	
Notes	Newer or rehabbed home on solid foundation Garage door and living space in basement Paved driveway ~8' deck overhang Concrete side yard to north Significant overwash	
Address	238 Central Avenue

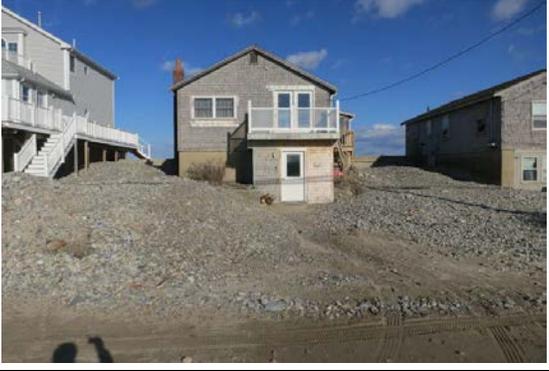
Road Elevation	7.56 feet NAVD88	
Ease of Construction	Problem	
Notes	Older home on solid concrete foundation Door to basement – unclear whether this is only storage Brick chimney Significant overwash Unpaved driveway	
Address	234 Central Avenue

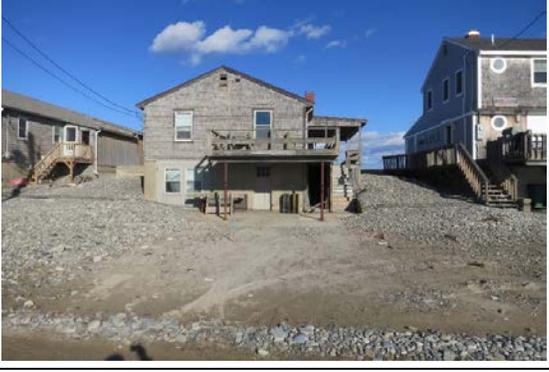
Road Elevation	7.26 feet NAVD88	
Ease of Construction	Problem	
Notes	Older home with solid foundation Significant signs of overwash Living space downstairs Concrete slab under deck

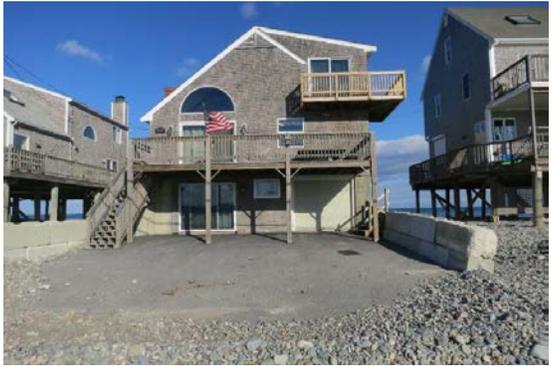
Road Elevation	7.64 feet NAVD88	
Ease of Construction	Challenge	
Notes	Newer home on solid foundation Garage and living space in basement ~10' deck overhang Paved driveway Slab ~1' above road Brick chimney	
Address	226 Central Avenue

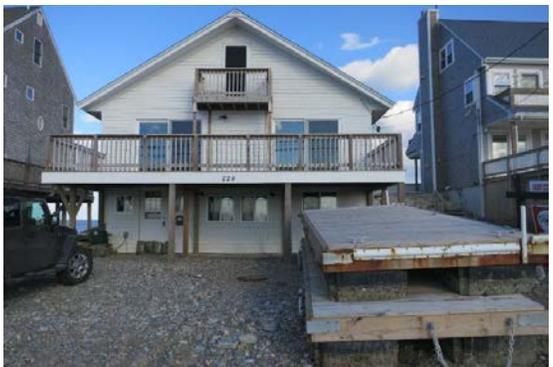
Road Elevation	8.39 feet NAVD88	
Ease of Construction	Problem	
Notes	Newer home with solid foundation ~12' deck overhang House is ~23-25' from road Living space in basement with door Unpaved driveway Slab at roadway elevation	
Address	222 Central Avenue

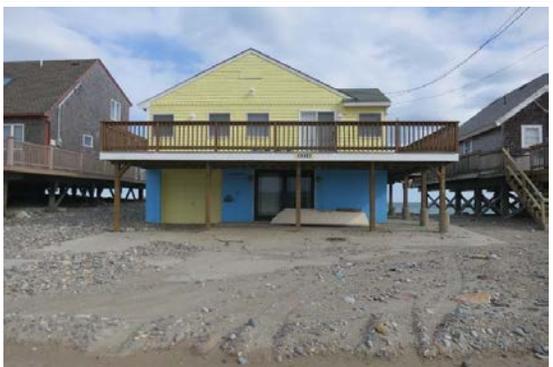
Road Elevation	9.80 feet NAVD88	
Ease of Construction	Problem, but road elevation is high	
Notes	Yellow/blue house on solid foundation Concrete driveway Living space in basement ~10' deck overhang Garage ~1' above road

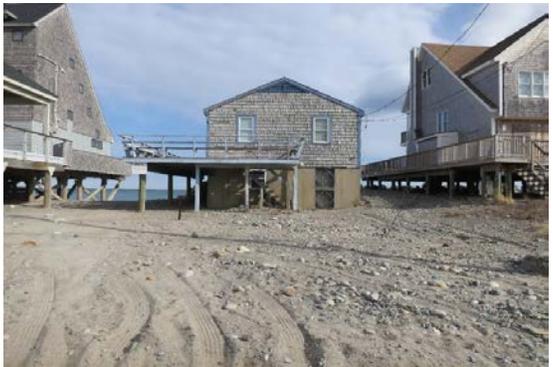
Road Elevation	9.19 feet NAVD88	
Ease of Construction	Acceptable	
Notes	Older home on solid foundation Storage with door underneath at road elevation Revetment ends, overwash to north	
Address	204 Central Avenue

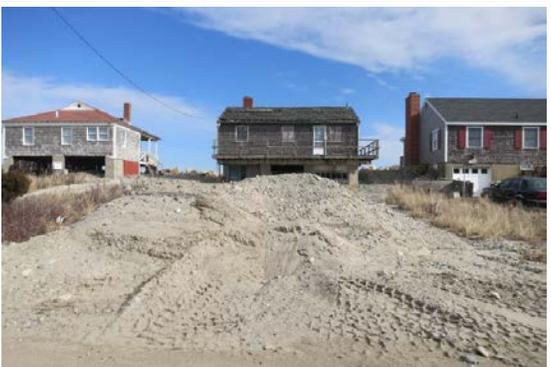
Road Elevation	7.22 feet NAVD88	
Ease of Construction	Acceptable	
Notes	Older condemned-looking home 2 garages half-buried in cobble Basement door ~10' deck overhang Unsupported piles broken off Pile of cobble along road

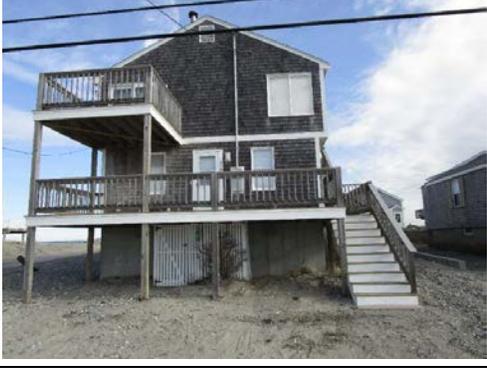
Road Elevation	7.68 feet NAVD88	
Ease of Construction	Challenge	
Notes	House on solid concrete foundation Full height basement above ground with door, likely storage space ~10' deck overhang Unpaved driveway	
Address	174 Central Avenue
