# Elevating Roadway Improvements and Dune/Beach Nourishment along North Humarock for Improved Coastal Resiliency

Town of Scituate  
Public Informational Meeting

March 28, 2017

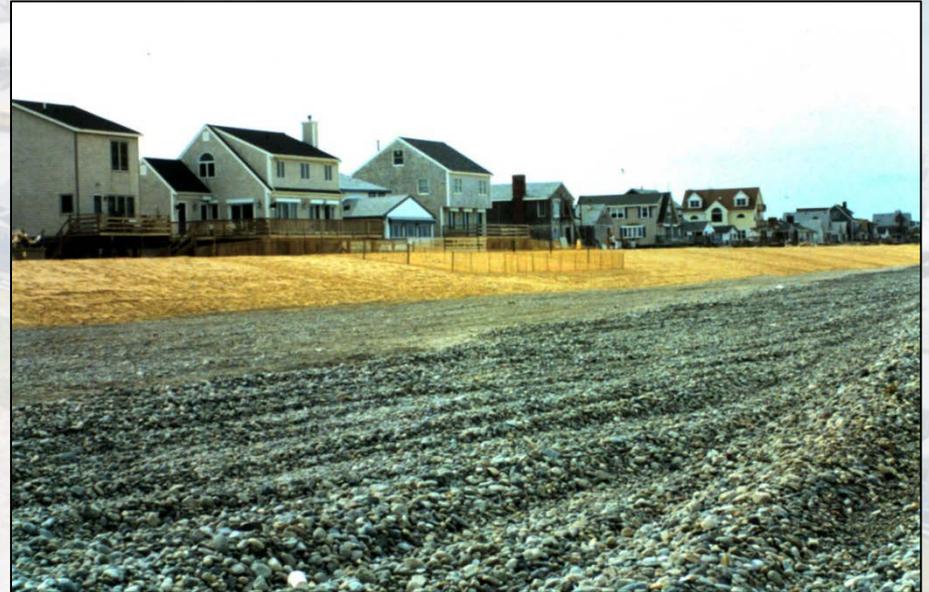
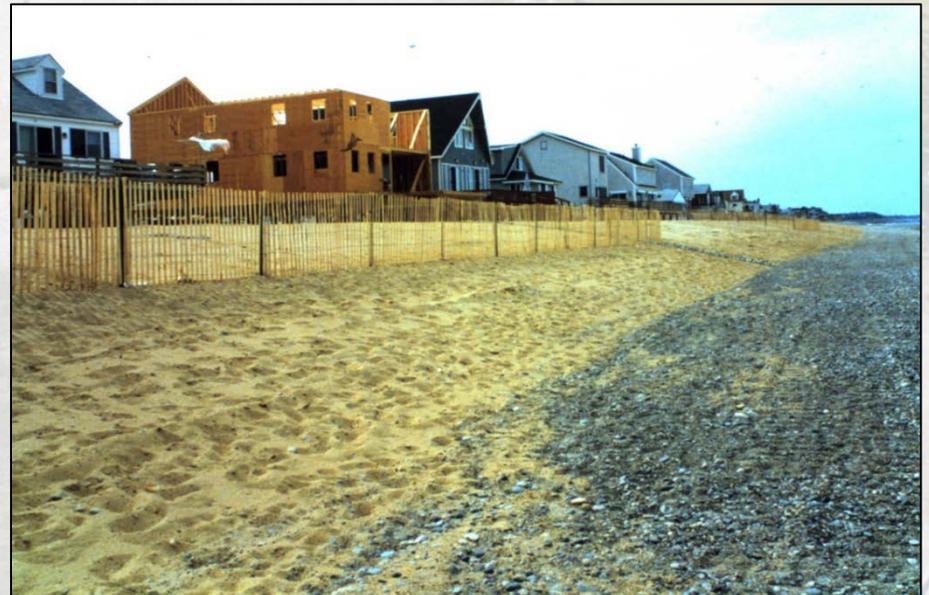
# 1994 Sacrificial Dune Project

- Designed for a 5-year storm (water levels of approximately 8 feet NAVD88)
- Sand placed from south end of Fourth Cliff to the Marshfield town line
- 49,000 cubic yards of nourishment
- Most of sand lost during Labor Day Storm (September 5, 1994, maximum water level of 5.5 feet NAVD88)

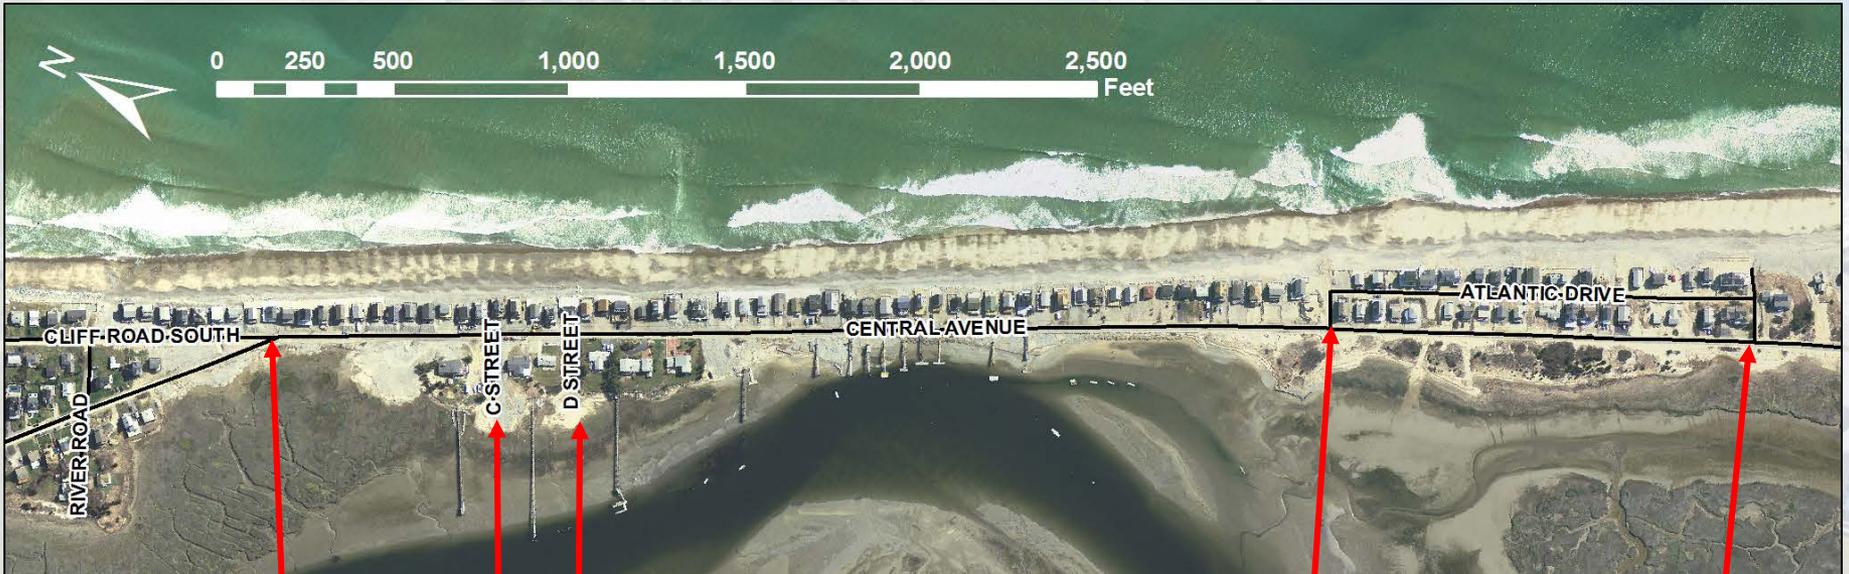
# Existing Elevation of Central Avenue
