Scituate Burial Sites Survey

Scituate, Massachusetts

2007

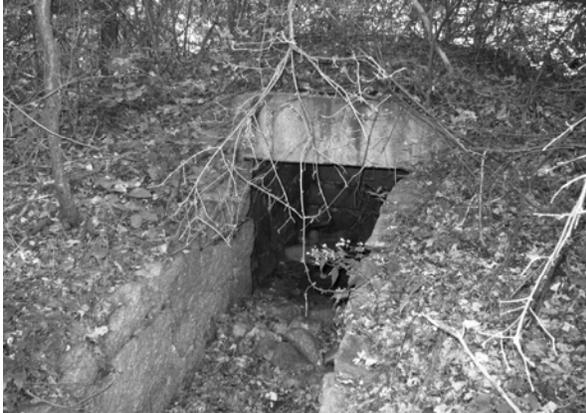
The Harrub-Northey tombs, located off Chief Justice Cushing Highway appear to have been abandoned many years ago.

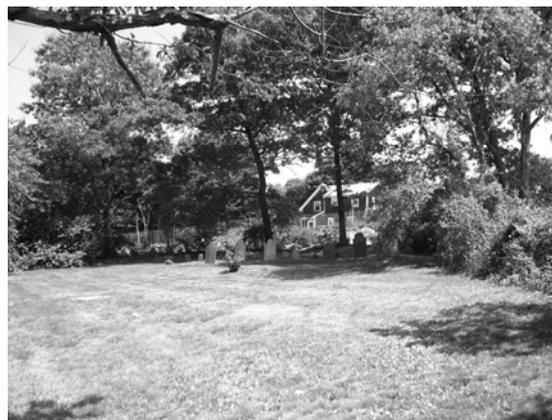
The Clapp Family Cemetery lies at the eastern end of Union Street, across from the Hanson Grain Building. Shingled and clapboard barns line the street leading to the cemetery, giving this historic "Fitt's Mill" section of Scituate a distinctive character. The cemetery consists of less than one acre of land and twelve visible graves. The edge of the pavement and gravel shoulder of Union Street form the cemetery's northern edge. From here, the landscape slopes southward from Union Street upward towards a railway line. The railroad, newly upgraded but not yet operational at the time of this survey, lies approximately 30 feet below the cemetery's southern edge within a cut. The cut itself is not visible from the cemetery grounds, but a mass of rip-rap and large concrete wall (built to retain the bank on the cut's opposite side) and 6' stockade fence (erected to screen the railway from residences on the south side), prominently stand out and create a harsh cemetery edge. A crumbling dry-laid stone wall lines the cemetery's western edge, separating the burial area from an adjacent corrugated metal mini-storage building. The cemetery contains a total of 22 gravestones and footstones, all bearing the name Clapp. Cherry, oak, and maple saplings have sprouted from the wall, and bittersweet has emerged. The cemetery itself contains only a few struggling plants - a badly diseased ash, two stunted oaks, and a mass of cherry trees. While the Cemetery's turf is even and neatly mown, the remainder of its features - the edges, plants, and views across the rail line, conflict with its purpose as a commemorative landscape in a historic vernacular setting.

- **Edges.** The edges on each side should be upgraded to provide a barrier between the intimate cemetery landscape and adjacent industrial ones. The stone wall lining the west side should be rebuilt to a 2' minimum height, and this wall should be extended around all three sides to enclose the entire landscape. A break in the wall, marked with stone posts, should appear at the northern

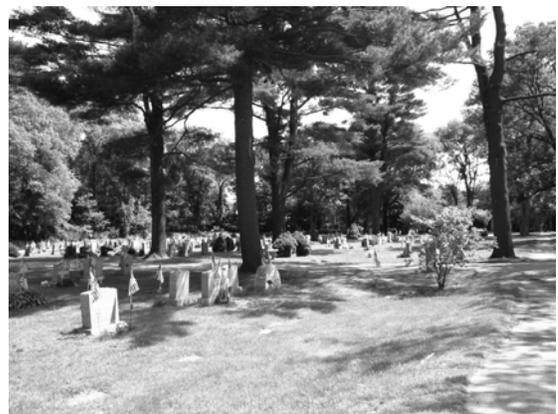
The cemetery's structures include a perimeter dry-laid stone wall, and granite curbing surrounding two family plots - the Benjamin Whitaker plot and the Barge plot. Many portions of the perimeter wall have failed, largely due to volunteer trees taking root in or next to the wall. Neither of the plot curbs is mortared, but iron dogs hold the stones of the Whitaker plot. While some of the curb stones have shifted slightly and shrub material grows from inside the Barge plot wall, both curbs stand in good condition. Many of the cemetery's grave markers are recently-placed granite memorials, however a good number of monuments and markers date to the 19th century. Many of these early markers are in need of extensive conservation treatment.

- **Walls.** The stone wall along Cudworth Road should be reconstructed to provide more separation between public the sidewalk and road and the more private, intimate cemetery. (Refer to the *Burial Site Management* section of this plan for a standard construction detail for a dry-laid fieldstone wall.) The existing perimeter wall should be rebuilt, once the volunteer trees have been removed. To stabilize the family plot curbs, the town should remove any shrubs, reset the stones in their original relocations, re-pin the curb stone joints, and replace any backfill (behind the curbs) with a light-weight material.

- **Grave Markers & Monuments.** The town should remove shrubs and small trees growing adjacent to gravestones to prevent further deterioration and overturning of the stones. Thirty-two damaged markers should be conserved per the recommendations of the *Gravestone Assessment*, found in Appendix B.

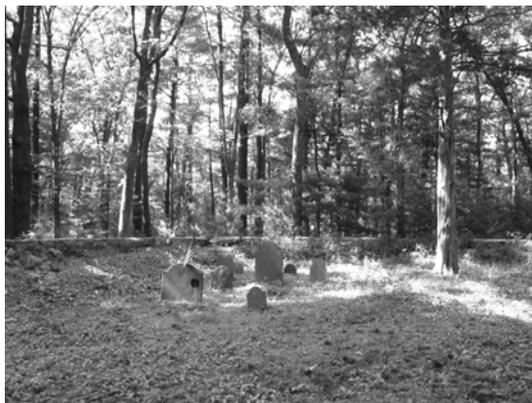
A 4' high mortared stone wall surrounds the entire 25' x 30' burying ground. This wall is mortared on its face, and contains iron dogs to secure its top stones. Overall, the wall is in good condition, with some shifting in areas where trees abut or are growing into the wall's base. The wall is stained in some areas, and lichen grows in patches in other spots. The gravestones and box tomb markers are all in good condition, although several of the stones and markers are covered with heavy biological growth. It appears that each headstone still retains its accompanying footstone.

- **Wall.** Because the wall is fairly stable, the town does not need to make repairs in the immediate future. Long term, the town should remove the trees growing near the walls, and rebuild portions that have moved as a result of tree growth.

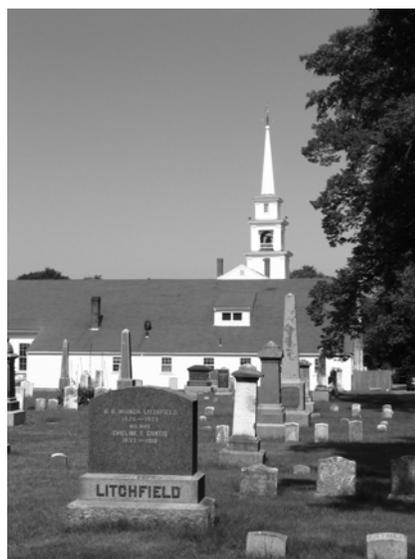
Visitors to Fairview Cemetery may enter through one of two gates – at the southeastern corner, adjacent to the church, or at the northwestern corner through a set of stone gateposts. A dry laid fieldstone wall surrounds the entire landscape, and hedgerows line most of the wall, providing a sense of privacy and intimacy within the cemetery. Some sections of this wall have failed, largely because volunteer trees have taken root either in or adjacent to the wall, causing the individual stones to heave. A green vinyl-coated chainlink fence stands in front of the fieldstone wall on the south and west sides, introducing a contemporary element into the historic site. Fairview’s grave markers range from modest marble tabletstones to large granite monuments. While many of the markers are in good condition, many others in the cemetery’s oldest sections (A and B) are in need of significant treatment. Several of these are large monuments, which require involved, lengthy treatment processes. The cemetery also contains several flat markers that have been obscured by turf and/or overgrown shrubs.

The cemetery is completely absent of trees except for a series of 30-40" caliper sugar maples planted evenly along the north and south borders, and a 48" caliper linden just inside the southeastern gate. The landscape in the dead of summer is hot and parched. In the newest section – E – mourners have planted dwarf Alberta spruce trees on either side of 30" standard markers.

- **Wall.** To repair the fieldstone perimeter wall, the town should first remove the volunteer trees growing close to the wall, and then reset and/or reconstruct the damaged wall sections.

- **Gravestones & Monuments.** The town should conserve the 75 gravestones and monuments per the recommendations of the *Gravestone Assessment* found in Appendix B. Additionally, the town should identify all flat markers and begin to carefully edge the stones, as a means of controlling growth of turf and/or shrubs.

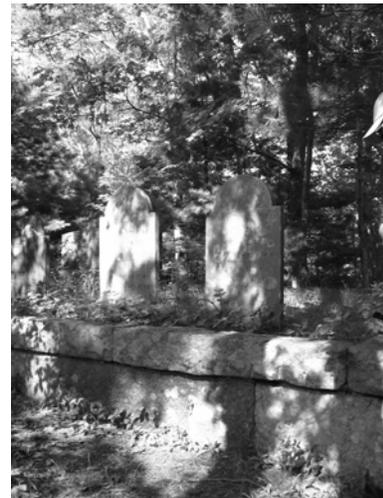
The burying ground lies atop a steep slope, approximately 50' above Judge Cushing Road. To reach the site, visitors must traverse the slope through overgrown cherry and white pine woodlands, dense thickets of viburnum, and masses of poison ivy. White pines, white oaks, and red maples surround the burying ground, which is retained by a 4' cut granite wall. Three white pines have sprouted inside the burying ground, obscuring graves. Poison ivy covers the burying ground floor. The landscape is in poor condition due to years of neglect and aggressive woodland growth.

The granite retaining wall is in very good condition, with only minor staining and growth of lichen. Several small volunteer trees have grown adjacent to the inside and outside of the wall, threatening its long term stability. By contrast, Hatch Burying Ground's gravestones are in the most serious condition of all Scituate's burial sites. Although small, several of the stones have broken (likely by vandals) into multiple pieces, requiring extensive conservation treatment. The volunteer trees, shrubs and poisonous vines have infiltrated the bases of the stones, causing further damage.

- **Wall.** To retain the excellent condition of the wall, the town should take three measures. First, the volunteer trees growing adjacent to the interior and exterior of the wall should be removed. Second, any mortar added to the exterior of the wall should be removed, and the joints allowed to remain dry. Third the wall should be cleaned of stains and biological growth. For more detailed treatment of the wall at the Hatch Burying Ground, refer to *Appendix A: Engineering Assessment*.

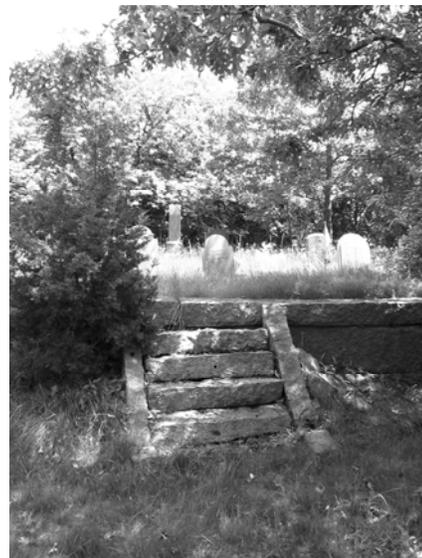
The overall condition of the wall and steps is very poor. The wall is significantly bowing, with a bow greater than two inches in most locations. Many small trees and shrubs have volunteered in and around the wall, further compromising the strength of the wall. It is likely that the original wall was dry laid, and that mortared was added at a later date, trapping water behind the wall

and adding further to its deterioration. The steps contain no hand rail, are quite steep and have significantly settled, making them uneven and difficult to negotiate. The cemetery contains several gravestones, most of which are in poor shape from both natural degradation and vandalism.

- **Wall.** To preserve the wall and steps, prevent further deterioration, and make the cemetery more accessible to visitors, the town should take three measures. First, the volunteer trees growing adjacent to the interior and exterior of the wall should be removed. Second, any mortar added to the exterior of the wall should be removed, and the joints allowed to remain dry. Third the wall should be cleaned of stains and biological growth. Fourth, the steps should be reset and a simple tubular steel handrail (painted black) added. For more detailed treatment of the wall at the Hatch Burying Ground, refer to *Appendix A: Engineering Assessment*.

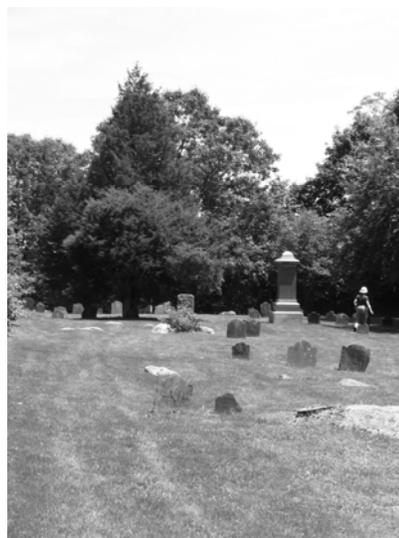
As Scituate's oldest and most historically significant cemetery, Men of Kent has been well-marked and conscientiously tended for many years. It lies along the south side of Meetinghouse Lane on a $\frac{3}{4}$ acre of land shaped like a sliver. A dry laid fieldstone wall surrounds the entire site, and on the north and east sides, the wall retains the cemetery. Overall, this wall is in poor condition with many volunteer trees and shrubs growing into the wall, causing the individual stones to tumble. A small break in the wall, flanked by stone posts, marks an entrance on the south side. Slate markers dominate the cemetery, and most are in good condition, with the work of many well-known carvers still visible on the stones.

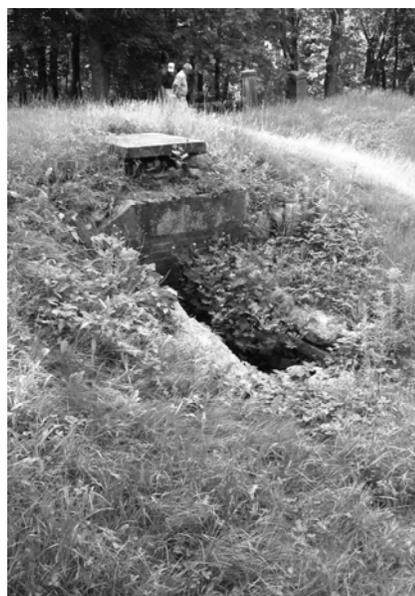
Visitors reach the Merritt Cemetery via a shaded dirt path, leading southward from Clapp Road approximately 350 feet. A stone wall lines the east side of the path, and mature shade trees, interspersed with suckering deciduous trees, shade the entire route. At the cemetery, the path surface changes to turf. A dry laid stone wall encloses the entire cemetery, with a small break in the wall at the northeast corner. The condition of this wall is poor, with many sections failing. Granite posts bearing the remainder of an iron gate (the hinges), flank the entrance. Mature cedars and maples stand outside the wall, providing a secure screen between the cemetery and adjacent residences (north and east sides).

Inside the cemetery, mature cedars and maples, and a lone horse chestnut dot the perimeter. Two of the maples appear near death, and the caretaker has marked them for removal (July 2005). Turf, mixed with perennial groundcovers, covers the entire cemetery floor. Single graves stand in the eastern half of the cemetery, and four mound tombs dominate the western half of the cemetery, each with a separate set of steps and doorway. The interiors of these seem to be in stable condition, but the exterior features have deteriorated. Decay on each tomb includes shifting and leaning headwalls, shifting cheek walls and missing tomb doors. The gravestones and monuments – many of them marble – have suffered environmental damage and been vandalized.

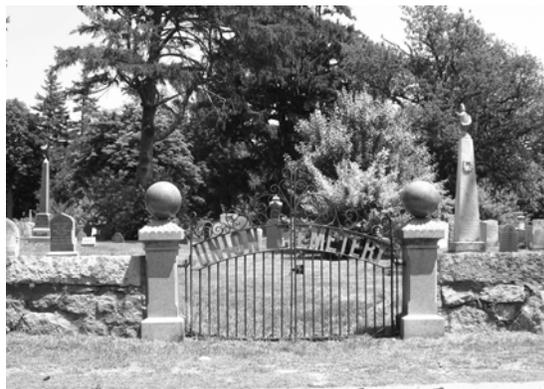
Union Cemetery lies at the corner of Meetinghouse Lane and Stockbridge Road in Scituate Center. A mortared stone wall lines the north and east sides, and a low dry laid fieldstone wall separates it from Old Saint Mary's Cemetery, a Catholic burying ground adjacent to Union's southeast corner. The stone wall is in very good condition, with just minor shifting occurring in a few spots. Chainlink fencing rims the north and east edges, screening Union from adjacent residences. The stone wall along Meetinghouse Lane and Stockbridge is set back from the edge of pavement, allowing pedestrians to pass along a grassy strip. Aging sugar maple trees line Meetinghouse Lane in front of the cemetery wall. Several of these trees are diseased and have lost limbs, and should be removed and replaced.

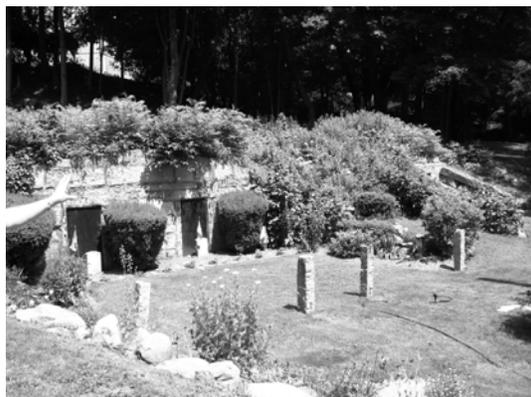
The Damon-Brown tombs (also known as the Damon-Brown-Stetson tombs) stand on private property along the east side of Country Way, at the end of a driveway leading to #330. They consist of three separate chambers, with the Damon and Brown (north) tombs joined by one headwall, and the Stetson (south) tomb supporting its own headwall. The Damon-Brown tombs are constructed of mortared granite, with dry-laid granite cheek walls. Each of the two chambers is accessed by a separate door, covered with a steel plate. The Stetson tomb headwall is mortared granite, and

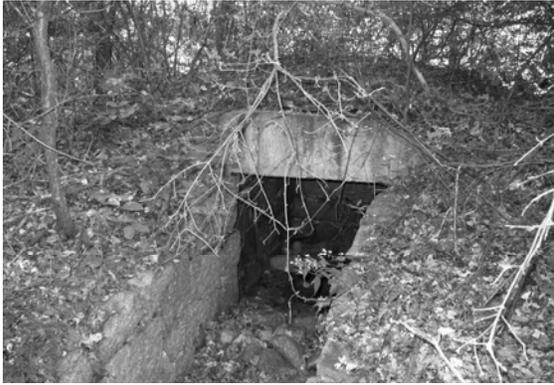
A field stone wall outlines the tomb area, and the two tombs lie within the wall. The doors of the tomb face north and entries to the doors are defined by field stone cheek walls. Granite lintels rest atop both tomb doorways, and the tomb doors have been removed. "I. M. Harrub 1841" is inscribed in the lintel of the east tomb. Overall, the tombs are in very good condition with only slight (one inch) movement in the Harrub tomb cheek wall, and no movement in the Northey tomb structure.

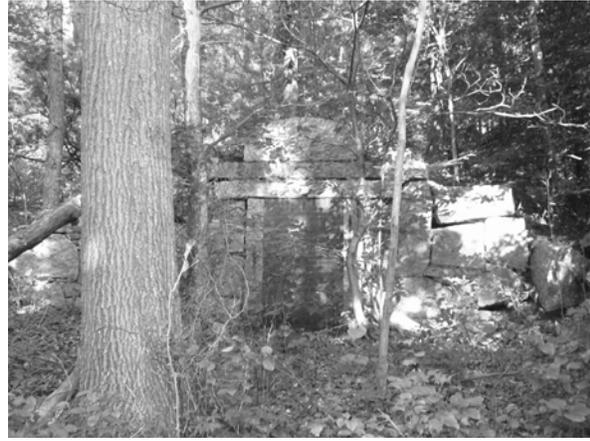
The tomb structure rests against a hillside, is constructed of cut granite, and is in fair to poor condition. The front wall has moved and the right cheek wall has failed, with stones missing. Deciduous trees have volunteered in and around the tomb, contributing the structure's deterioration. One tree has fallen on the tomb to the left of the door. While the door has been sealed with mortared brick, hardware remaining in the door jam area suggests the tomb once had a door.

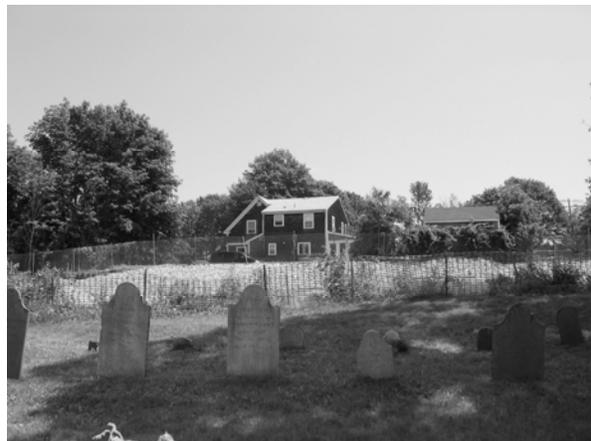
The Clapp Family Cemetery should be treated in conjunction with the MBTA Greenbush line project (behind the fence in the photo's middle ground).

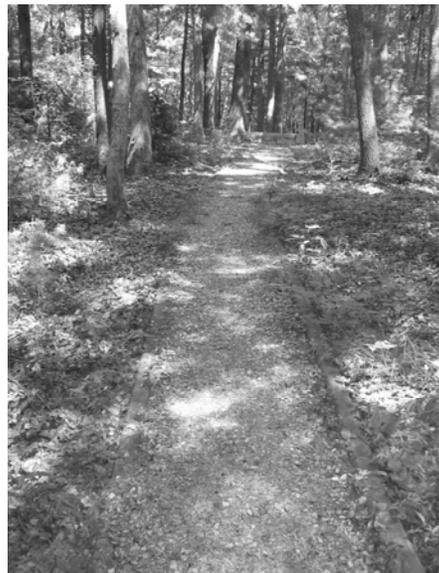
The existing pathway to the Cushing Family Cemetery is lined with wood timbers. These should be replaced with granite edgestones as they rot.

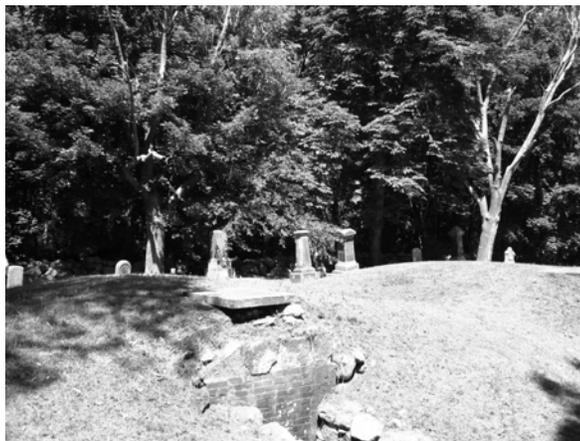
The tombs and the Merritt Cemetery, as well as the burial site's landscape, are a medium priority preservation project.

- *Preserve the Merritt Cemetery*, establishing a pull-off parking area for visitors at Clapp Road, clearing invasive plants from around the cemetery perimeter, rebuilding the perimeter wall, removing diseased or dead trees from the cemetery interior, stabilizing the tombs, and conserving the monuments and markers.

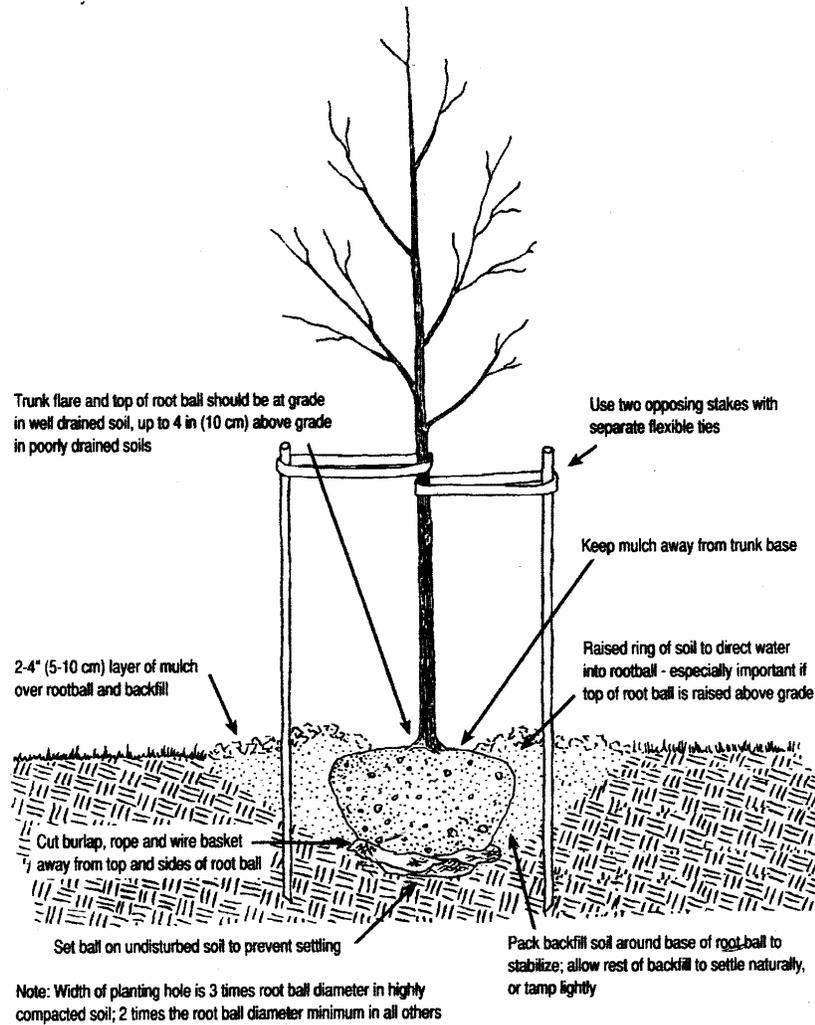
Tree Planting Detail. Source: University of Connecticut Cooperative Extension Service.
