Introduction and Executive Summary

Overview

Inventory and Evaluation

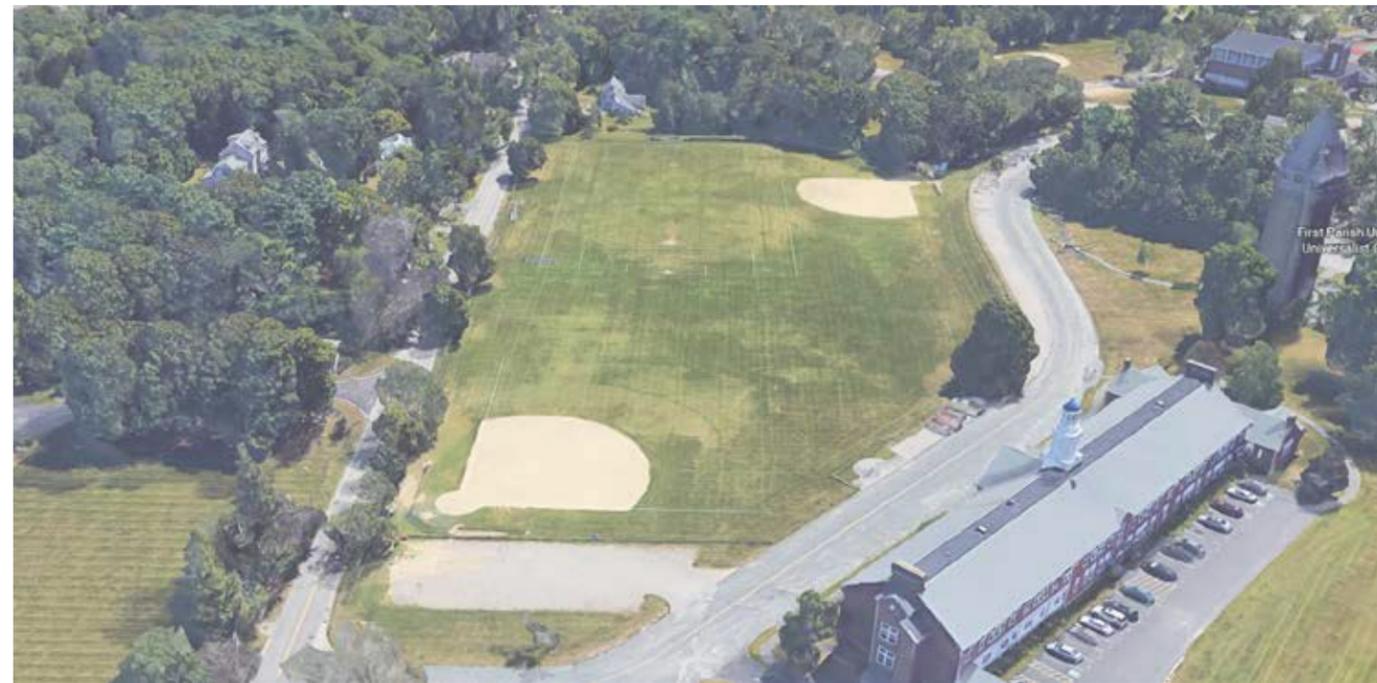
CENTRAL FIELDS

Overall - Fields are in fair condition see maintenance inspection checklist for details. Fields have a decent stand of grass with patchy broadleaf weeds throughout and bare spots in high use areas. Softball field 1 has been recently had a partial renovation this included the infield but did not include grading of the entire site. Because grading for the site could not be included grading continues to move on site water across the infield toward home plate causing the infield surface to retain water for longer periods of time than an ideal grading configuration. Mounds and Home Plate areas were in need of repair.

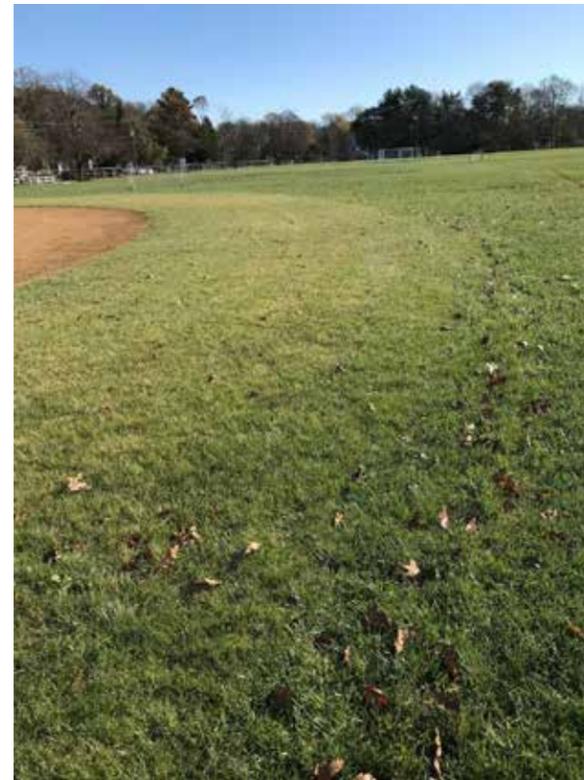
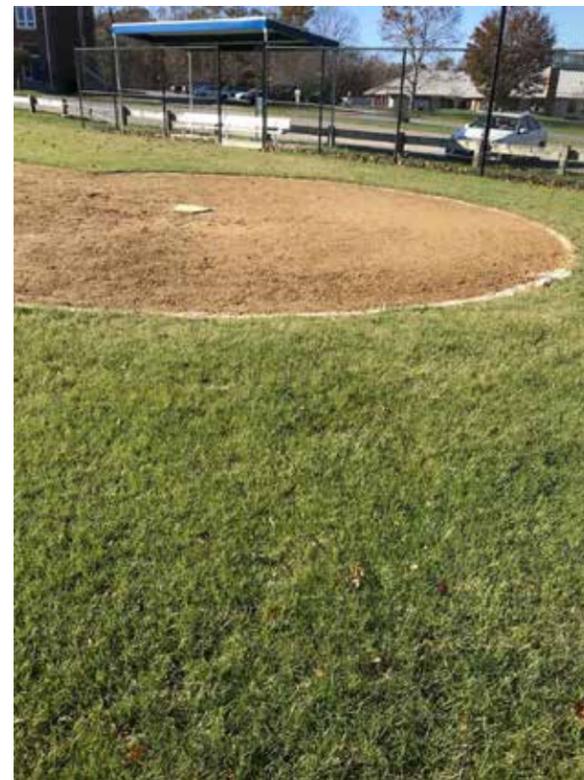
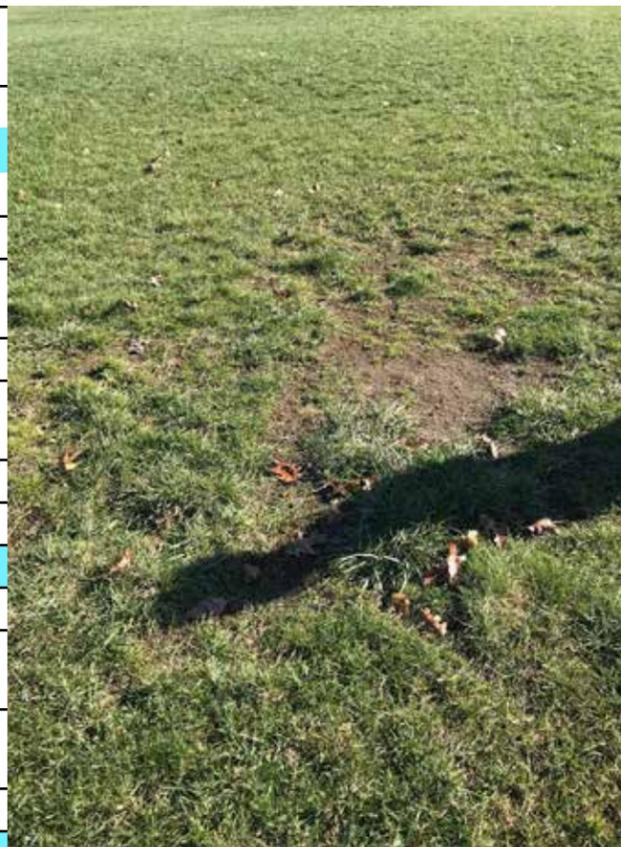
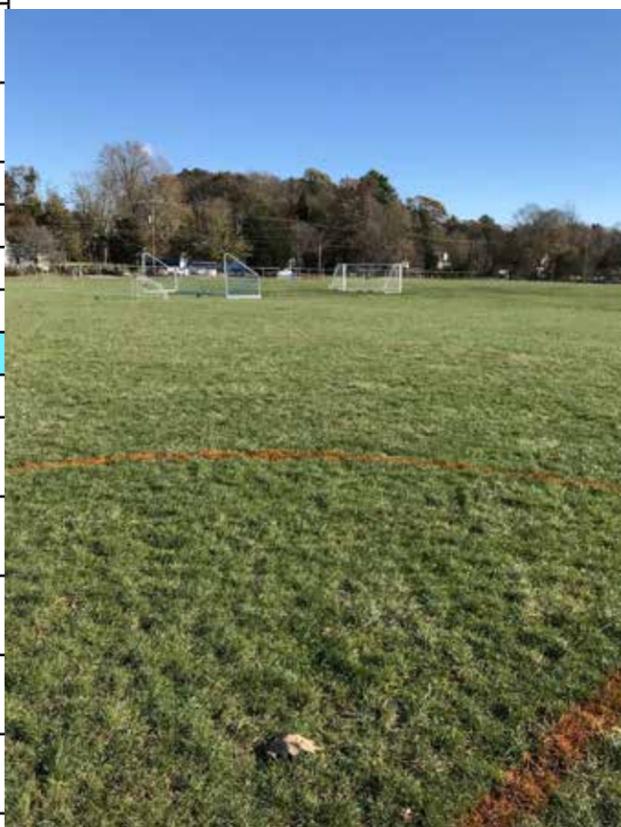
Maintenance Inspection Checklist	
Athletic Fields and Practice Areas	
Field Name or Location: Central Fields	
Date: 11/17/17	
Inspected By: Justin Robertshaw and Arthur Eddy

A. Turf Density	
	Field has a dense stand of grass and no bare areas are present.
	Field has a dense stand of grass but thinning is evident in goal mouths, out-field player positions, and commonly expected wear areas.
x	Field has good grass cover on most of the field but bare areas are evident in goal mouths, outfield player positions, coach's boxes, or like.
	Turf is thin or sparse on the majority of the field and bare areas are evident in goal mouths, outfield player positions, coach's boxes, or like.

F. Field Contours Baseball /Softball	
x	Infield mix is level and slopes or is crowned to provide surface drainage of water away from the skin. Skin is in good condition but does not drain to the outfield. This may cause some issues with skin playability in the spring or after a heavy rain
	Infield mix is mostly level but has some high and low spots around bases, pitching area, and homeplate.
	Infield mix has significant high and low areas especially around bases, pitching area, and homeplate.

G. Pitchers Mound Baseball /Softball	
	Is the mound covered or is a cover evident in the vicinity? Circle one: YES NO
x	Mound is in good repair. Table around pitching rubber is intact. Landing area slope is correct.
x	Mound is in average state of repair and is shaped correctly. The table and slope show minor wear at the pitching rubber and landing area less than 3" deep. Home plate shows some major wear on SB2 and is in need of repair
	Mound is badly worn and correct shape has degraded. There are wear areas at the pitching rubber and landing area 3" or deeper.

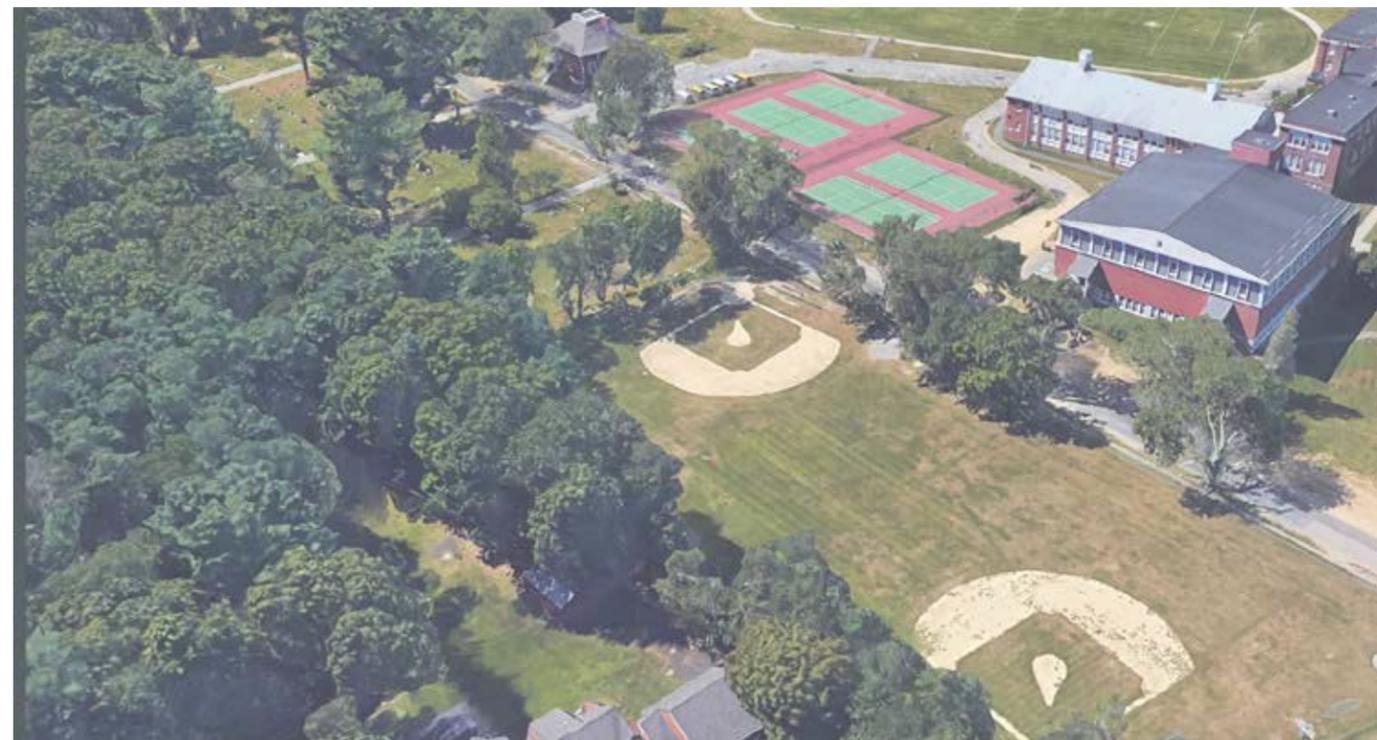
CUDWORTH FIELDS

Overall - Fields are in poor condition see maintenance inspection checklist for details. Fields have a patchy stand of grass with significant broadleaf weeds throughout. Slopes and Drainage are the major draw backs to these fields. Fields also have exposed boulders within the field of play creating a potential safety concern. These fields should be considered for lower level use and with minimal improvements will serve younger population well. The mounds and Home Plate areas were in need of repair.

Fields are considered T-ball / Little League with a soccer overlay due to the physical presence of infields. Usage shows a predominance of soccer and if this is planned to continue the town should consider removing the infields and backstops associated with T-ball to improve safety, playability and space requirements for soccer.

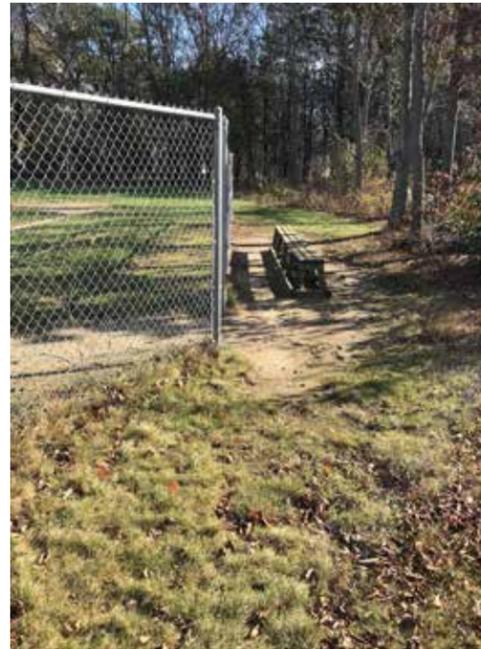
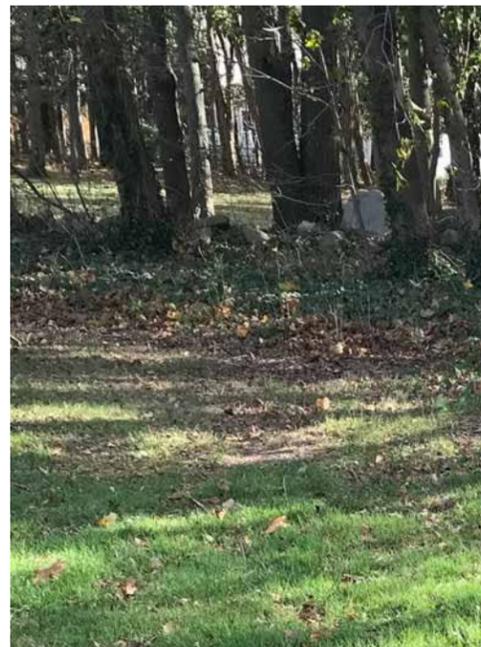
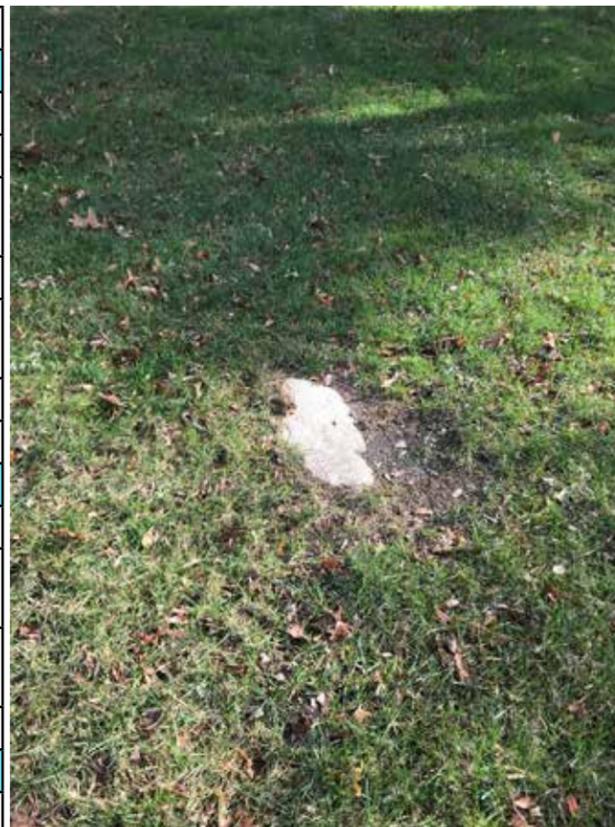
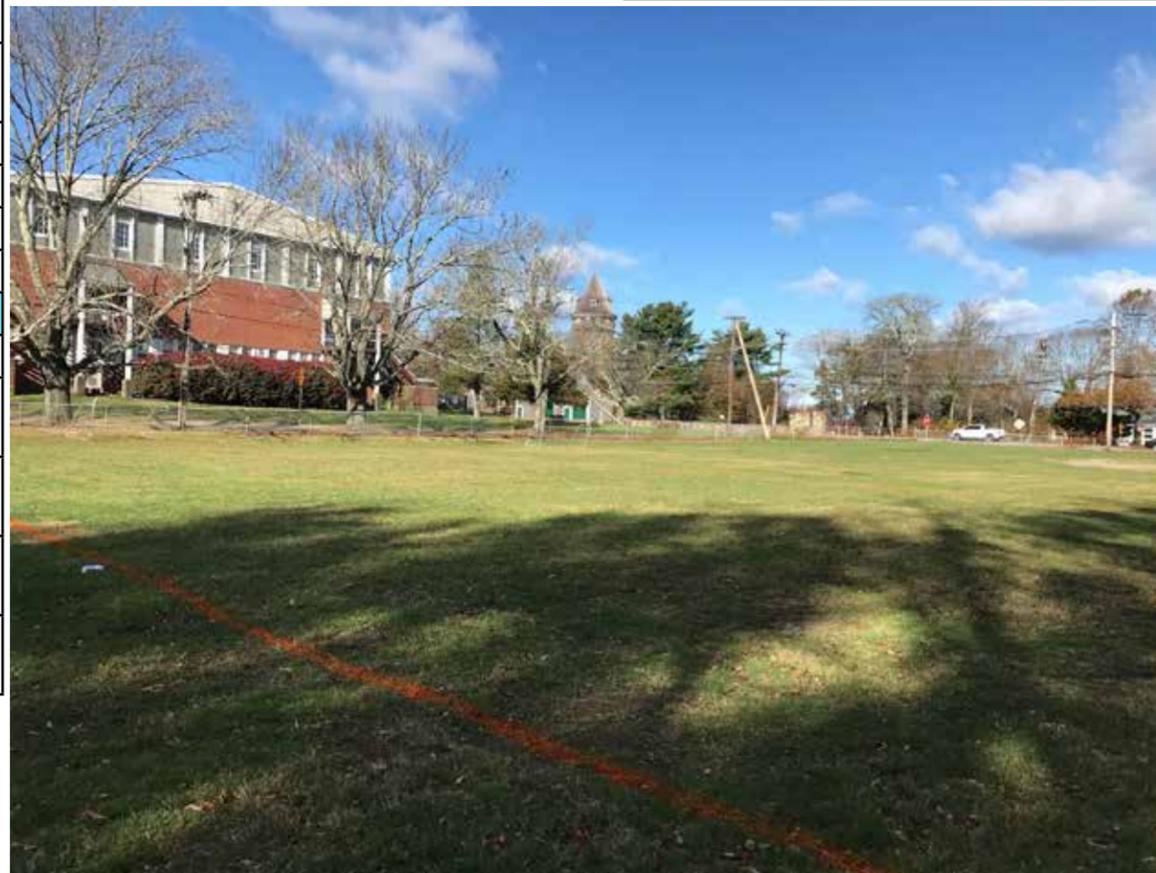
F. Field Contours Baseball /Softball	
	Infield mix is level and slopes or is crowned to provide surface drainage of water away from the skin.
	Infield mix is mostly level but has some high and low spots around bases, pitching area, and homeplate.
x	Infield mix has significant high and low areas especially around bases, pitching area, and homeplate.

G. Pitchers Mound Baseball /Softball	
	Is the mound covered or is a cover evident in the vicinity? Circle one: YES NO
	Mound is in good repair. Table around pitching rubber is intact. Landing area slope is correct.
x	Mound is in average state of repair and is shaped correctly. The table and slope show minor wear at the pitching rubber and landing area less than 3" deep.
	Mound is badly worn and correct shape has degraded. There are wear areas at the pitching rubber and landing area 3" or deeper.

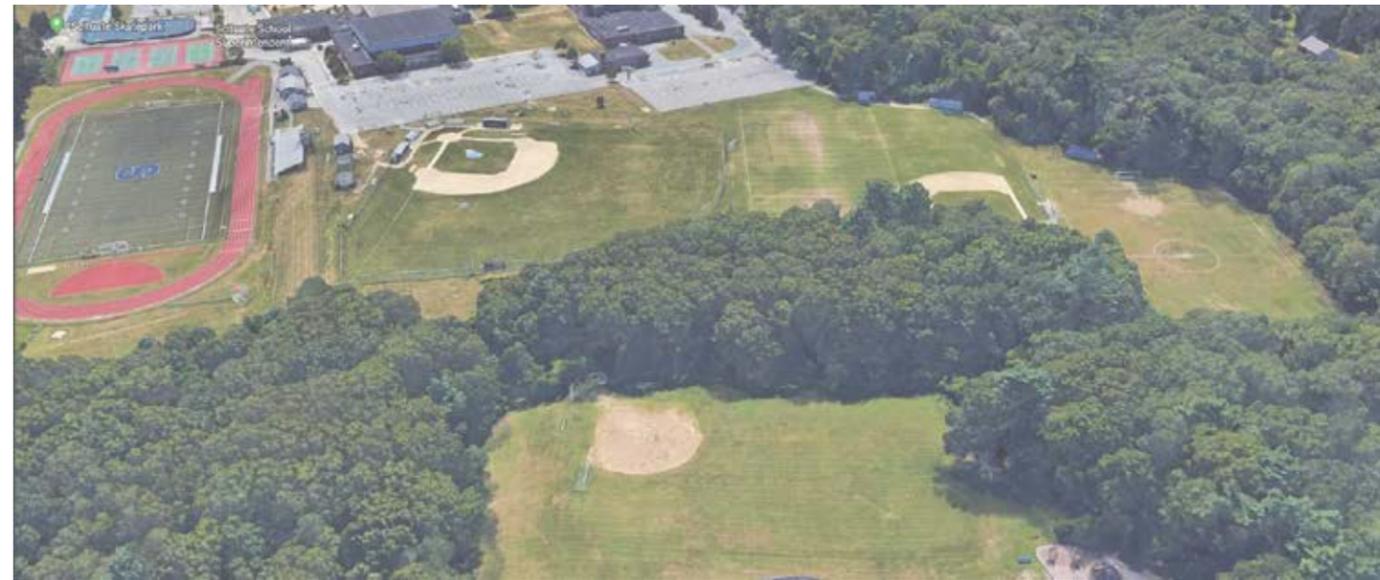
CUSHING SCHOOL FIELD

Opportunities- This field was constructed to relieve capacity issues and Title Nine regulatory issues in 2016. The biggest opportunity for the future will be to complete the irrigation systems as designed. Without irrigation this field will deteriorate quickly due to its use.

This natural grass field was renovated in 2016. Field was renovated to a standard full size field hockey field with appropriate slopes and drainage. Unfortunately an irrigation system was not installed due to multiple factors including water restrictions due to drought conditions and a lack of available water supply from the current well. This lack of water as well as an early and intense use of the field has caused irreversible damage to the grass. Irrigation experts have previously recommended installation of a new 8" well to support this field separate from the currently irrigated fields at SHS. When installing a new well for this field consideration should be given to minor renovation, this includes laser grading the surface and installing sod to replace damaged and sparse vegetation.

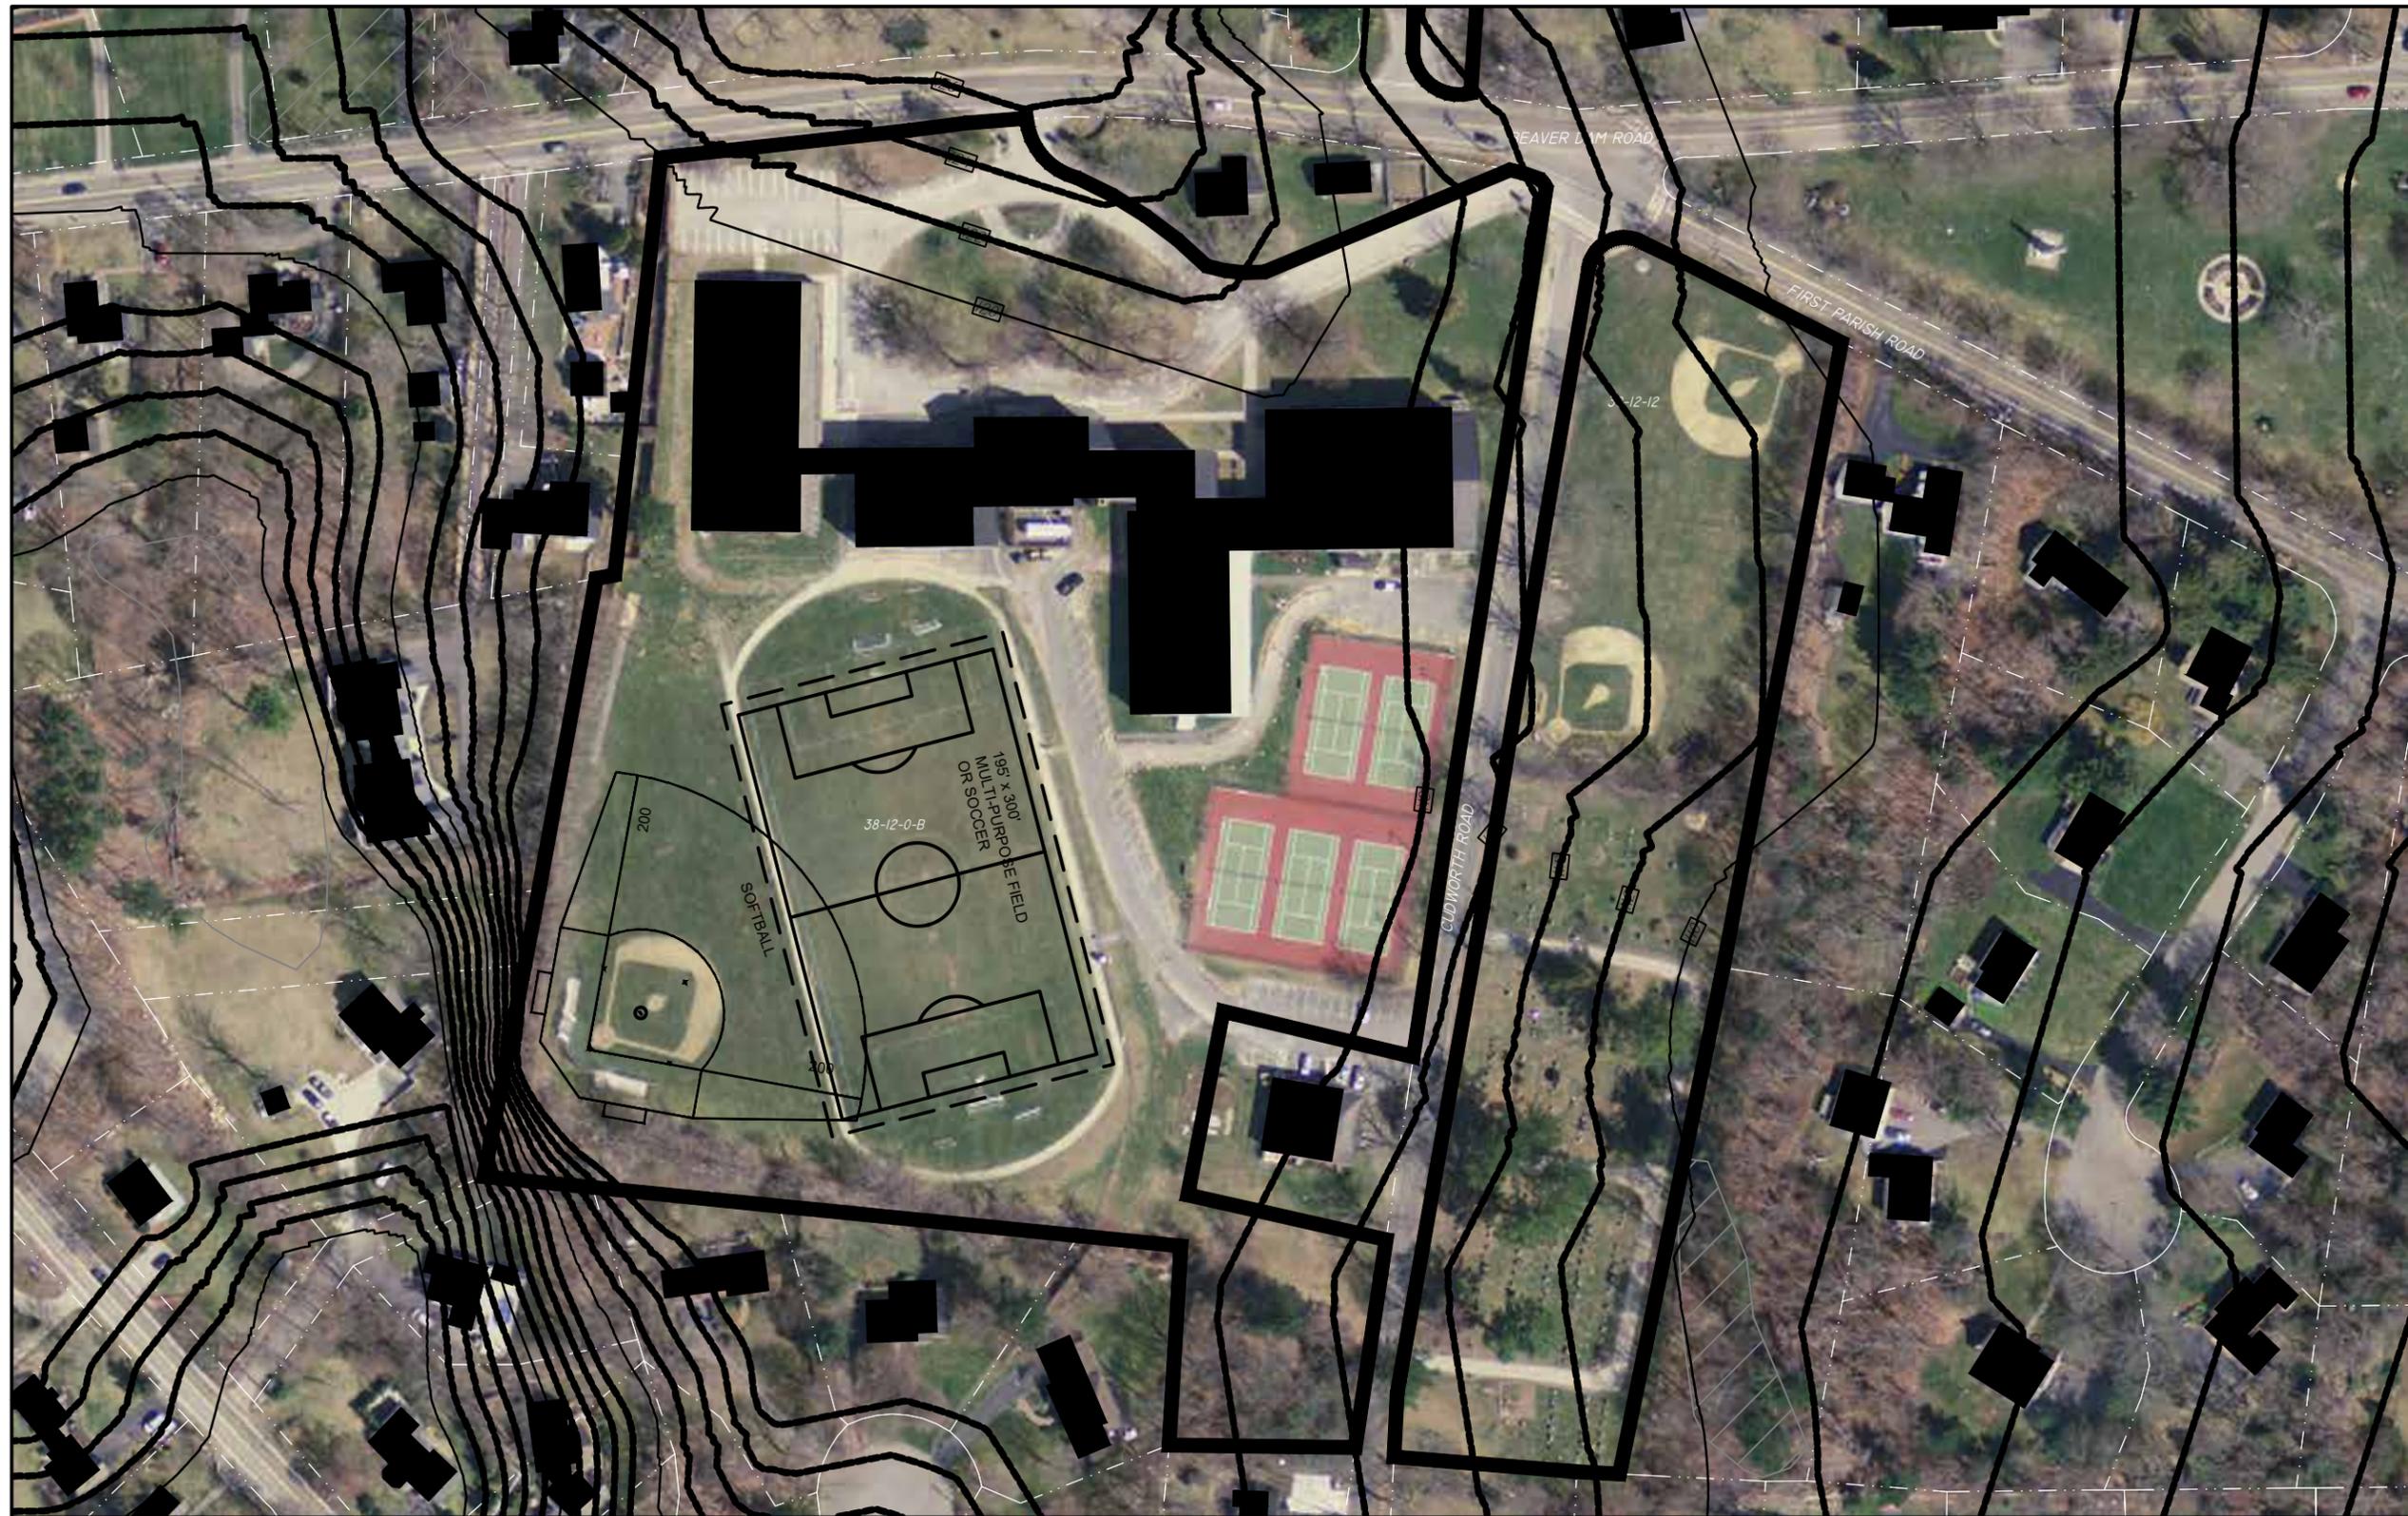
GATES FIELD - 327 FIRST PARISH RD
CUDWORTH - CUDWORTH ROAD
1" = 50'

Overall - Fields are in fair /poor condition see maintenance inspection checklist for details. Fields have a patchy stand of grass with significant broadleaf weeds throughout and bare spots in high use areas down the middle of the field. Cinder track is in need of maintenance in order to maintain it's form/edge. Baseball outfield is bi-sected by the cinder track this scenario is potentially dangerous and should be avoided when possible. The mounds and Home Plate areas were in need of repair.

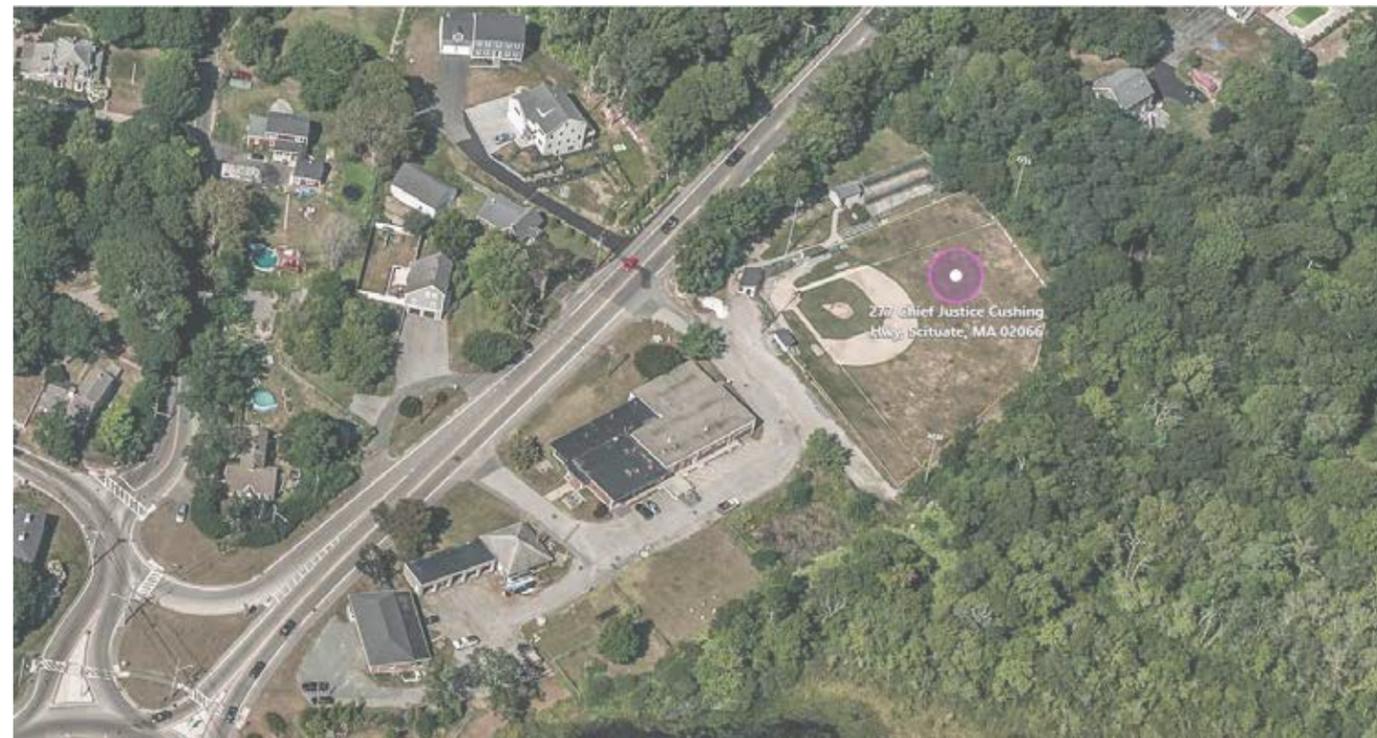
GREENBUSH BASEBALL FIELD

Athletic Field Equipments- 1 baseball backstops, 2 batting cages, block dugtouts, scoreboard and lighting

Field should be considered a game field. The field is well taken care but is currently showing it is past it is past due for renovation. Any renovation should be considered major and replace most existing components including, dugtouts, fencing, backstop, scoreboard and irrigation. Drainage improvements should be made so that surface drainage of the infield is relatively flat 0.5%-1.0% toward the outfield and 1-1.5% through the outfield.

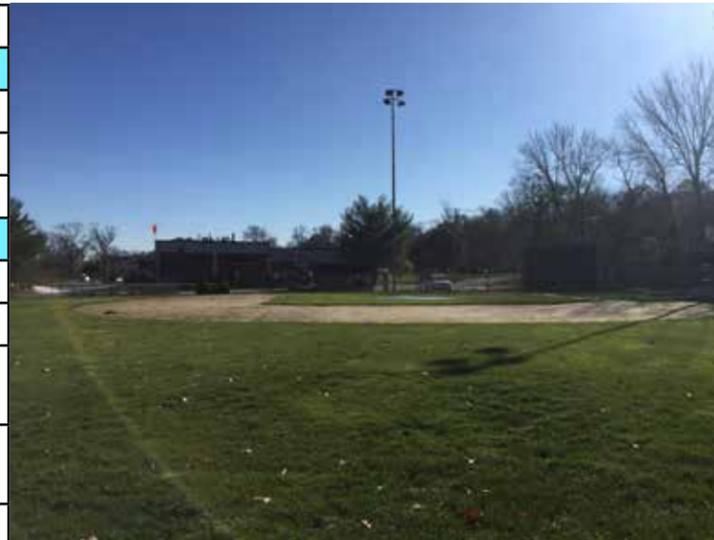
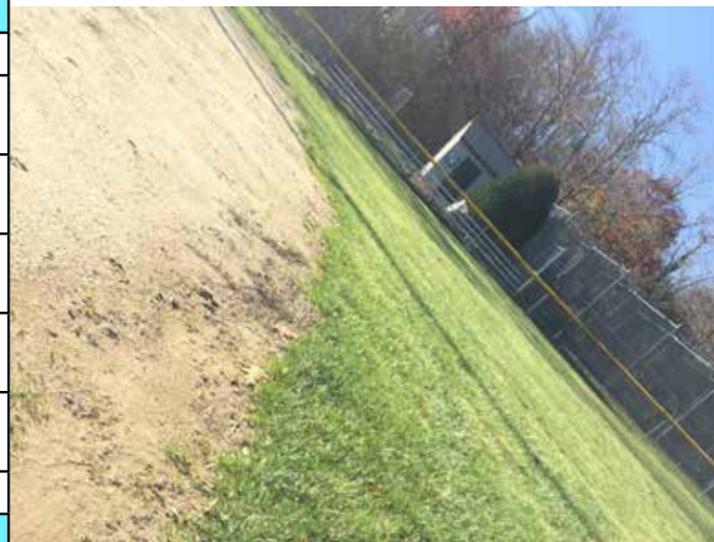
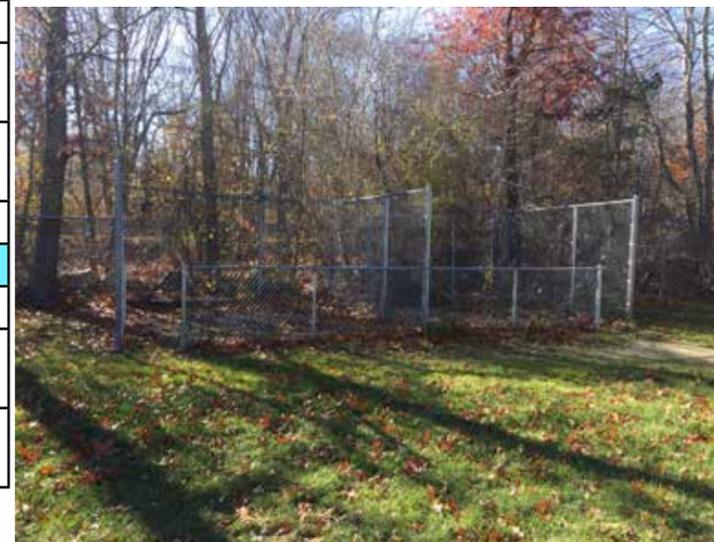
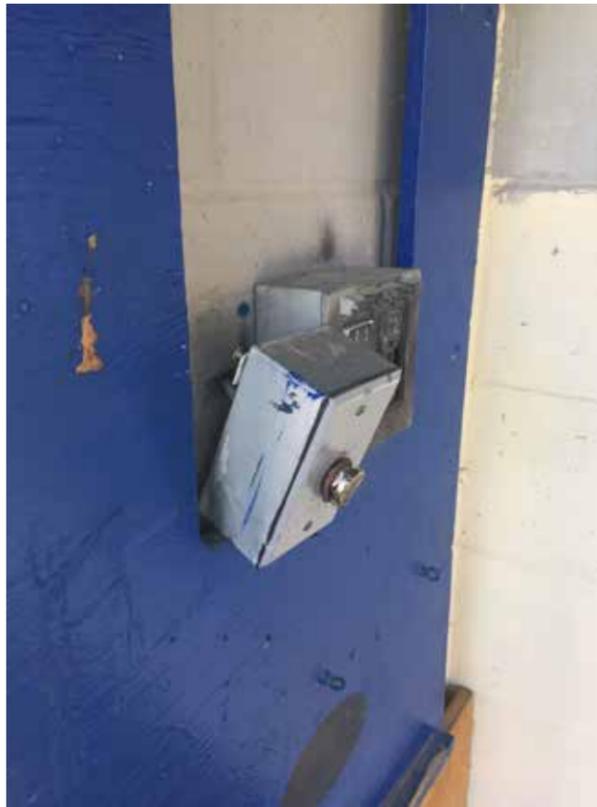
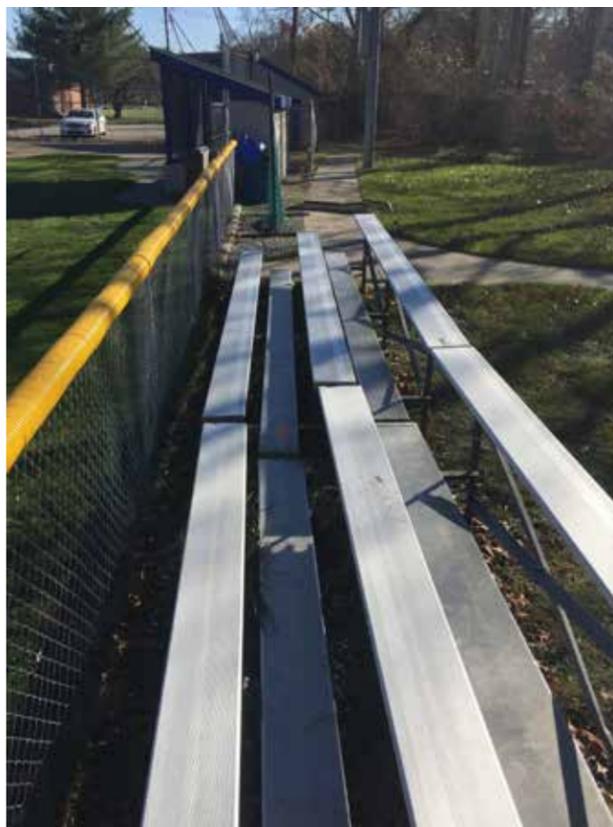
D. Mowing and Trimming	
	Turf is cut at an appropriate height for use and all trim in the playing area is no more than 30% higher than the mowed grass.
x	Turf is too high or low for the intended use and all trim in the playing area is no more than 30% higher than the mowed grass.

L. Lights	
	Lights are operational. Operation of lights is unknown condition looks to be good. Product is Musco Light Structure which is now 2 generations old
	Light poles are structurally sound with no visible damage at the connection to the concrete footer.
	Electrical junction boxes and conduit are secure.
M. Trash / Recycling Receptacles	
x	Sufficient barrels are available in high traffic areas such as dugouts and bleachers.
	Barrels are not overflowing and have liners in place.
	Receptacles are cleanly painted with no rusted metal or graffiti visible.
N. Signage	
	Emergency and DPR signs are in visible locations and secured properly.
x	Signs are readable and not faded or broken.

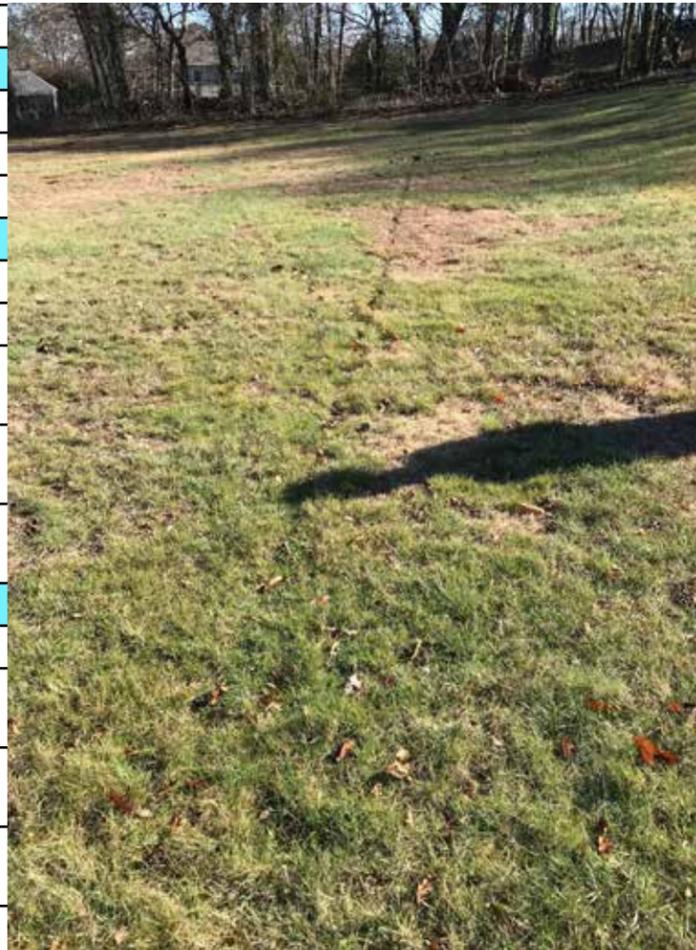
F. Field Contours Baseball /Softball	
	Infield mix is level and slopes or is crowned to provide surface drainage of water away from the skin.
	Infield mix is mostly level but has some high and low spots around bases, pitching area, and homeplate.
x	Infield mix has significant high and low areas especially around bases, pitching area, and homeplate. Field looks to be a former Little League Field now setup for lacrosse practice

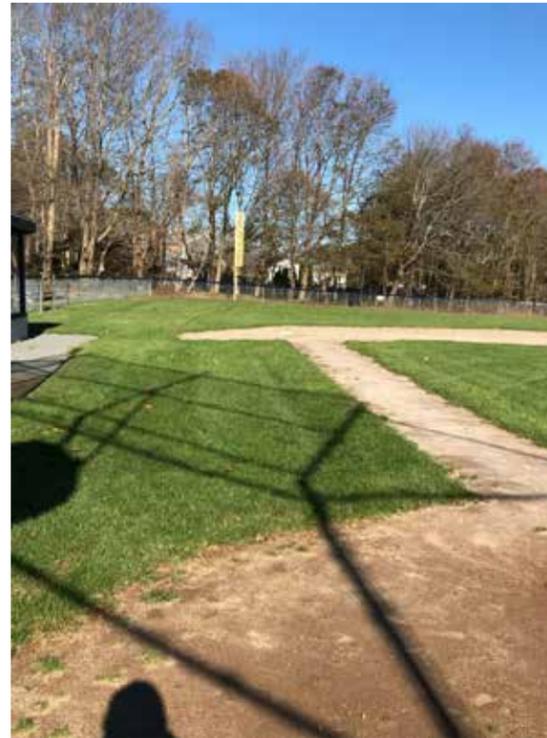
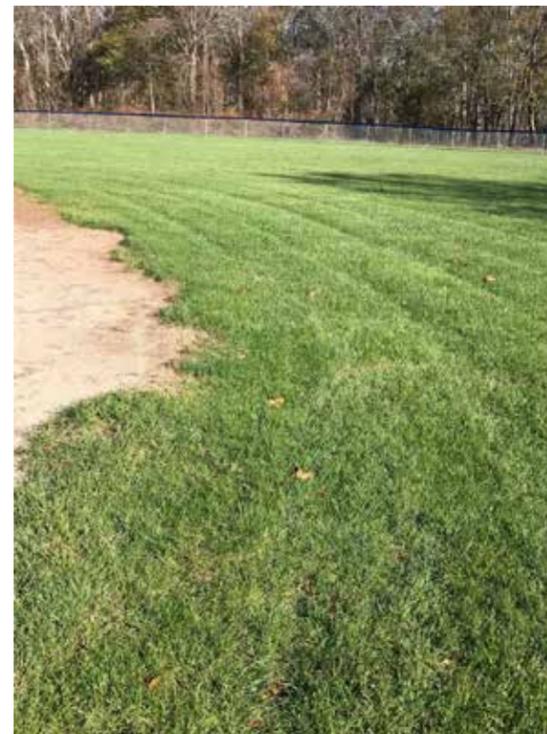
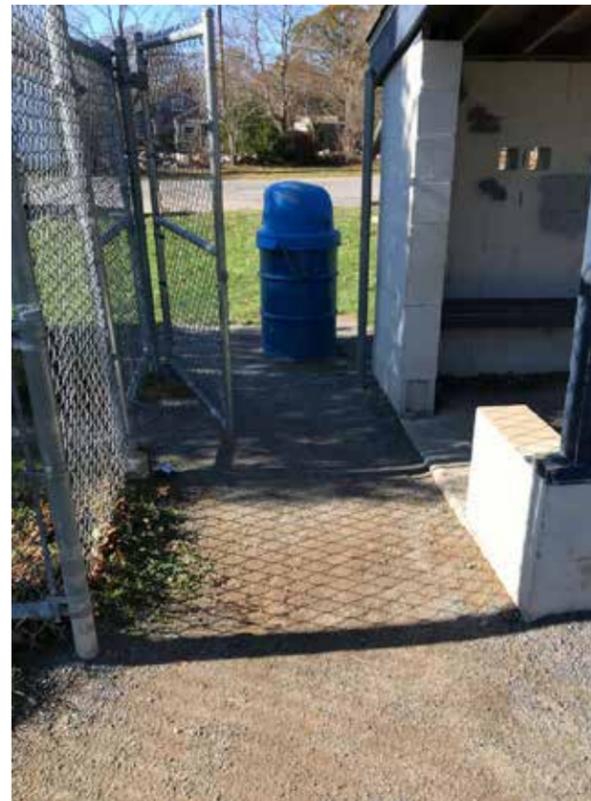
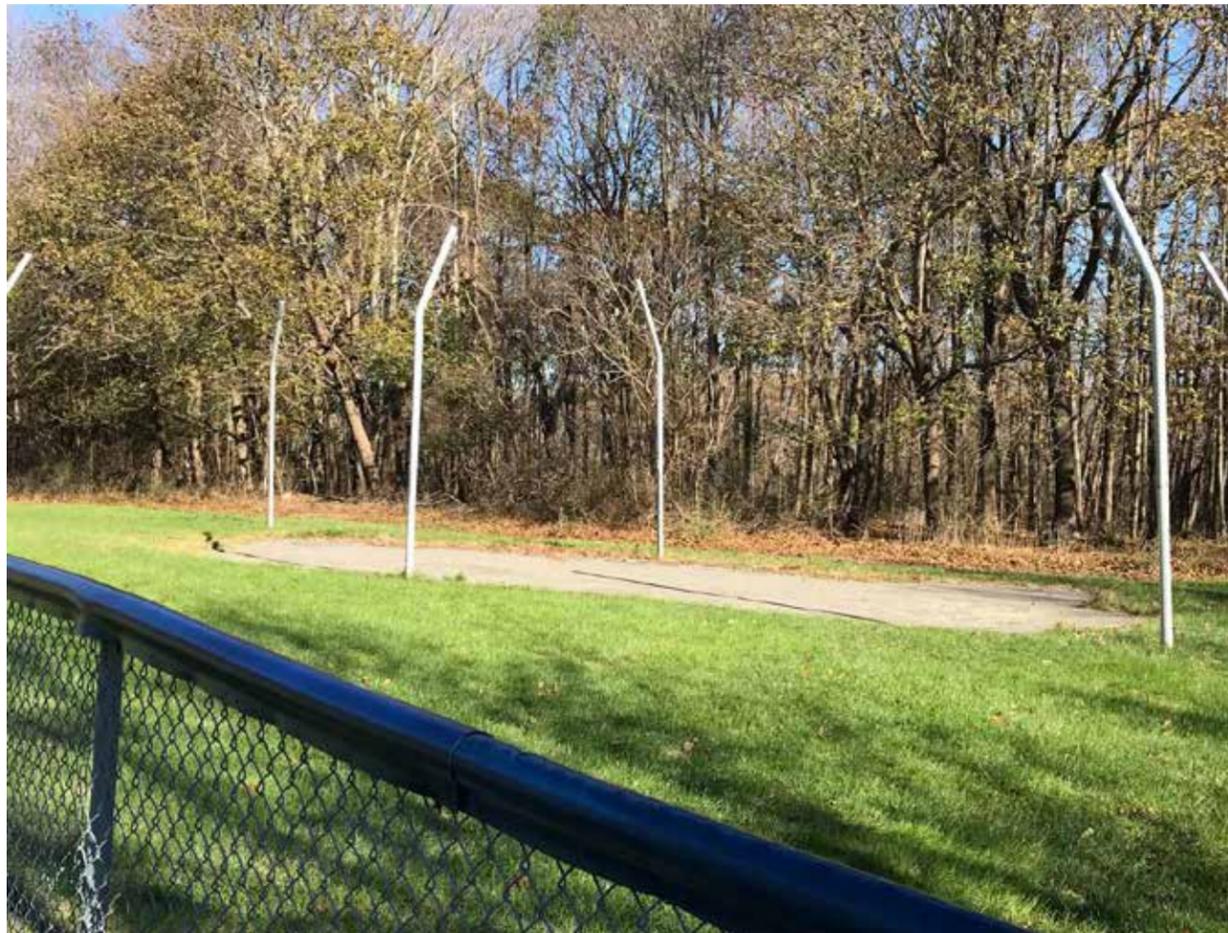
K. Dugouts	
	Structure is sound. Roofing appears intact and no leaks are evident. All lumber appears solid with no rotting visible. Large crack in the settled masonry of the third base dugout.
x	Seating surface is clean and free of protrusions. No catch points or sharp edges are exposed.
	All surfaces are cleanly painted with no rotten lumber or rusted metal evident. No graffiti in sight.
	All electrical enclosures are secure, GFI's have covers in place, lights and electrical plugs work, no wires are exposed.
	Protective Fence fabric is 6' in ht. and is free of holes and is properly tied to the upright and crossing supports

Field should be considered a game field. The field is well taken care but is currently showing it is past it is past due for renovation. Any renovation should be considered major and replace most existing components including, dugouts, fencing, backstop, scoreboard and irrigation. Drainage improvements should be made so that surface drainage of the infield is relatively flat 0.5%-1.0% toward the outfield and 1-1.5% through the outfield. ADA access to the field should be improved.

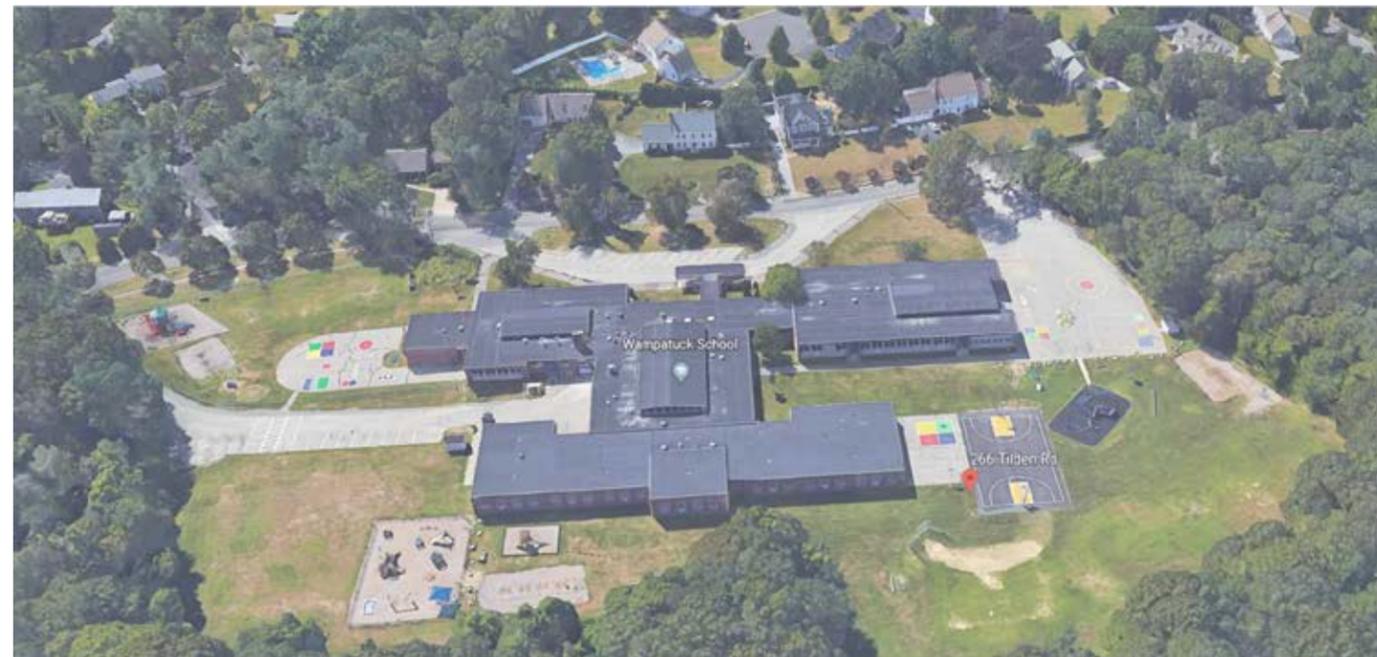
WAPATUCK FIELD

Overall - Fields are in poor condition. Little League field does not seem to have been used other than PE for some time. Open space in the front of the school does not have grades to support an athletic field.

Athletic Field Equipments- Backstop (needs replacement if the field is to remain a baseball field in the future.
