Introduction and Executive Summary

Overview

Inventory and Evaluation

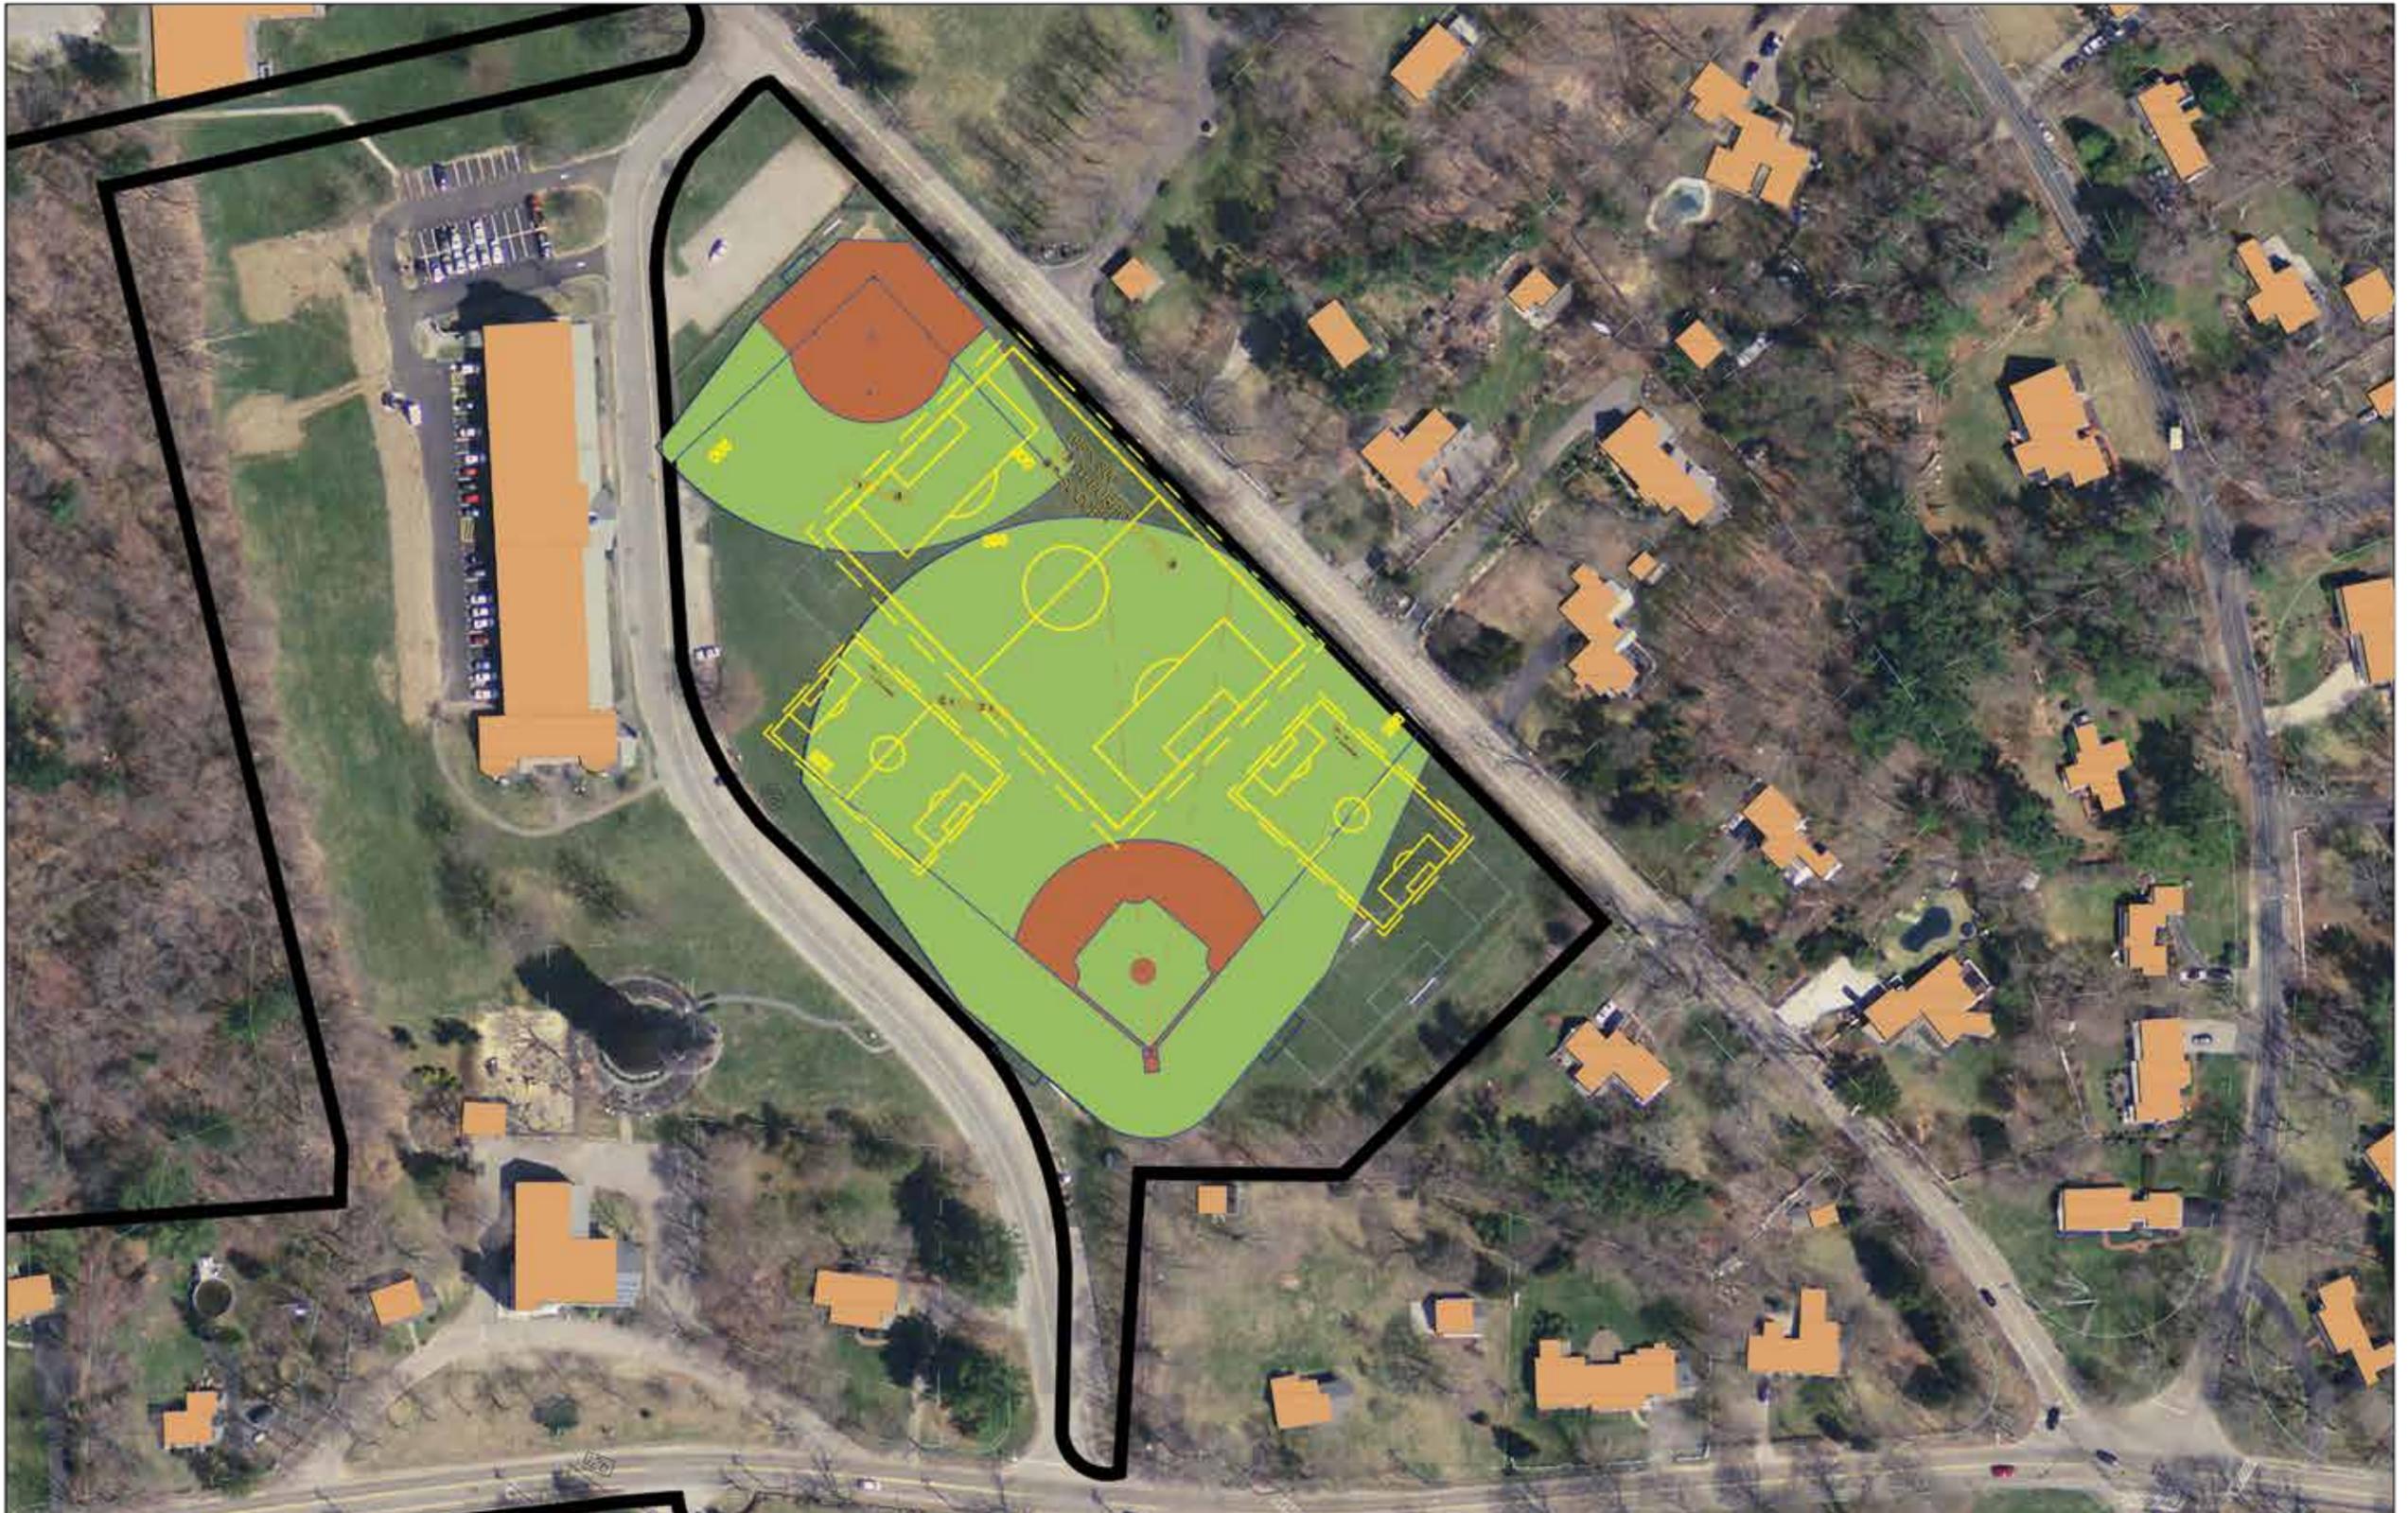
Cudworth Fields

Item	Total
Little League Field Improvements	
Replace backstops	
Remove grass from infields	
New infield mix	
Remove boulders from outfield replace add top soil and new sod	
Grading improvements	
Subtotal	\$117,000
SUBTOTAL OF SITE CONSTRUCTION ITEMS	\$117,000
OH&P	\$11,700
CONTINGENCY	\$5,850
TOTAL	\$135,000

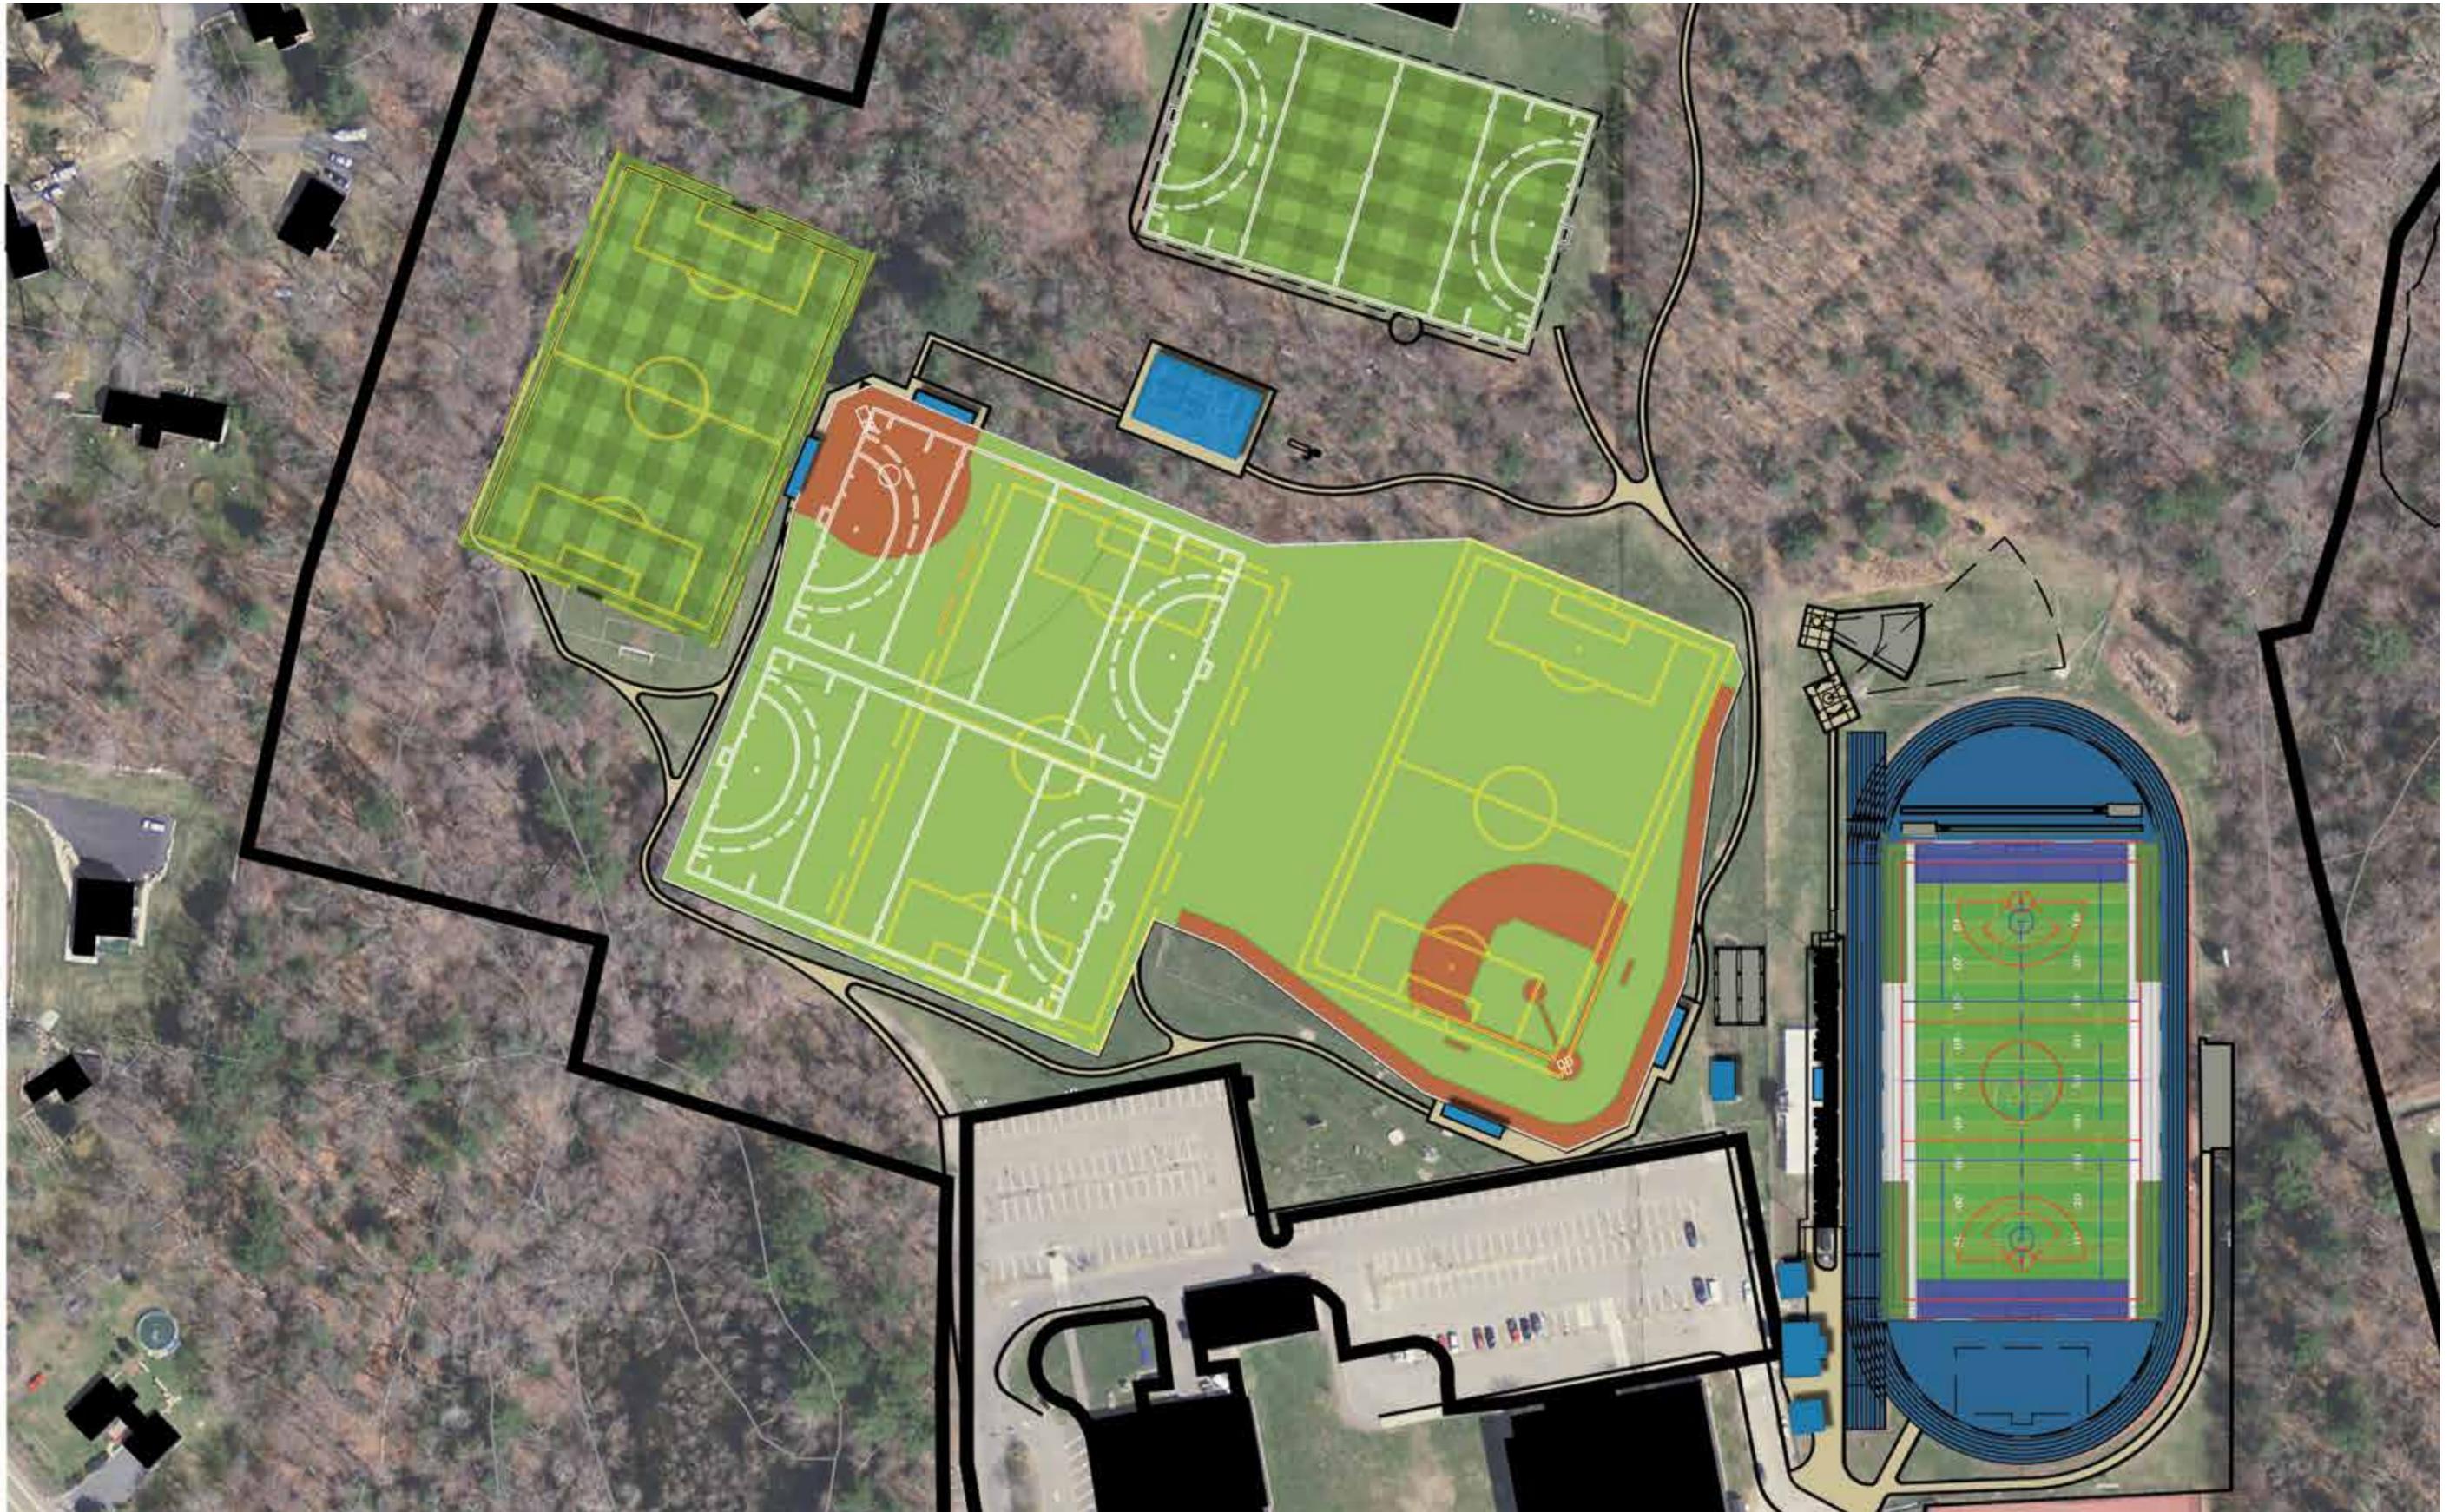
Scituate High School Fields

Opinion of Probable Cost - Scituate High School BB/SB Fields Phase

Key Recommendations:
Remove and Replace the existing track and synthetic turf field at SHS
Create a large multi-use synthetic turf complex at SHS including Baseball, softball and multi-use overlays. This will relieve capacity issues as well as the intense maintenance required to keep up with the overuse of fields at the high school.
