On behalf of the Town of Scituate (Town, Applicant), GZA GeoEnvironmental, Inc. (GZA) has prepared this Notice of Intent (NOI) application to describe the proposed Project that includes repair of storm-damaged foreshore structures along 91 Surfside Road (North Scituate Beach). The Project is being partially funded through the Federal Emergency Management Agency (FEMA), with a match provided by the Town of Scituate. The following sites/foreshore protection structures are being proposed for repair:

### **2.1 SITE 2: 91 SURFSIDE ROAD REVETMENT**

#### 3.1 SITE 2: 91 SURFSIDE ROAD REVETMENT

SCITUATE FORESHORE PROTECTION REPAIRS  
SITE NO. 2: 91 SURFSIDE ROAD  
SCITUATE, MASSACHUSETTS

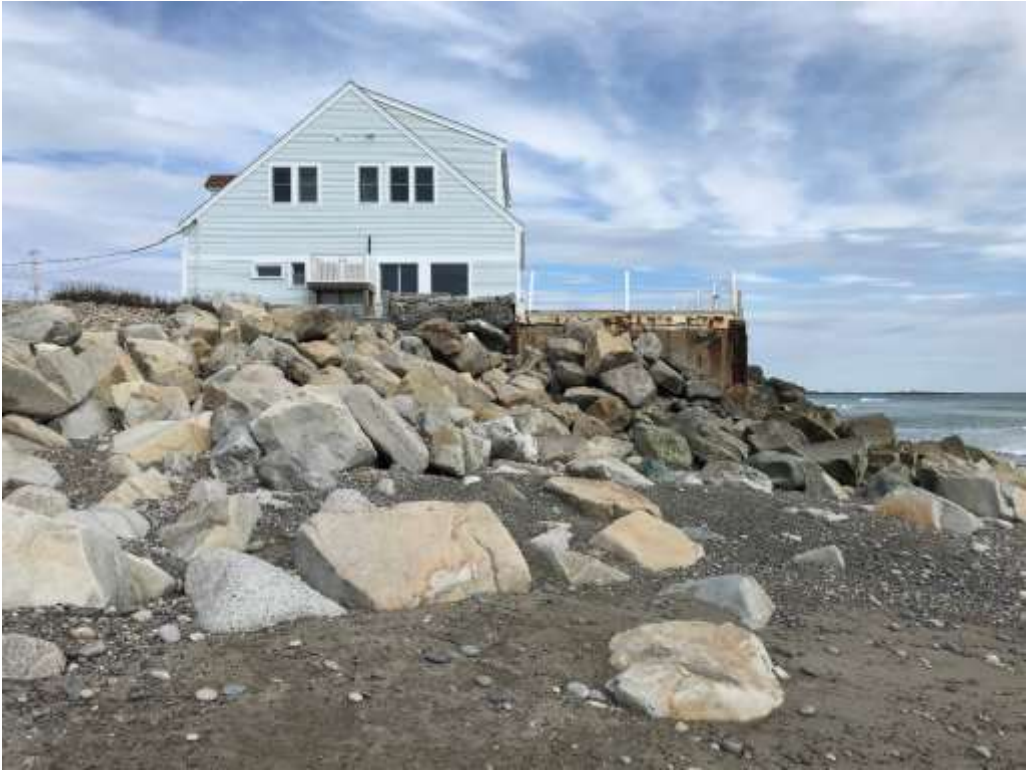
| <b>Photo No.</b><br>1 | <b>Date:</b><br>4/14/20 | | |

During recent site visit inspections, GZA observed that the revetment armor stones appeared to generally consist of 4- to 12-ton angular stones. Numerous displaced or missing armor stones were observed with large voids exposing the face of

the seawall and finer stone revetment core materials. The seawall was observed to be damaged and deteriorated with corrosion of steel H-piles and spalling and displacement of the concrete panels.

| <b>Description:</b><br>Typical displaced<br>revetment toe and slope<br>along the southern return<br>wall. | | | |

The proposed work includes approximately 50 linear feet of existing, damaged revetment repair fronting the existing steel H-pile and concrete paneled seawall at 91 Surfside Road. The width of the 91 Surfside Road revetment repairs will vary based on field conditions encountered and the extent of damage but will generally be limited to approximately 28 feet wide. This work will include limited removal and resetting of existing revetment stone and installation of supplemental (off-site) stone to restore the existing structure to its pre-disaster geometry and function. Mitigation of coastal hazards will be provided by the addition of supplemental revetment stone that is typically larger or favoring the larger end of the range of the existing stone sizes. This work is expected to require working during favorable tidal and ocean conditions with temporary equipment access to the beach. The repaired revetment will generally occur within the footprint of the existing structure and will not extend further seaward.

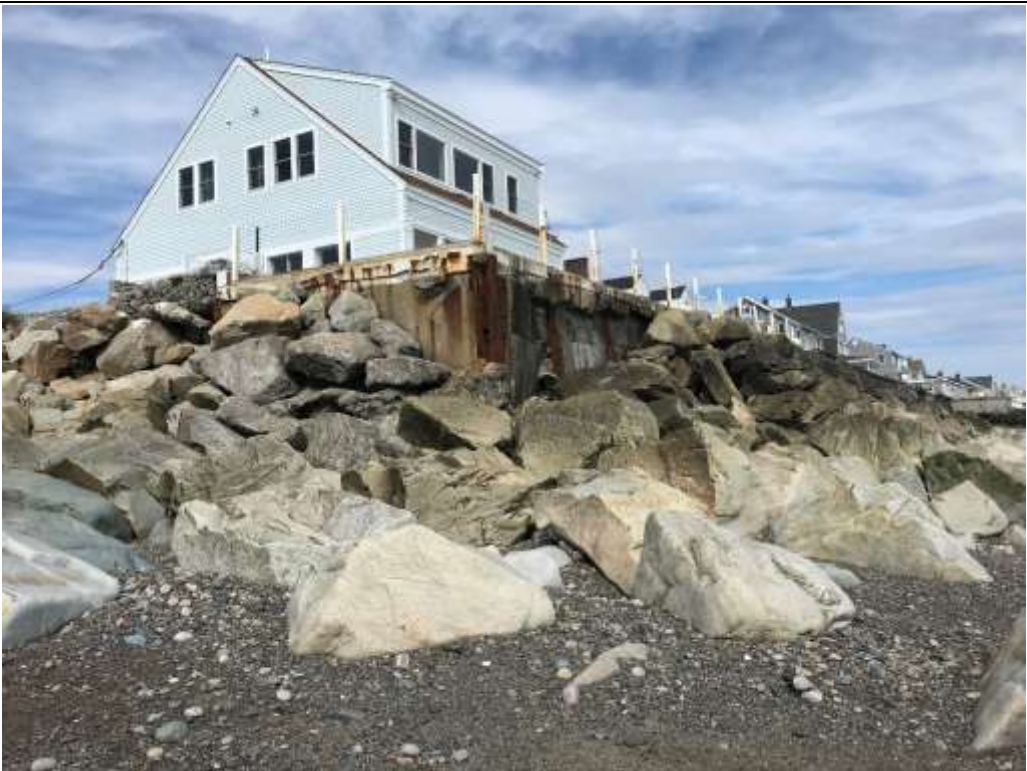
| <b>Photo No.</b><br>2 | <b>Date:</b><br>4/14/20 | |

| <b>Description:</b><br>Overview of displaced<br>revetment toe and slope<br>along deteriorated steel<br>H-pile and concrete panel<br>seawall. | | |

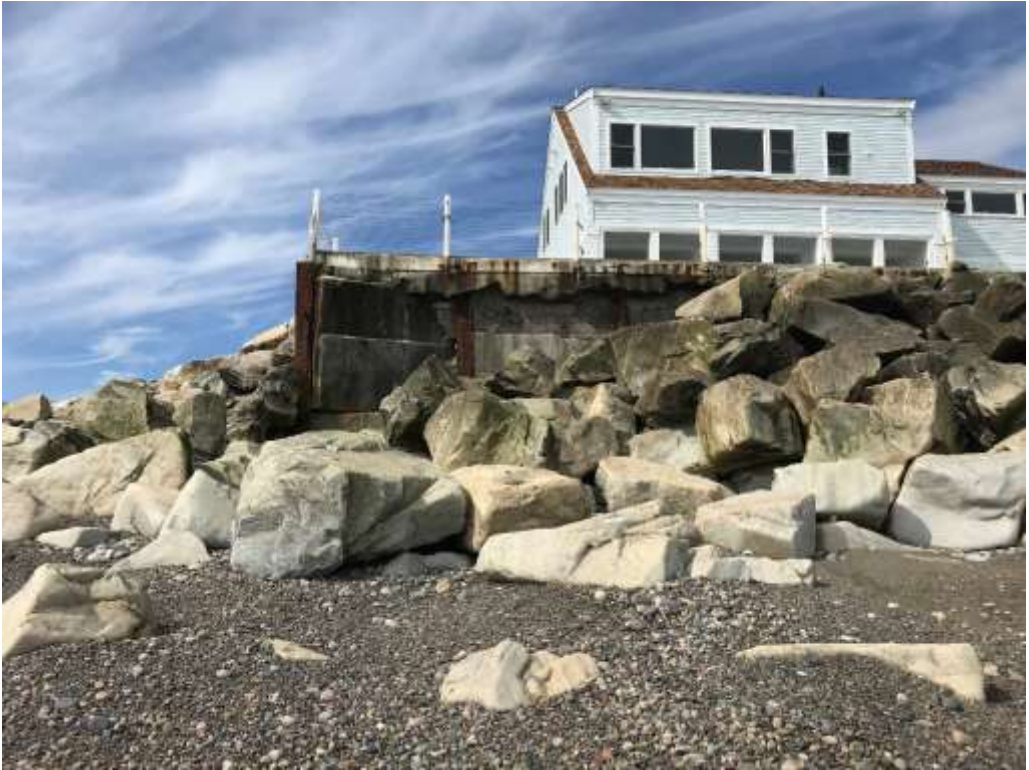
| <b>Photo No.</b><br>3 | <b>Date:</b><br>4/14/20 | | |

| <b>Description:</b><br>Typical displaced<br>revetment toe and slope<br>along seawall. | | | |

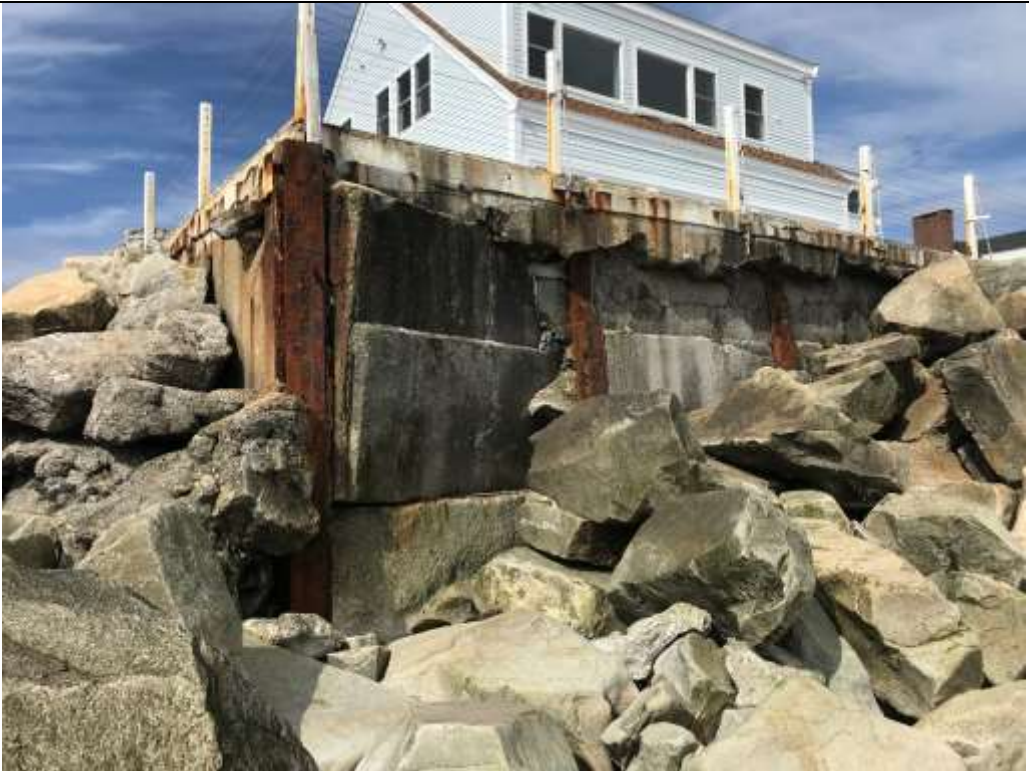
| <b>Photo No.</b><br>4 | <b>Date:</b><br>4/14/20 | |

| <b>Description:</b><br>Typical damaged and<br>deteriorated steel H-pile<br>and concrete panel<br>seawall. | | |
