Coastal Erosion, Sediment Transport, and Prioritization Management Strategy Assessment for Shoreline Protection Scituate, Massachusetts

August 2016

Applied Coastal Research and Engineering, Inc.
766 Falmouth Road, Suite A1
Mashpee, Massachusetts 02649

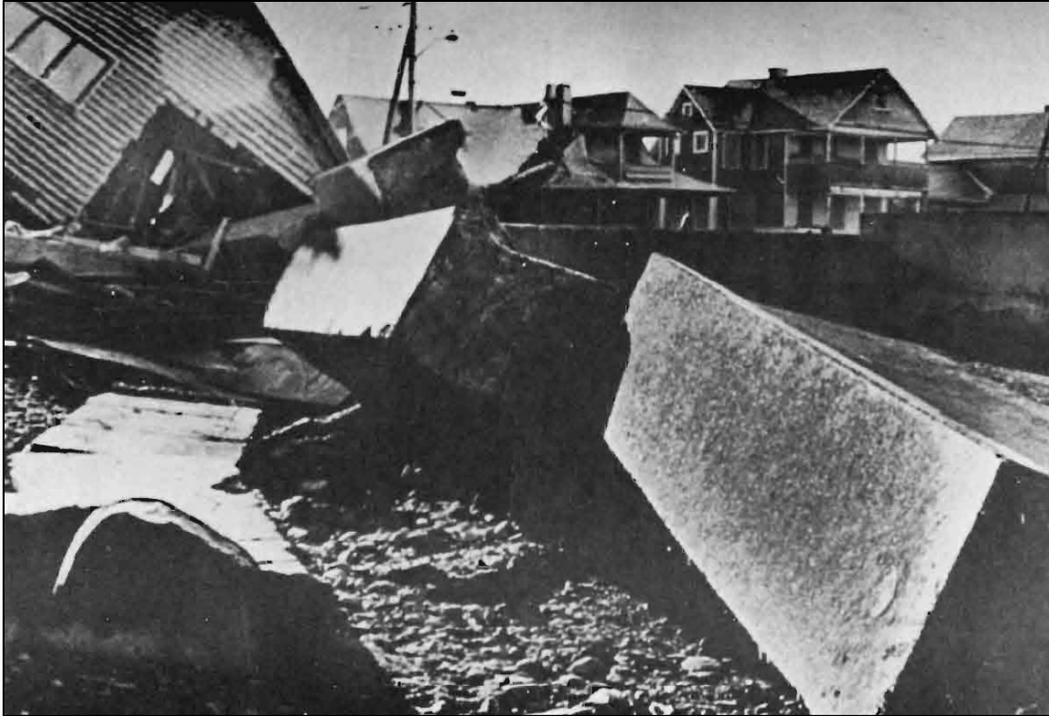
Figure 1.2 Portions of the North Scituate Beach seawall destroyed during the Blizzard of 1978 (image credit: *The Boston Globe*).

The Blizzard of 1978 was included as the storm of record, with a return period of greater than once every 100 years. While substantial infrastructure damage occurred during this storm event (Figure 1.2), the FEMA National Flood Insurance Program (NFIP) had not been officially implemented at the time of the event. Regardless, the severity of infrastructure damage associated with the highest storm surge experienced in Boston since the tide station went into operation in 1921 provides the benchmark for comparison of South Shore coastal storms in the past century. Although slightly less severe, the 1991 No-Name Storm was selected because it represented the most significant storm event in the past 30 years and represented the most severe storm event that occurred since FEMA NFIP had been implemented. In addition, the more recent Winter Storms Nemo and Juno also were reviewed to represent “typical” events that occur on a relatively frequent basis. These lower return period events were selected due to the detailed storm damage documentation available from the Town, including coastal infrastructure improvement needs associated with ongoing damage. Understanding the geographical distribution of storm damage for relatively frequent, as well as more severe infrequent, storm events allowed for a detailed economic assessment of damages relative to storm severity for different locations along the coastline.

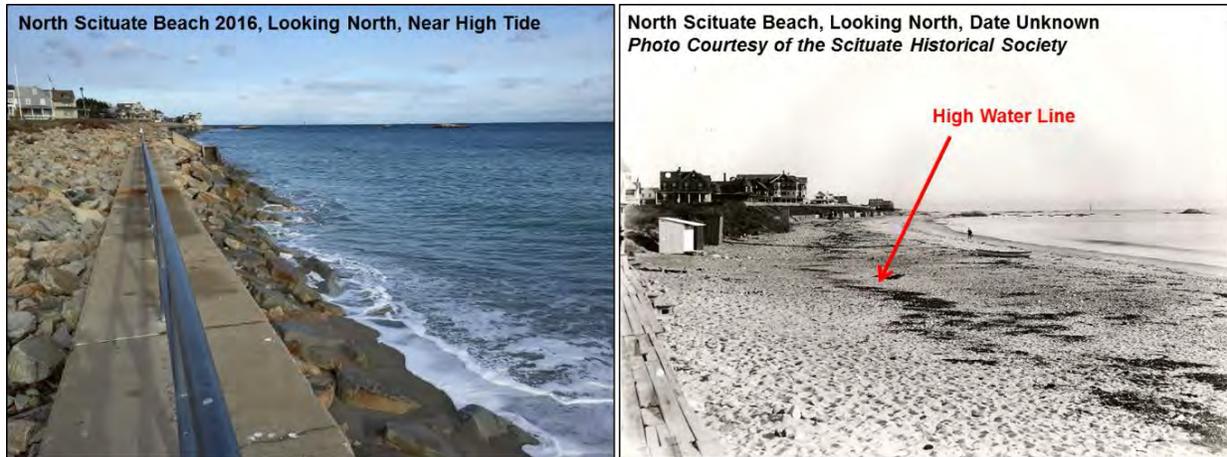
Figure 2.1 Photographs of North Scituate Beach from 2016 (left) at the time of high tide and likely in the early 1900s (right) indicating the location of the high water line. As shown, significant landward migration of the high water line has occurred over the past 100 years.

Regionally, the Scituate shoreline consists of glacial till headlands, bedrock outcrops, and outwash deposits, as well as associated marine deposits in the form of barrier beaches. Glacial deposits historically provided the principal source of beach sediments, consisting of a broad range of sand, gravel, cobbles, and boulders, depending on the composition of the eroding glacial deposit. Many of these original sources of beach materials have been largely eliminated due to the construction of revetments and seawalls along the shoreline. Figure 2.1 and Figure 2.2 illustrate the change in beach conditions exacerbated by coastal armoring at North Scituate Beach and Third Cliff, respectively.

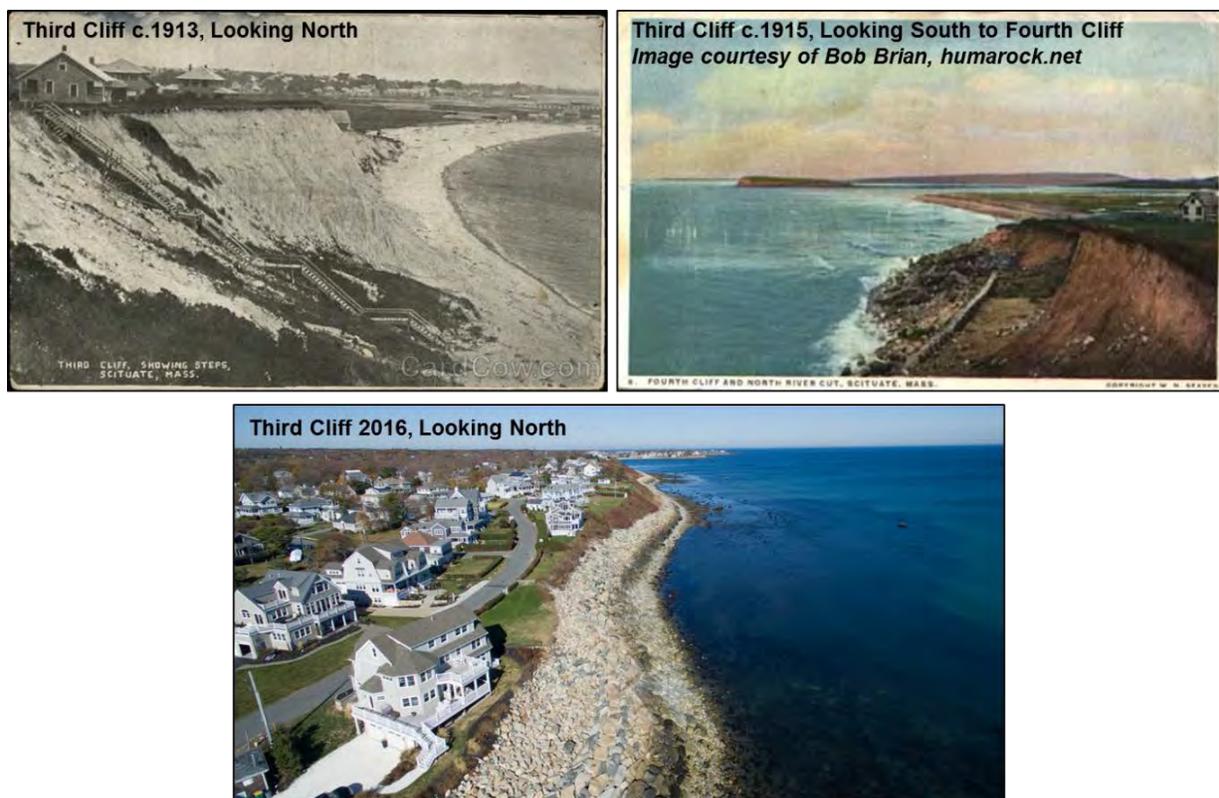
Figure 2.2 Photographs of Third Cliff from 1913 (top left) and 2016 (bottom), as well as a sketch from 1915 (top right). As shown, significant landward migration of the high water line has occurred over the past 100 years.

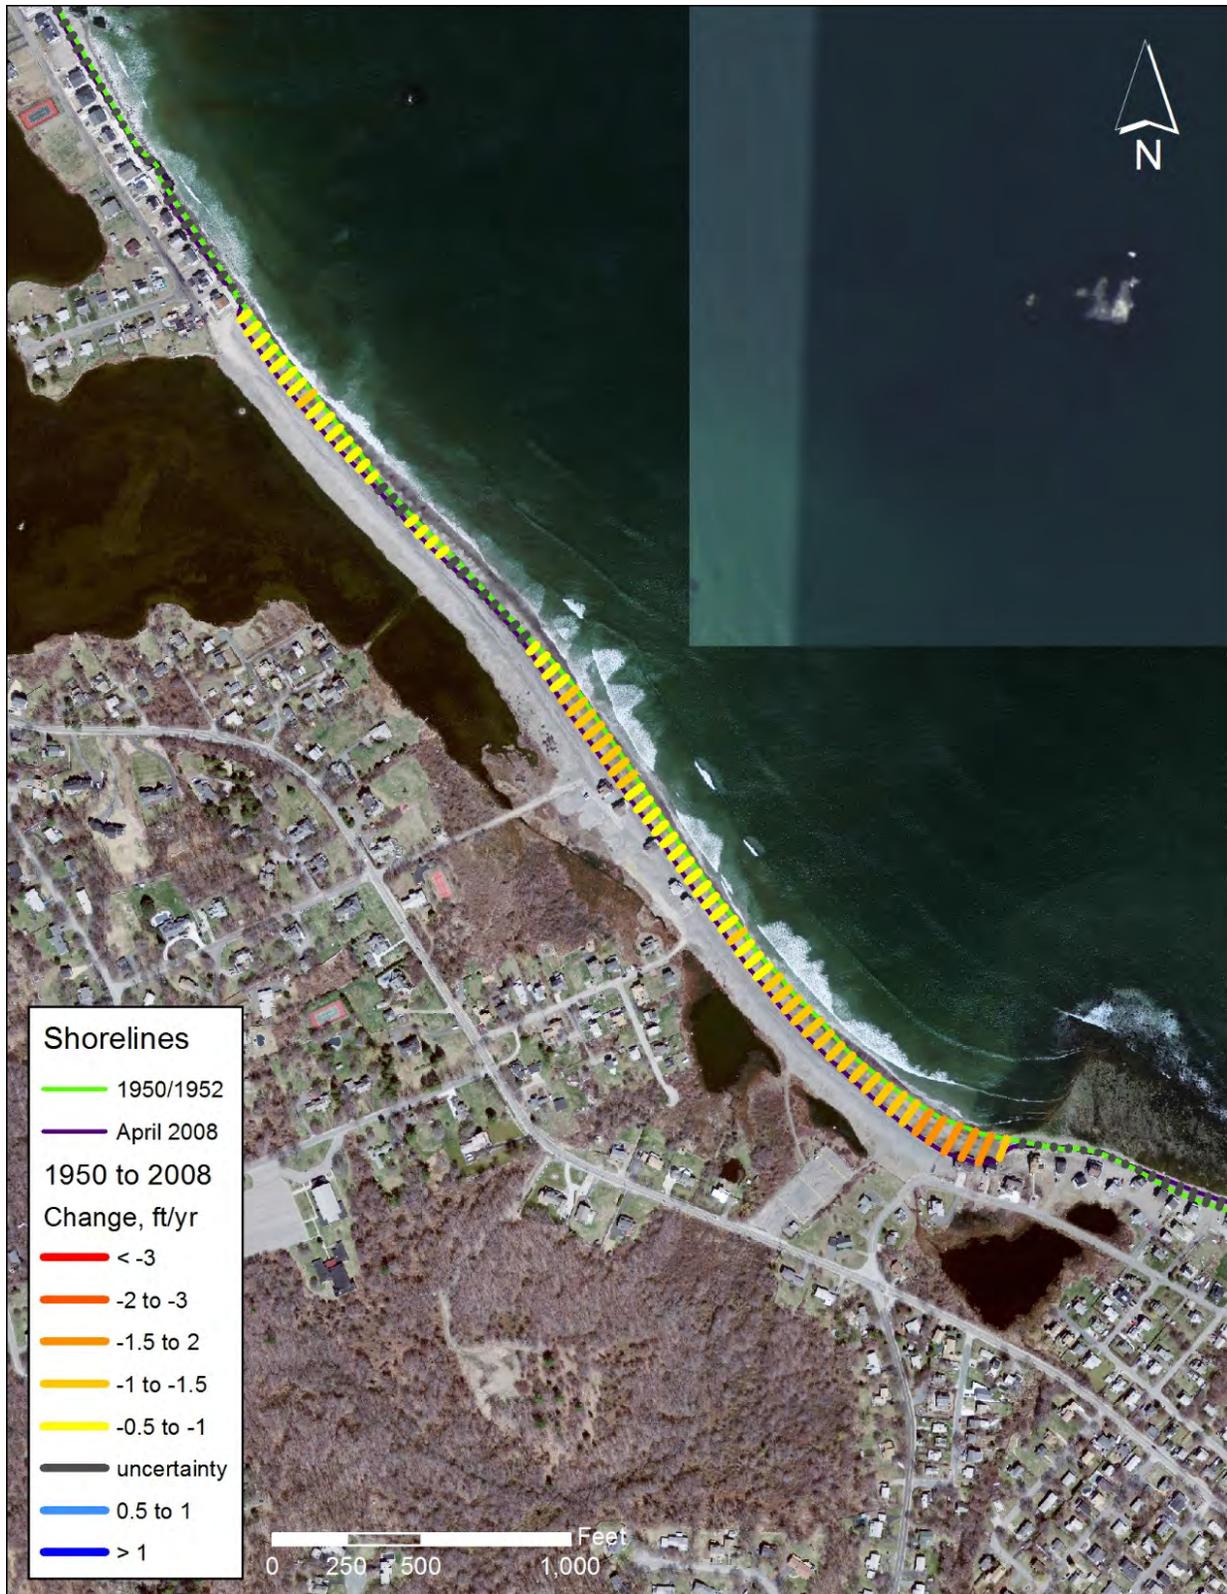
Figure 2.3 Historical shoreline change for Mann Hill Beach from 1950/1952 to 2008.

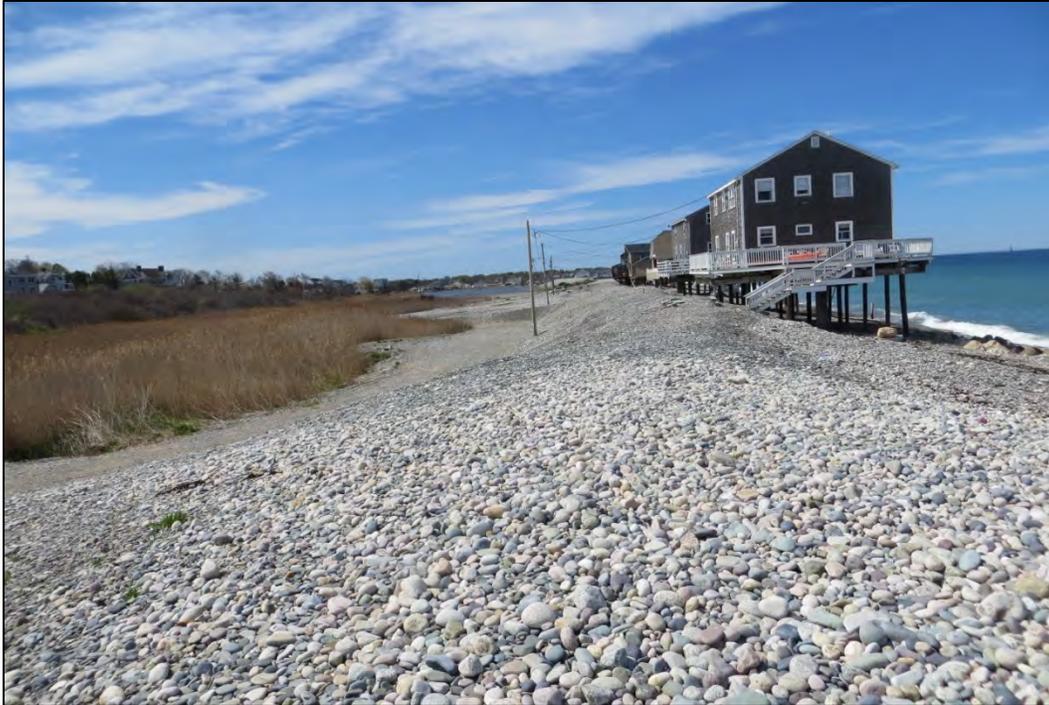
Figure 2.4 Dwellings along Stanton Lane illustrating proximity of the typical high tide line to the structures, as well as the position of the houses on the seaward side of the cobble dune crest (photo taken by Applied Coastal on May 10, 2016).

Without ongoing maintenance, the dune crest of Transect 1 would likely look similar to Transect 2, located at Egypt Beach (Figure 2.10). Since 2000, overwash of the cobble dune has reduced the crest elevation and moved the material landward into Sheep's Pond, creating overwash fans shown in Figure 2.11. Storm overwash into Sheep's Pond has led to concerns regarding infilling of the natural inland drainage path connecting this pond to Mushquashcut Pond. Lowering of the nearshore profile also was observed between the 2000 and 2010 surveys; however, the profile lowering offshore is only 1 to 2 feet. In addition to lowering of the beach/dune berm, landward migration of the dune crest has led to dwellings constructed along this shoreline stretch to become more exposed to storm wave action, as the homes along Stanton Lane are now located seaward of the dune crest (Figure 2.4).

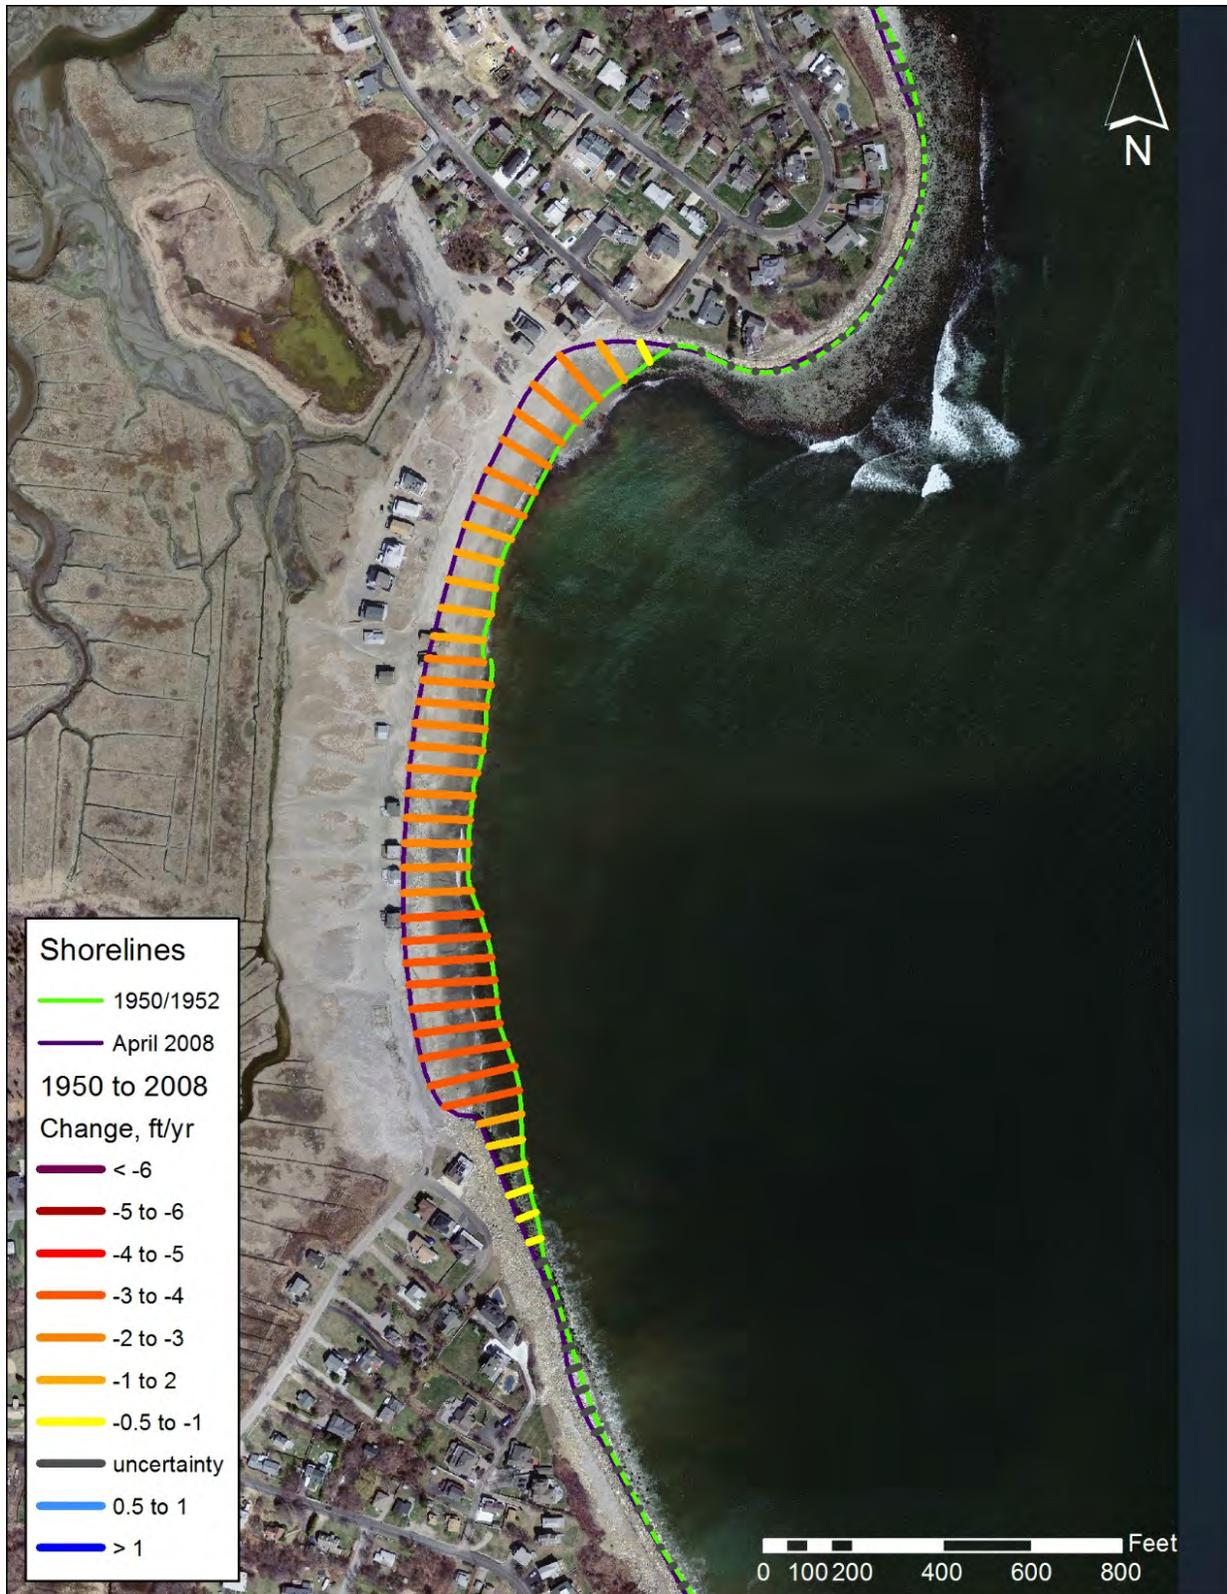
Figure 2.5 Historical shoreline change for Peggotty Beach from 1950/1952 to 2008.

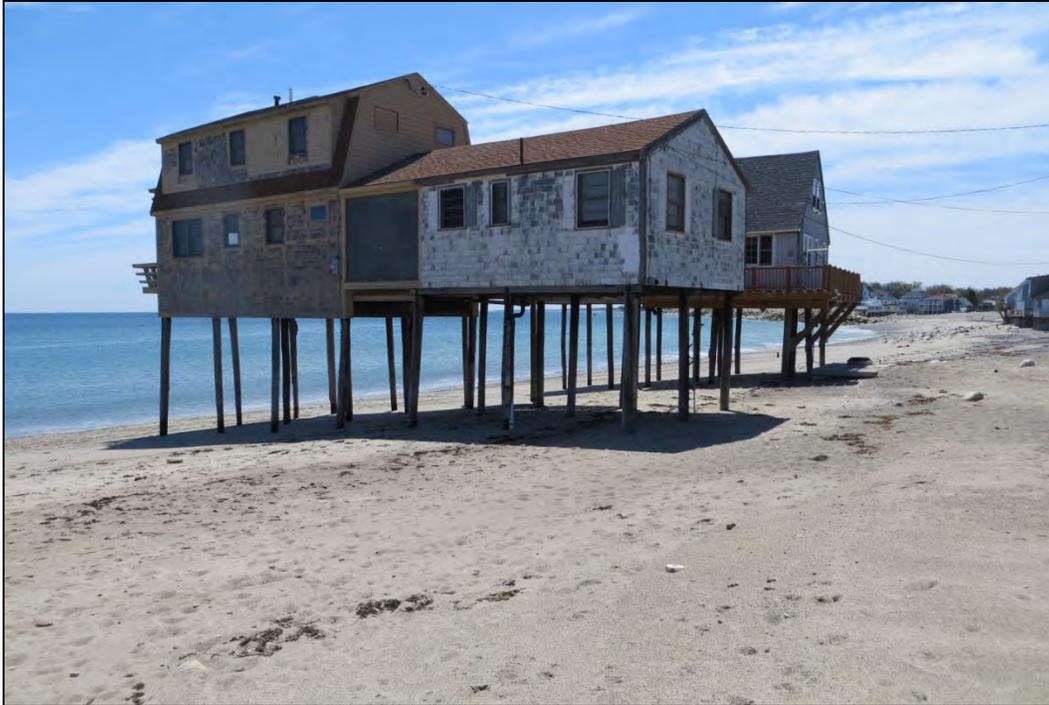
Figure 2.6 Dwellings along Town Way Extension, where the daily high tide line is under the buildings and the position of the houses is well seaward side of the low dune at Peggotty Beach (photo taken by Applied Coastal on May 10, 2016).

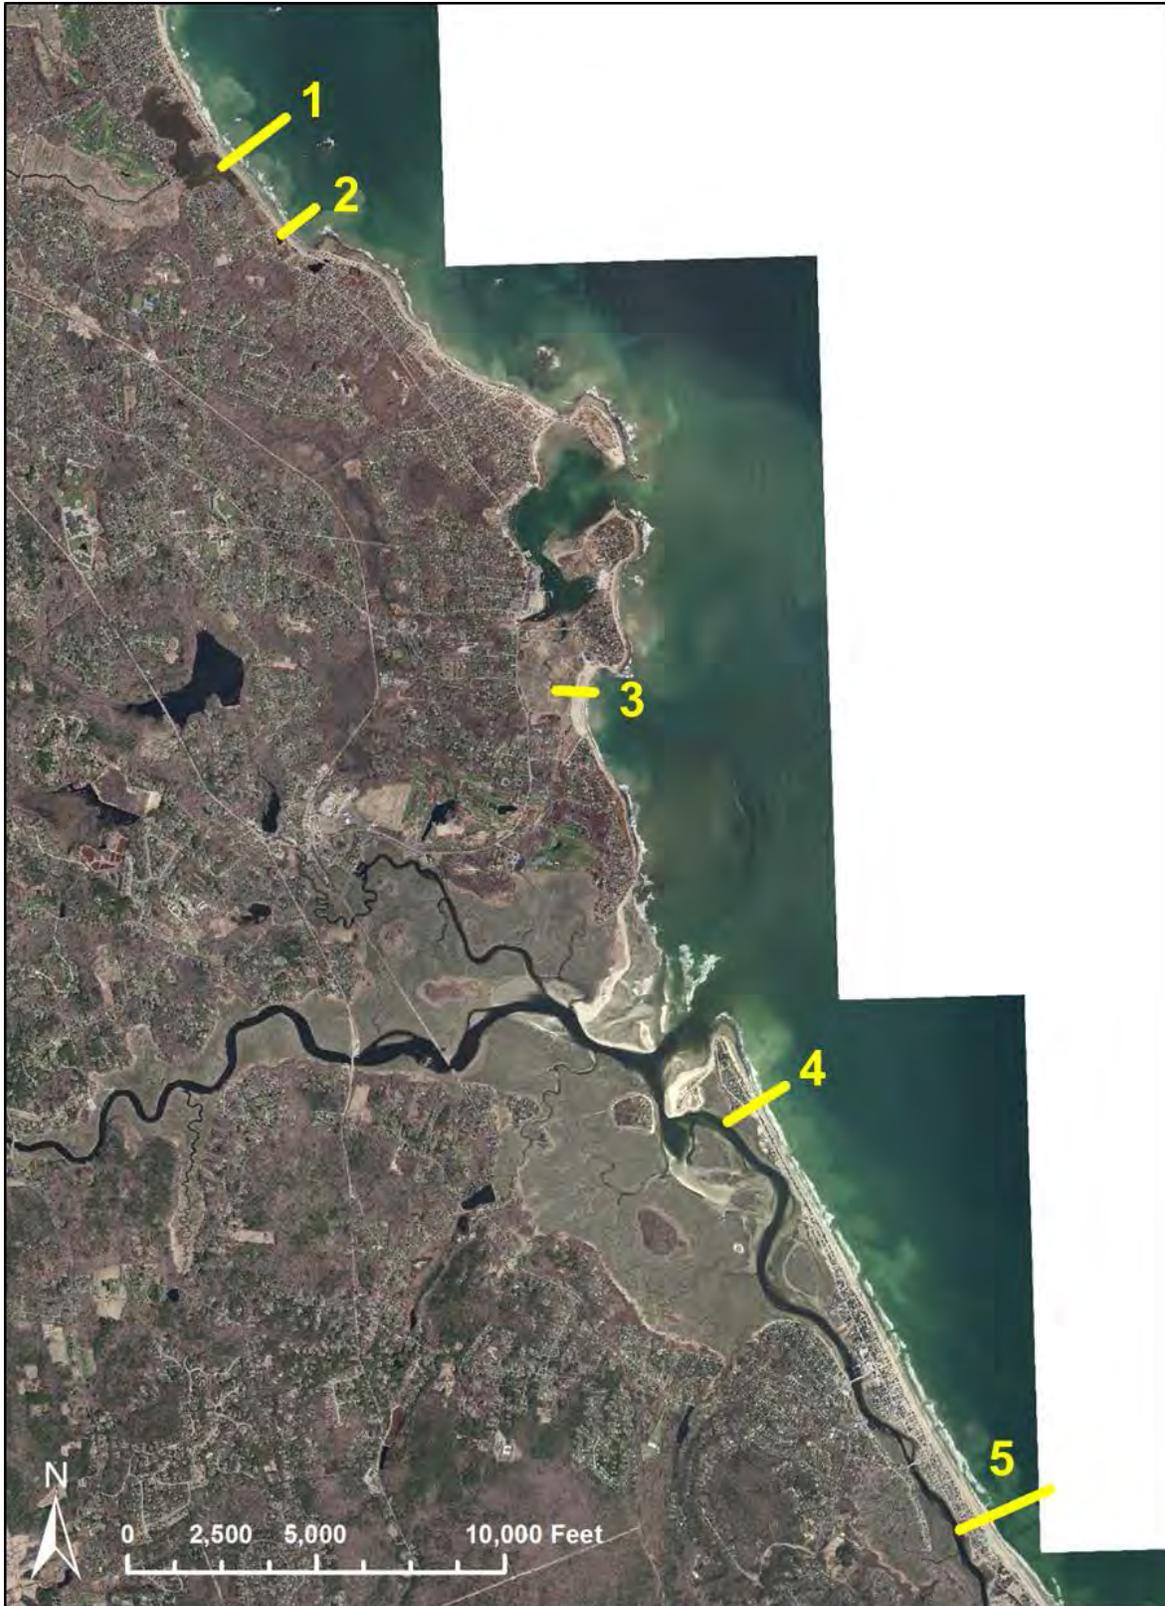
Figure 2.8 Location of cross-shore profile change analysis transects.

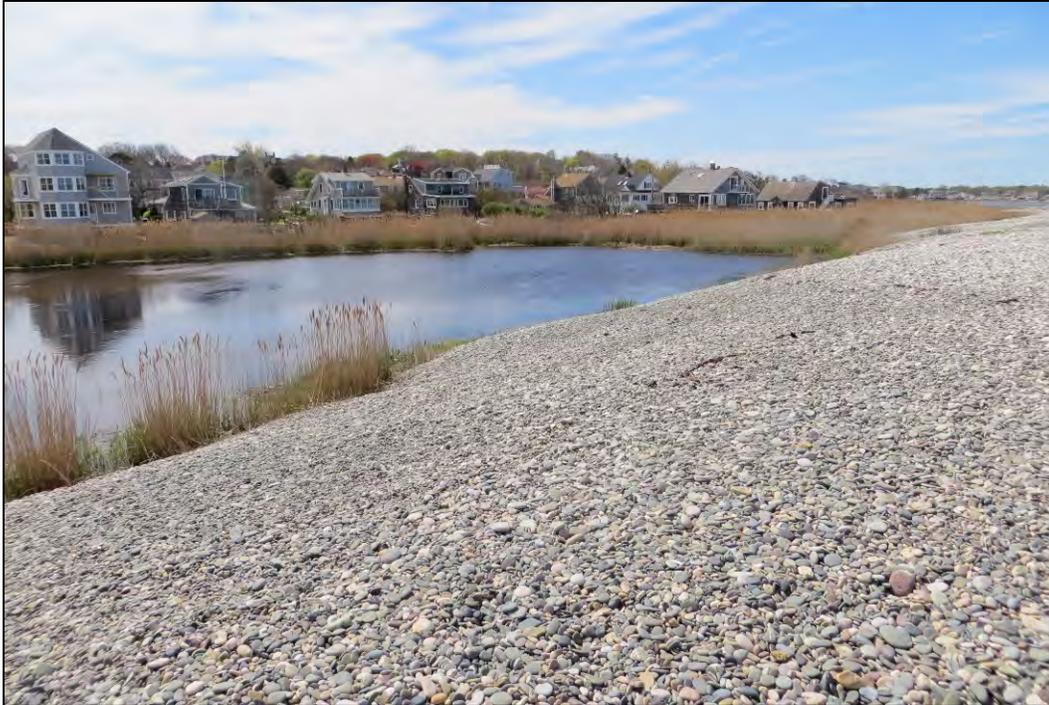
Figure 2.11 Overwash of beach material from Egypt Beach into Sheep's Pond creates large overwash fans (photo taken by Applied Coastal on May 10, 2016).

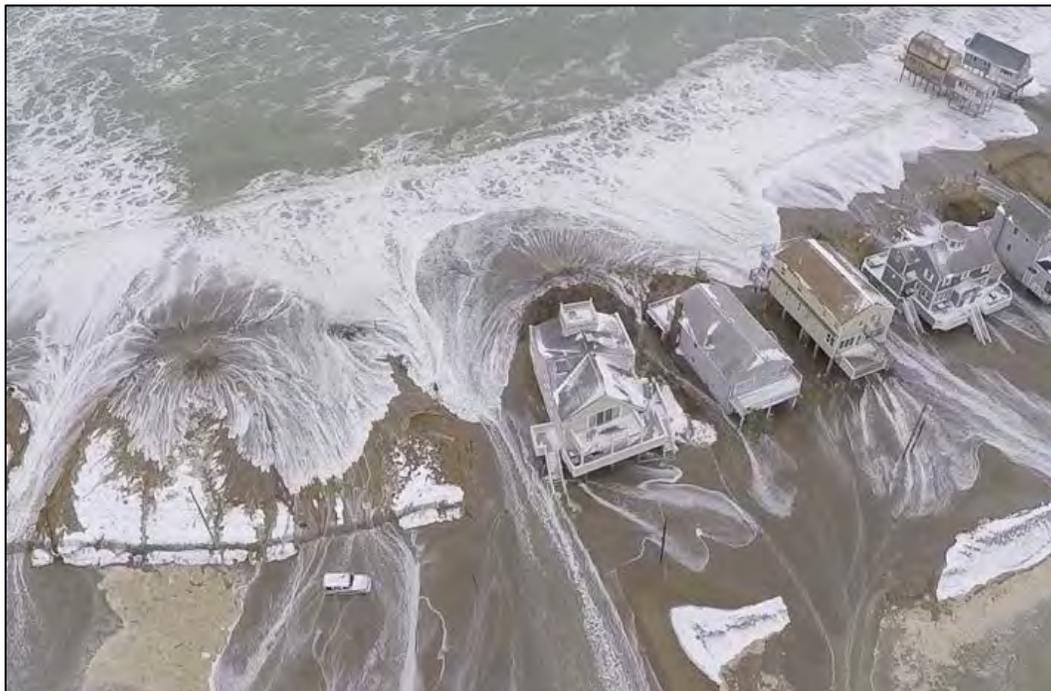
Figure 2.13 Overwashing of Peggotty Beach during the high tide after a storm on February 2, 2016 (photo by Peter Miles).

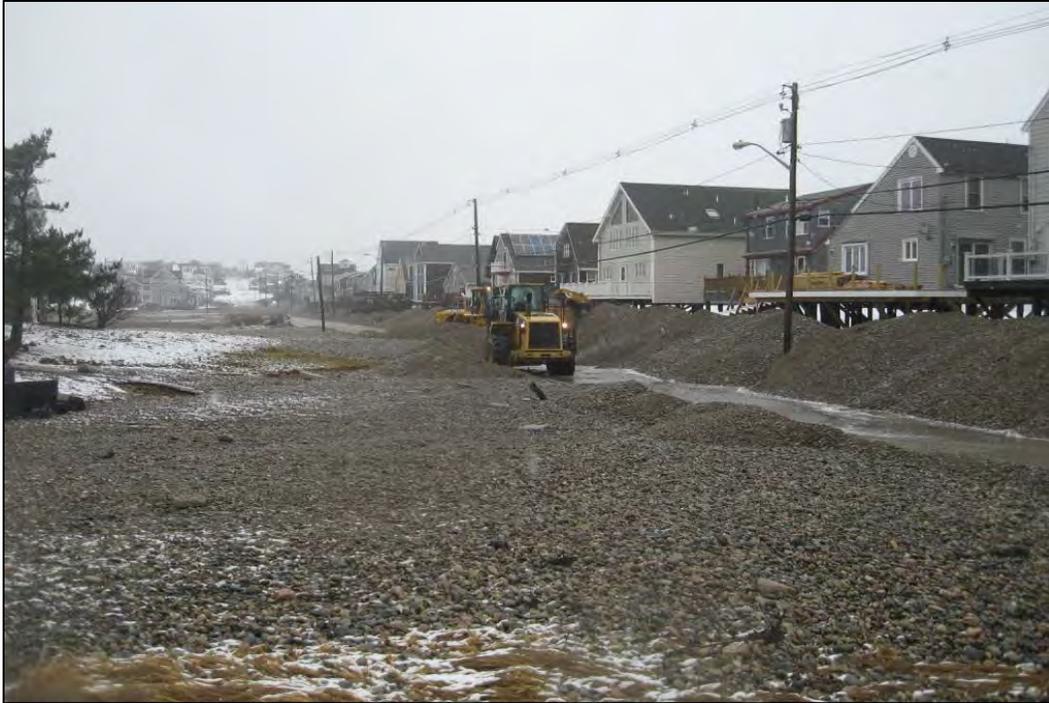
Figure 2.15 Clearing efforts along Central Avenue in the north section of Humarock Beach following a storm in 2013 (photo by Jason Burtner, www.mycoast.org).

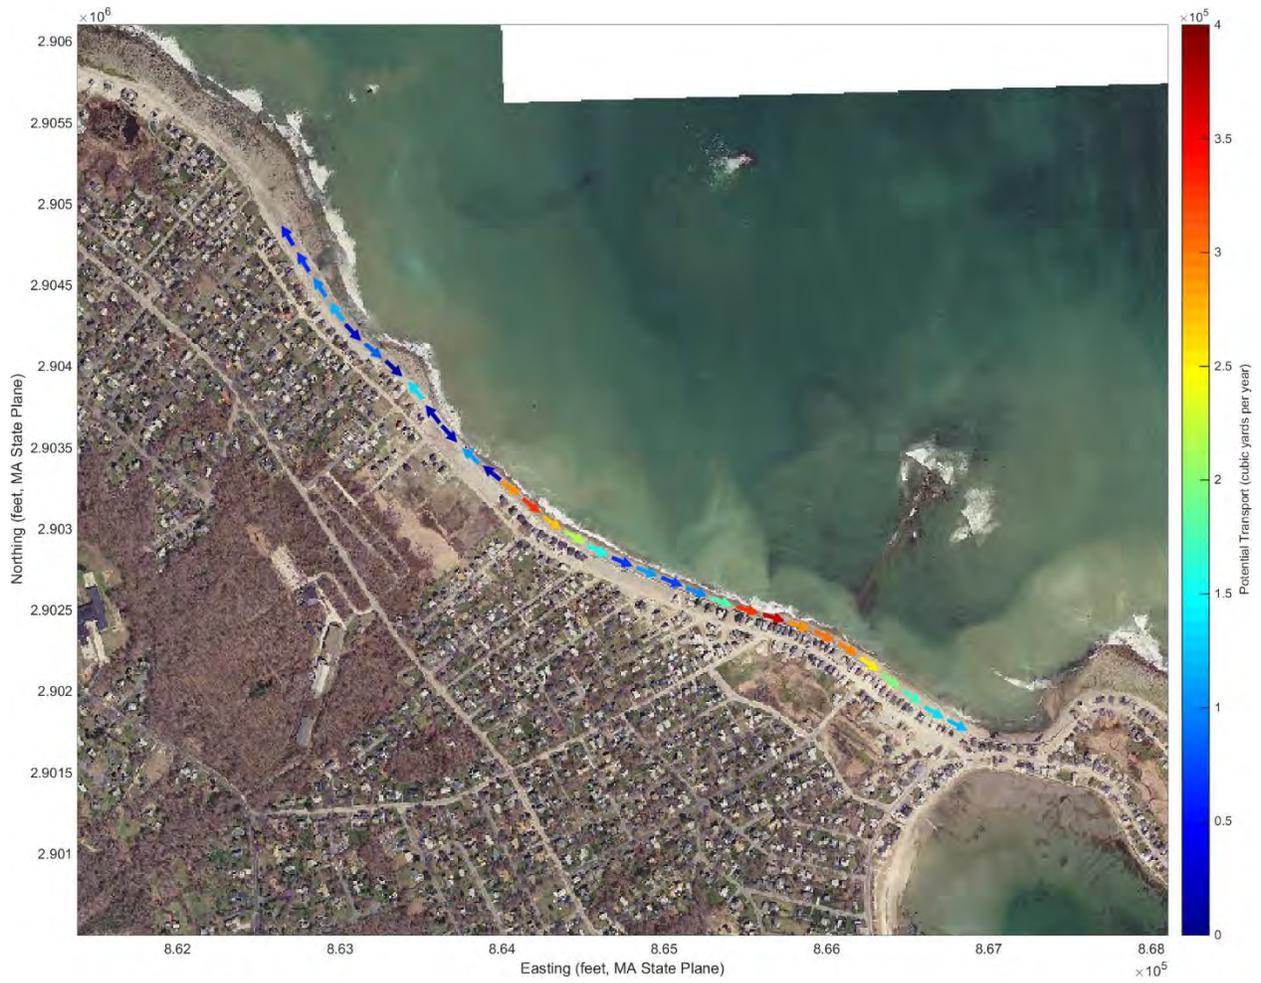
Figure 3.15 Modeled annual potential sediment transport along Oceanside Drive. The sediment transport vectors represent the net direction and magnitude of transport along the coast.

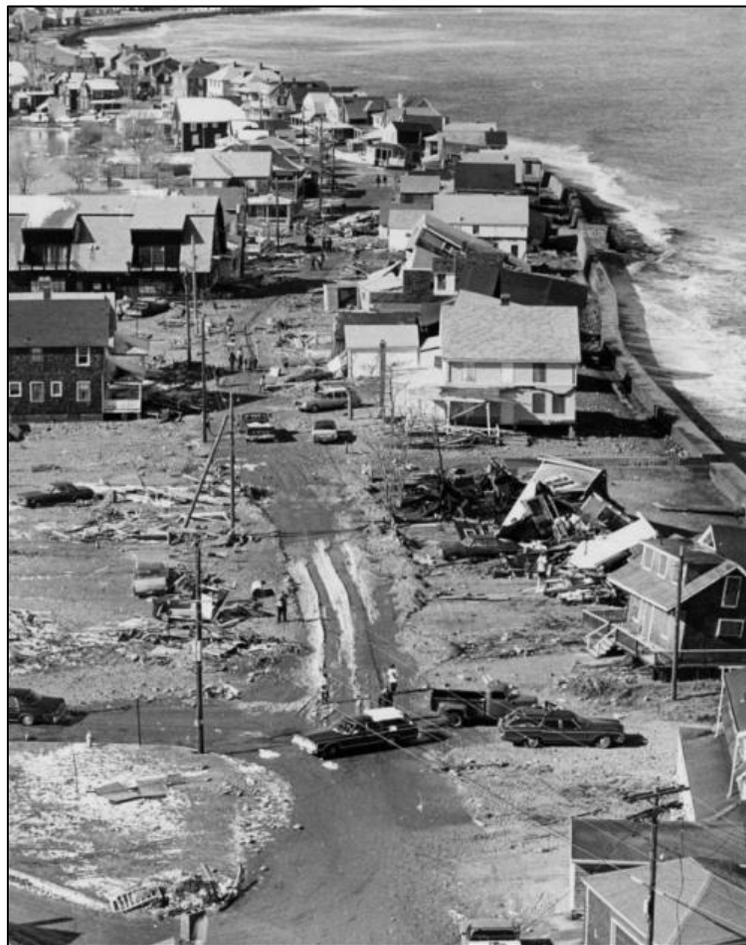
Figure 4.6 Turner Road damage from the Blizzard of 1978 (image credit: www.blizzardof78.org).

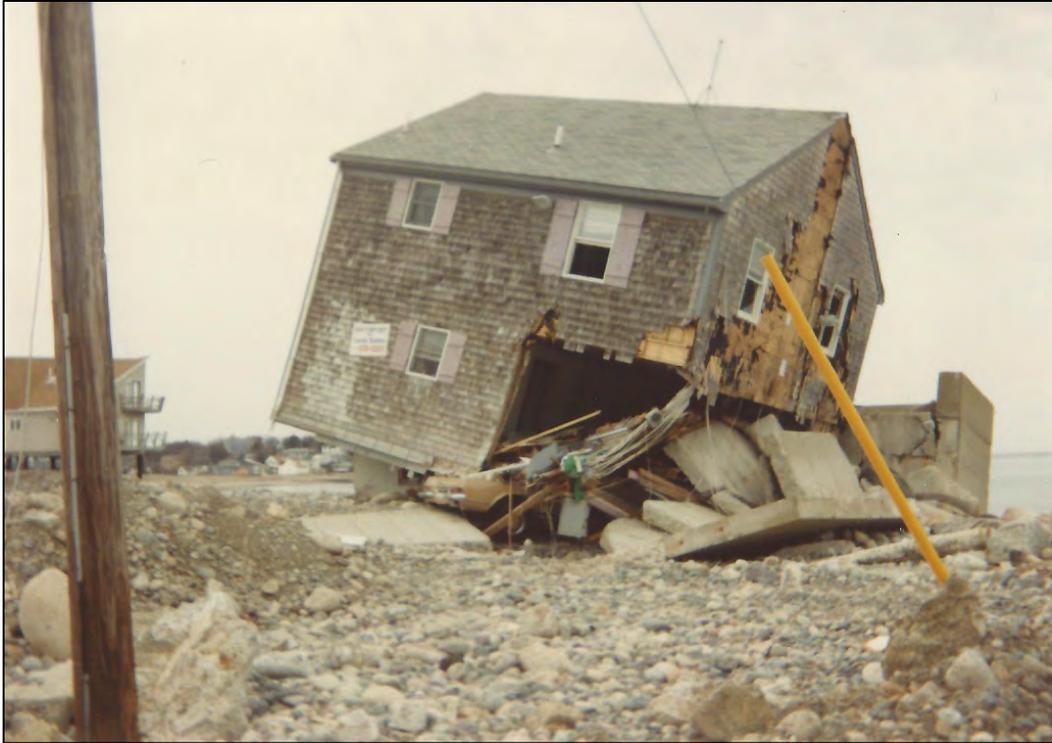
Figure 4.9 Destroyed home from the 1991 No-Name Storm (photo from the Scituate Historical Society).

Spatial distribution of the FEMA repetitive loss claims incurred by the storm are mapped in Figure 4.8. Widespread damage was recorded along the entire Scituate shoreline, as shown in Figure 4.9, with the exception of the Cliffs. In total, 446 FEMA repetitive loss claims were filed totaling over \$34 million. The costs to Town were summarized in a FEMA claim:

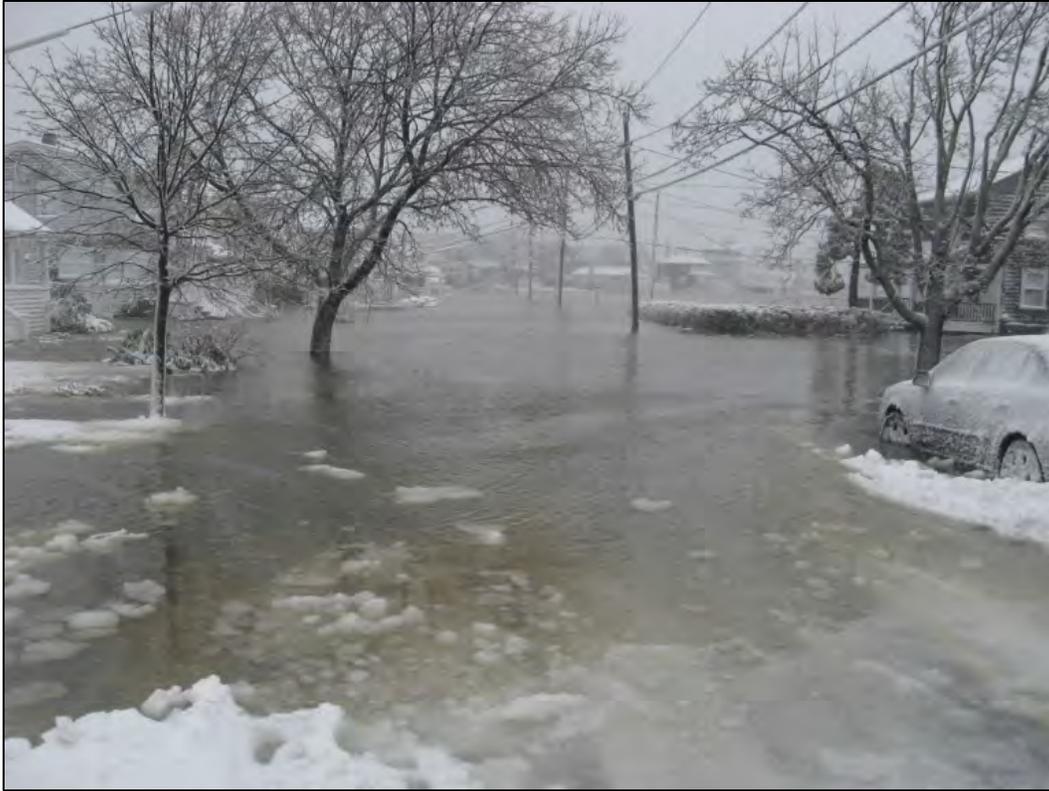
Figure 4.12 Impassible roads along Oceanside Drive during Winter Storm Nemo (photo by Jason Burtner, www.mycoast.org).

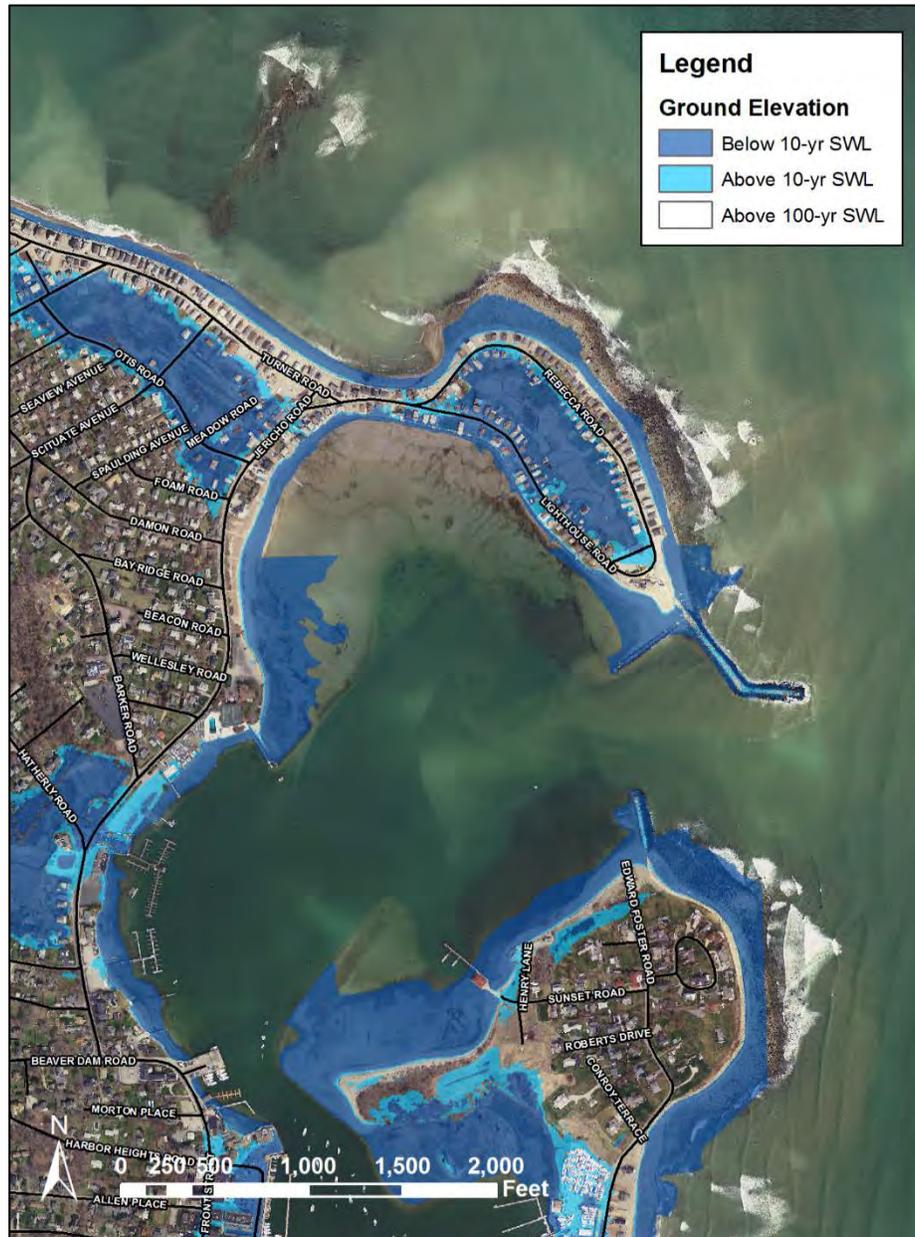
Figure 5.5 Mapping of landform elevation at Cedar Point and First Cliff. Dark and light blue shading indicates that the area is flooded during 10- and 100-year storms by still water (excluding waves), respectively.

Along the Scituate shoreline, the difference between the 10-year and 100-year still water elevation (SWL, the surface of the water if all wave and wind action were to cease) is less than 1.5 feet. Low elevation areas are more prone to flooding and merit a higher priority rating. For example, Figure 5.5 shows the comparative flooding susceptibility of Cedar Point versus First Cliff during 10-year and 100-year storms. The majority of Cedar Point is shown to be below the 10-year still water elevation while First Cliff is above the elevation for the 100-year storm. Additional figures for other areas of the Town are presented in Appendix C.

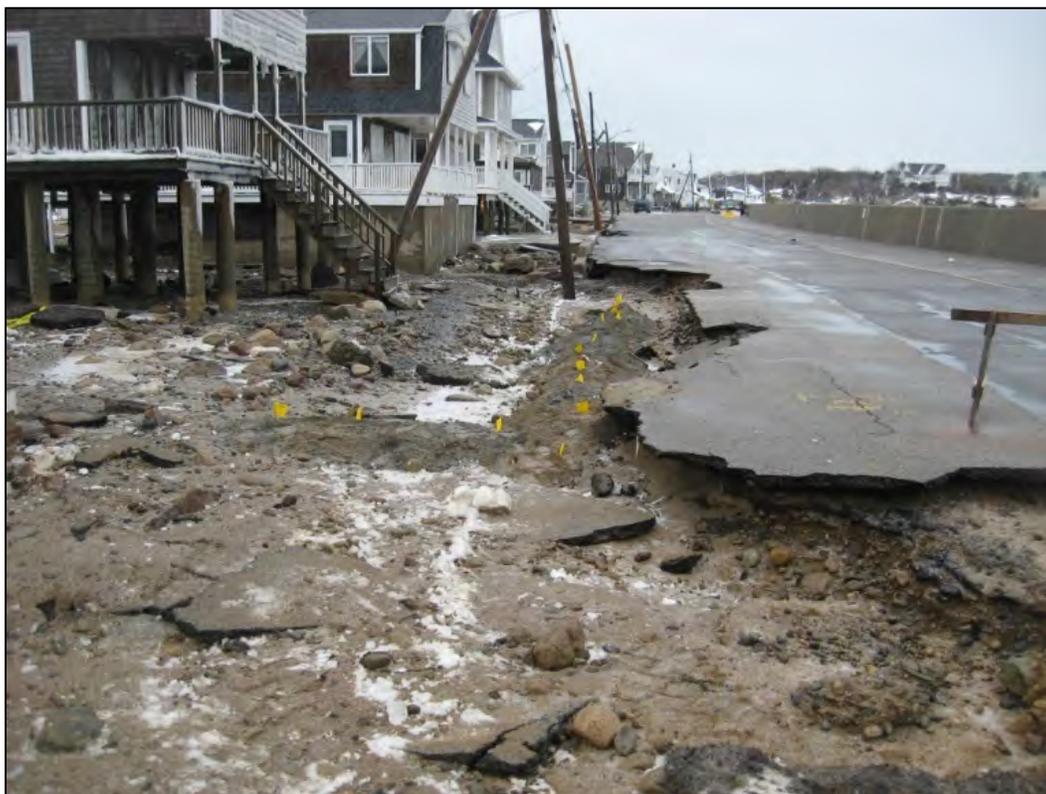
Figure 5.6 Exposed gas lines along Glades Road behind Minot Beach. Photo from February 11, 2013 storm report by Jason Burtner (*mycoast.org*).

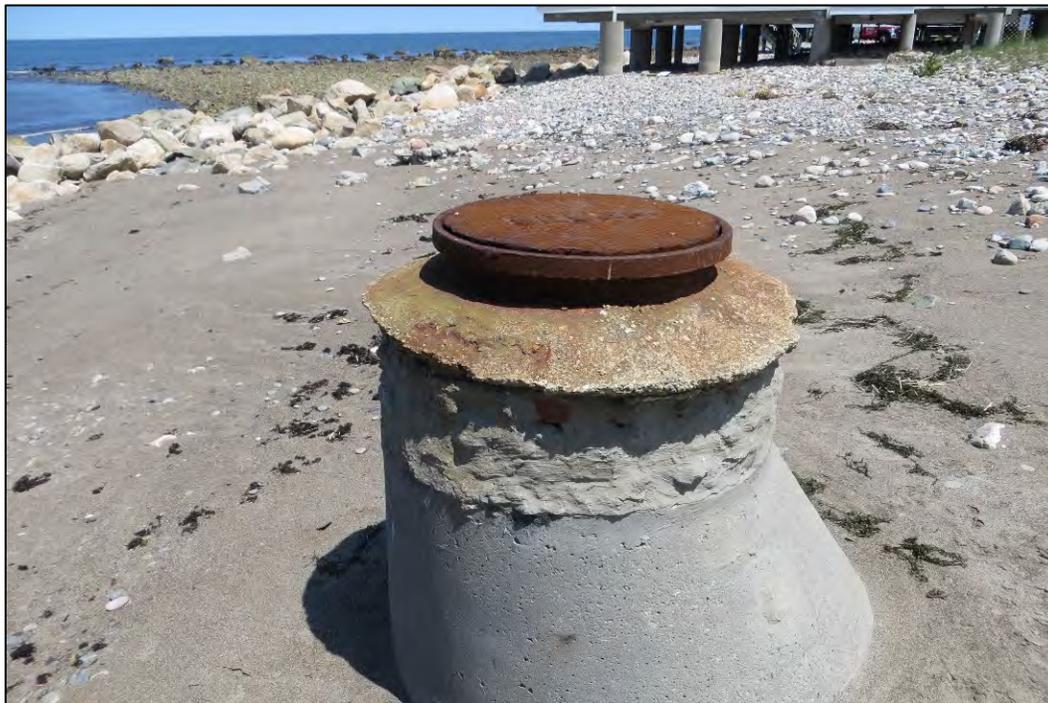
Figure 5.7 An exposed sewer manhole at Egypt Beach (photo taken by Applied Coastal on May 12, 2016).

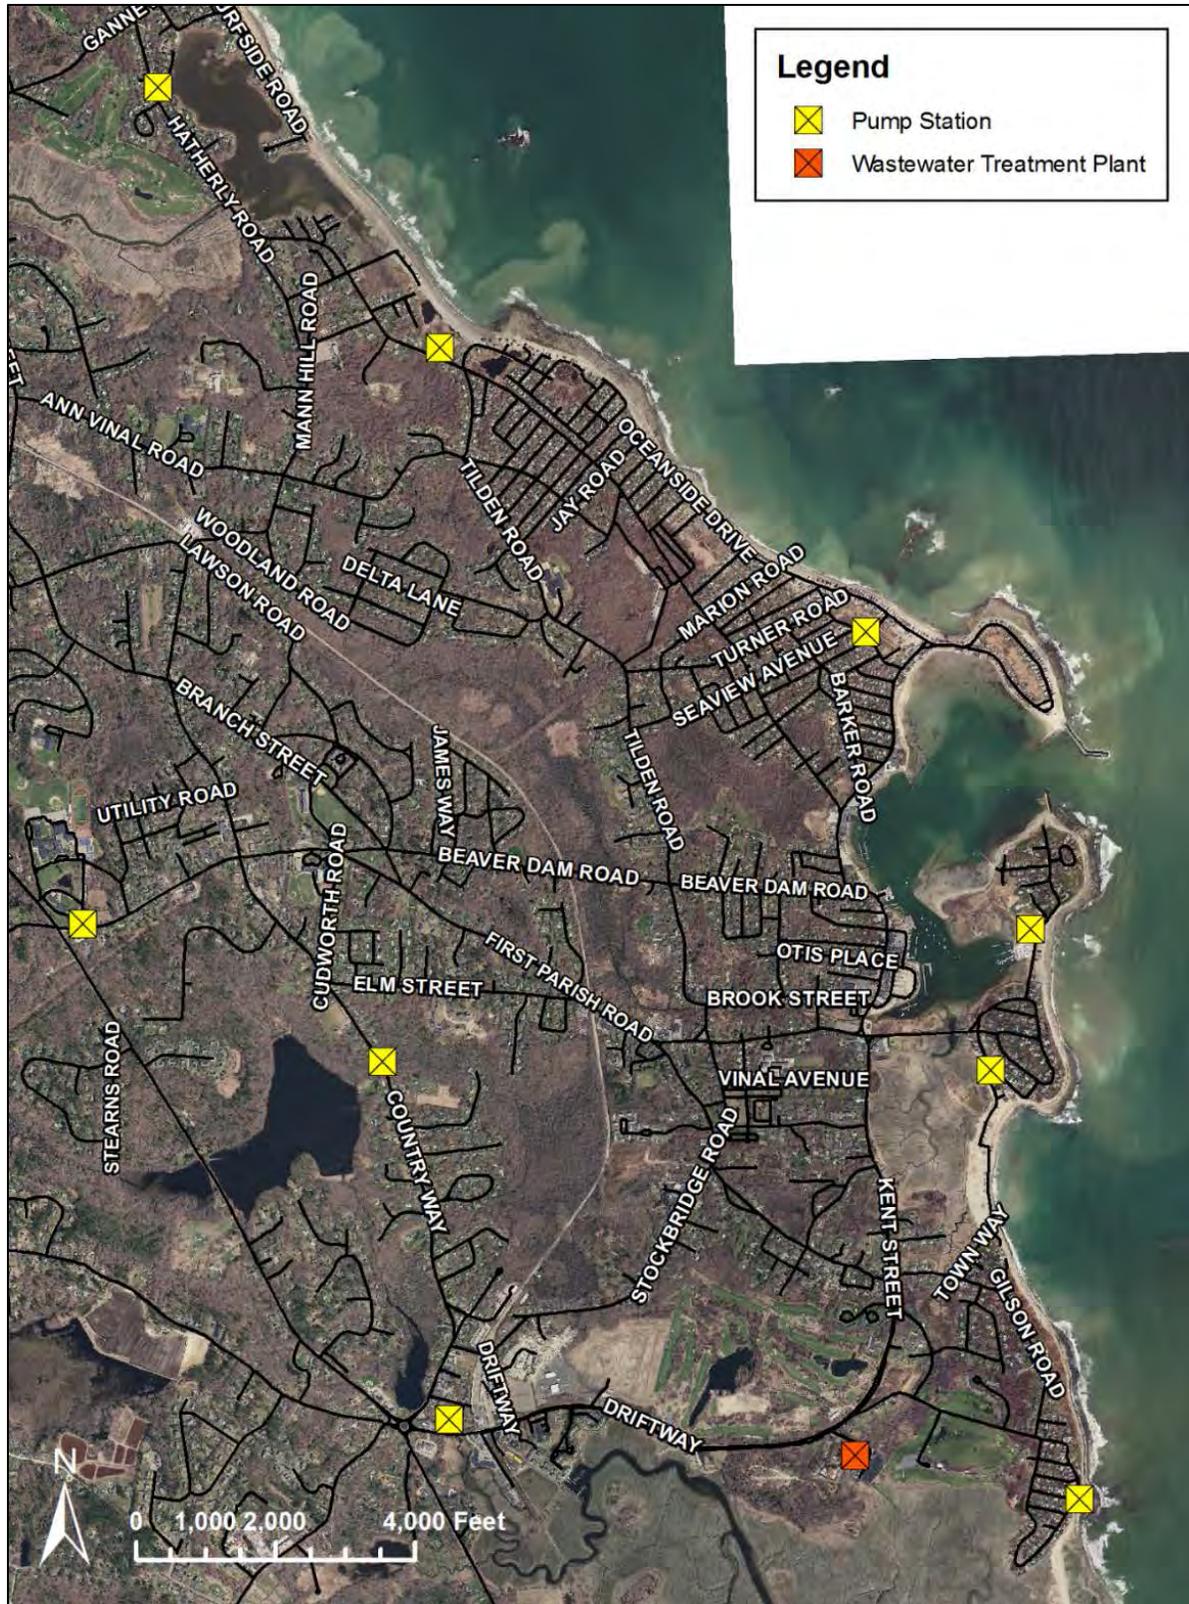
Figure 5.8 Pump stations and wastewater treatment plant in Scituate.

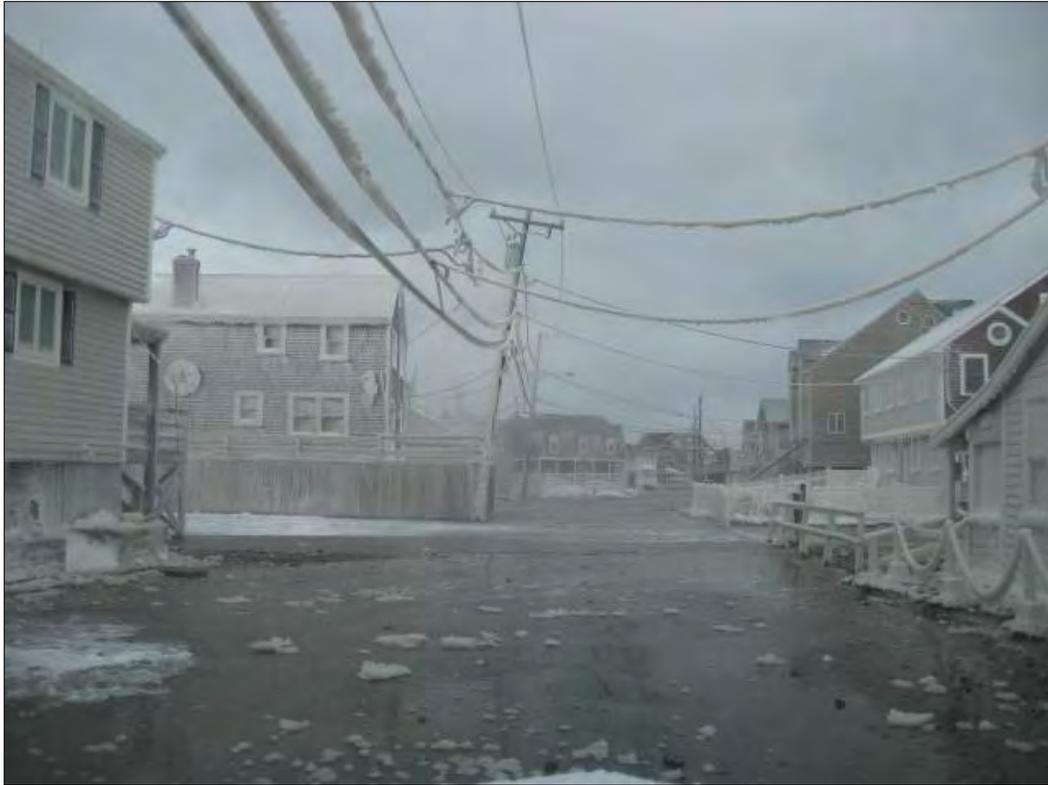
Figure 5.9 Frozen utility lines and leaning poles on Lighthouse Road. Photo from January 3, 2014 storm report by Jason Burtner (*mycoast.org*).
