Coastal Erosion, Sediment Transport, and Prioritization Management Strategy Assessment for Shoreline Protection Scituate, Massachusetts

August 2016

Applied Coastal Research and Engineering, Inc.
766 Falmouth Road, Suite A1
Mashpee, Massachusetts 02649

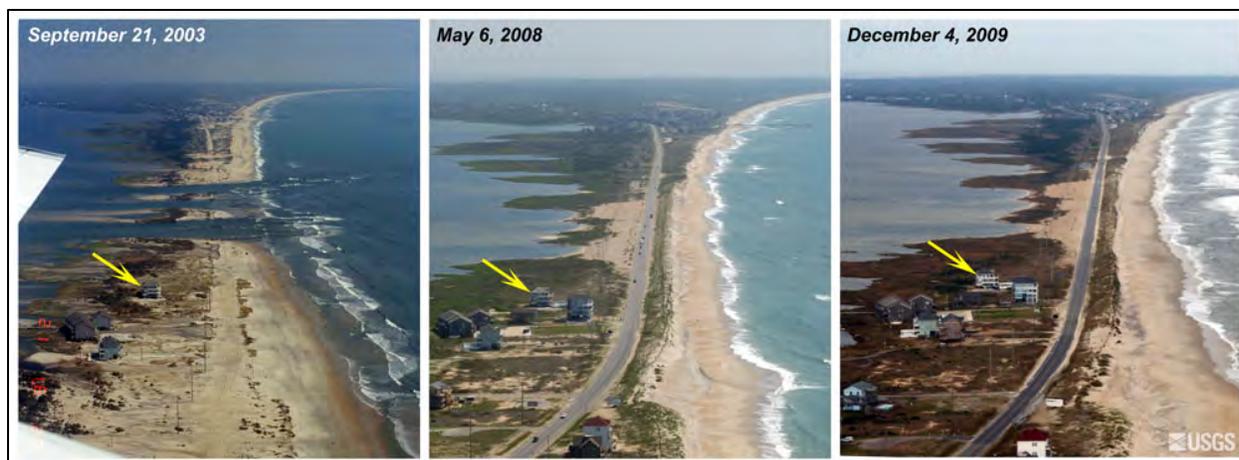
Figure 5.10 Oblique aerial photography looking north along Hatteras Island, NC on September 21, 2003 (left, after hurricane Isabel), May 6, 2008 (middle) and December 4, 2009 (right), roughly two weeks after the storm. The yellow arrows point to the same location in each photograph. The inlet formed during Isabel was filled, and a protective dune was constructed in front of the new road (*image credit: USGS*).

One unique aspect of barrier beaches is their potential to breach during a severe storm event. A breach is where the barrier beach is broken down by waves, allowing the seawater to extend inland. In most cases, storm-induced breaches heal naturally, as the inlet formed typically is not the most hydraulically efficient inlet to the back barrier estuary. Notable regional exceptions include the recent inlets to Pleasant Bay through the Nauset Barrier Beach in Chatham (as a result of storms in 1987 and 2007) and the formation of New Inlet between Third and Fourth Cliffs in Scituate (as a result of the Portland Gale in 1898). Due to the extensive development along the Scituate shoreline since the Portland Gale, there are concerns that even a temporary breach of a barrier beach could create significant public safety concerns, as well as prohibiting access to year-round residences “cut-off” by the breach. However, the main concern remains the formation of a permanent breach or a breach that would be difficult to close once a daily tidal regime becomes established, similar to a recent beach in Hatteras Island, NC (Figure 5.10).

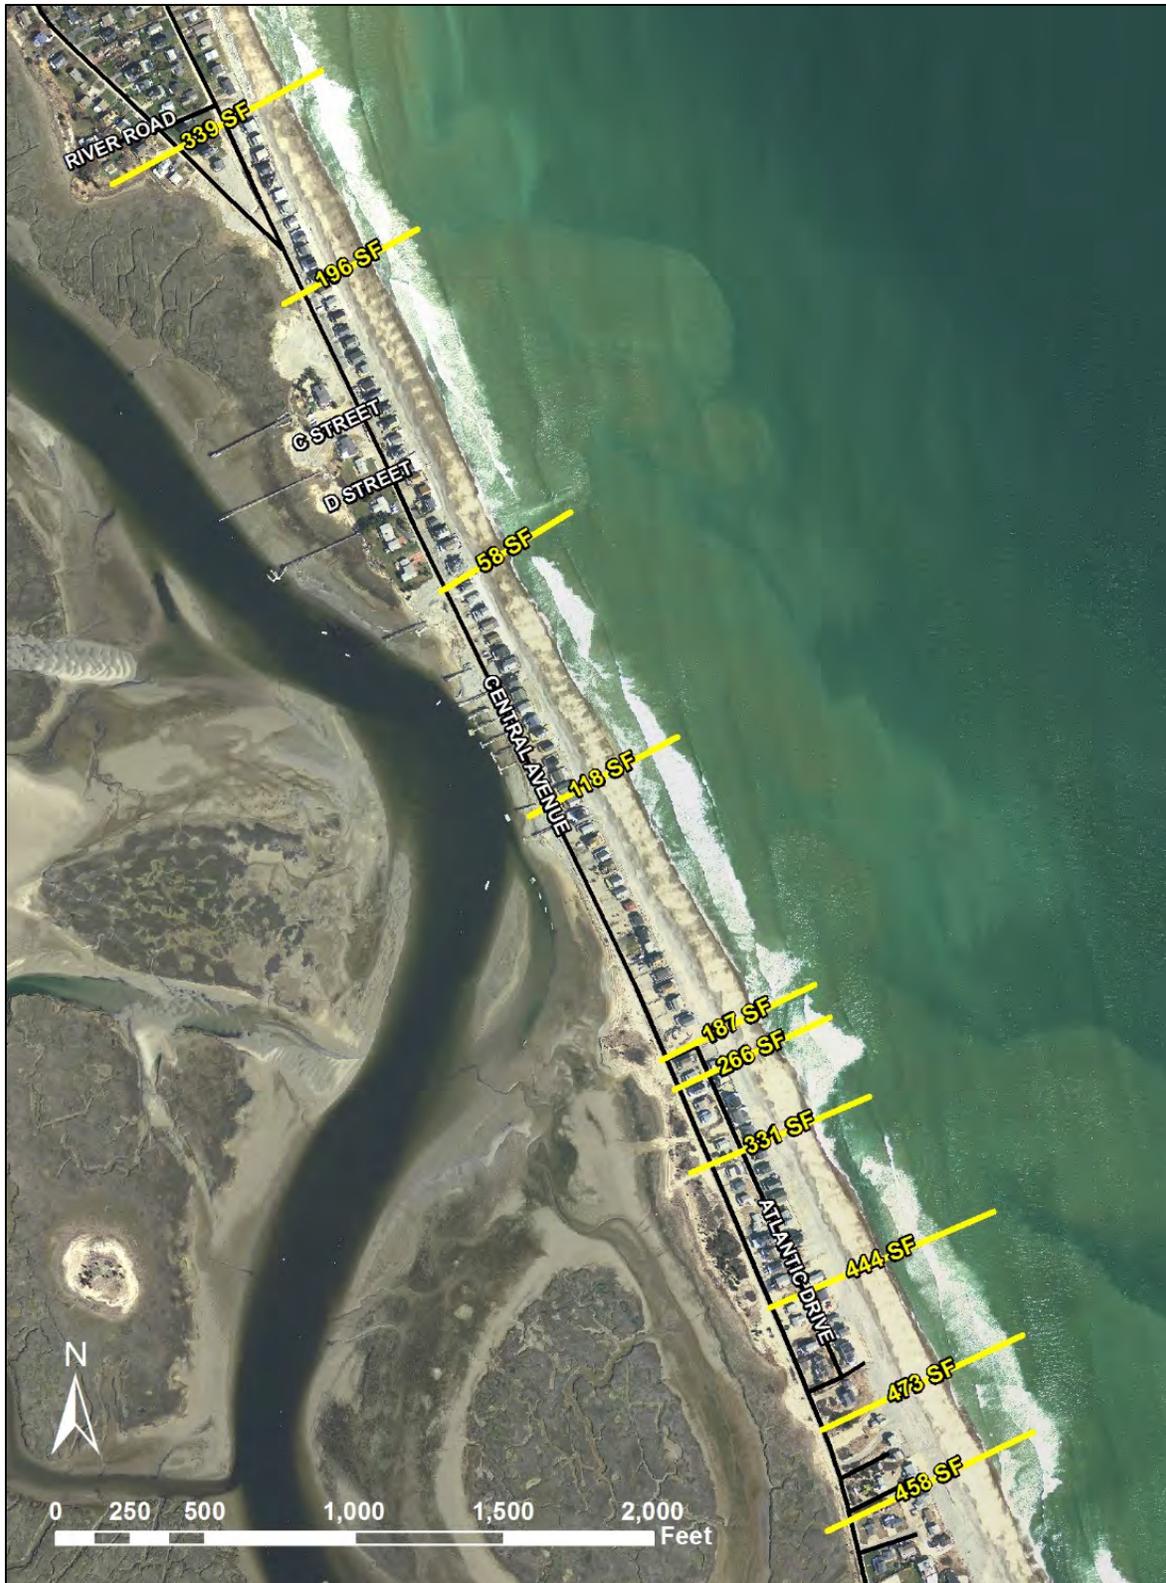
Figure 5.11 Dune volume along transects in Humarock North. Note the particularly vulnerable areas between D Street and Atlantic Drive.

At the north end of Humarock, formation of a breach along the barrier beach system is more likely as regular overwash has lowered and narrowed the barrier beach over time. Figure 5.11 summarizes the dune volume along Humarock North above the 100-year still water elevation. As a guideline developed by FEMA, it is anticipated that dunes with a cross-sectional area of less than 540 square feet above the 100-year still water elevation cannot withstand a 100-year storm event. The section between D Street and Atlantic Drive is of particular concern as barrier beach is extremely narrow, as narrow as 200 feet, and the dune volumes are only about 10% of the dune volume needed to withstand a major storm event. Table 5.10 presents the priority rating scheme and Table 5.11 summarizes the priority rating given to each study area with respect to breaching potential.

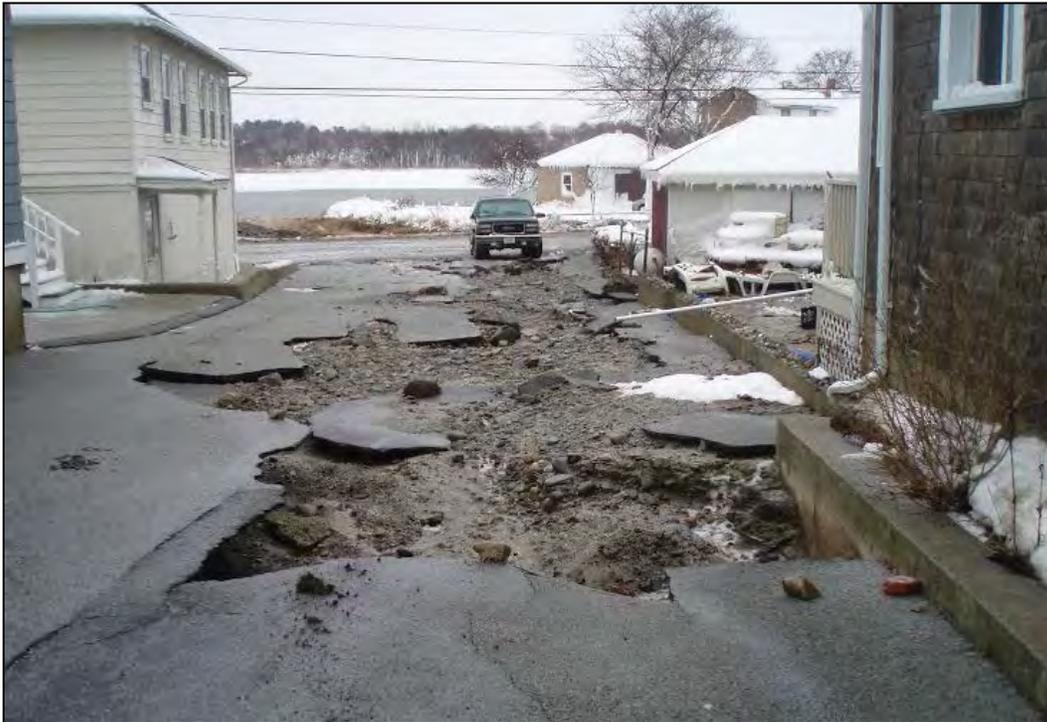
Figure 6.4 Damage to pavement caused by wave overtopping in Hull, MA (photo credit: MCZM).

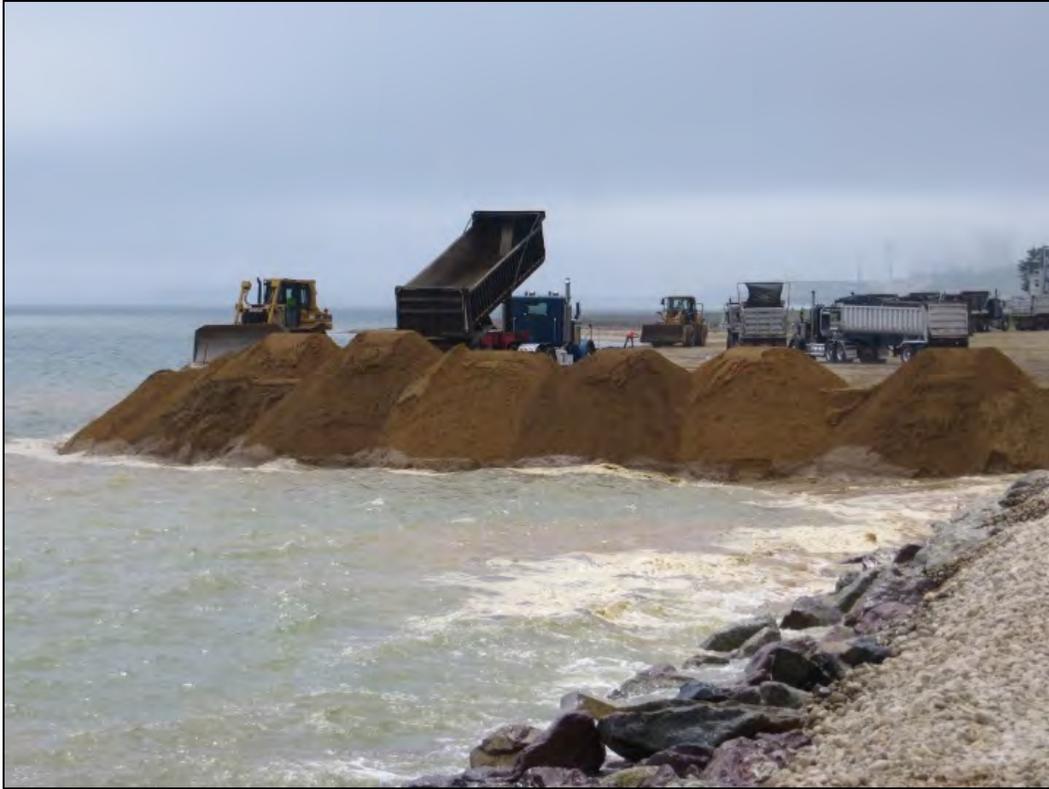
Figure 6.6 Placement of large-scale beach nourishment at Winthrop Beach, Massachusetts, where the designed beach berm was approximately 7 feet above the local high tide level (phot by Applied Coasta/).

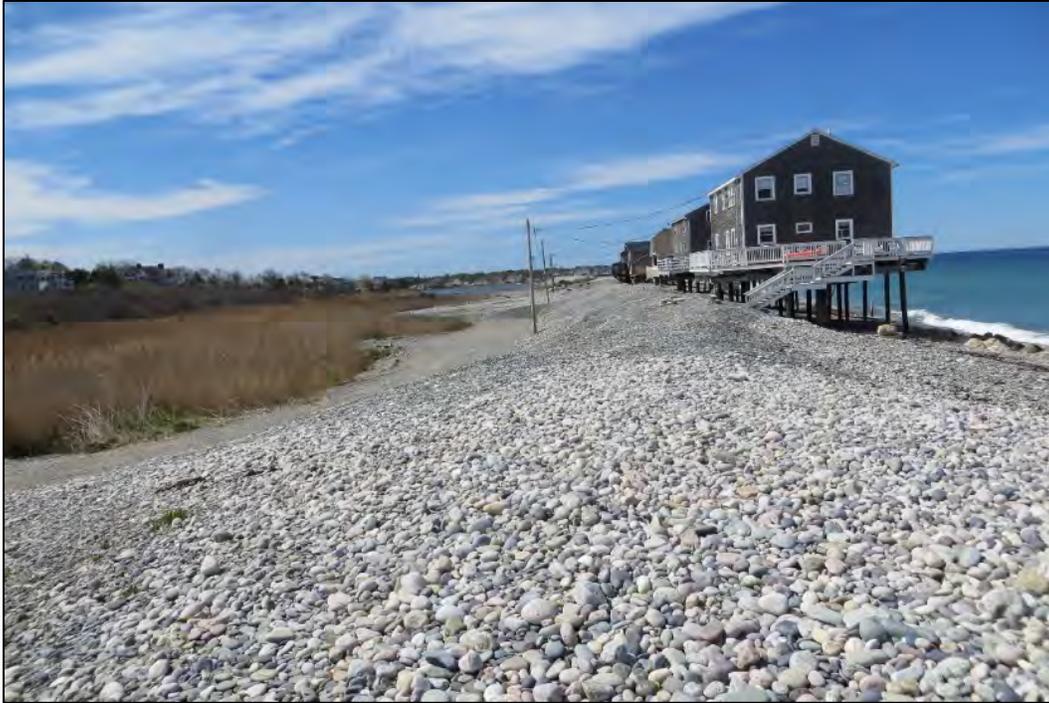
Figure 6.8 Mixed sediment dune at Mann Hill Beach, where the existing homes are located seaward of the dune crest (photo taken by Applied Coastal on May 10, 2016).

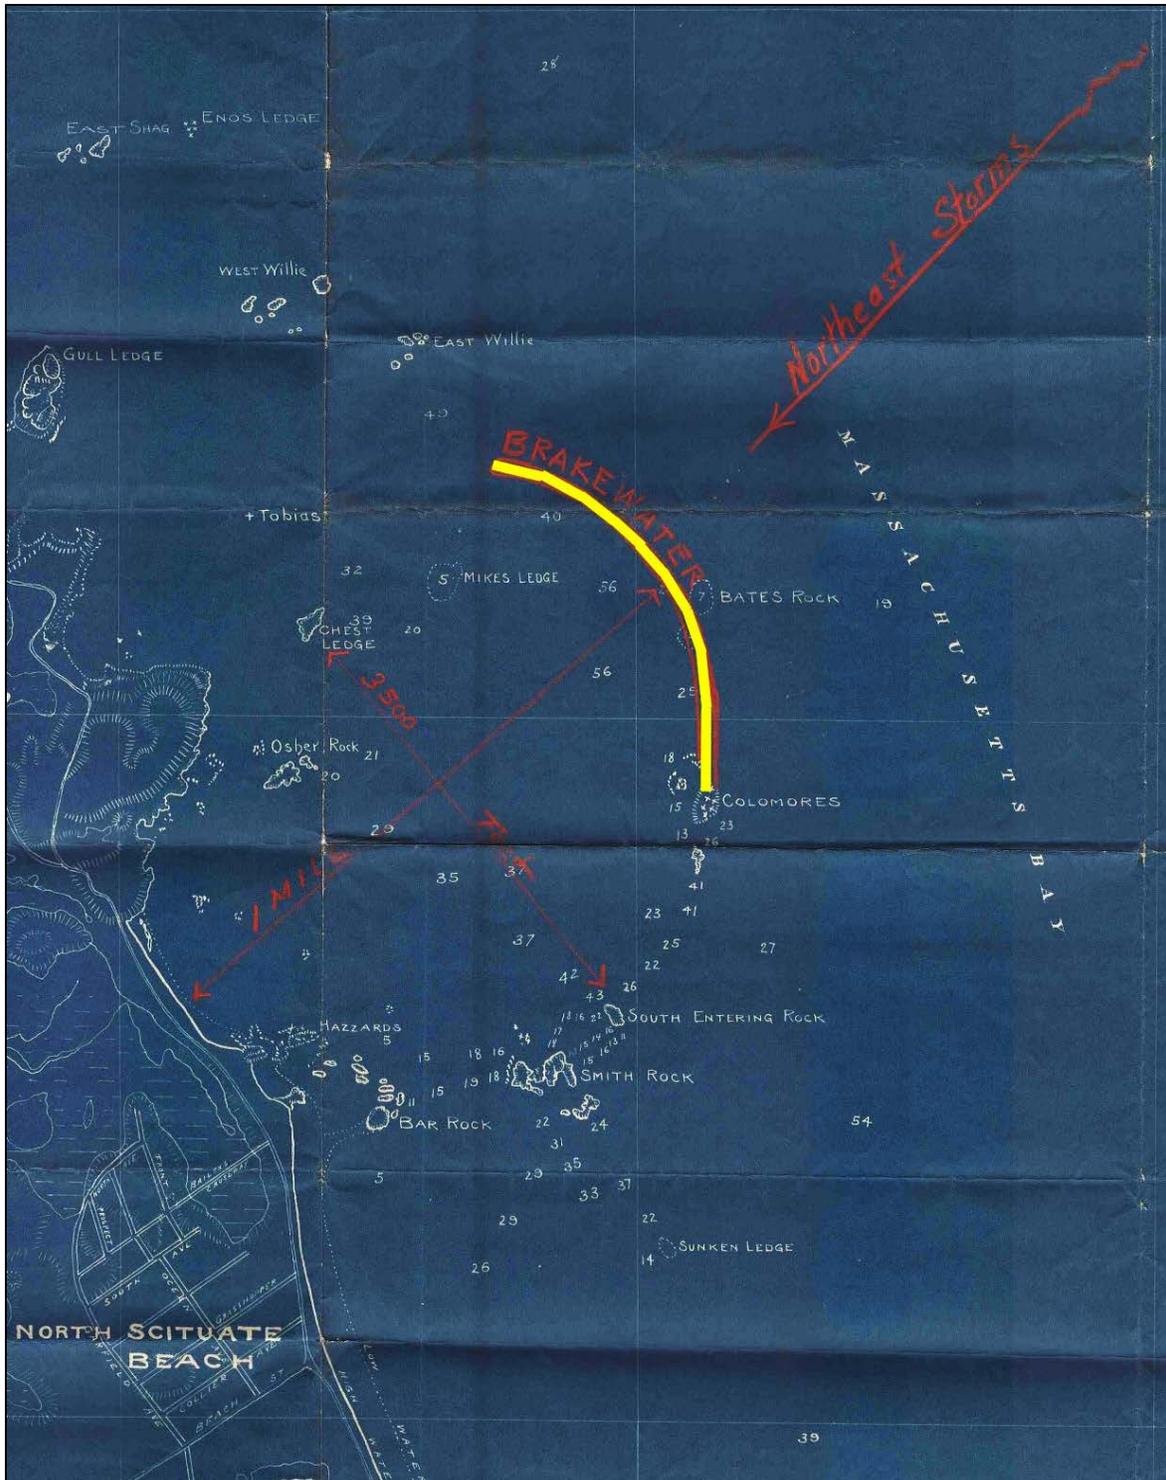
Figure 6.10 Offshore breakwater concept for the Minot Beach area, where the approximate 3,500 feet breakwater would serve to protect about ½ mile of beach (Source: 1911 Plan from Fred Tupper, C.E.).

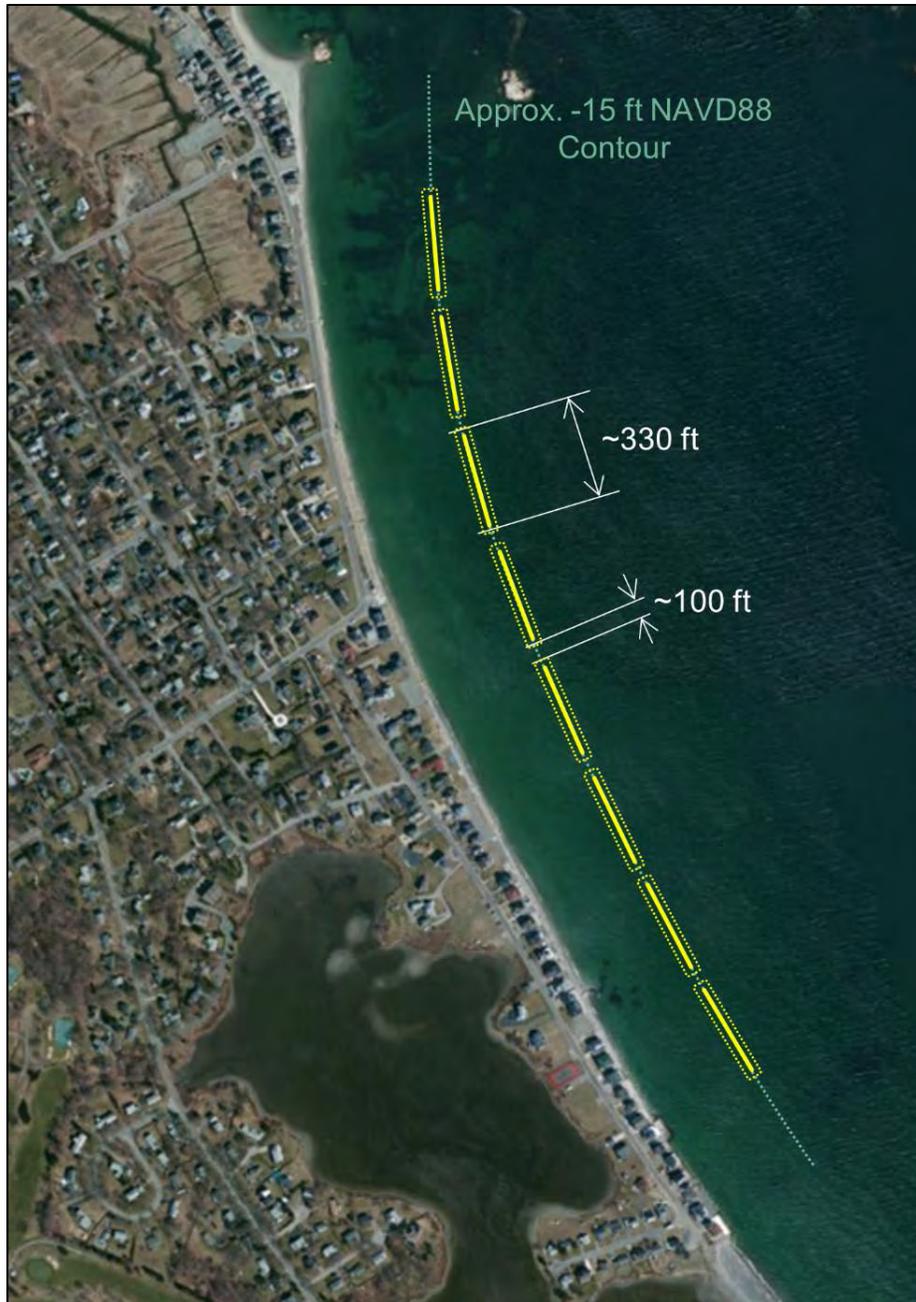
Figure 6.11 Approximate breakwater placement along the North Scituate Beach and Surfside Road shoreline. Dashed yellow outline shows the approximate footprint of the breakwater. This breakwater configuration was considered as a potential shore protection approach in the alternatives analysis for the North Scituate Beach Nourishment Project.

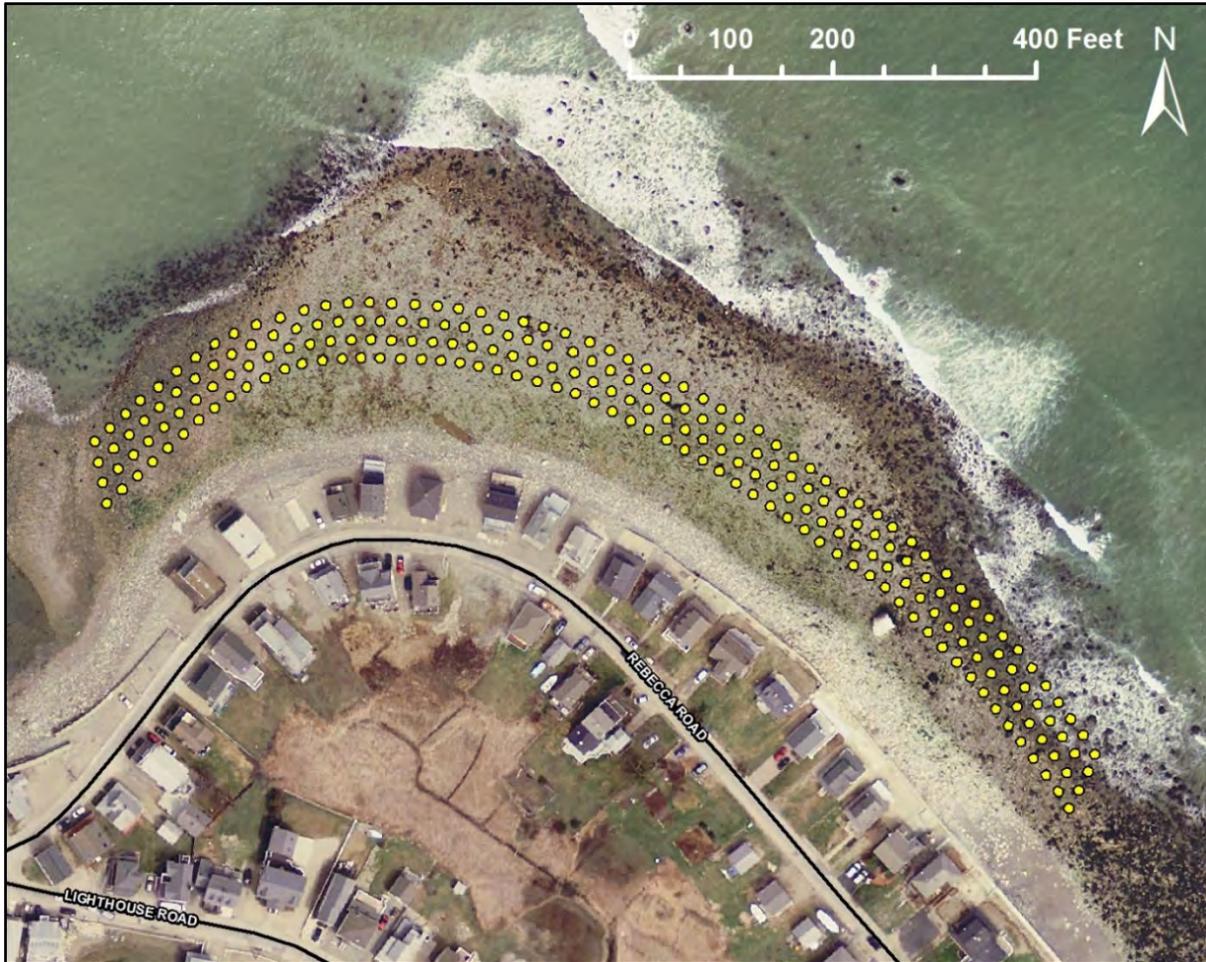
Figure 6.13 Configuration of individual boulders (represented by the yellow circles) forming a boulder dike along Cedar Point.

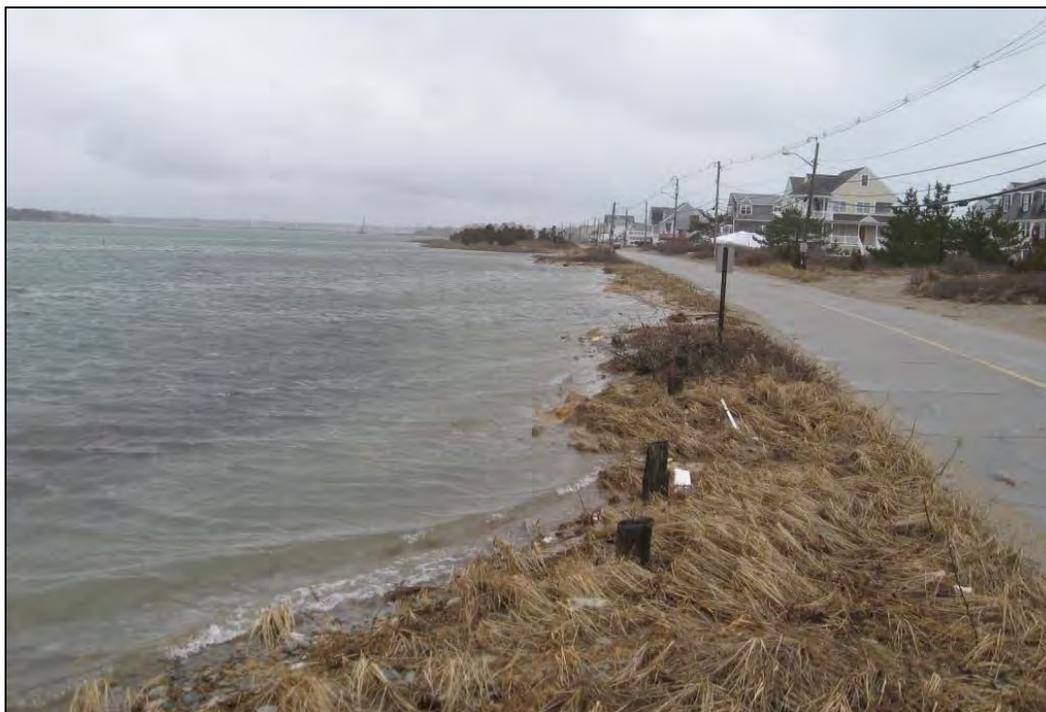
Figure 6.14 High tide along the river side of Central Avenue on March 31, 2014 (photo by Jason Burtner, www.mycoast.org).

Elevating flood-prone roads can improve emergency egress, reduce overwash and the need for debris clearing, and may also offer improved protection from breaching. Many of the identified critical roads have elevations between approximately 2 and 3 feet below the 10-year and 100-year still water elevation, respectively. Figure 6.14 shows that high spring tide along the river side of Central Avenue is less than two feet from the existing road elevation.

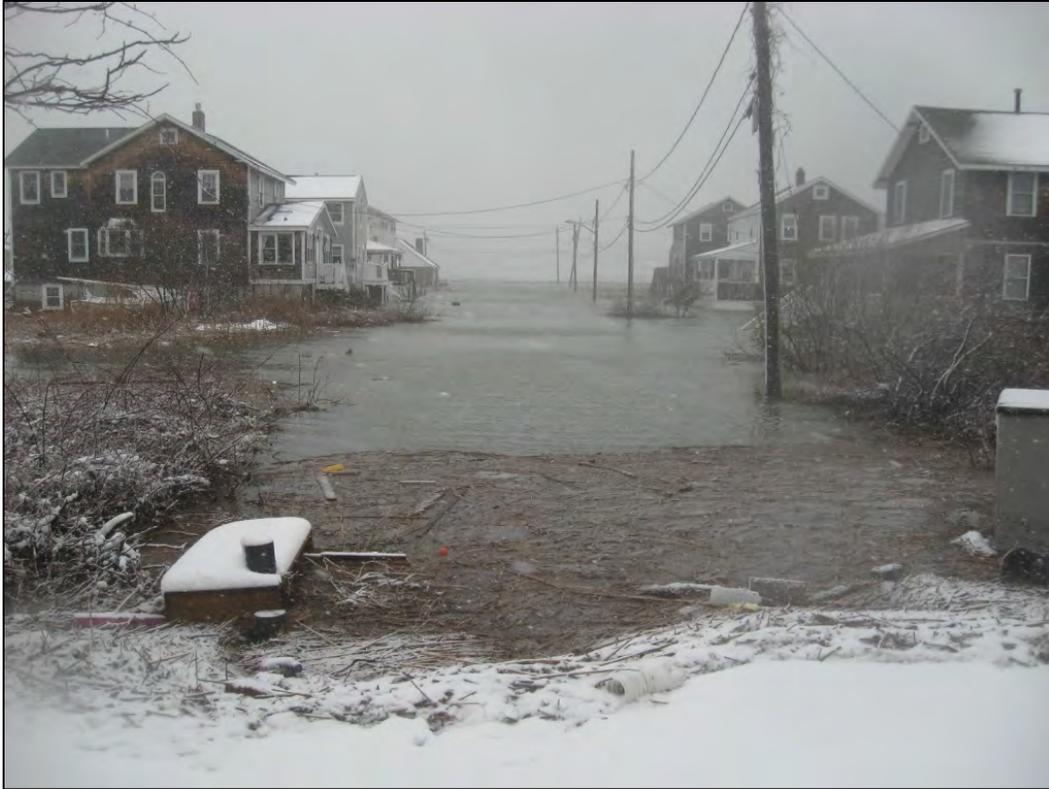
Figure 6.15 Flooding of 7th Avenue during a storm on March 8, 2013 (photo by Jason Burtner, www.mycoast.org).

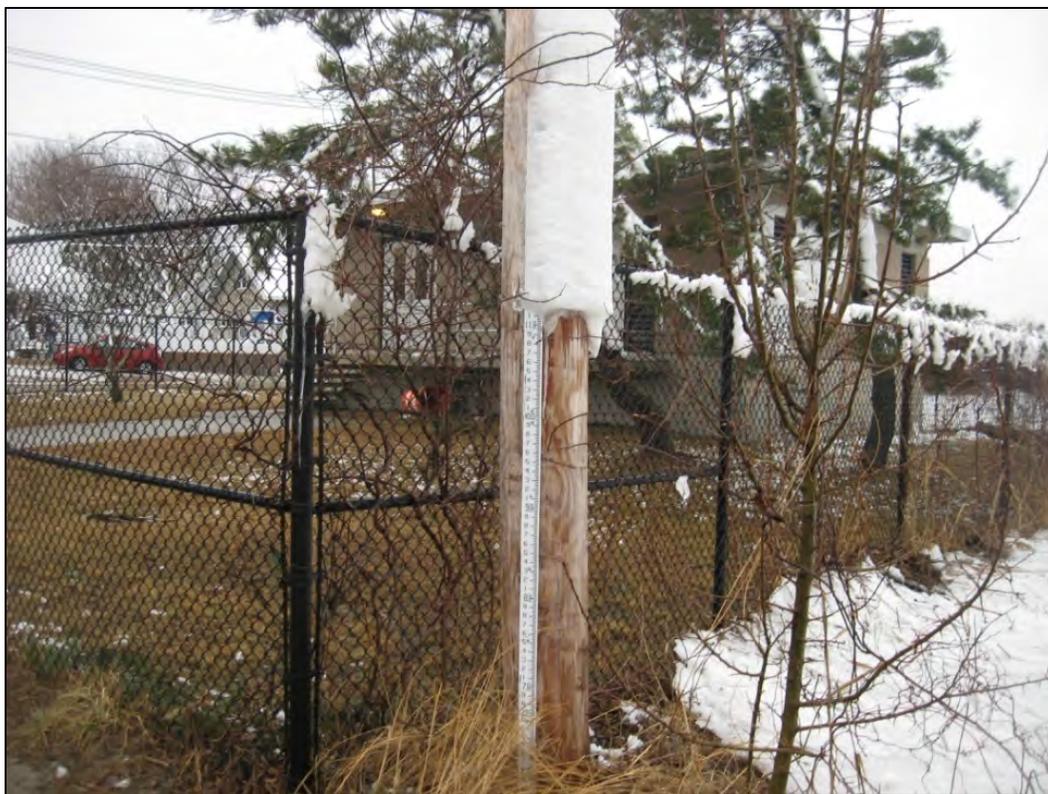
Figure 6.16 Flooding elevation is shown by the snow line at the Sand Hill pump station after Winter Storm Juno (photo by Jason Burtner, www.mycoast.org).

The operation of the pump stations may be interrupted during storm events from flooding of the power generators. While there are six pump stations located close to the shore in the Town, the stations located at Chain Pond in the Egypt Beach parking lot and at Sand Hills (at the intersection of Otis Road and Scituate Avenue) are prone to flooding due to their relatively low elevation. During Winter Storm Juno, flooding at the Sand Hills pump station was above the first floor level of the pump station as shown by the snow line in Figure 6.16. According to the Town of Scituate Department of Public Works, the power generators in both pump stations are located inside the buildings on the first floors and may benefit from being elevated.

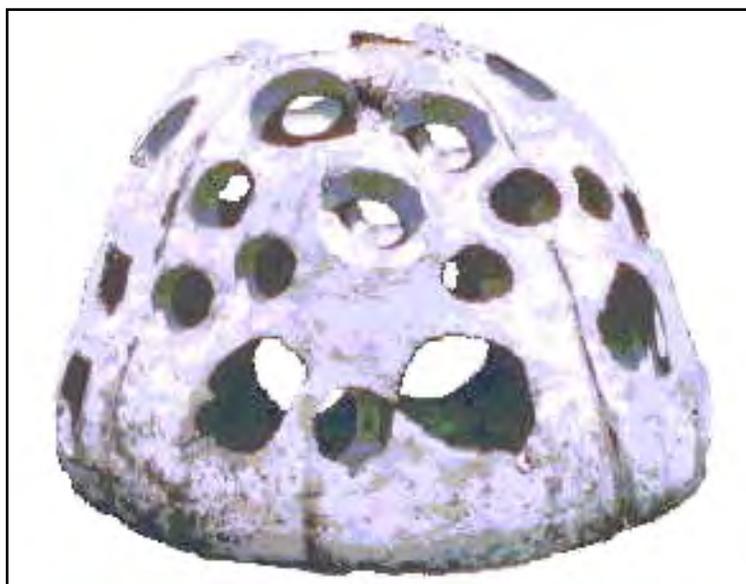
Figure 6.17 Individual Reef Ball™ unit (image credit: reefball.org).

The first technology evaluated were Reef Ball™ units which are typically round-topped concrete balls with holes throughout (Figure 6.17). The purpose of a Reef Ball™ structure would be to create a submerged breakwater that attenuates some of the wave energy while also creating a habitat for mussels and other coastal species. The concrete used to make the units is typically a microsilica-based concrete that is abrasion resistant, high strength, and has a pH similar to that of the natural sea (~8.3) (*reefball.org*). The units can be designed in numerous shapes, sizes, and textures depending on the intended environment. According to *reefball.org*, the largest Reef Ball™ unit available is the “Goliath” which is 6 feet wide and 5 feet tall and costs approximately \$450 per unit. The majority of the weight of a Reef Ball™ unit is at the base of the structure to increase stability. In addition, it is possible to increase the height of the Reef Ball™ unit by adding a “booster ring”.

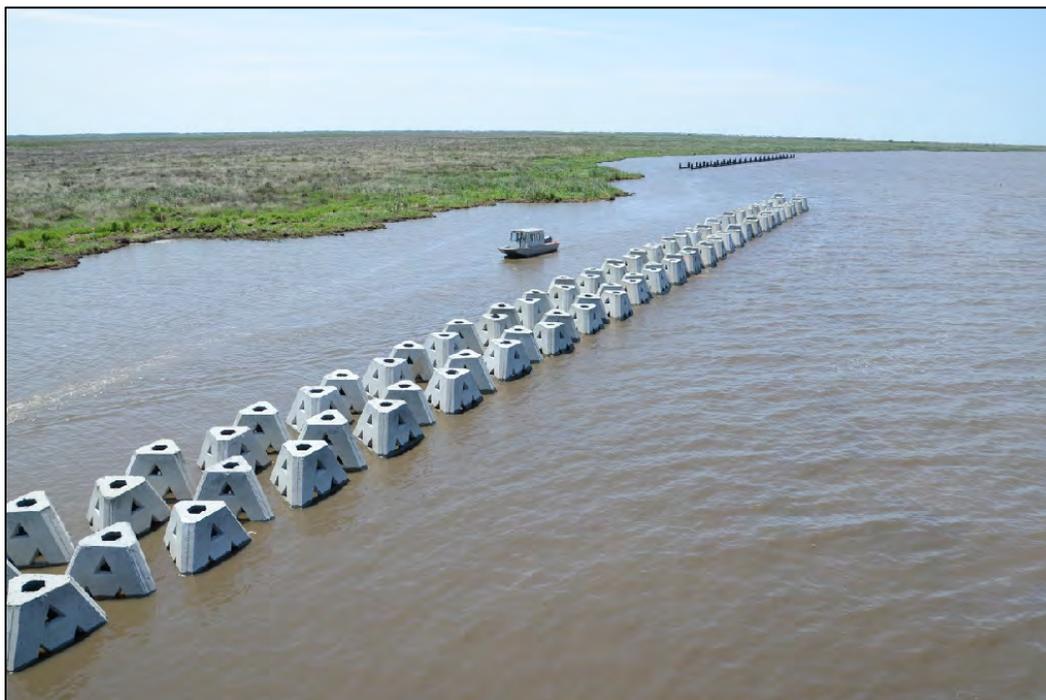
Figure 6.19 Photograph of the Shark Island WAD™ project completed in New Iberia, Louisiana (*photo credit: www.livingshorelinesolutions.com*).

The second artificial reef technology considered was WAD™ units. The units are made of precast concrete, are pyramidal in shape, and have pressure release openings on the sides (Figure 6.19). WAD™ units are intended to function as a detached breakwater that minimizes the effect of storm surge through wave energy attenuation and to provide a substrate for shellfish to colonize on. Similar to the other technologies, size and configuration of the WAD™ units is highly project specific. WAD™ units have been used for many projects as detached breakwaters from Maryland to Jamaica.

Along the Scituate shoreline, the spring tide range is in excess of 10 feet; therefore, artificial reef units submerged at low tide would effectively provide no wave attenuation at high tide, similar to, but less effective than an armor stone submerged breakwater (see Figure 6.19). If the structure is utilized in an emergent situation, where it is exposed for much of the tide, subsidence and scour become major concerns, similar to other coastal engineering structure in this dynamic environment. Similar to the boulder dike, these concrete units could be placed on the natural boulder platforms (e.g. Cedar Point or Egypt Beach); however, concerns regarding construction materials remain in this coarse-grained sediment environment. Specifically, during storm conditions, gravel and cobble are highly mobile, causing rapid degradation of exposed concrete surfaces. An example of this effect is shown for a concrete outfall structure along Oceanside Drive is shown in Figure 6.20. Therefore, artificial reef structures were not deemed appropriate for the Scituate shoreline due to both the inability to attenuate waves when submerged and the lack of durability of the concrete construction material.

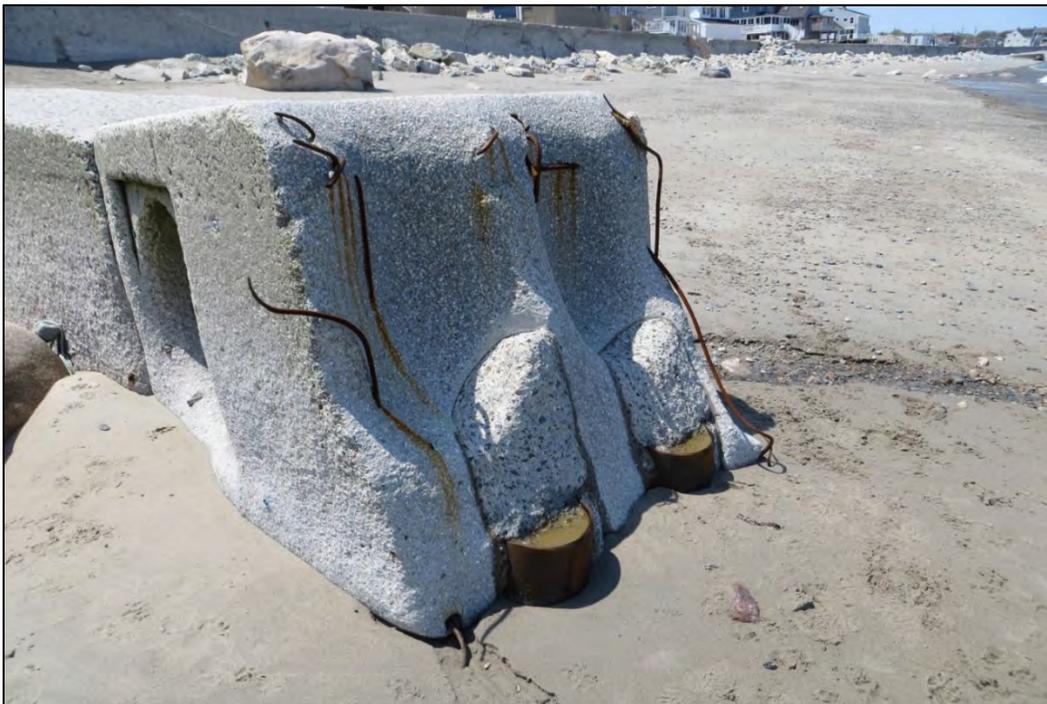
Figure 6.21 Observed scouring of concrete surface of outfall structure along Oceanside Drive. It is anticipated that degradation of concrete would be more rapid along the cobble/boulder strewn platforms at Cedar Point or Egypt Beach.

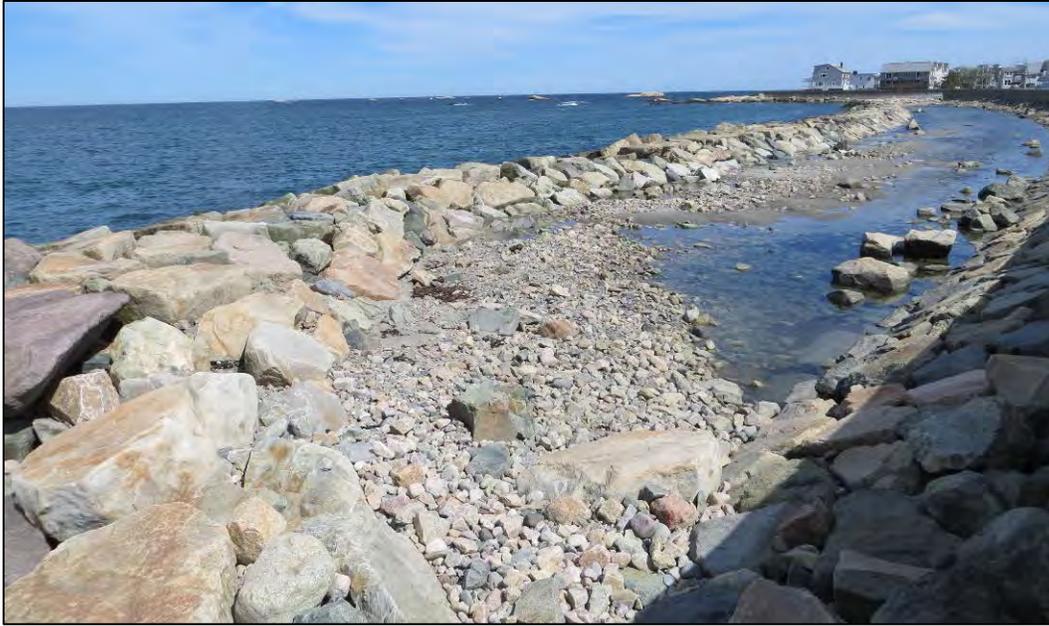
Figure 7.3 Existing revetment dike at Minot Beach (photo taken by Applied Coastal on May 10, 2016).

A roughly 1,200-foot long revetment dike is situated approximately 50 feet seaward of the south seawall section at Minot Beach. The crest elevation of the existing revetment dike, shown in Figure 7.3, is approximately 9 feet NAVD88 and the crest is approximately 14 feet wide. To increase the wave dissipation capacity of the dike, the proposed design suggests increasing the crest of the dike well above the 100-year still water and surge elevation to 13 feet NAVD88 and increase the crest width to 20 feet. The proposed revetment dike would decrease the wave transmission by 15% and lowers the wave overtopping rates to below pavement damage levels during the 100-year storm. Unfortunately, the proposed design does not prevent damage during a hypothetical 2-foot sea level rise (SLR) scenario. A schematic of the proposed design is presented in Figure 7.4 and the wave overtopping rates are summarized in Table 7.4.

As much of the Minot Beach shoreline is fronted by a revetment dike (Figure 7.3), it is possible to utilize this existing structure to “perch” beach nourishment on the landward side of the structure to attenuate incoming storm wave energy. This perched beach system would be completely contained by the revetment dike and could be constructed by using the existing 1,200-foot revetment dike as a sill to support the lower portion of the beach profile. A schematic of the proposed nourishment template is presented in Figure 7.5. The cobble beach is expected to reshape immediately after construction and the crest of the beach, initially at 12 feet NAVD88, will adjust to match the runup elevation to minimize overtopping (CIRIA/CUR, 1991).

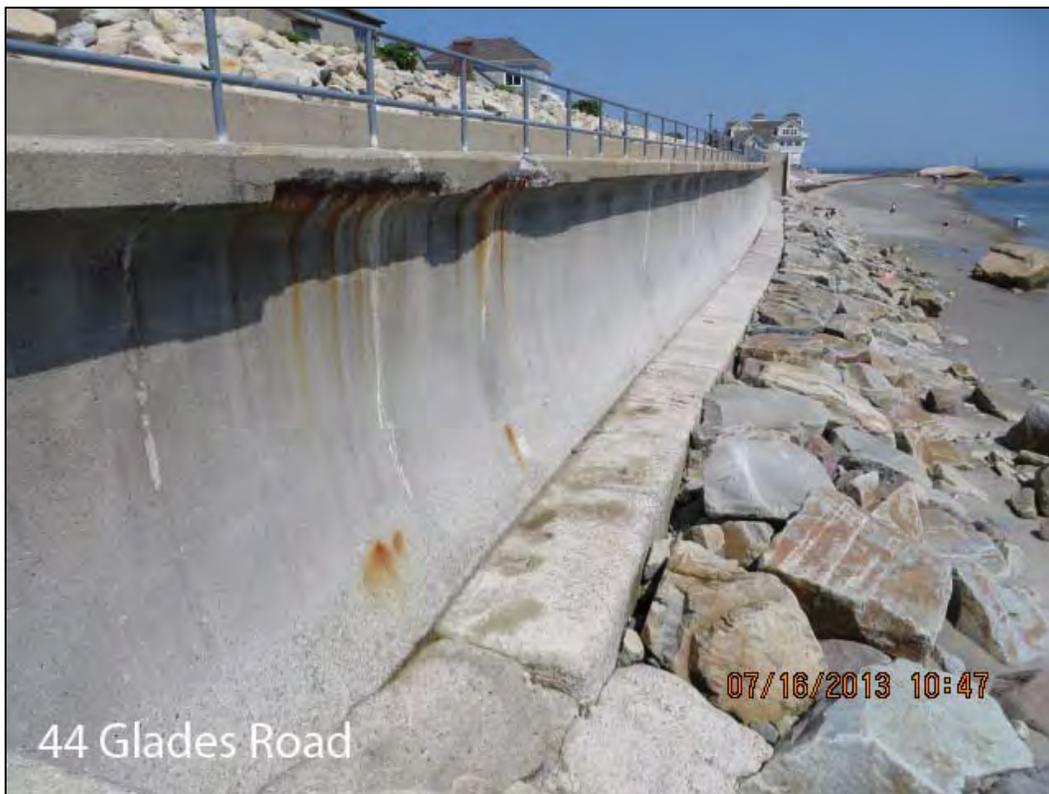
Figure 7.8 Existing seawall and revetment along North Scituate Beach (photo by CLE Engineering).

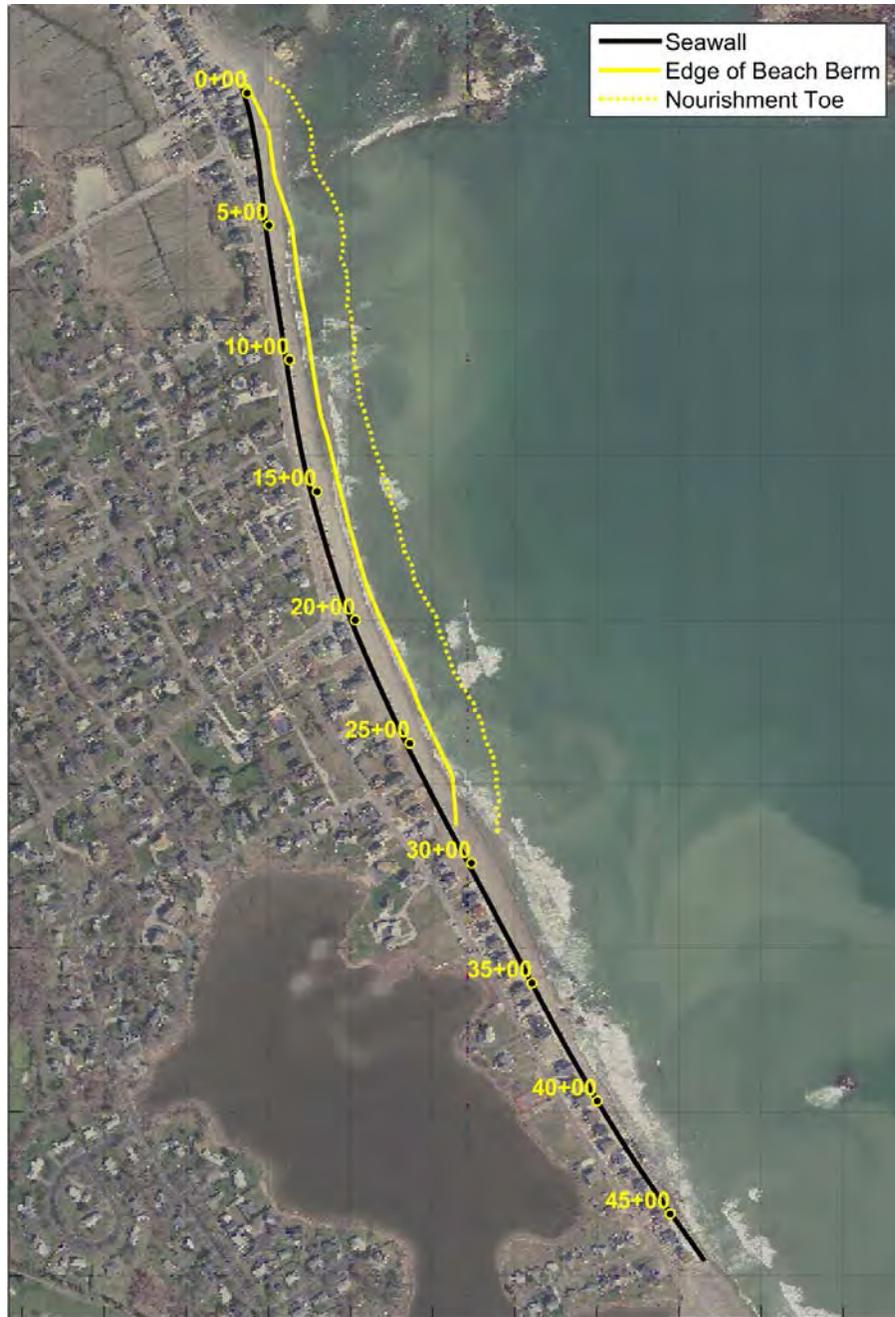
Figure 7.10 Proposed initial phase of the North Scituate Beach nourishment project.

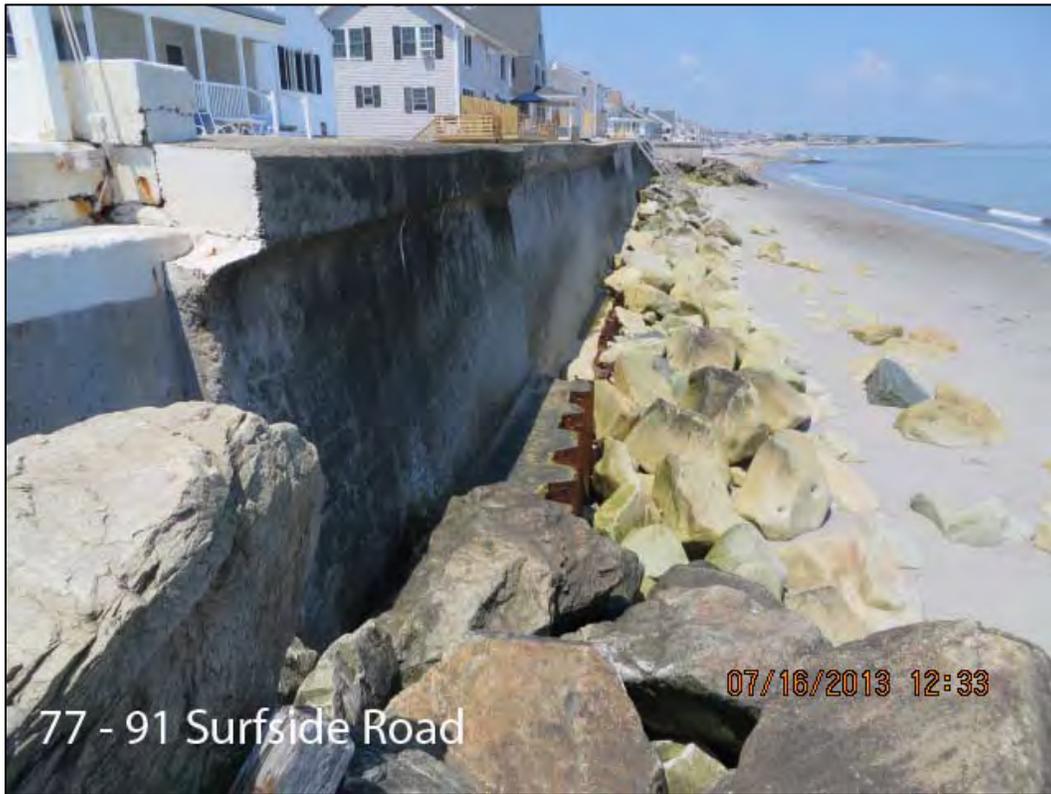
Figure 7.11 Existing seawall and revetment along Surfside Road (photo by CLE Engineering).

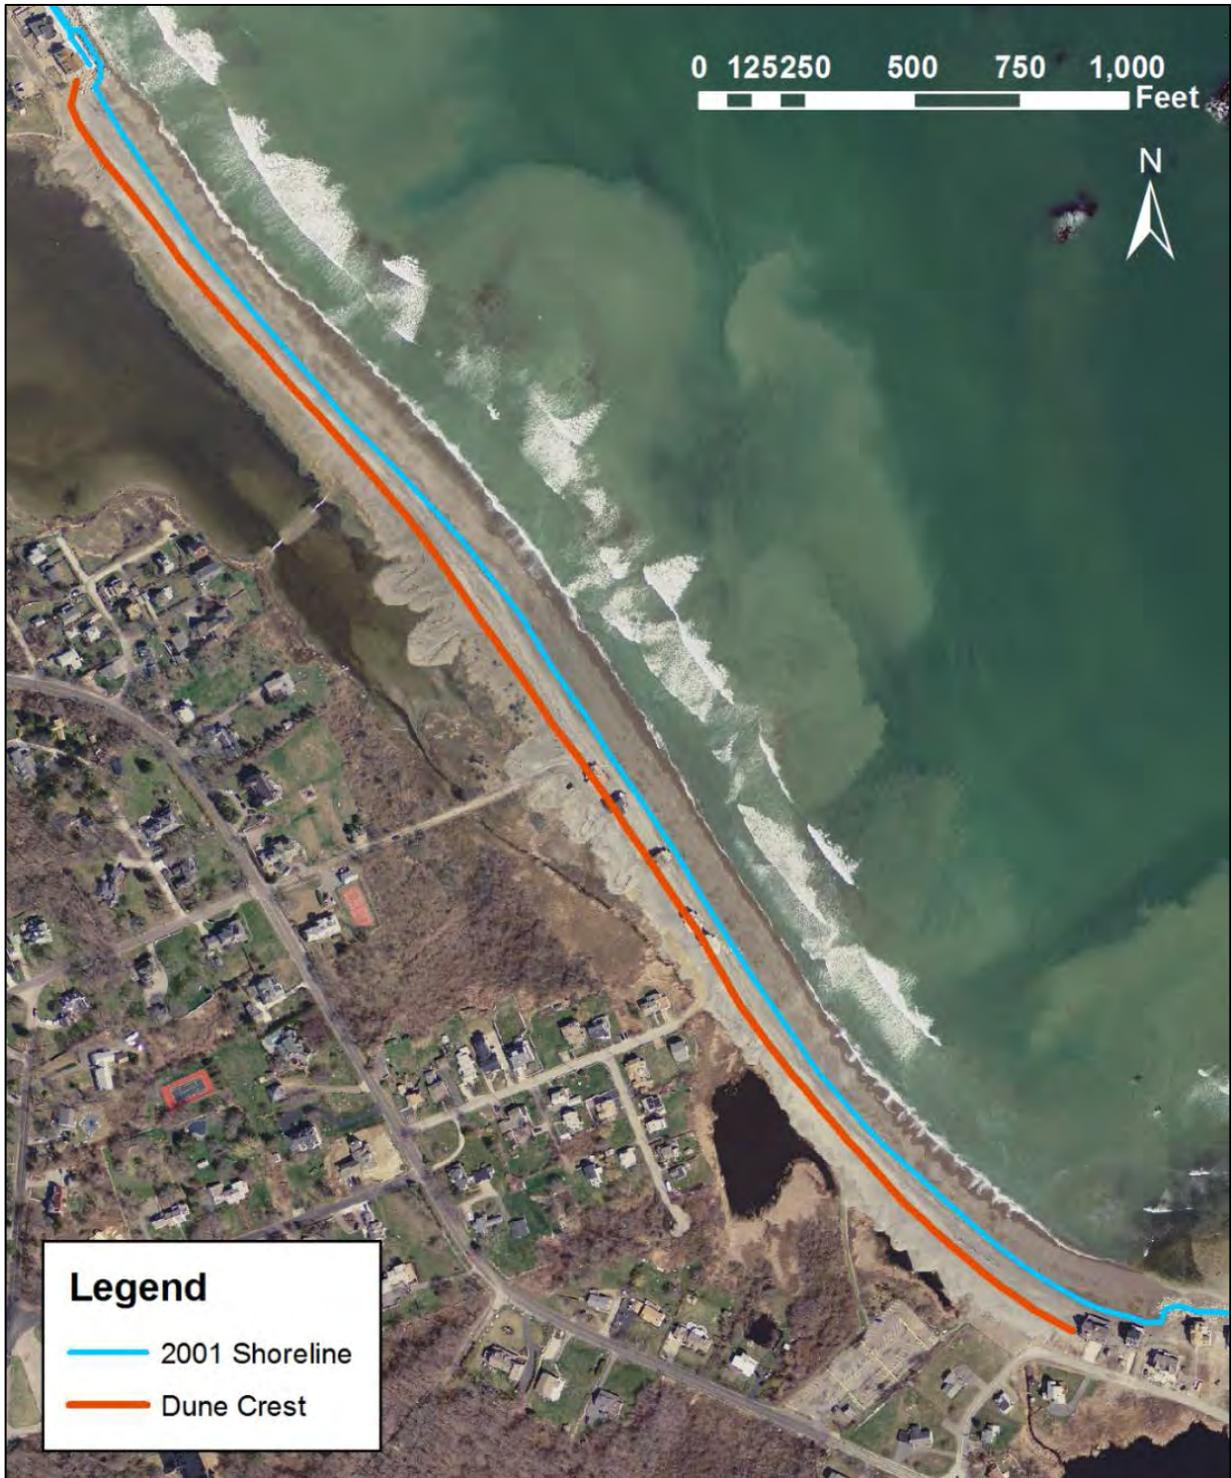
Figure 7.13 2001 shoreline and dune crest along Mann Hill Beach and Egypt Beach.

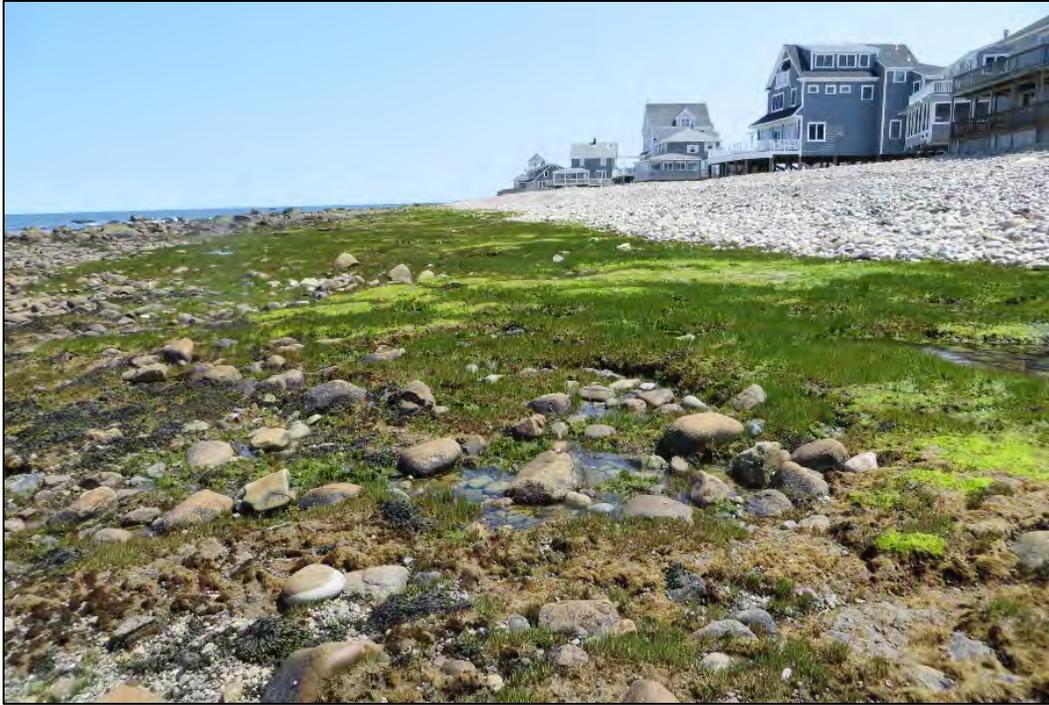
Figure 7.16 Salt marsh along the Egypt Beach (photo taken by Applied Coastal on May 12, 2016).

A rocky inter-tidal platform extends along Egypt Beach from Bay Street to Standish Avenue. There are patches of salt marsh located along the shore of the northern section, as shown in Figure 7.16. The elevation of the platform is approximately 3 feet NAVD88. The proposed boulder dike, presented in Figure 7.17, would be constructed along approximately 2,300 feet of Egypt Beach, from Bay Street to Standish Avenue, and at least 100 feet from the shore to avoid disturbing the existing salt marsh. Boulders weighing approximately 10 to 12 tons and approximately 6 feet in diameter would be placed in four staggered rows to increase wave energy dissipation over the platform during small storms (e.g. low return period storms like Winter Storm Nemo and Juno). The boulder spacing would be approximately 10 feet center-to-center. During significant storms (e.g. high return period storms like the Blizzard of 1978), the boulders would likely be submerged and less effective at dissipating wave energy.
