Coastal Erosion, Sediment Transport, and Prioritization Management Strategy Assessment for Shoreline Protection Scituate, Massachusetts

August 2016

Applied Coastal Research and Engineering, Inc.
766 Falmouth Road, Suite A1
Mashpee, Massachusetts 02649

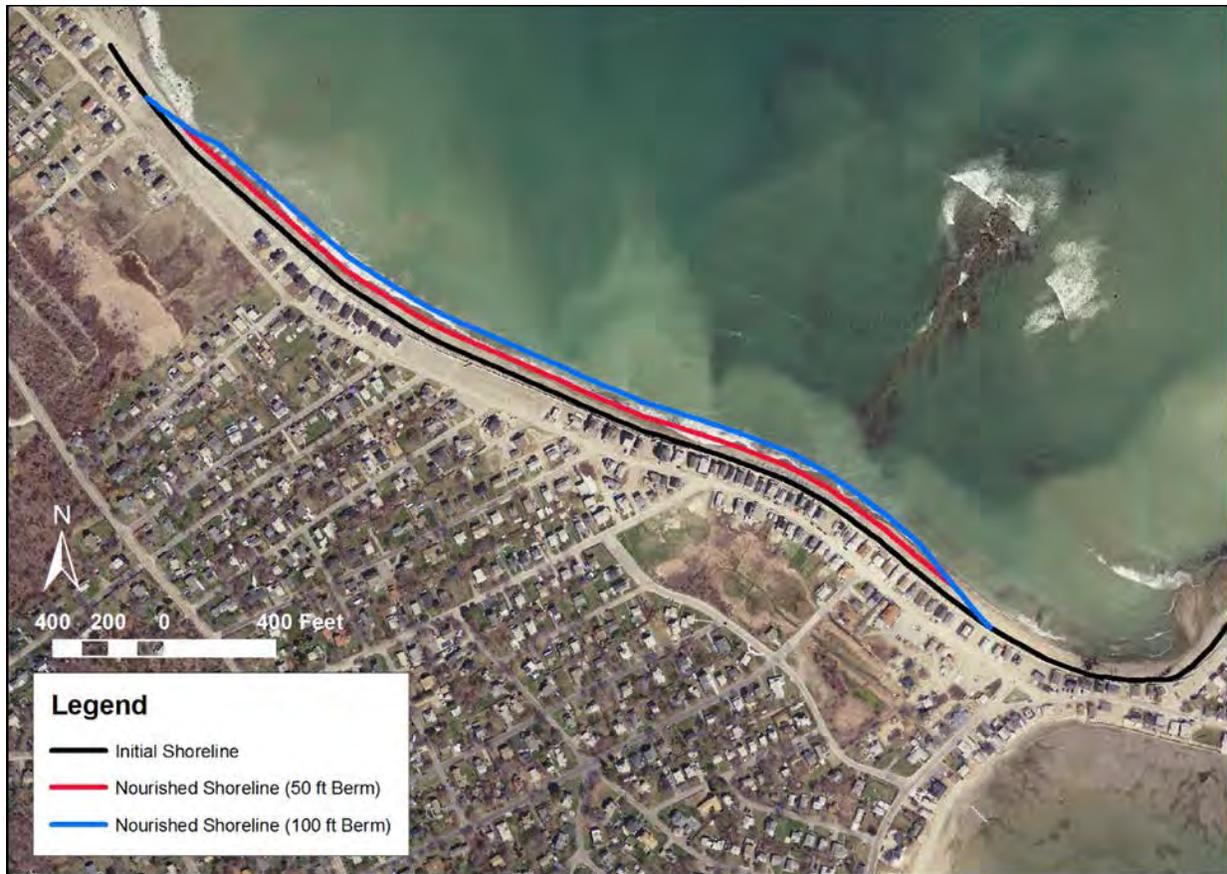
Figure 7.19 Nourishment options for Oceanside Drive extending from 7th Avenue to Jericho Road.

Two beach nourishment options were considered for Oceanside Drive extending from 7th Avenue to Jericho Road (3,800 feet) as presented in Figure 7.19 with berm widths of 50 and 100 feet. The berm elevation in both options was 13 feet NAVD88 to correspond with the 50-year runup elevation. Table 7.13 summarizes the required nourishment volume, footprint area, and construction cost for each option.

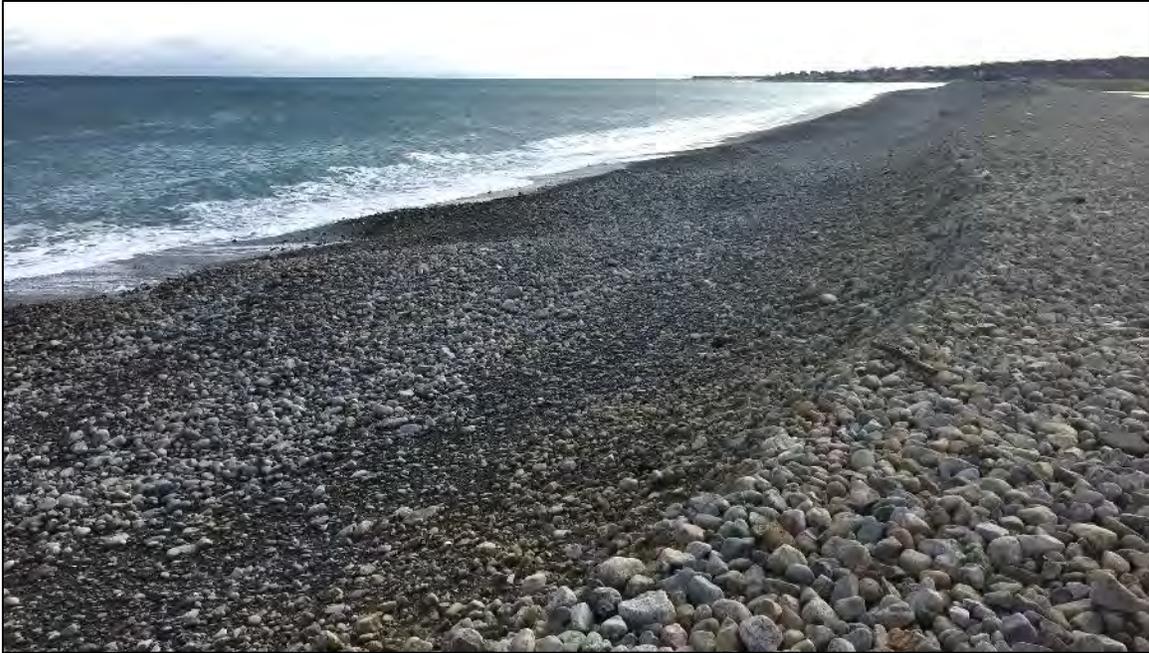
Figure 7.22 Natural cobble beach at Mann Hill Beach in Scituate, MA.

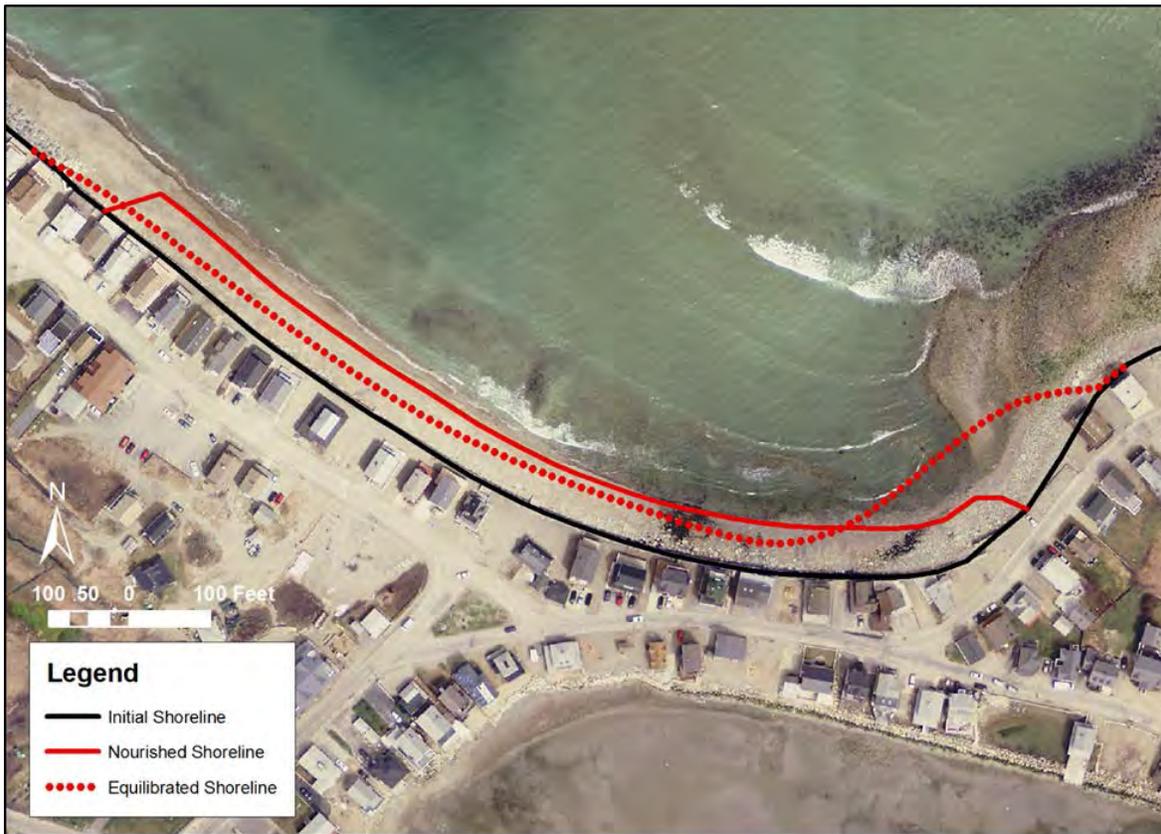
Figure 7.23 Cobble-nourished and equilibrated shoreline along Turner Road and Lighthouse Road.

A cobble nourishment is proposed from 153 Turner Road to the parking area on Rebecca Road (1,200 feet) to reduce wave overtopping and to provide breaching protection for Lighthouse Road. Cobble beaches tend to reshape over time to dissipate waves and reduce overtopping while providing a more stable beach relative to sand. Figure 7.22 shows a natural cobble beach at Mann Hill Beach. The nourishment, with a berm width of 60 feet and a crest elevation of 12 feet NAVD88, equilibrates over time as shown in Figure 7.23. From the berm, the beach slopes seaward at a 1V:4H slope until it intersects with the ocean bottom. During equilibration, see Figure 6.7, the majority of the cobble is transported to the southeast and builds up along the west-facing portion of Rebecca Road. The profile of the cobble nourishment is expected to reshape immediately after construction and the berm crest will adjust to match the runup level to minimize overtopping (CIRIA/CUR, 1991). The reshaped profile along the narrowest section of Lighthouse Road is shown in Figure 7.24. Based on Powell (1990), the crest of the cobble berm after a 50-year storm is expected to reach 17 feet NAVD88 which is approximately 2 feet higher than the existing seawall.

Approximately 137,000 cubic yards of cobble material is required at a cost of \$4.6 million. Preliminary shoreline modeling shows that the nourishment equilibrates and stabilizes without renourishment, however maintenance and monitoring is required to document the movement of the material over time.

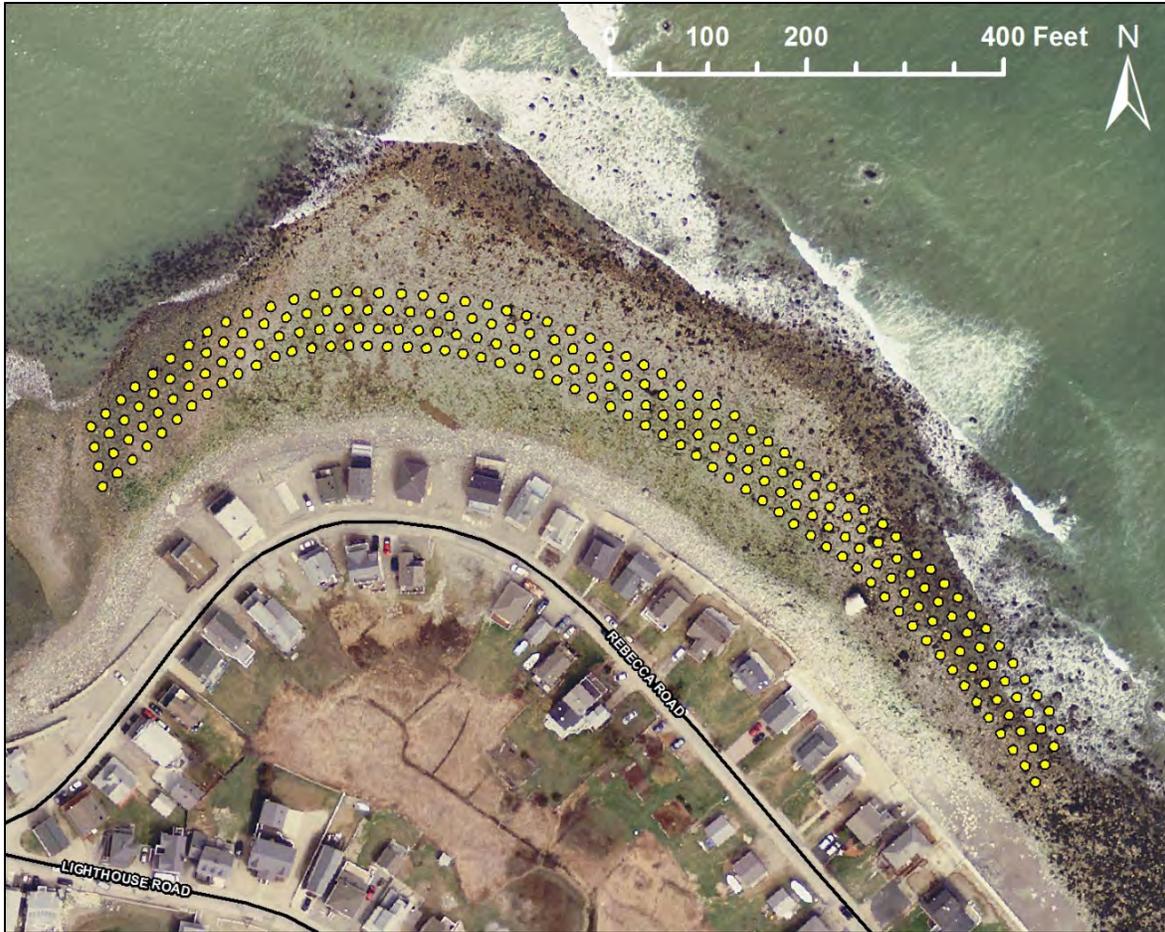
Figure 7.25 Configuration of individual boulders (represented by the yellow circles) forming a boulder dike along Cedar Point.

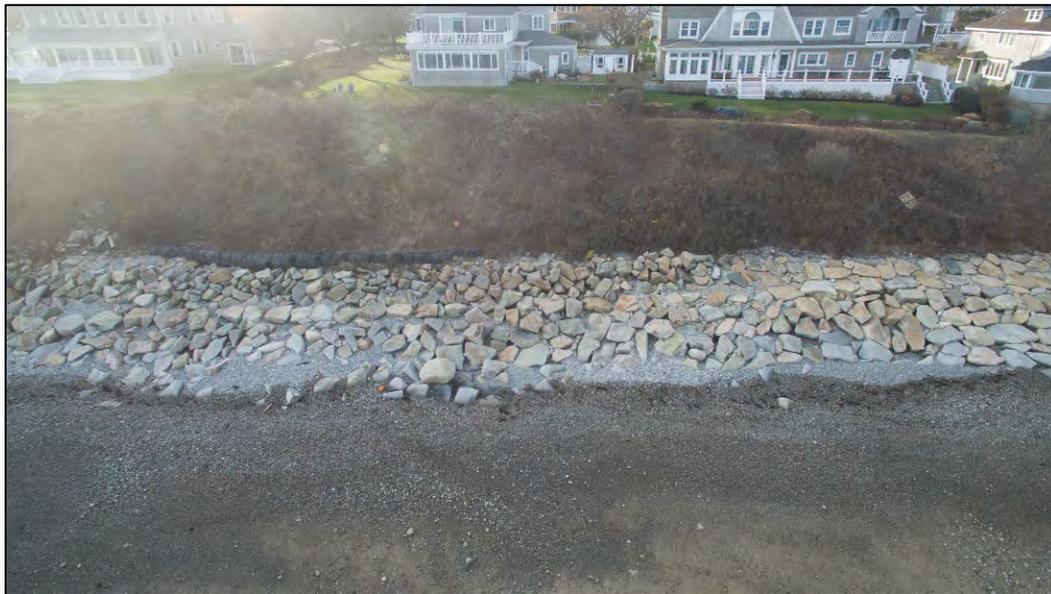
Figure 7.32 Existing revetment along Second Cliff (photo by Kevin Ham).

The condition of the 2,200-foot revetment along Second Cliff was generally rated as “poor” by CLE Engineering in 2013. Under existing conditions, wave overtopping during the 100-year storm is shown to damage pavement. However, the history of storm damage on Second Cliff does not indicate that wave overtopping is an issue. Figure 7.32 shows that the lack of damage to private and public infrastructure may be attributed to the distance at which the homes are set back from the top of the revetment and the vegetation fronting the homes which aids in dissipating the energy of the overtopped waves.

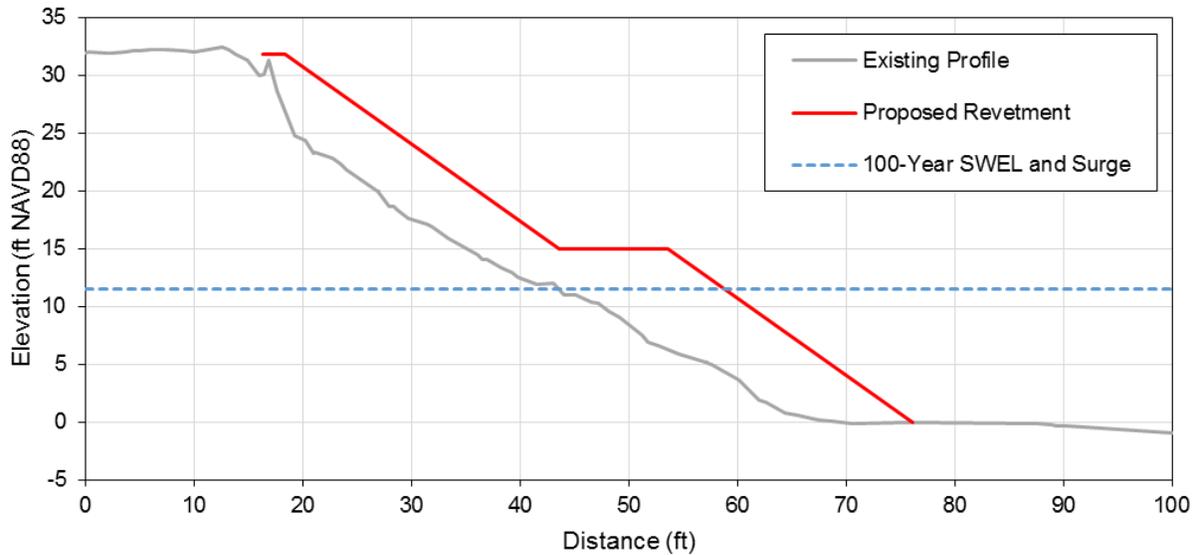
Figure 7.33 Schematic of the proposed revetment design along Second Cliff where the revetment is extended to a higher elevation and a berm is added to dissipate wave energy.

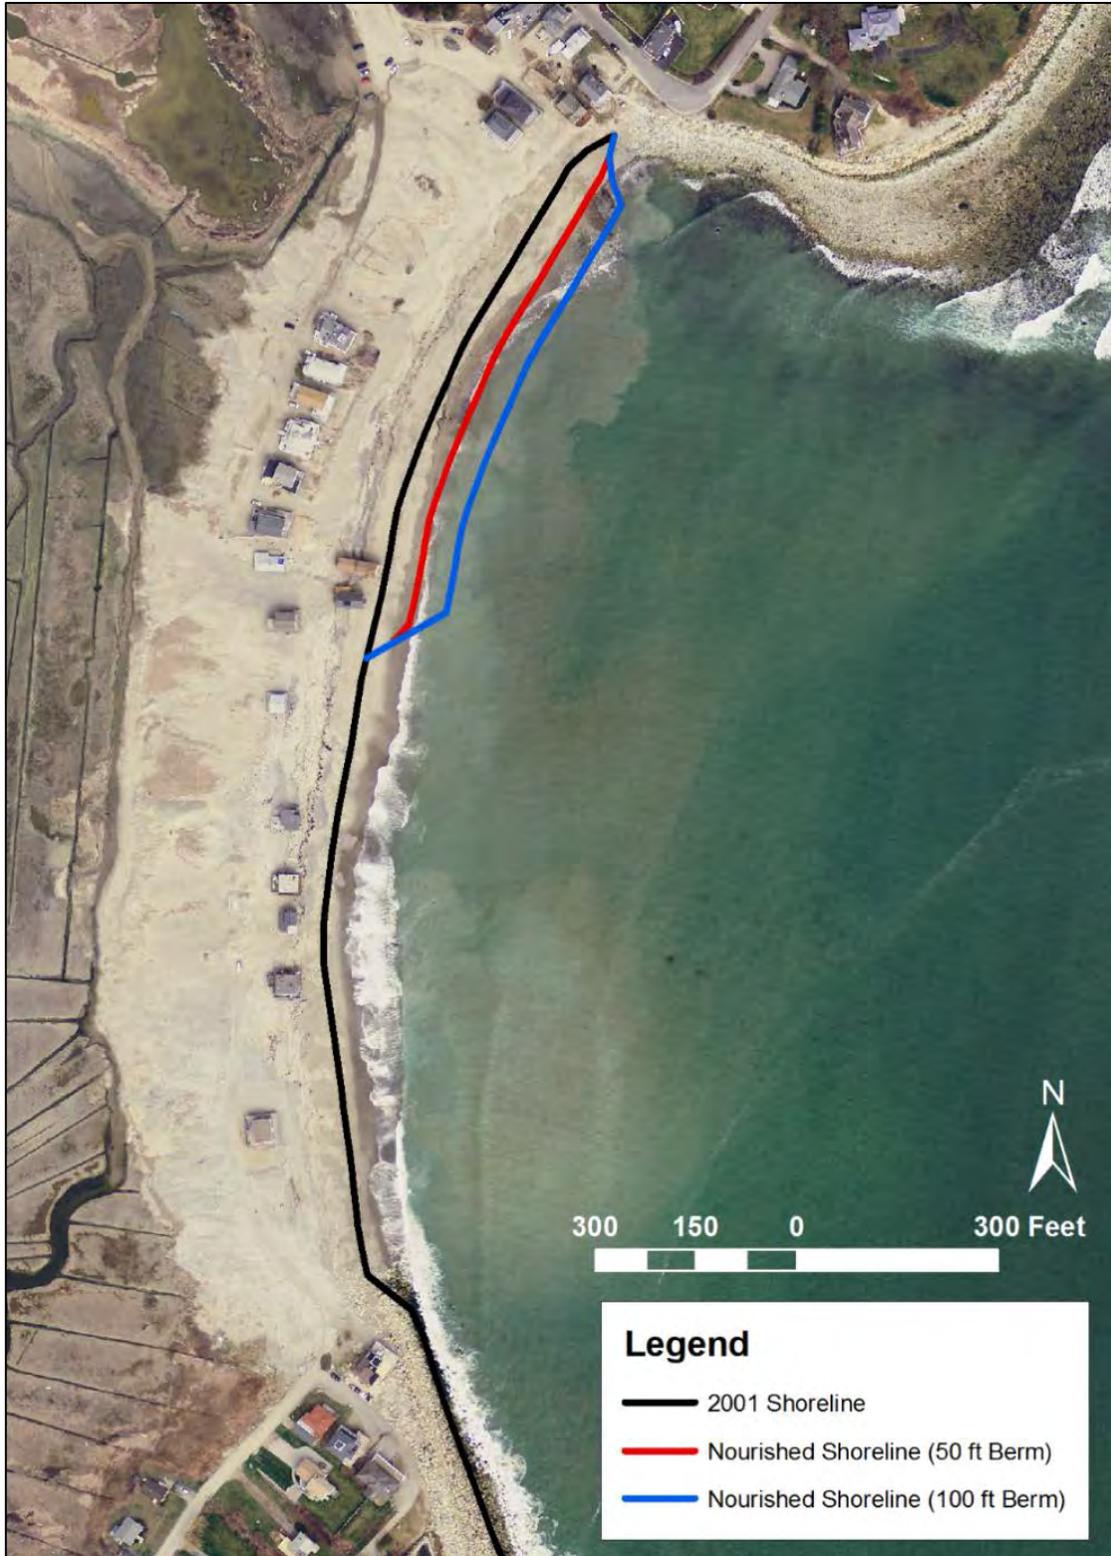
Figure 7.34 Two nourishment options for the northern area of Peggotty Beach.

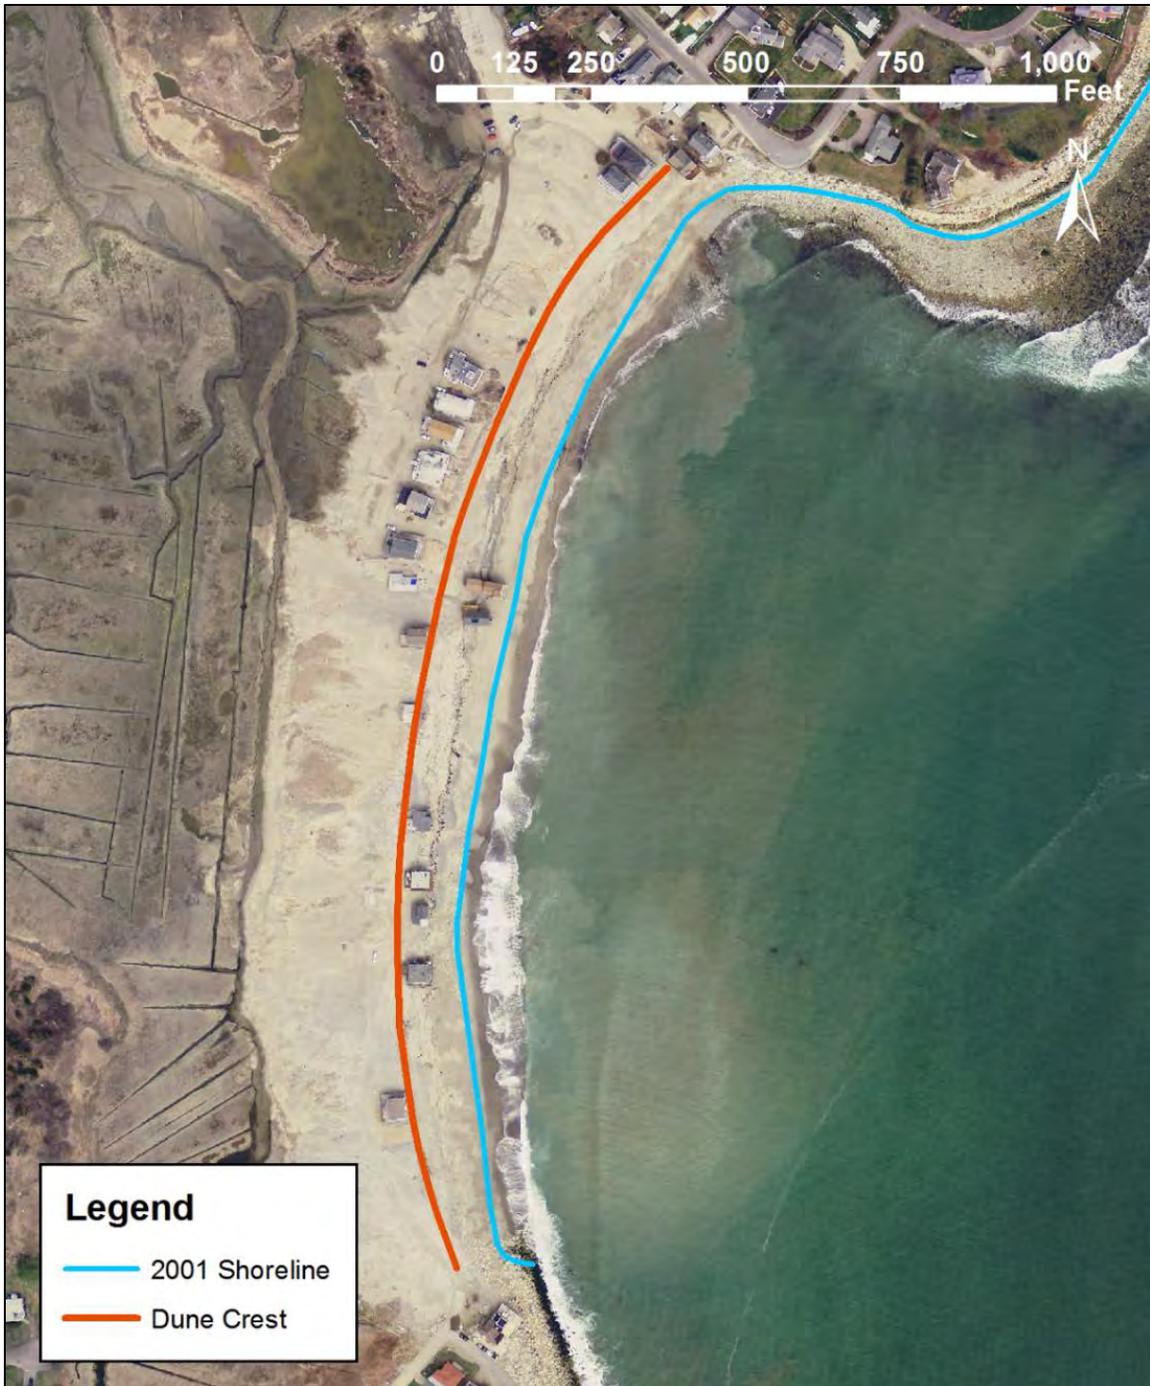
Figure 7.38 Location of the dune crest and high water shoreline along Peggotty Beach.

Figure 7.38 shows the location of the dune crest and high water shoreline along Peggotty Beach. Along the northern portion of the beach (780 feet), the seven homes are situated landward of the dune crest while along the southern portion (1,000 feet) the homes are generally location on or seaward of the dune crest. The susceptibility of storm damage is increased when homes are located on the seaward side of the dune. Historic FEMA repetitive loss claims spanning from 1978 to 2015 indicate that total value of claims for the homes along Town Way Extension (homes located seaward of the dune crest) was more than 40 times greater than those along Inner Harbor Road (homes located landward of the dune crest).

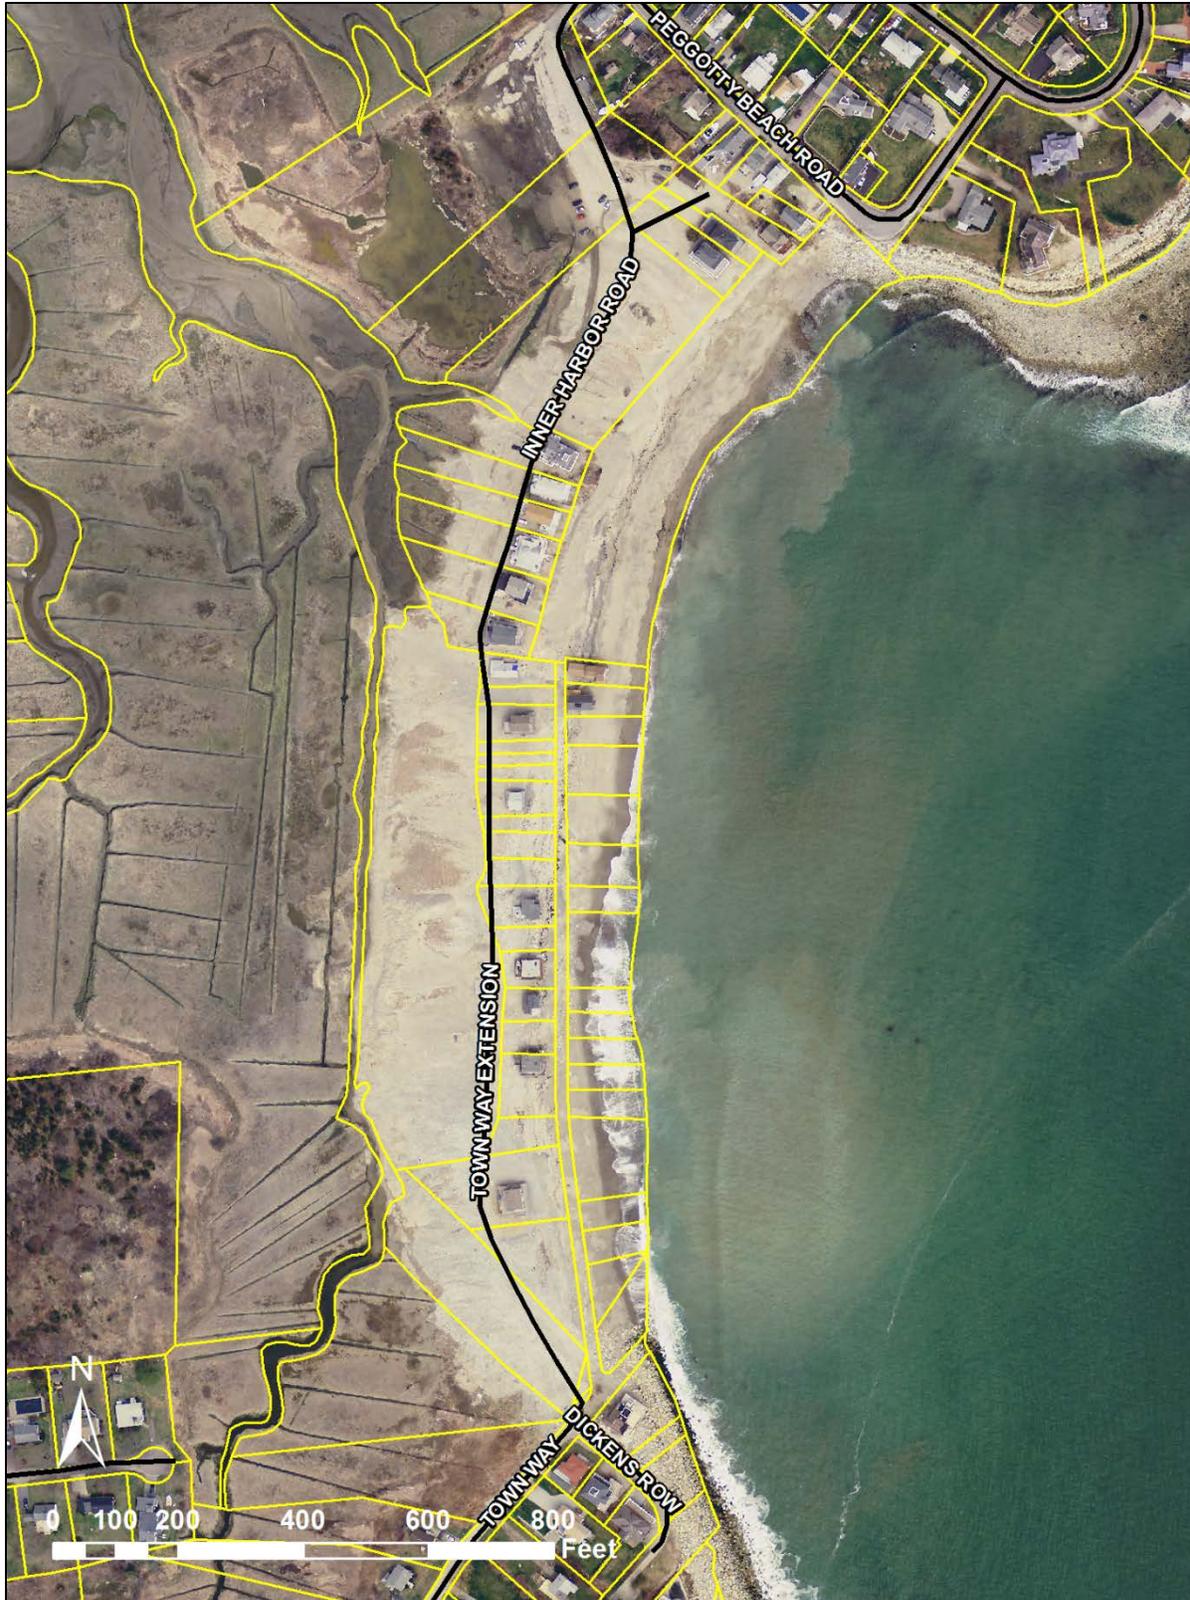
Figure 7.41 Properties along Inner Harbor Road and Town Way Extension on Peggotty Beach.

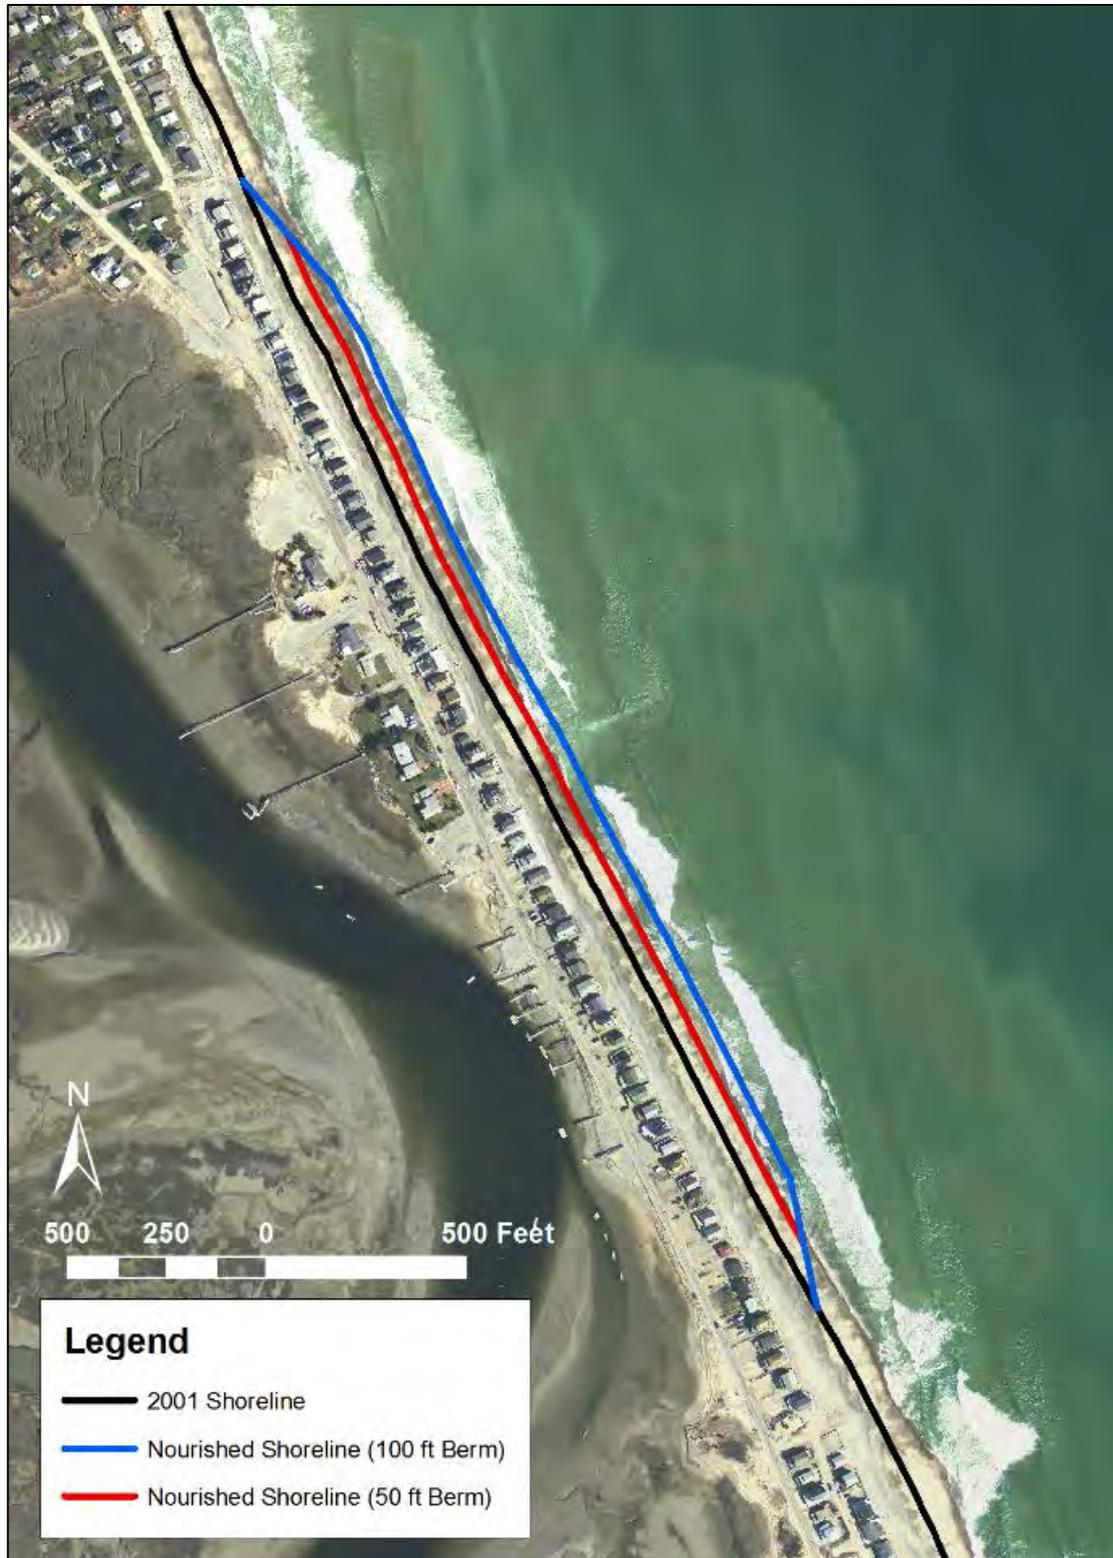
Figure 7.47 Two nourishment options for Humarock North extending from River Road to Seaview Avenue (“short-length” nourishment).

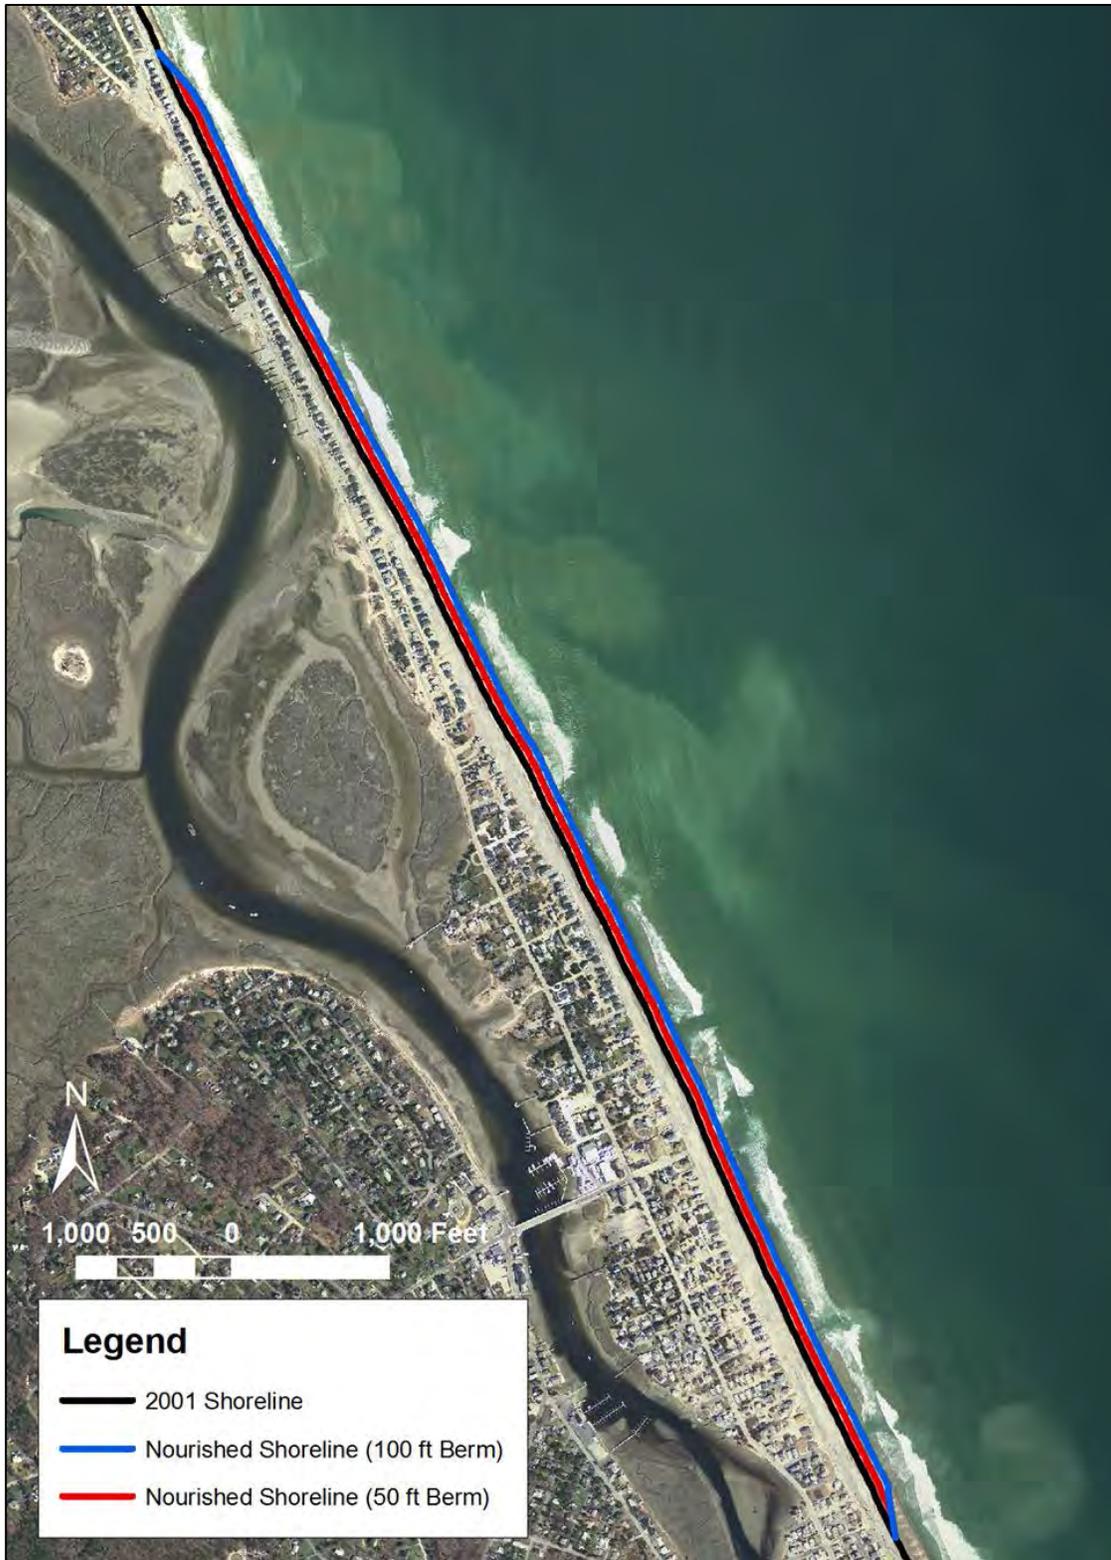
Figure 7.48 Two nourishment options for Humarock North and South extending from River Road to Julian Street (“long-length” nourishment).

Four options for beach nourishment were considered for Humarock Beach. For all options a berm elevation of 13 feet NAVD88 was selected by determining the 50-year runoff elevation along the beach. The required nourishment volume, footprint area, and construction costs are summarized in Table 7.31. Two options were considered wherein nourishment is placed along the most storm damaged and breach susceptible portion of Humarock North, from River Road to Seaview Avenue (“short-length” nourishment). Two additional options were considered that would span all of Humarock Beach, from River Road to Julian Street (“long-length” nourishment). Along each section, the beach berm was extended 50 and 100 feet from the existing high water shoreline. From the berm, the beach slopes seaward at a 1V:10H slope until it intersects with the ocean bottom. Extent of the nourishment options are shown in Figure 7.47 and Figure 7.48.
