APPENDIX D WETLANDS VEGETATION STUDY

Technical Memorandum

Re: **DEIR Appendix D – Wetlands Vegetation Study**
Reservoir Dam – NID# MA 000478
Reservoir Dam Water Storage and Fish Passage Improvement Project

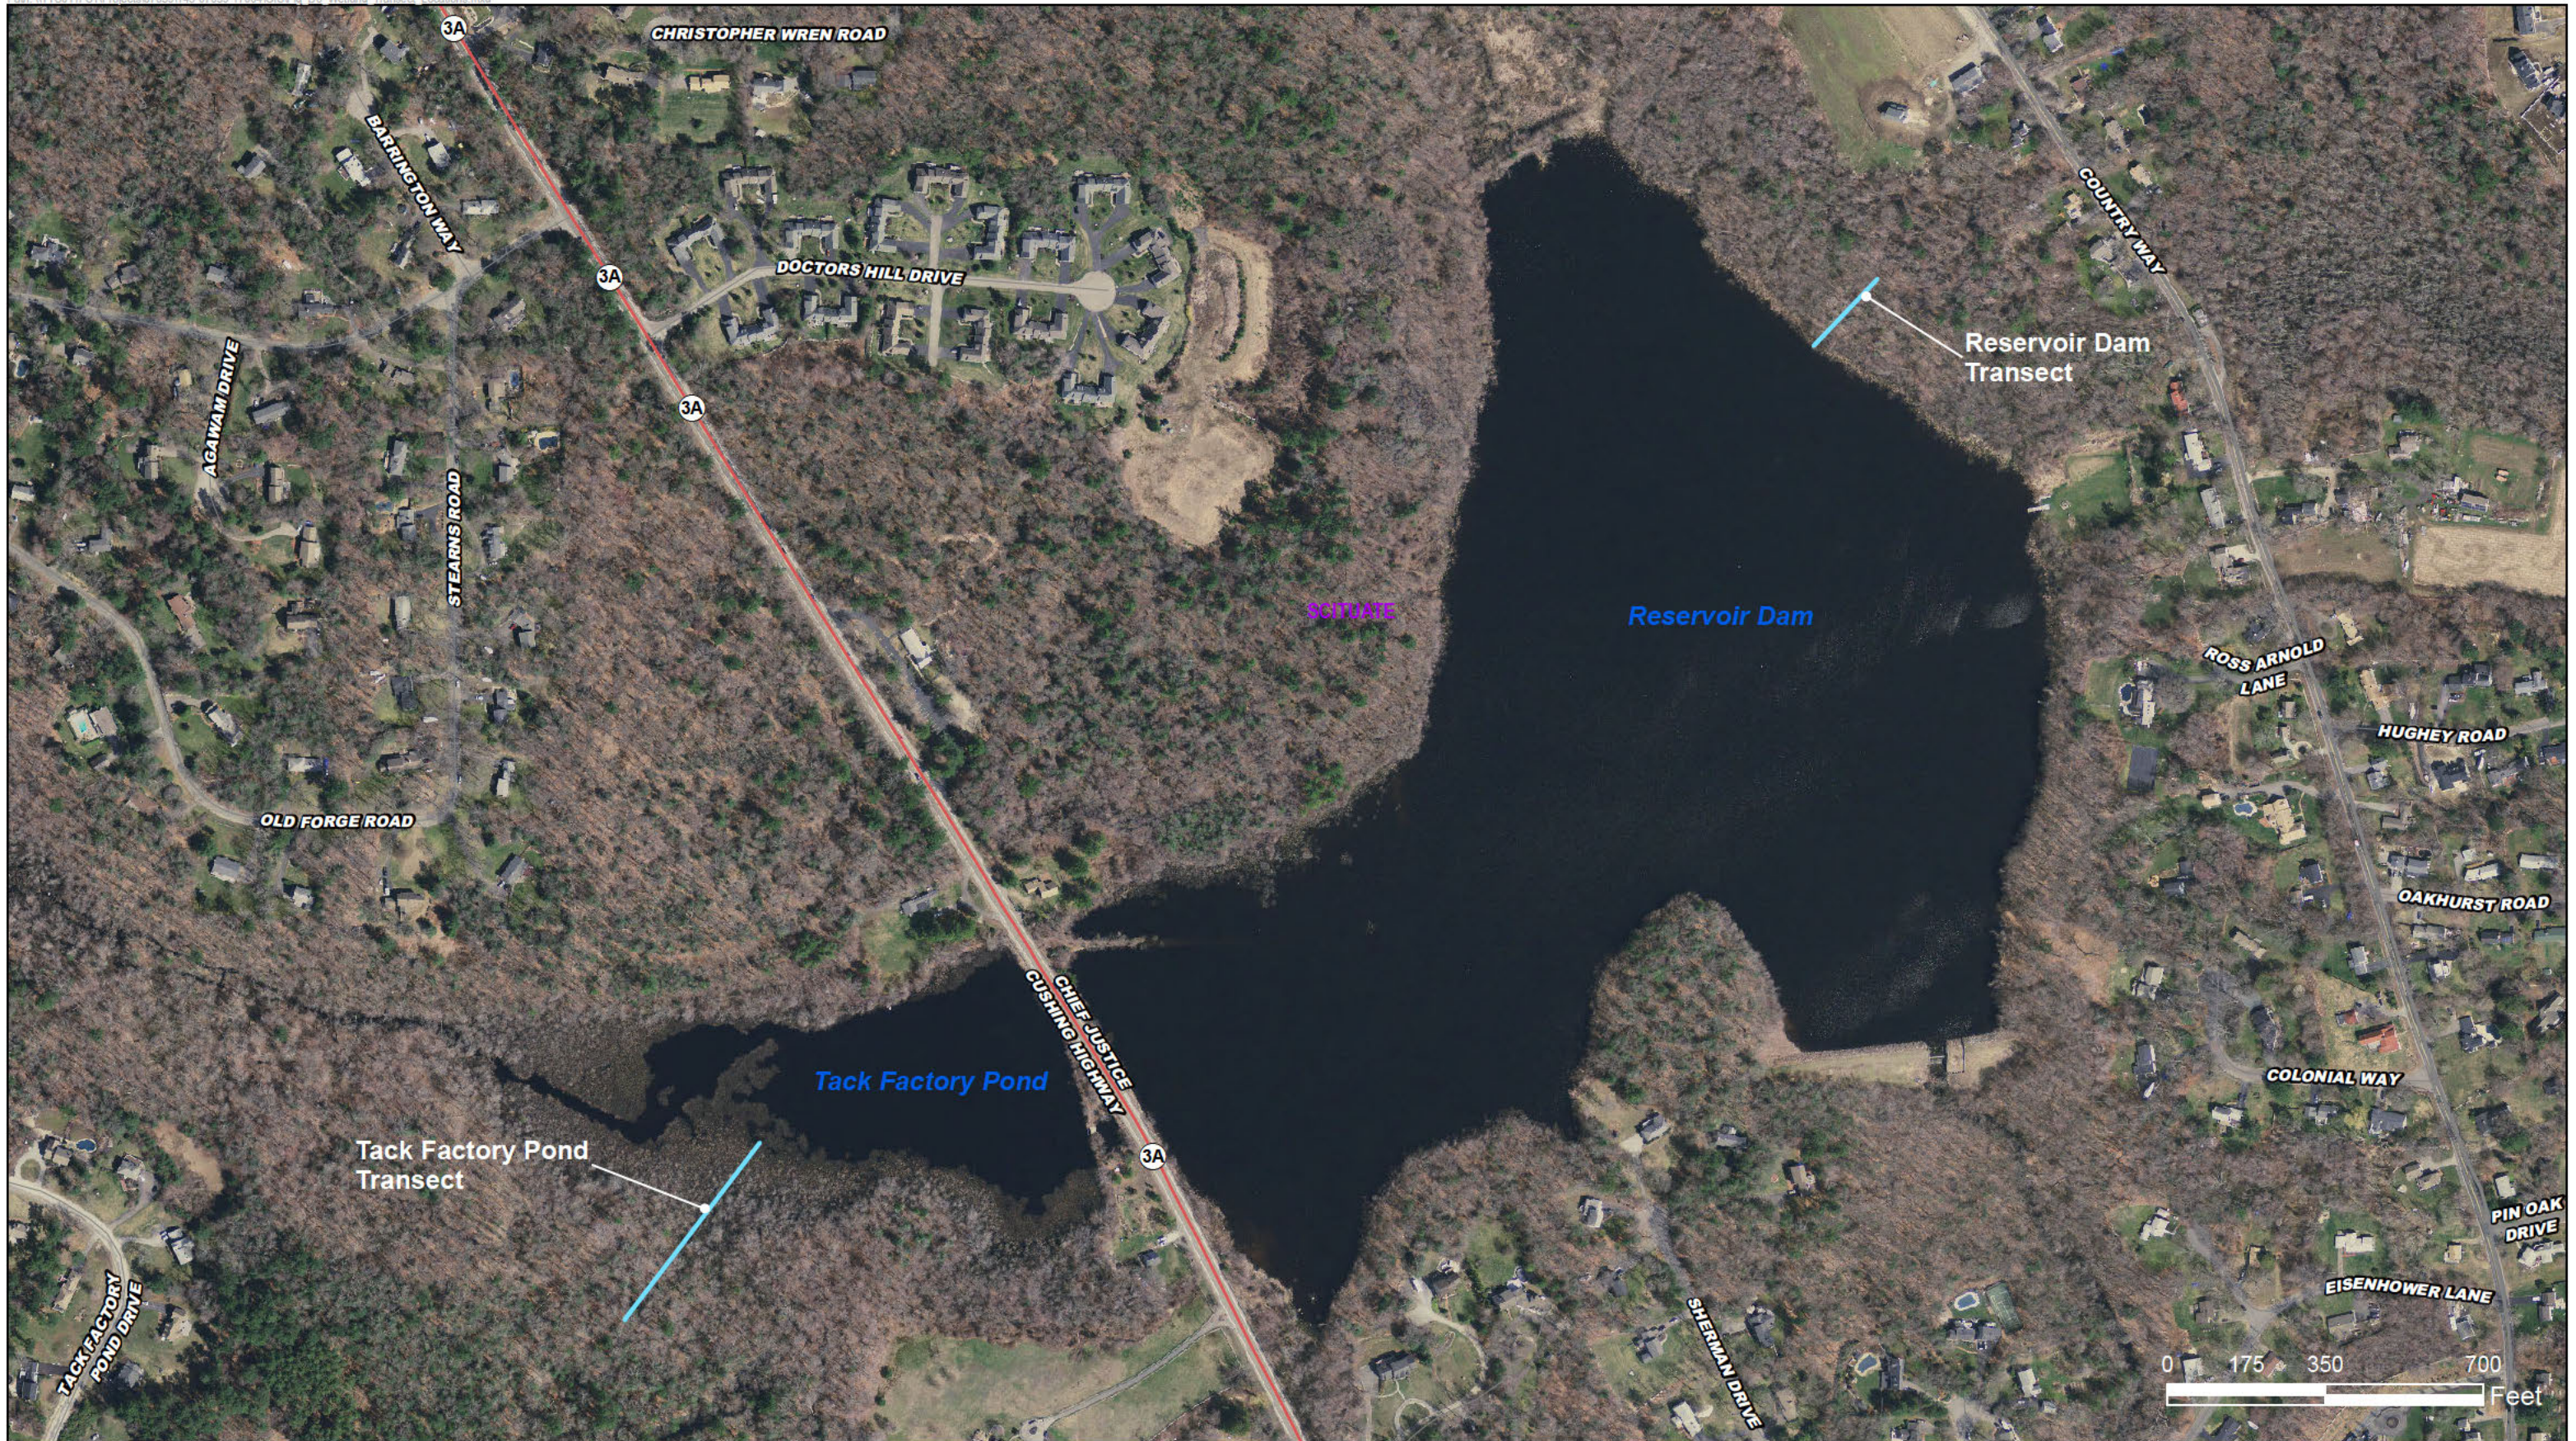
Figure D-5

- Transect Location
- Town Boundary (Survey)

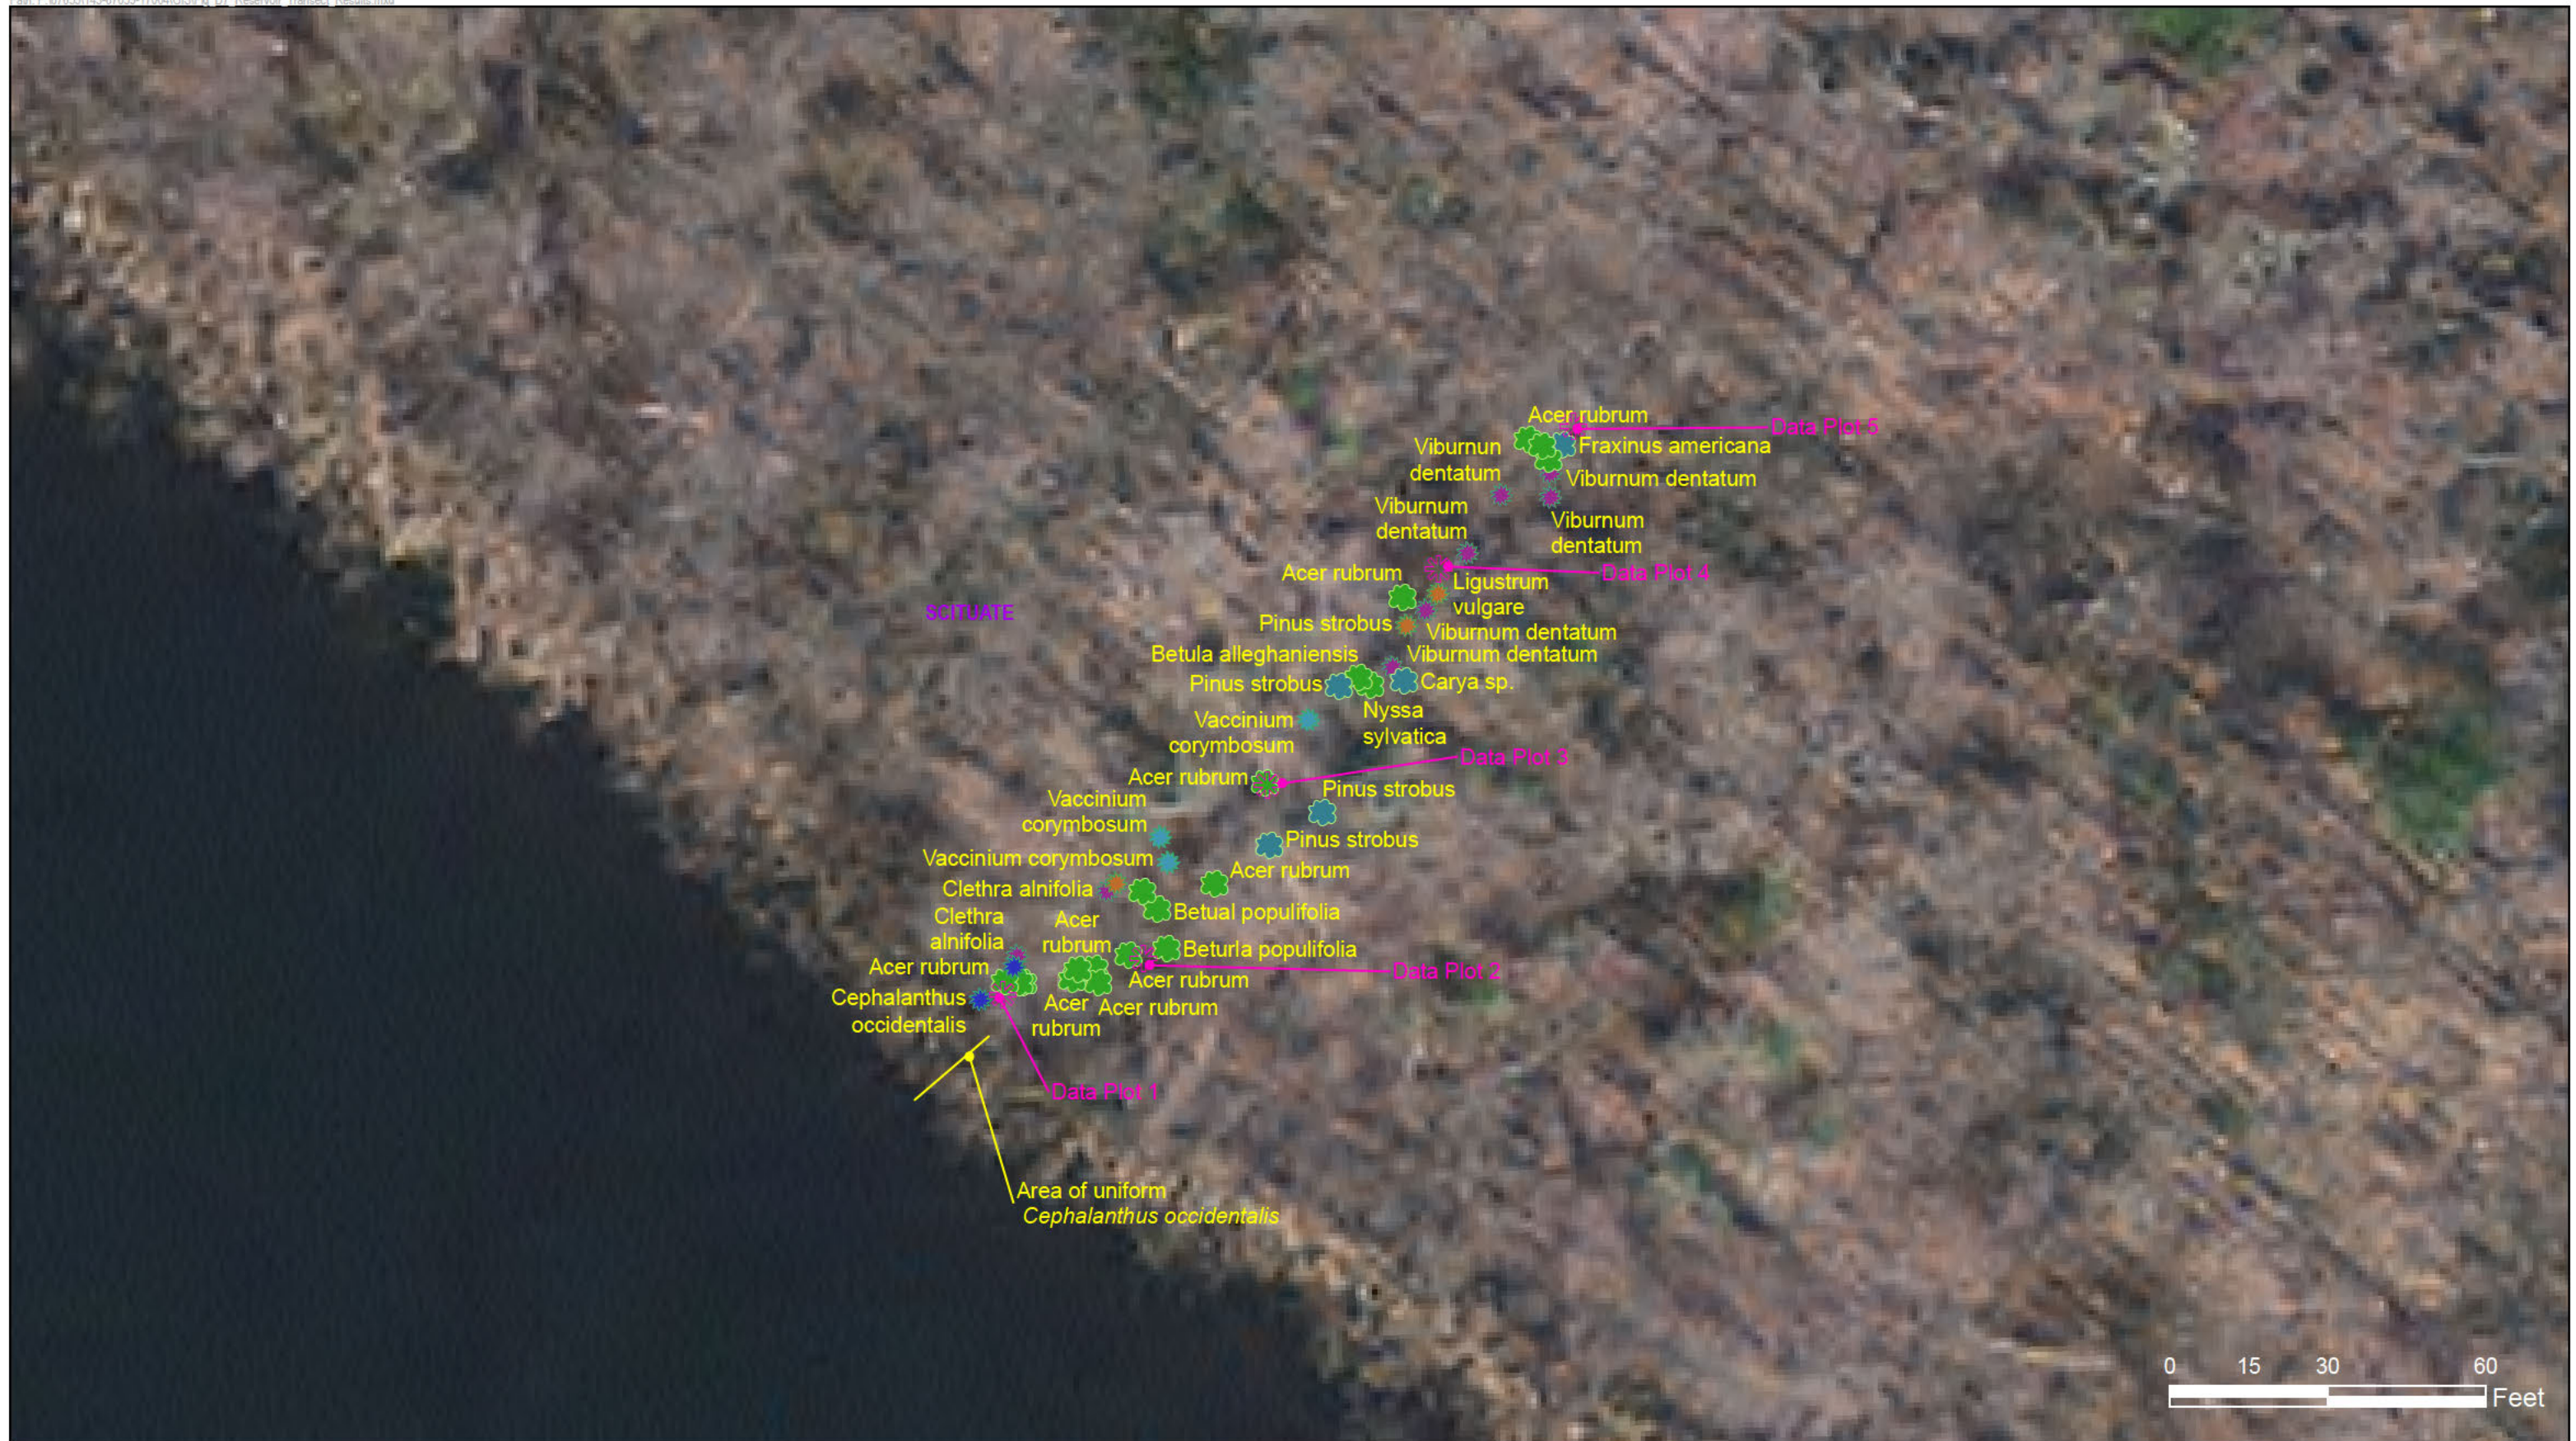
Figure D6

- Data Plots
- Shrub, FAC
- Tree, FACU
- Shrub, FACW
- Tree, FAC
- Shrub, FACU
- Shrub, OBL
- Town Boundary (Survey)

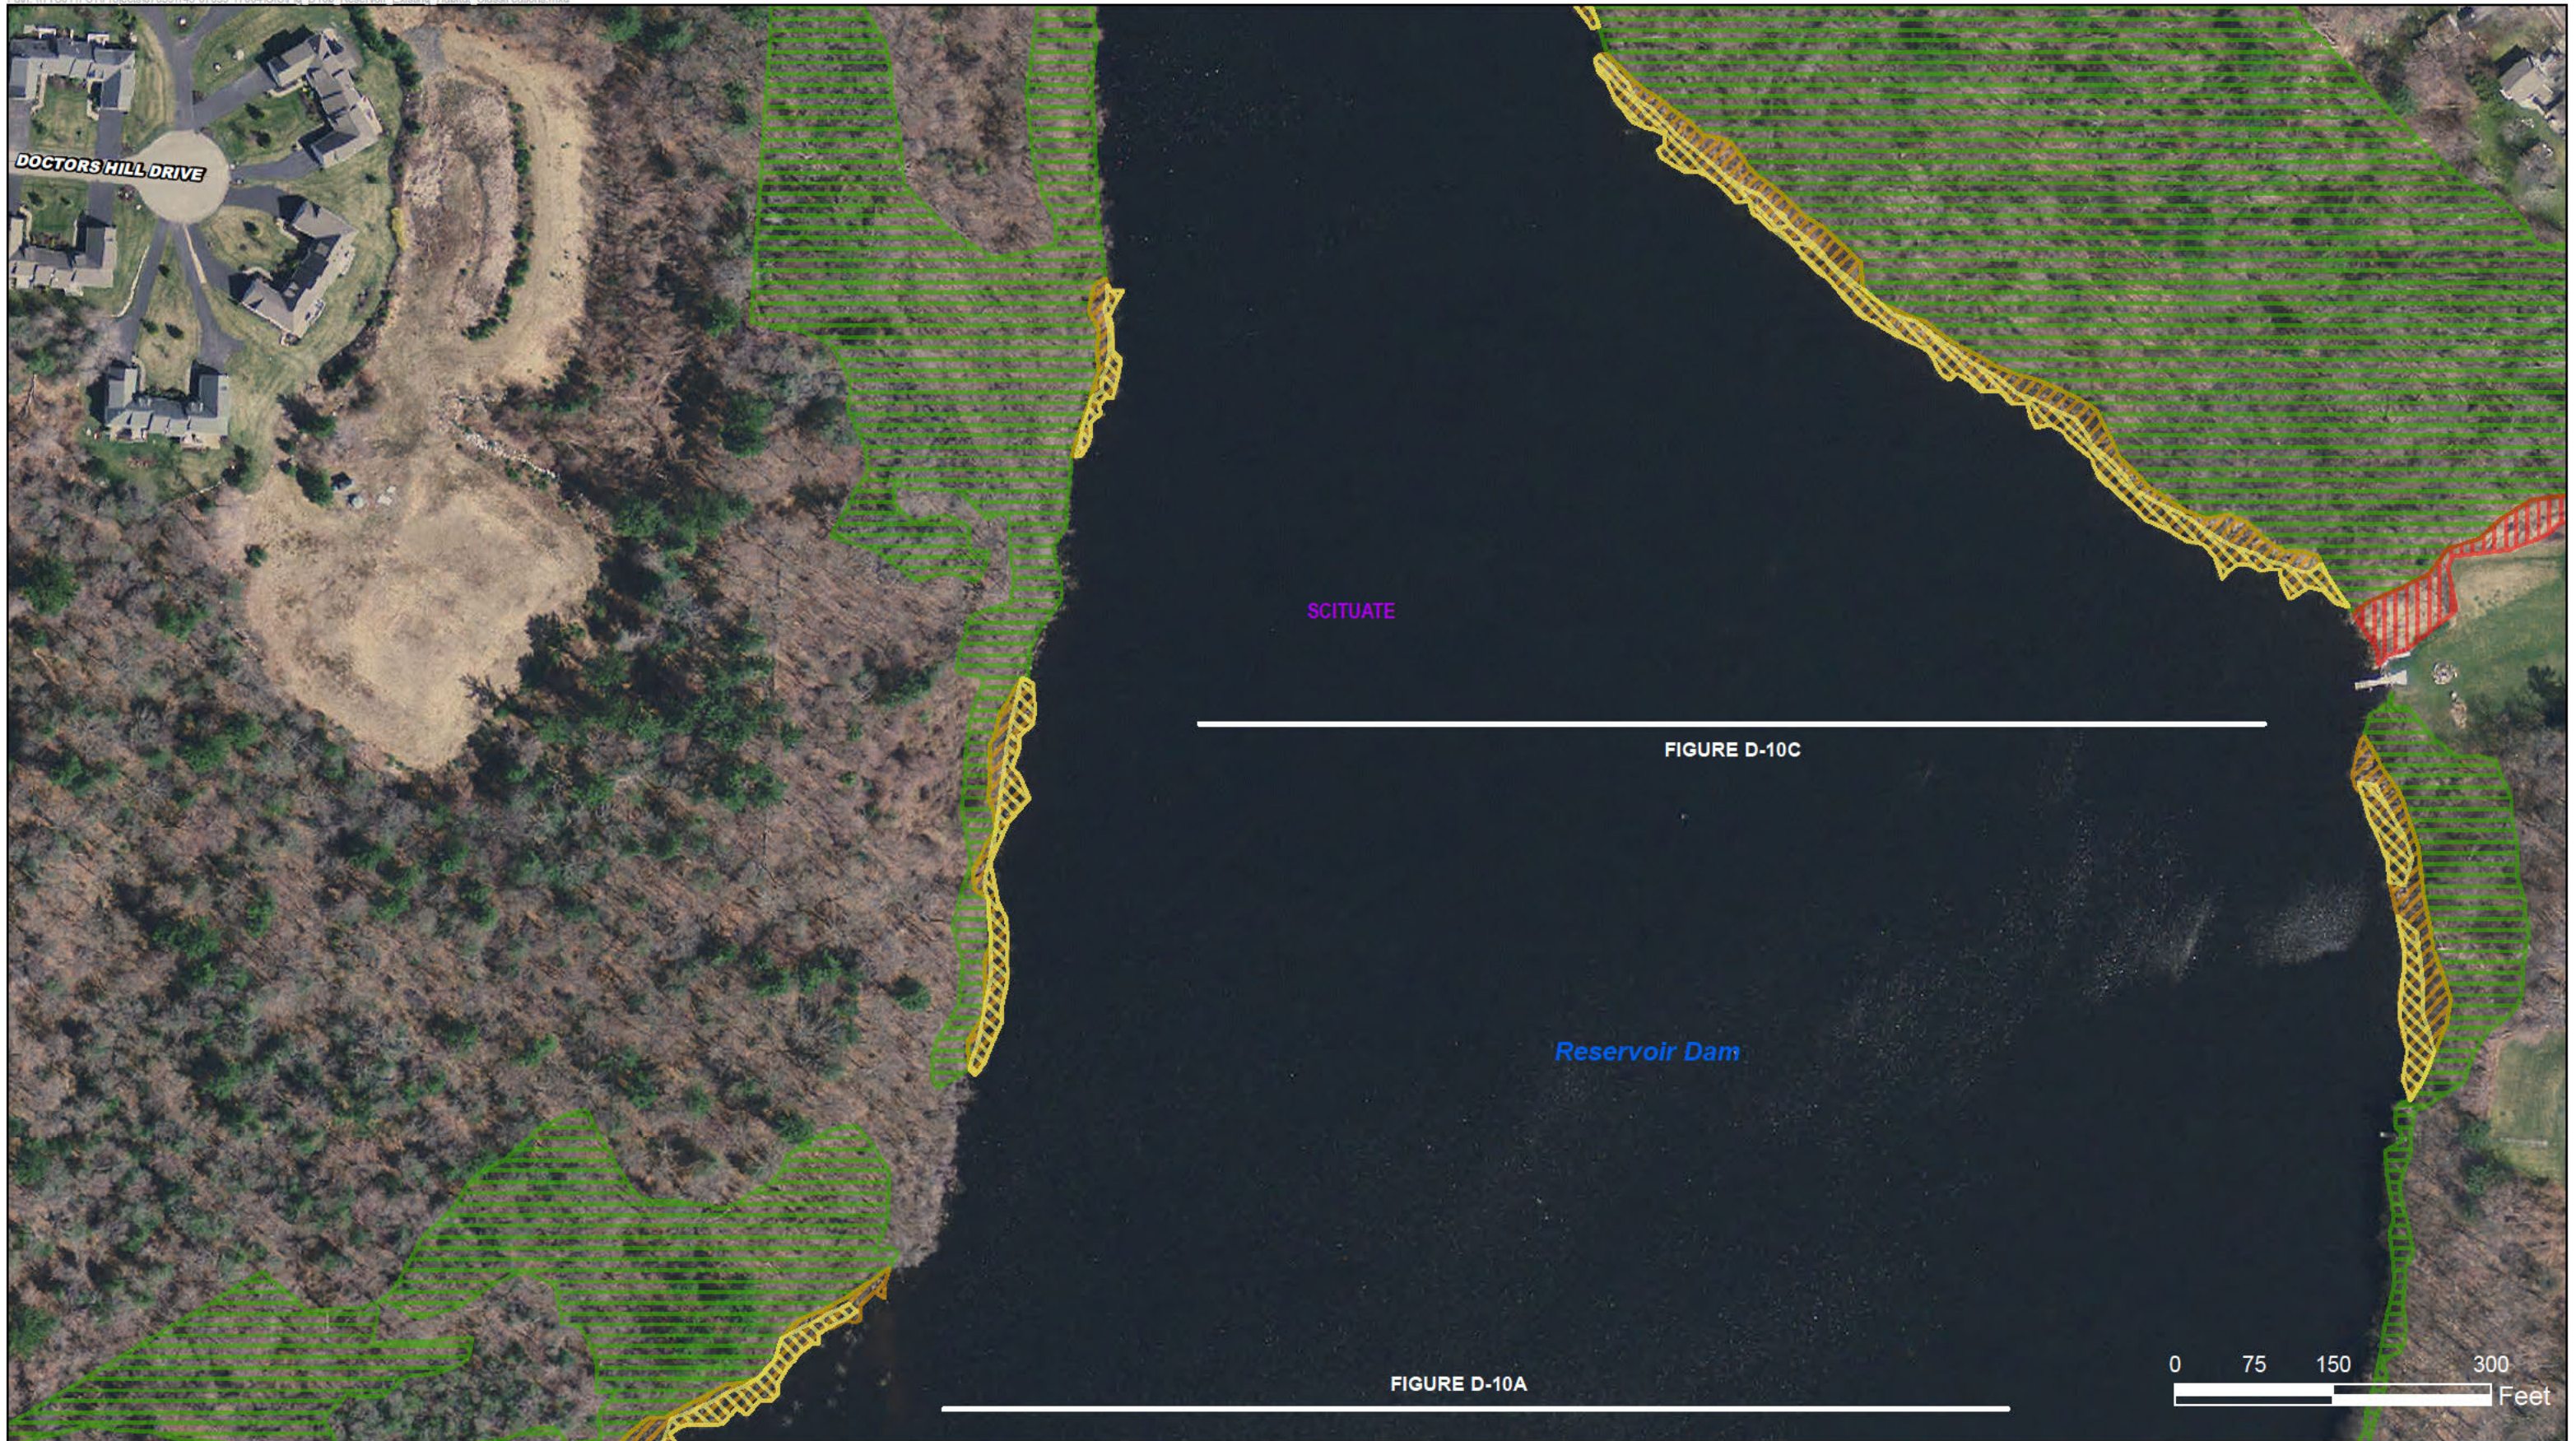
Date:	July 1, 2019
Project No.:	143-67639-17004
Designed By:	SK
Drawn By:	SK
Checked By:	KD
Figure D-10A

**RESERVOIR DAM
 EXISTING WETLAND HABITAT
 CLASSIFICATIONS**

Forested Wetland	Emergent Wetland
Scrub Shrub Wetland	Town Boundary (Survey)
Buttonbush (Subset of scrub shrub)

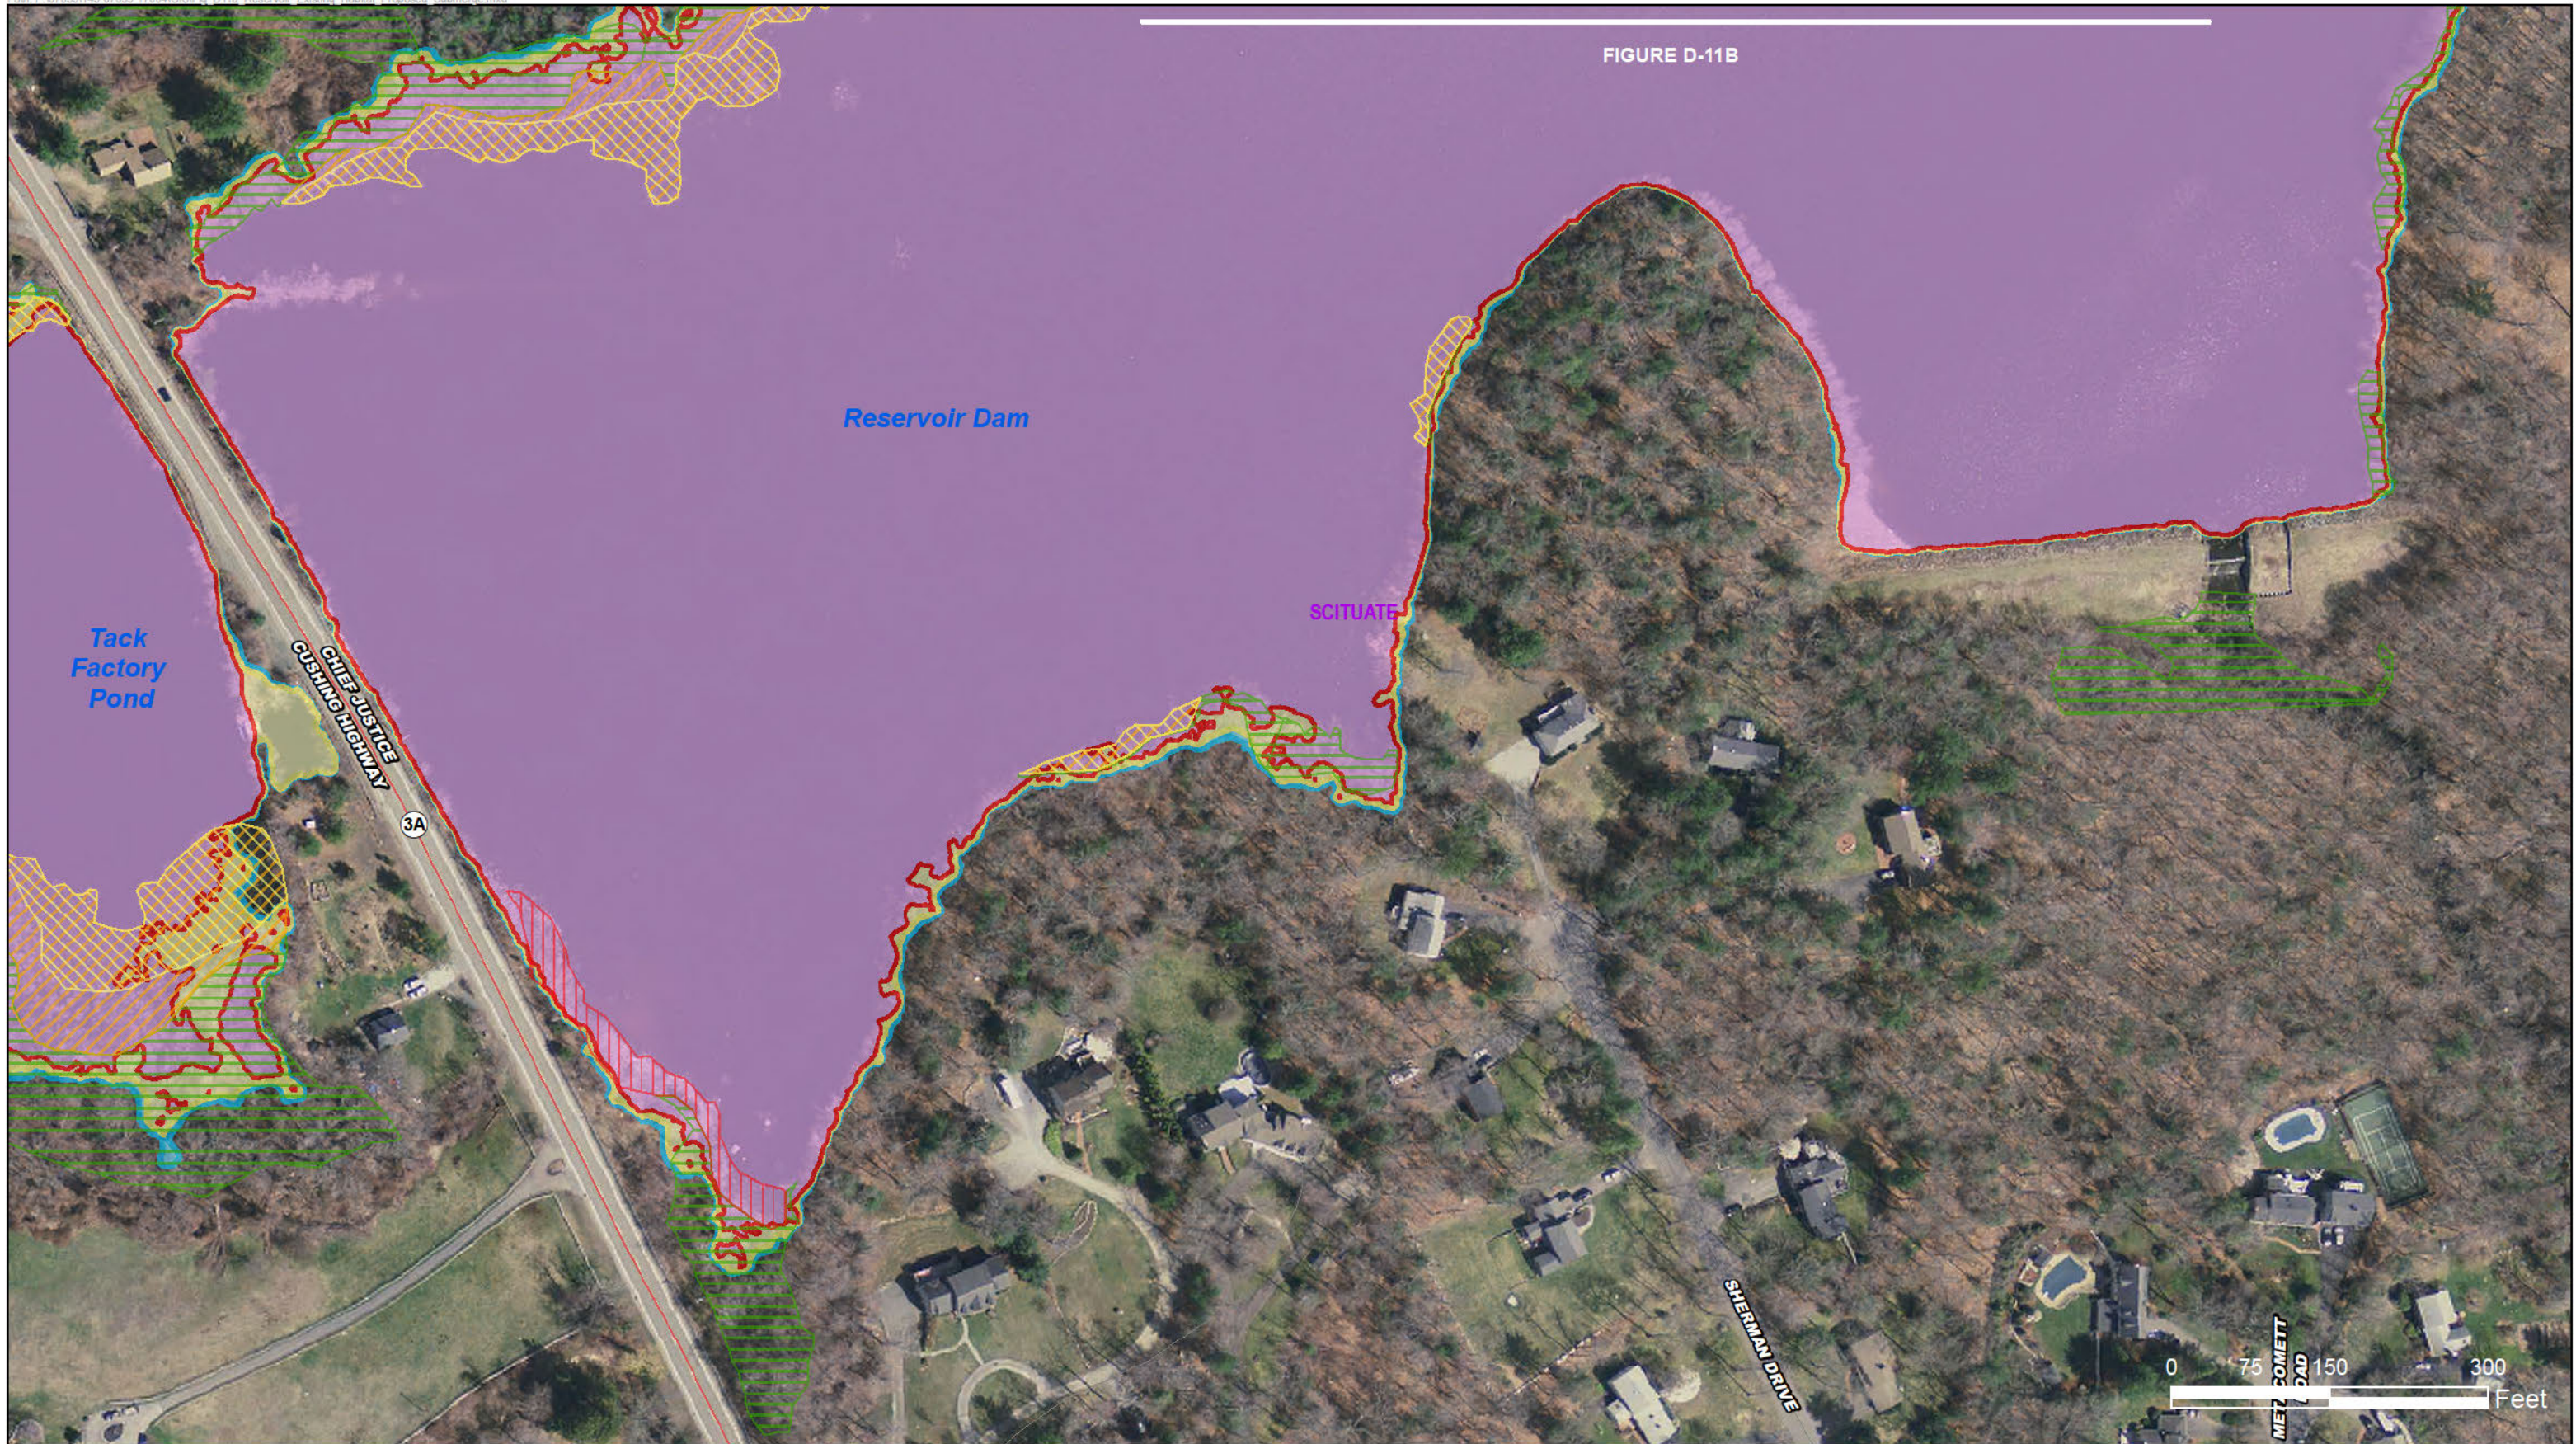
Date:	July 1, 2019
Project No.:	143-67639-17004
Designed By:	SK
Drawn By:	SK
Checked By:	KD
Figure D-10C

**RESERVOIR DAM
 EXISTING WETLAND HABITAT
 CLASSIFICATIONS**

Submergence Duration	Wetland Type
40.4	Forested Wetland
40.2	Scrub Shrub Wetland
40	Buttonbush (Subset of scrub shrub)
	Emergent Wetland
	Town Boundary (Survey)

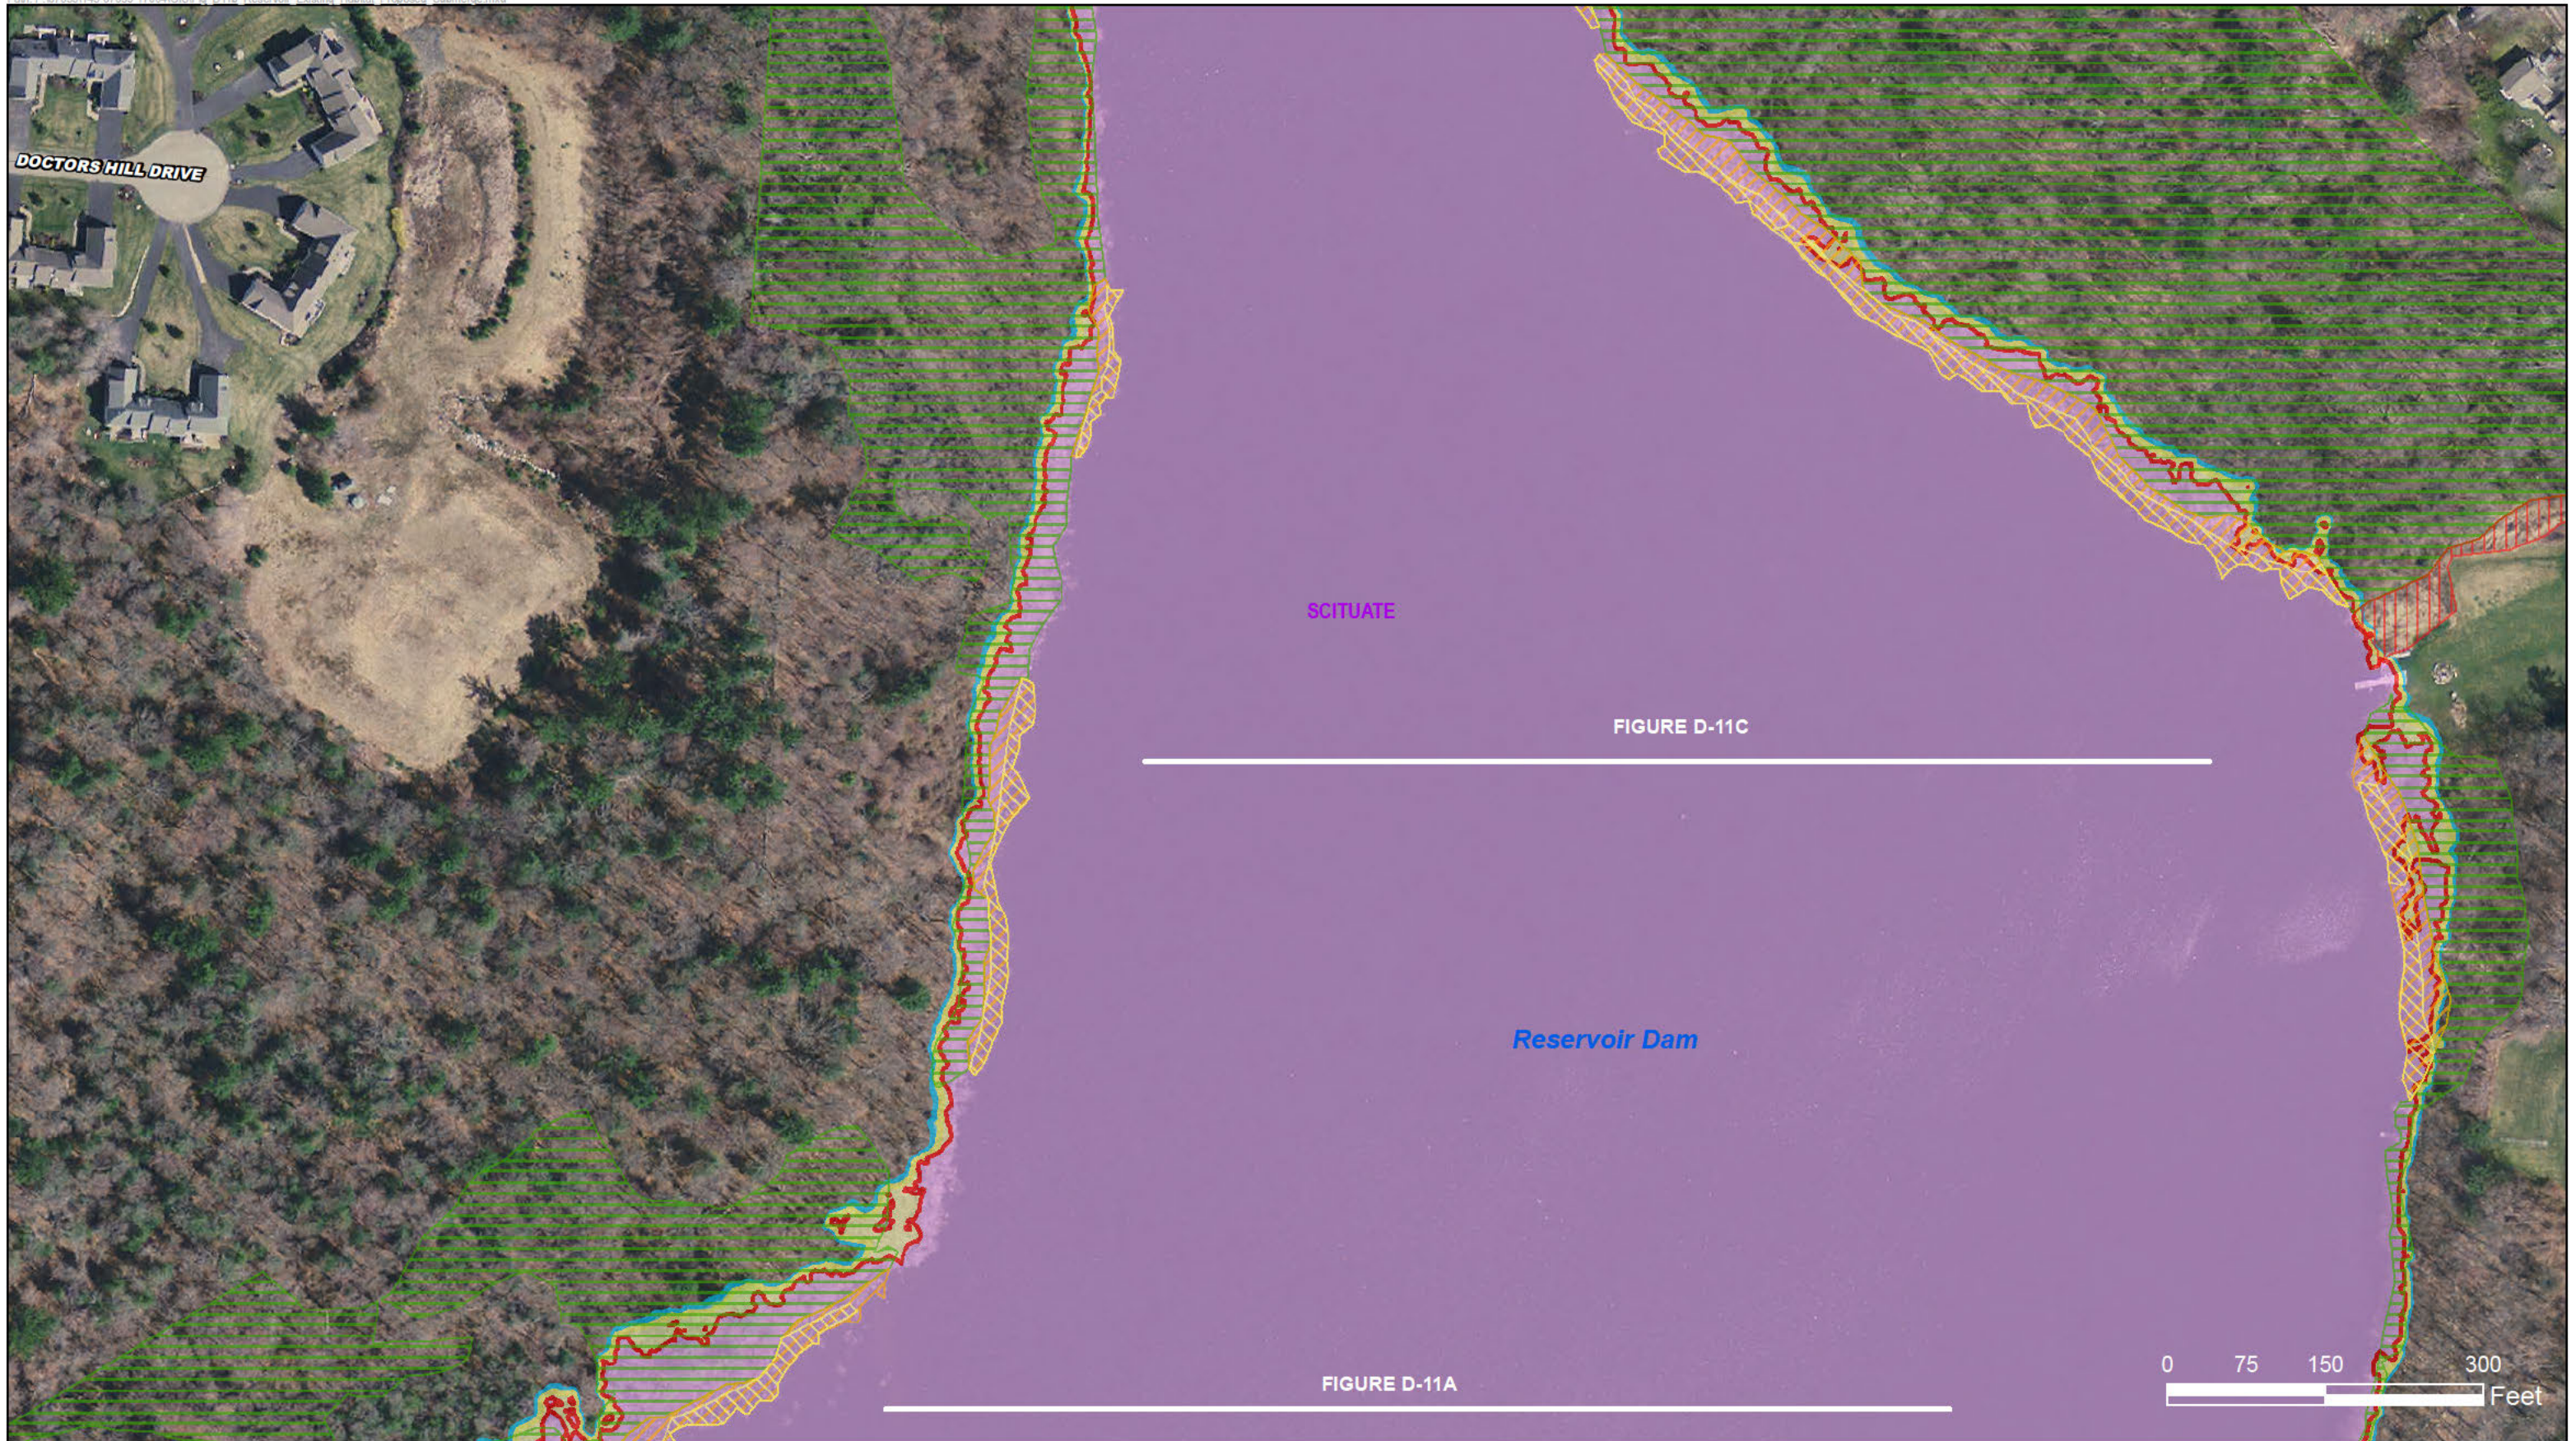
Figure D-11A

40.4	Forested Wetland
40.2	Scub Shrub Wetland
40	Buttonbush (Subset of scrub shrub)
	Emergent Wetland
	Town Boundary (Survey)

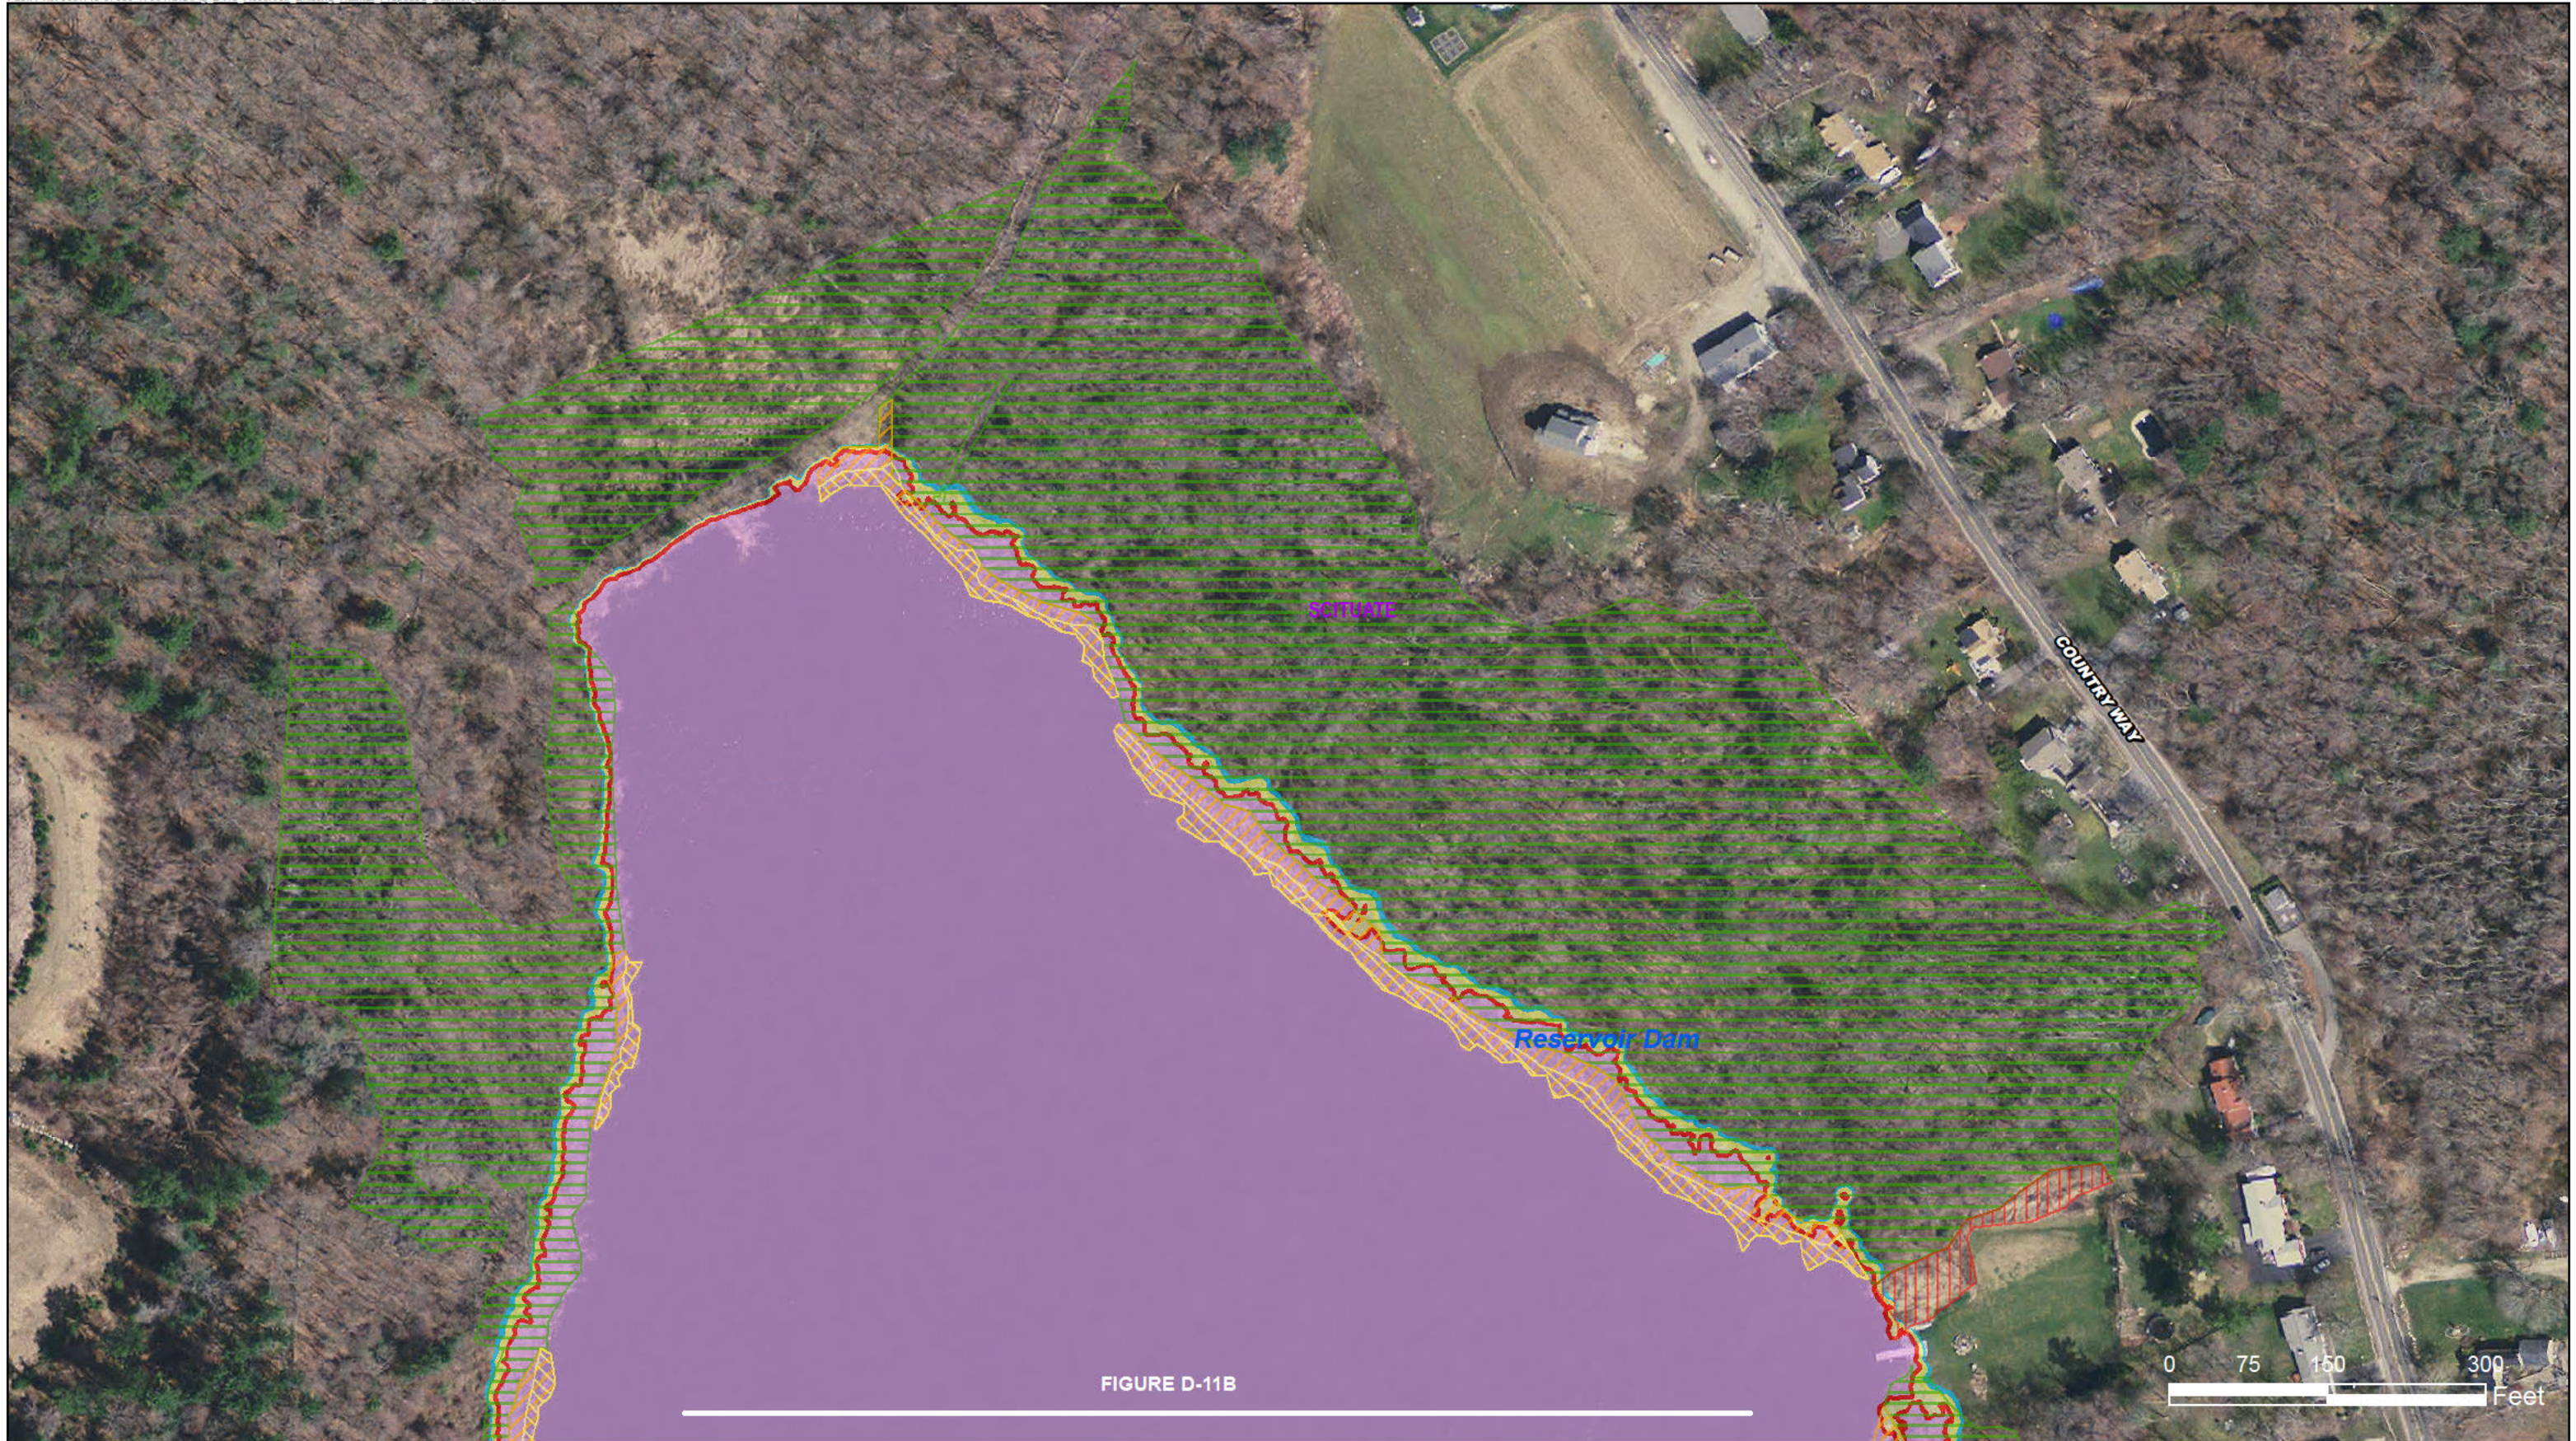
Figure D-11B

Legend	
Submergence Duration	Forested Wetland
40.4	Scub Shrub Wetland
40.2	Buttonbush (Subset of scrub shrub)
40	Emergent Wetland
	Town Boundary (Survey)
