**Bailey-Ellis House Windows, Tower and Door Restoration
and Preservation Projects**
709 Country Way, Scituate, Massachusetts

Prepared by Scituate Arts Association, Inc.
Janet Cornacchio, President,
Robin Glazier, Clerk,
July, 2022

CONDITIONS ASSESSMENT and PRESERVATION PLAN
for the BAILEY-ELLIS HOUSE
709 Country Way, Scituate, Massachusetts

Prepared by Wendy Frontiero,
Architect and Preservation Consultant
October 2011

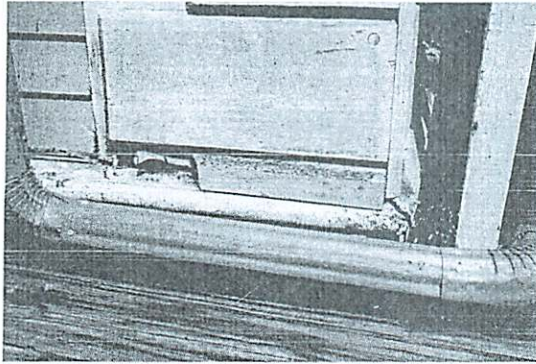
19. Main (southwest) façade, corner of entrance porch and front cross gable – Horizontal run of downspout along deck; deterioration of wood trim

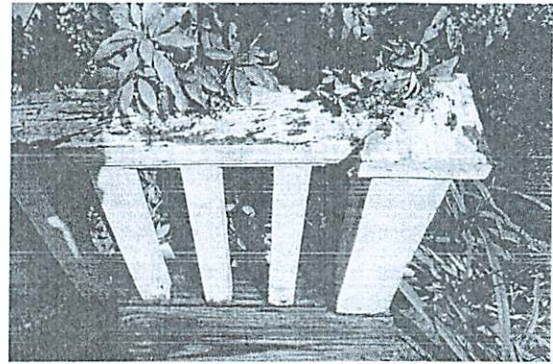
20. Southeast façade – Main entrance: shrub growing too close to building and railing; paint failure and deterioration of wood trim

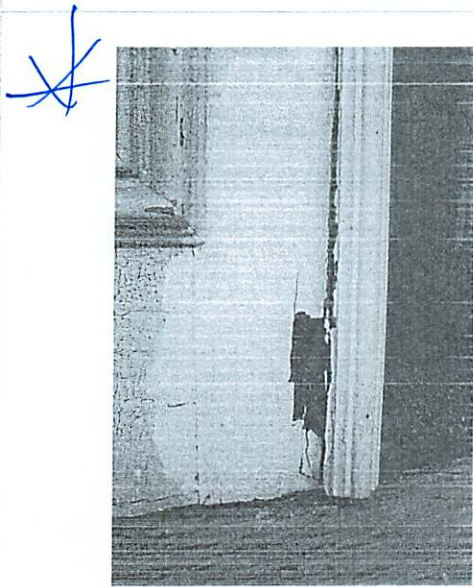
The double-leaf, *main entrance doors* exhibit decay at the base; a loose parting strip; missing trim at the glazed panels; plastic glazing replacing the original glass; and severe alligating of paint. (see photos 21-22) The front (southwest) door to the shed has minor deterioration at the base of its door trim.

21. Main (southwest) façade - Main entrance door: deteriorated stile

15. Repair *main entrance door*, including replacement of existing plastic panels with salvaged and/or reproduced historic glass panes or historically appropriate new glass. *Weather-strip all exterior doors.*

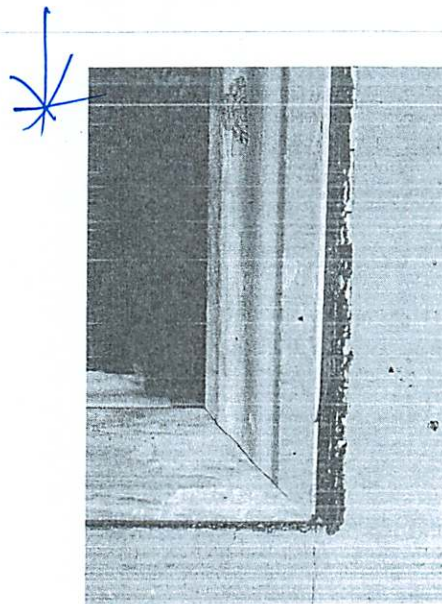
22. Main (southwest) façade - Main entrance door: missing trim

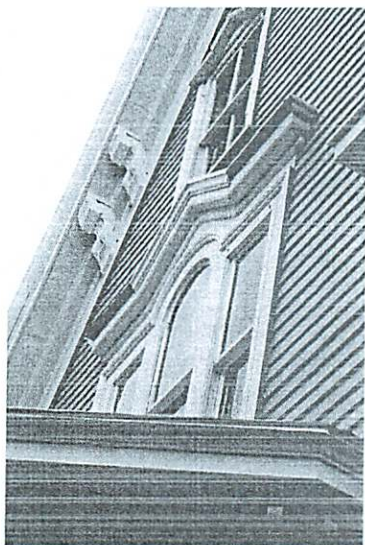
Window and door trim is in generally good condition. Isolated instances of *missing trim* were observed, most prominently at the cornice on cornice trim on the tripartite window grouping on the cross-gable at the back of the Main House. (see photo 43) The *triangular dormer window sills* on the front (southwest) façade appear worn and weathered.

43. Northeast façade, back cross gable - Missing cornice trim on tri-partite window at chamber above back parlor

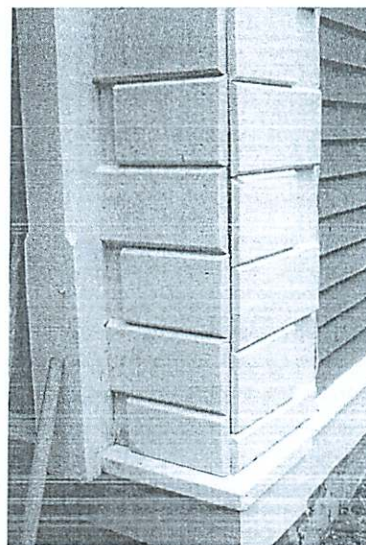
44. North corner of Main House – Separation of quoin boards; missing porch floor

17. Consider replacing the missing floor of the back porch, behind the music room, to provide a more finished appearance. (This porch was once part of a larger, balustraded deck that wrapped around the north end of the Main House.)

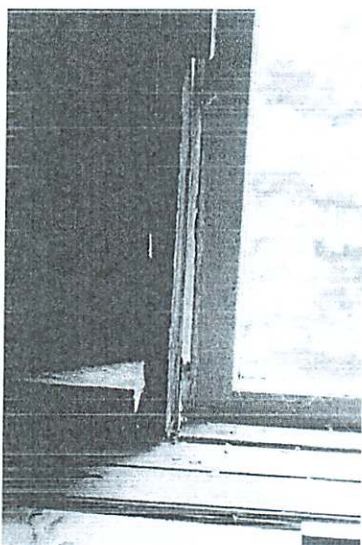
Three examples of insufficient *trimming-out of wall openings* were observed: at the attic window in the cross-gable on the back (northeast) of the Main House, at the northwest attic window on the End Building Addition, and at the back (northeast) door of the shed addition, leaving significant gaps in the building envelope. (see photos 45-46) Consequences include air, water, and animal infiltration.

45. Northeast façade - Attic window above back parlor: missing trim/casing

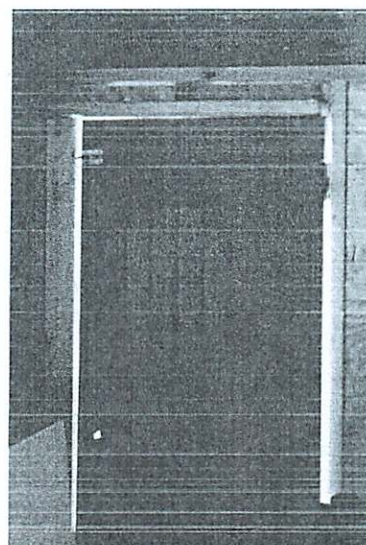
46. Northeast façade - Back door of shed: Missing trim/casing

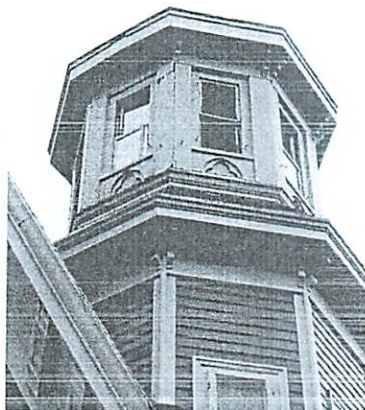
Extensive paint failure is found on the tower, the underside of the roofs of the back porch (behind the music room) and dining room, and at the raking trim on the southeast gable end of the End Building Addition. (see photo 47)

The architectural integrity of tower is compromised by separating and decaying trim (mullion boards between windows, corner boards, window trim, soffits, and eaves); broken panes of glass; and deteriorated window sash. Close inspection is needed to better assess the extent of deterioration. (see photos 47-50)

47. Northeast façade - Tower

10. *Carefully investigate existing conditions of the tower*; stabilize and/or restore. Retain as much existing material as possible; match historic elements in kind. Provide temporary plywood coverings for windows if necessary before full restoration can be undertaken.

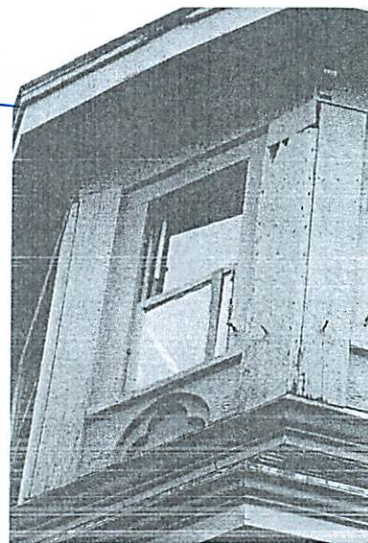
48. Northeast façade - Tower detail: broken glass; deteriorated wood trim

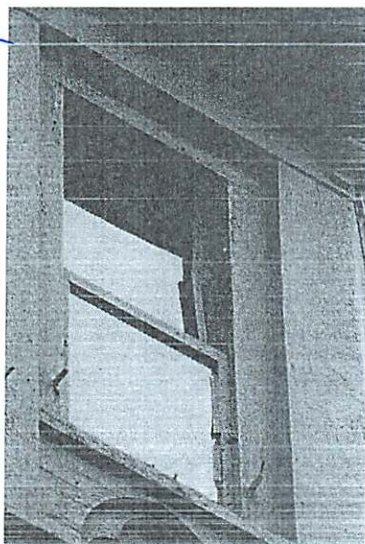
49. Northeast façade - Tower detail:
Deteriorated wood trim

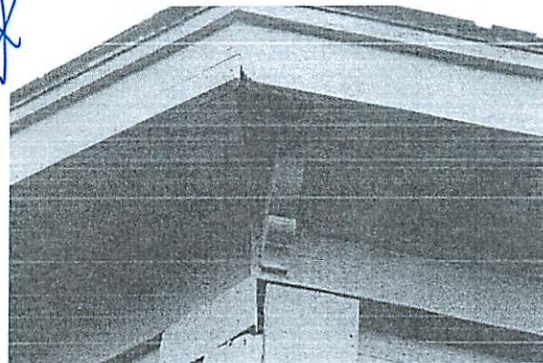
50. Northeast façade - Tower detail:
Deteriorated wood trim and soffit

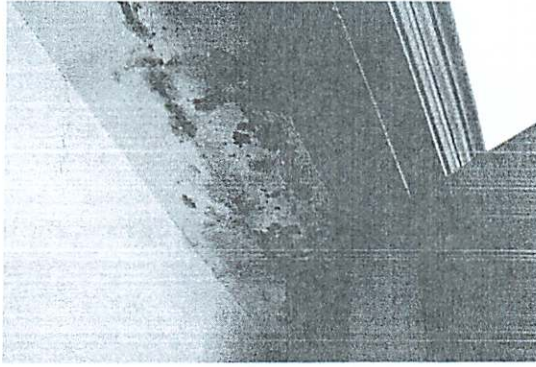
56. Main House – Chamber above front parlor: water damage in closet ceiling

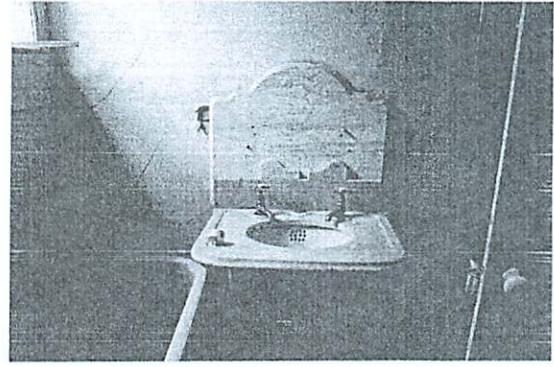
Significant instances of plaster damage—with long, wide, deep, and diagonal cracks—were observed in the following areas: the pantry vestibule adjacent to the dining room; the 1st floor bathroom; the 2nd floor bathroom in the Main House; the former kitchen in the Middle Addition; and the western closet in the chamber over the front parlor. (see photo 57)

57. Main House - 2nd floor bathroom: deteriorated plaster and marble sink

2. *Repair major plaster cracks* in the walls and ceilings of the pantry area in the Middle Addition and in the 2nd floor bathroom in the Main House. At a minimum, these areas should be monitored for ongoing activity.
Cause for concern; Low to moderate cost; Moderate to high preservation sensitivity.

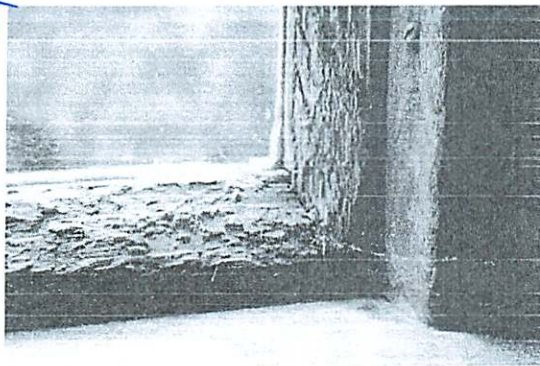
Windows are also typically intact and in good condition. *Window sills* on the northwest and southwest facades of the Main House are often weathered, along with miscellaneous window sash (usually the bottom rail of the lower sash) on the End Building Addition. Deteriorated glazing putty is especially noticeable at the tripartite window grouping in the chamber over the front parlor. Isolated but extreme examples of deteriorated window sash were observed in the back pantry and in the second floor of the tower, where large chunks of wood sash frames have reportedly been chewed away by animals. (see photo 58)

58. Main House – 2nd floor of Tower: damaged window sash

13. Conduct a detailed window inventory of all sash in the building, noting the condition of sills, trim, sash frames, glass panes, muntins and putty, and operating hardware (locks and sash cords). Continue ongoing program to replace all *cracked/broken glass* in windows with old glass; re-putty *muntins* as necessary, consider adding interlocking metal *weather-stripping* to operable sash.

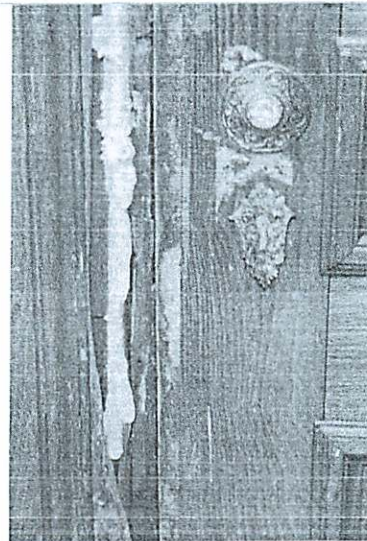
59. Dining room - Door between dining room and front porch: damaged trim
