SPRING 2024 NORTH SCITUATE BEACH NOURISHMENT

Project Details:

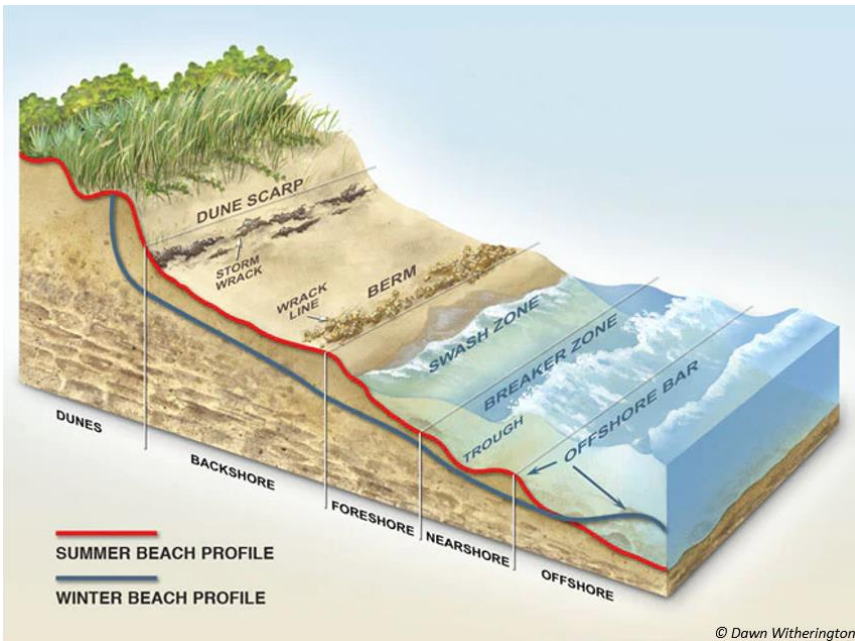
Figure 1: Cross-section of a typical sandy beach showing the summer (red line) and winter (blue line) profiles.

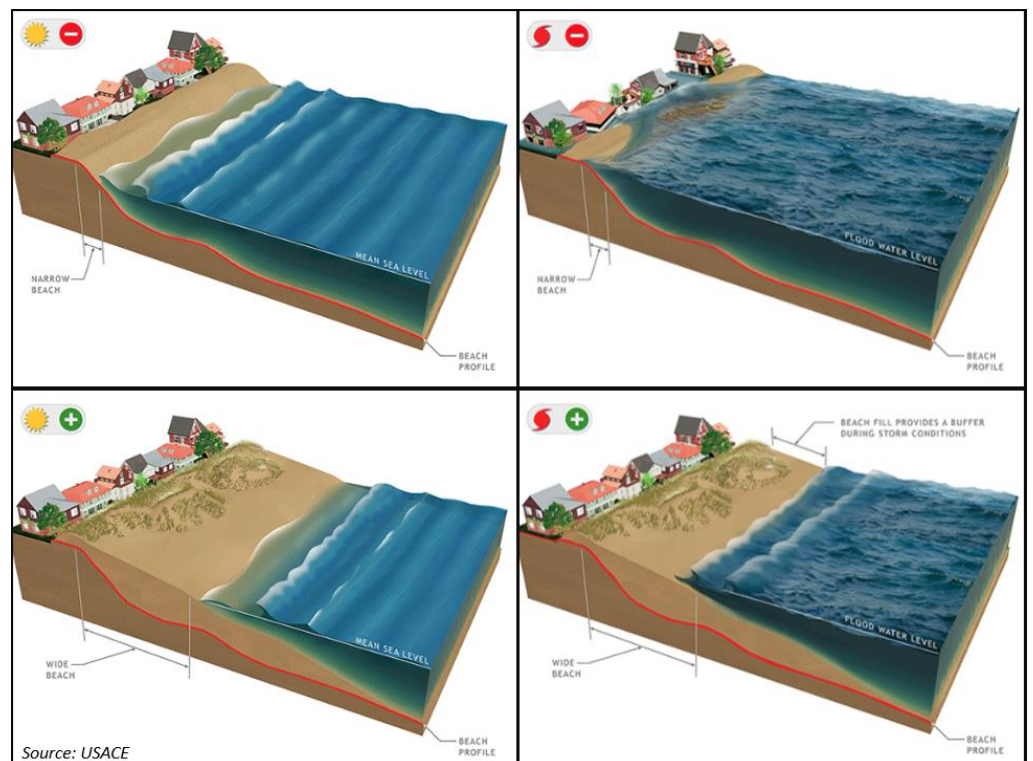
Figure 2: Cross-section representation of the protection provided by an engineered beach nourishment during a coastal storm.

beach nourishment design can provide storm damage protection and reduce coastal flooding in low-lying areas of the community (Figure 2).

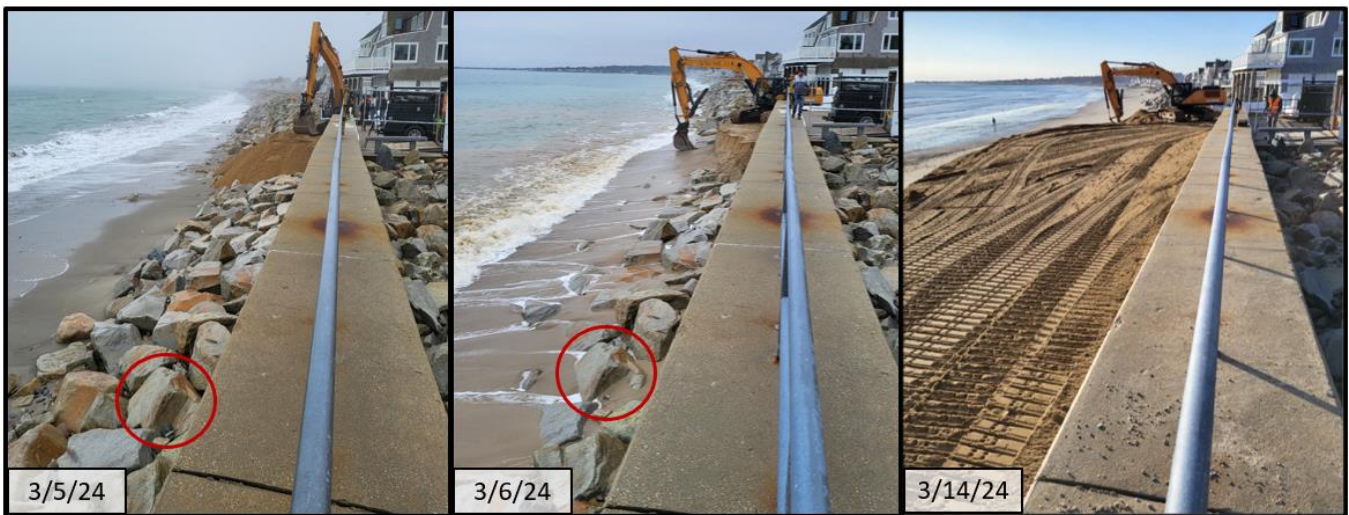
Figure 4: Beach elevation change from before nourishment (left), during the first week of construction (middle), and second week of construction (right). The red circle shows the partial burial of a specific rock in the revetment through natural spreading of the material and the complete burial due to placed nourishment material (source: SCS).

nourishment will change dramatically, the majority of the material remains within the template of the nourishment area during short storm events. As an anticipated response, this reduces the amount of material that is needed in these areas of the nourishment template. Figure 4 shows how the spreading and redistribution of nourishment material elevated the surrounding beach during the first week of construction, contributing to the accelerated rate of placement during the next following week.
