North Scituate Beach Nourishment Project

Public Meeting
January 18, 2024

Sustainable Coastal Solutions, Inc.

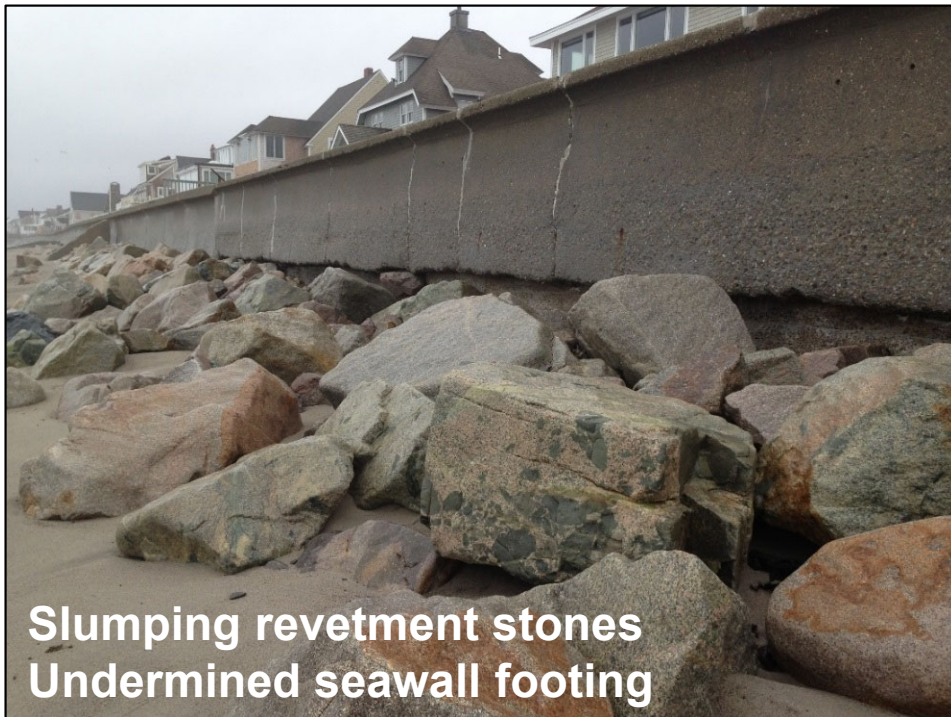
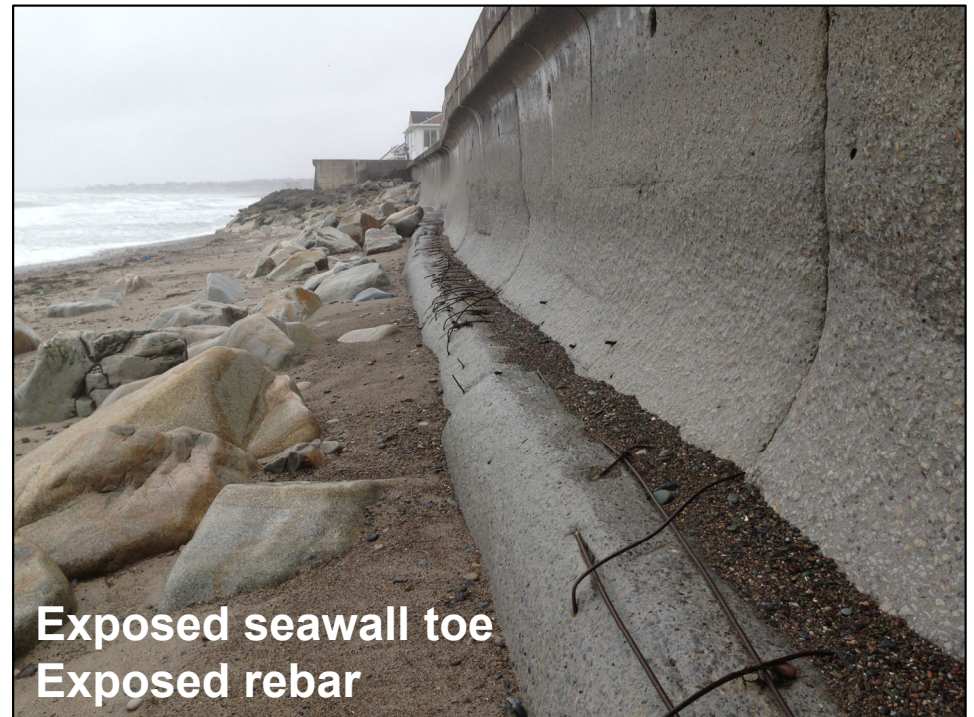
Existing Conditions

- 2013 South Shore Coastal Infrastructure Inventory found that the majority of the seawall and revetment is in Fair condition with evidence of wall cracking and spalling, loose and/or slumping stones, and undermined seawall footings at several locations
- Much of the revetment is below water at high tide
- While submerged, the revetment does not efficiently dissipate wave energy, therefore the seawall is the primary means of shore protection during storms

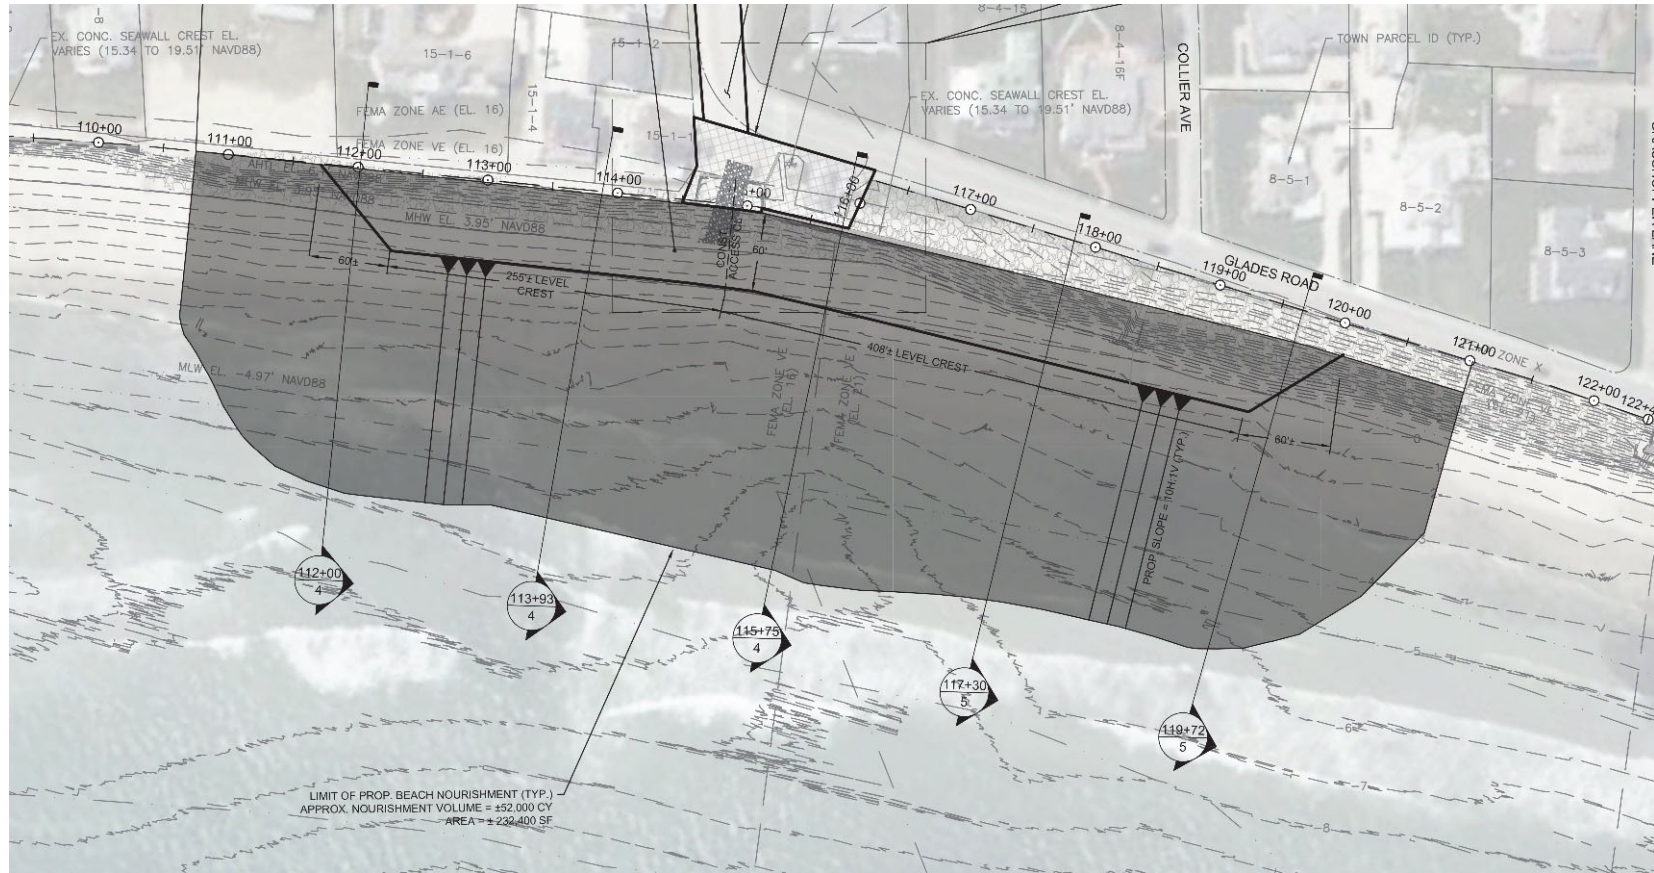
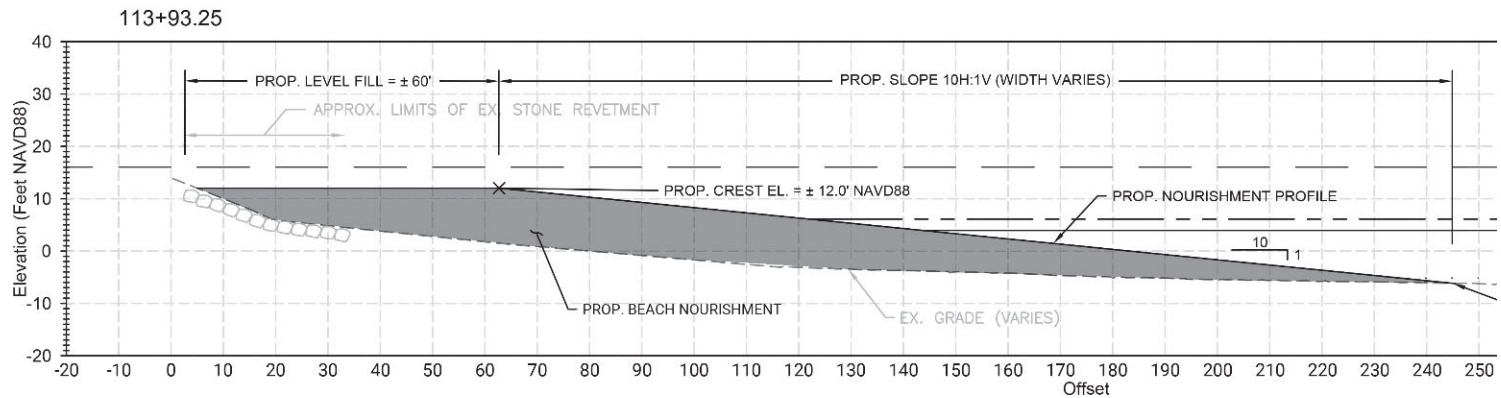
North Scituate Beach Nourishment Design

Partial Project Based Upon Available Funding

Project Length

- Approximately 1,000 feet

Volume of Nourishment Material

- 52,000 cubic yards (~2,600 truckloads likely at 50-to-60 trucks/day)

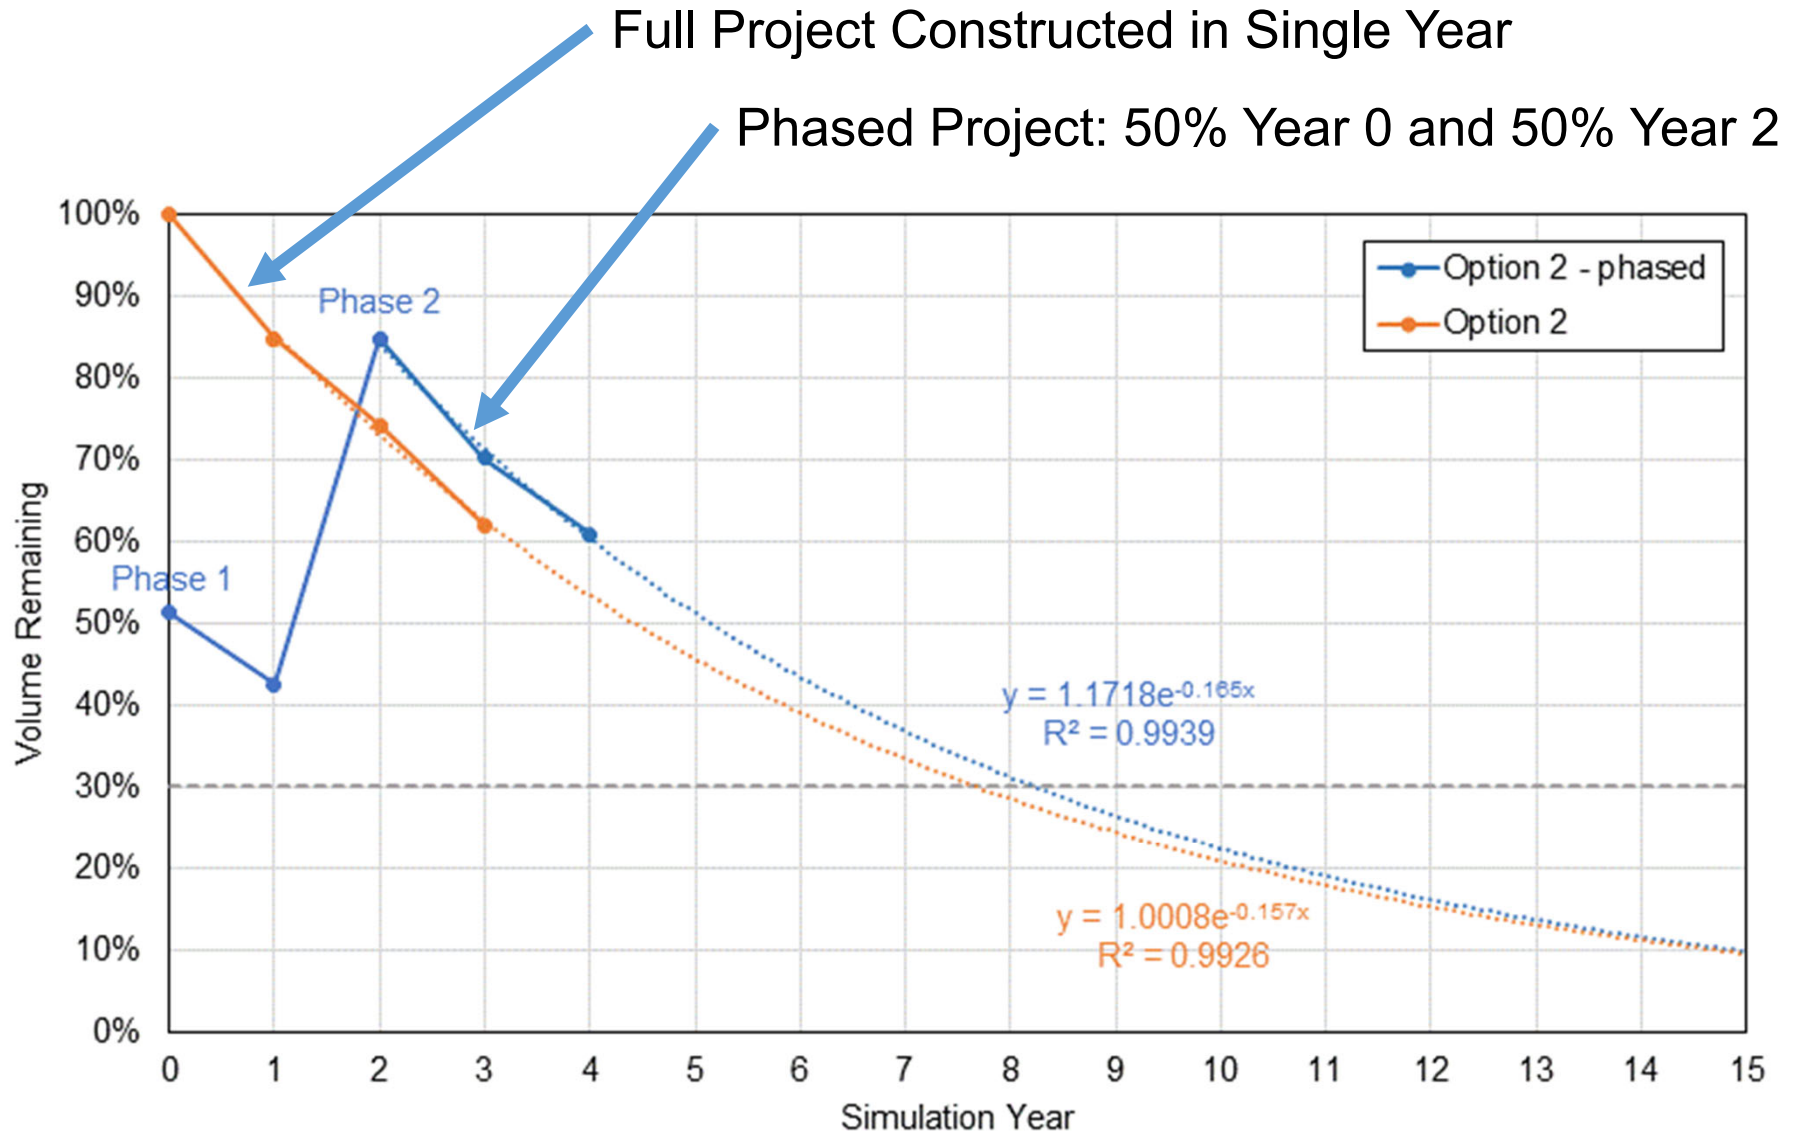
Phased Project Construction Example

- Future MCZM Resilience Grant funding may be available for future phases
- Original design assumed a “phased approach”
