Elevating Roadway Improvements and Dune/Beach Nourishment along North Humarock for Improved Coastal Resiliency

North Humarock, Scituate, Massachusetts

June 2017

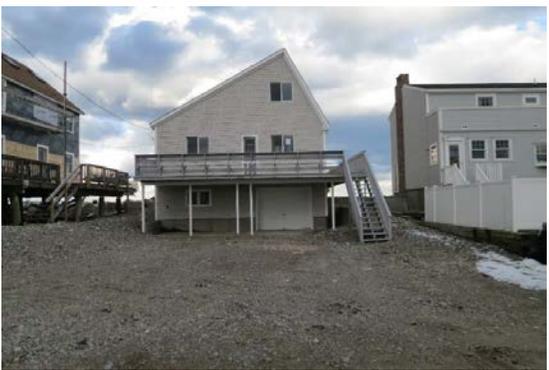
Road Elevation	9.69 feet NAVD88	
Ease of Construction	Acceptable	
Notes	Rehab on solid concrete foundation with brick fireplace Slab ~6" above road Garage ~8' deck overhang Unpaved driveway	
Address	254 Central Avenue

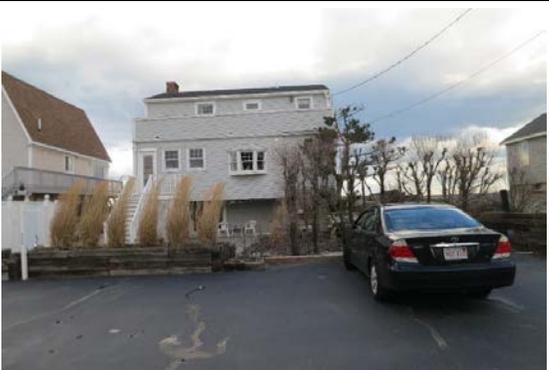
Road Elevation	9.88 feet NAVD88	
Ease of Construction	Acceptable	
Notes	Newer rehab home on cinder block foundation Living quarters underneath home Paved driveway Slab at roadway elevation	
Address	253 Central Avenue

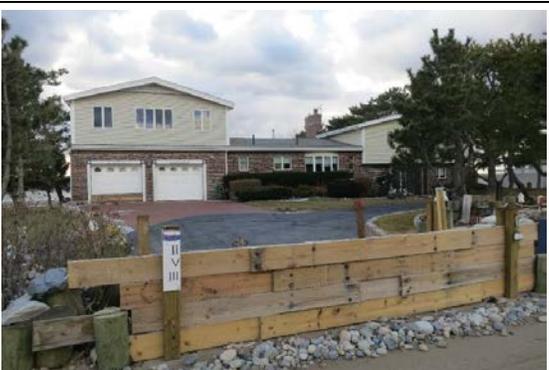
Road Elevation	9.78 feet NAVD88	
Ease of Construction	Good	
Notes	Brick house ~2' above road Lawn Paved driveway	
Address	252 Central Avenue

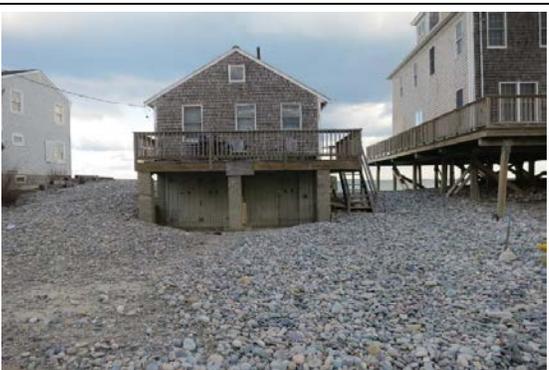
Address	250 Central Avenue

Road Elevation	9.78 feet NAVD88	
Ease of Construction	Acceptable	
Notes	Older home on solid foundation with storage doors underneath ~6' deck overhang Unpaved driveway

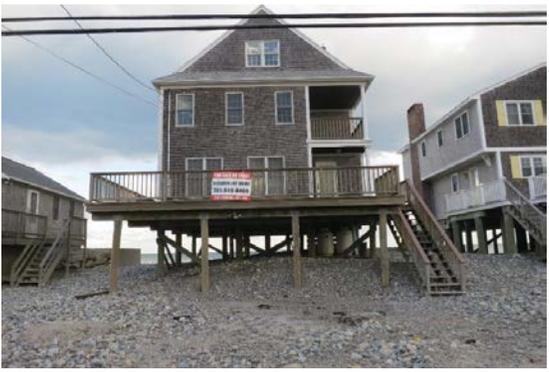
Road Elevation	9.65 feet NAVD88	
Ease of Construction	Good	
Notes	Newer house on piles ~10' deck overhang Unpaved driveway	
Address	248 Central Avenue

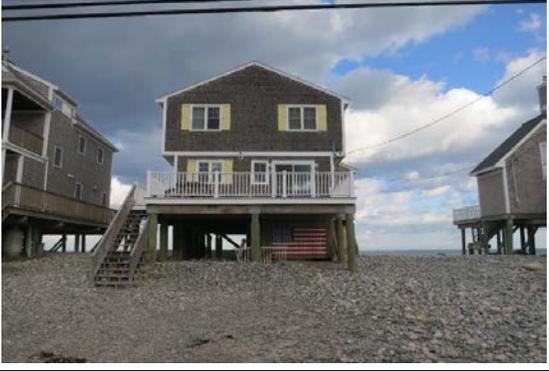
Road Elevation	9.28 feet NAVD88	
Ease of Construction	Good	
Notes	Newer house on piles ~10' above road Brick chimney on slab with concrete piles(?) Unpaved driveway	
Address	247 Central Avenue

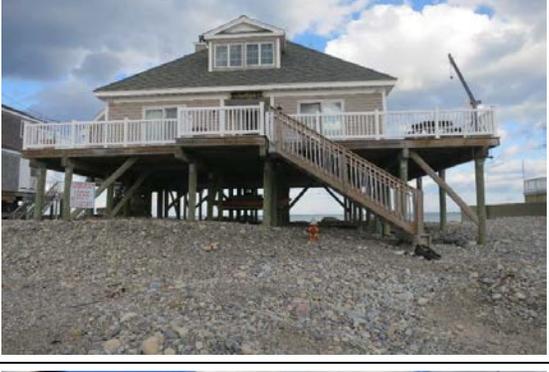
Road Elevation	8.78 feet NAVD88	
Ease of Construction	Good	
Notes	Newer house on piles Fire hydrant adjacent to deck Unpaved driveway	
Address	242 Central Avenue

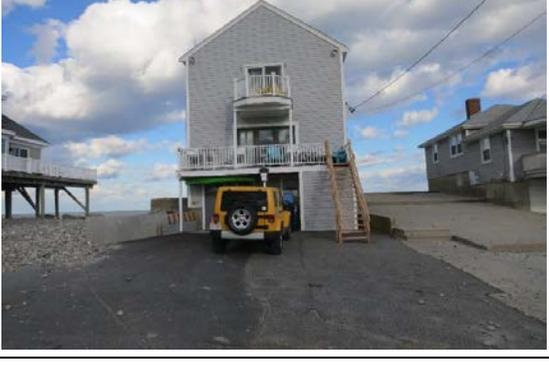
Address	240 Central Avenue

Road Elevation	8.42 feet NAVD88	
Ease of Construction	Acceptable(?)	
Notes	Newer or rehabbed home on solid foundation Living space in basement ~1' above road Paved driveway Large concrete slab around front and north side of home

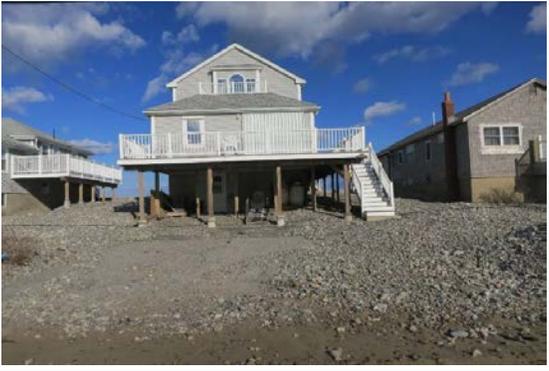
Road Elevation	7.72 feet NAVD88	
Ease of Construction	Acceptable	
Notes	Newer home on solid concrete foundation ~20' porch and deck overhang Slab ~2' above road Paved driveway	
Address	236 Central Avenue

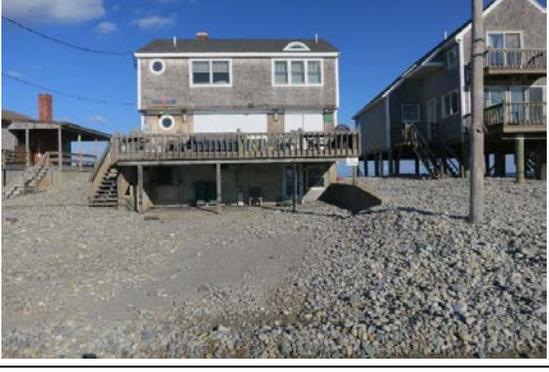
Address	230 Central Avenue

Road Elevation	7.35 feet NAVD88	
Ease of Construction	Acceptable	
Notes	Modern house on concrete foundation Slab at road level Paved driveway Door in basement with window but looks like storage ~12' deck overhang

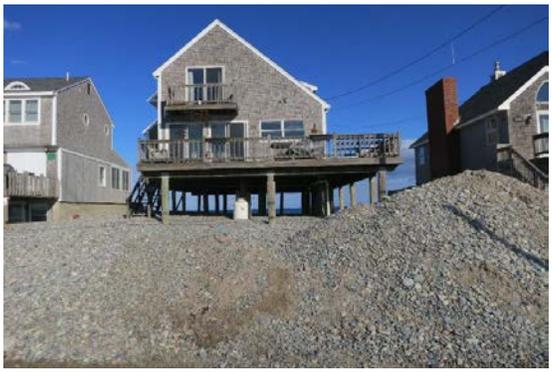
Road Elevation	7.54 feet NAVD88	
Ease of Construction	Good	
Notes	Modern house on piles Floor ~8' above road Unpaved driveway	
Address	228 Central Avenue

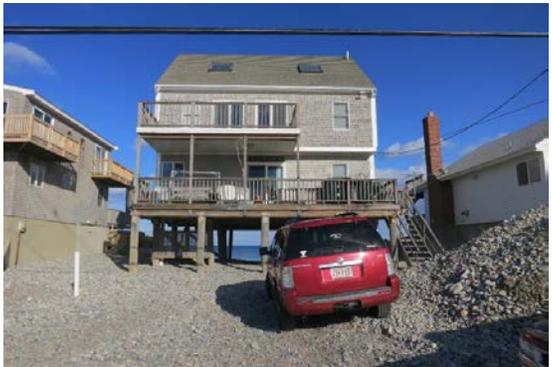
Road Elevation	8.14 feet NAVD88	
Ease of Construction	Good	
Notes	Modern home on piles Floor ~8' above road Unpaved driveway	
Address	224 Central Avenue

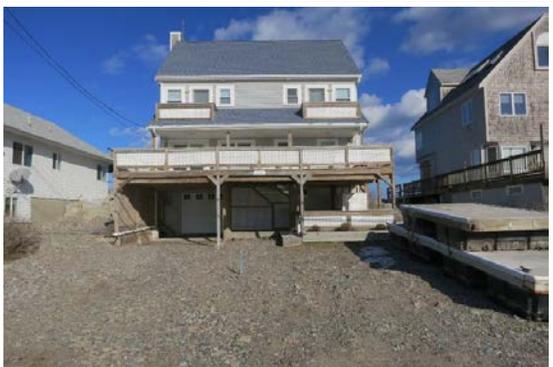
Address	220 Central Avenue

Road Elevation	8.82 feet NAVD88	
Ease of Construction	Acceptable	
Notes	Newer home on solid foundation Garage door ~18' deck overhang Unpaved driveway

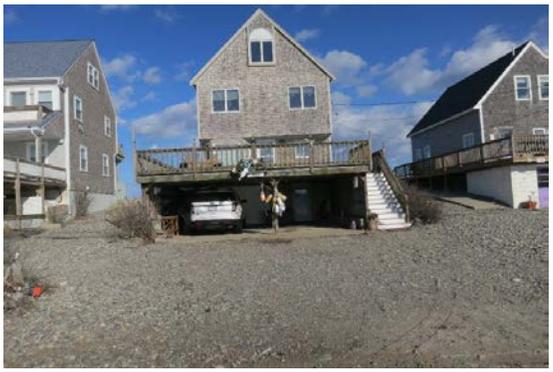
Road Elevation	9.05 feet NAVD88	
Ease of Construction	Acceptable	
Notes	Newer home on solid foundation Garage door and side door ~20' deck overhang Basement floor ~1' above road Concrete slab under deck Driveway unpaved	
Address	218 Central Avenue

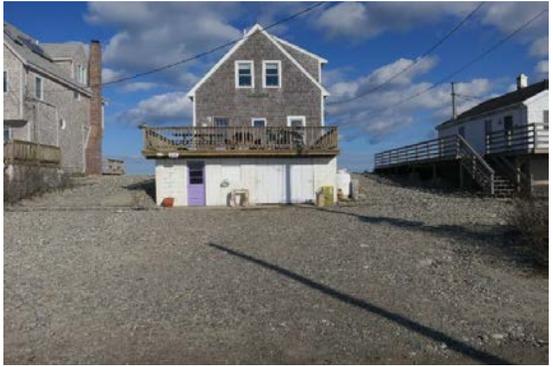
Road Elevation	9.17 feet NAVD88	
Ease of Construction	Acceptable	
Notes	Newer home on old cinder block foundation Foundation extends to within 4' of deck overhang Looks like storage underneath Basement elevation ~1' above road	
Address	216 Central Avenue

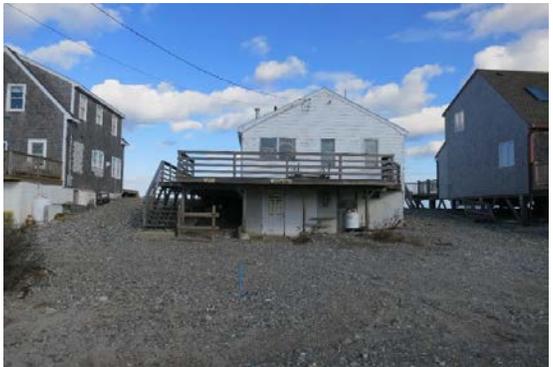
Road Elevation	9.64 feet NAVD88	
Ease of Construction	Acceptable	
Notes	White older home on solid foundation ~10' deck overhang Unpaved driveway Looks like door to storage in basement Basement floor near elevation of road	
Address	214 Central Avenue

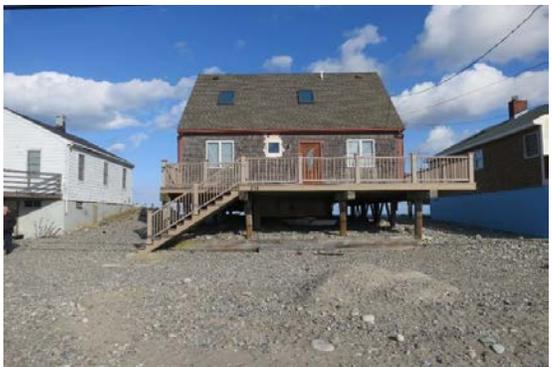
Address	212 Central Avenue

Road Elevation	9.66 feet NAVD88	
Ease of Construction	Good	
Notes	Cape style home on open piles ~15' deck overhang Unpaved driveway

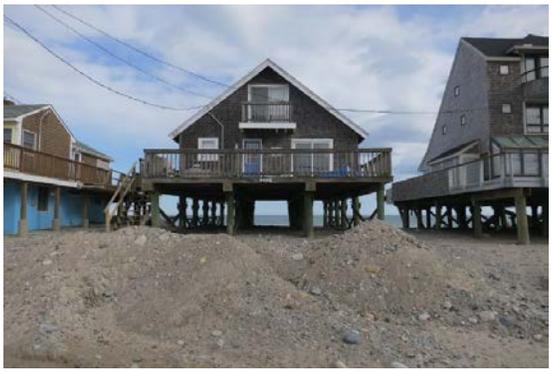
Road Elevation	9.77 feet NAVD88	
Ease of Construction	Good	
Notes	House on piles ~8' above road	
Address	208 Central Avenue

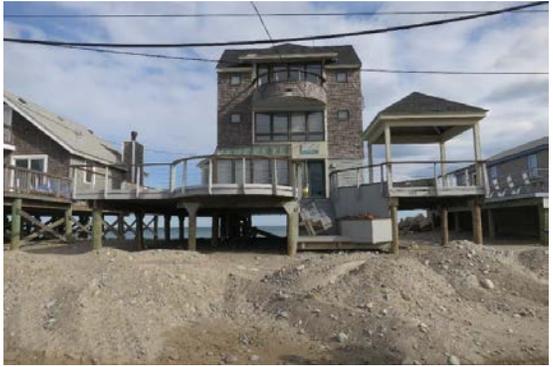
Road Elevation	9.45 feet NAVD88	
Ease of Construction	Good	
Notes	Modern house on piles ~7' above road ~20' deck overhang Unpaved driveway	
Address	206 Central Avenue

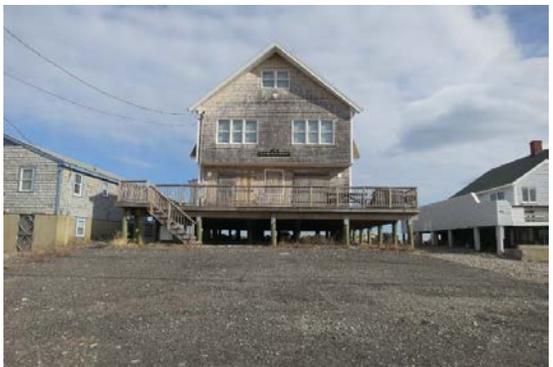
Road Elevation	8.81 feet NAVD88	
Ease of Construction	Good	
Notes	House on piles ~8' above road Unpaved driveway	
Address	202 Central Avenue

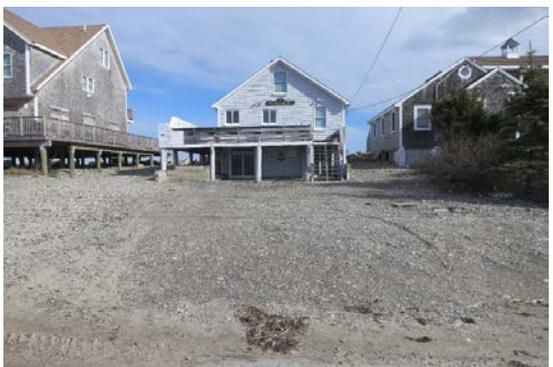
Address	200 Central Avenue

Road Elevation	8.64 feet NAVD88	
Ease of Construction	Acceptable	
Notes	Gray/blue older home on solid foundation Living space with sliders in basement ~1' above road Unpaved driveway

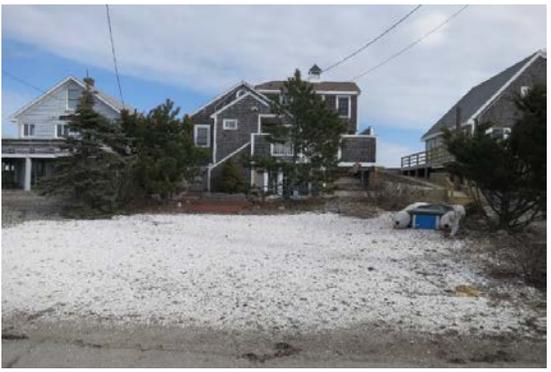
Road Elevation	8.28 feet NAVD88	
Ease of Construction	Acceptable	
Notes	Modernized solid foundation with living space in basement Basement ~1' above road Shell driveway	
Address	198 Central Avenue

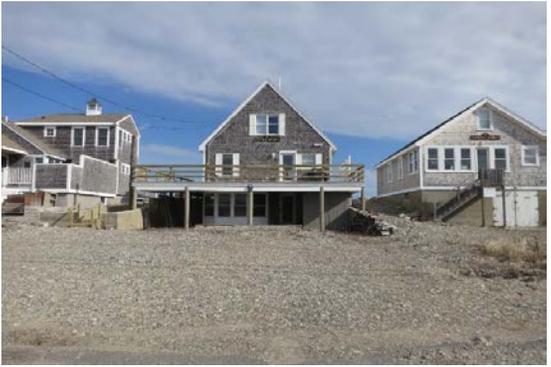
Road Elevation	8.18 feet NAVD88	
Ease of Construction	Acceptable	
Notes	Older home with surrounding deck on piles Solid foundation with living space underneath at road level Concrete walls around house to direct flooding Also concrete walkway to north Unpaved driveway	
Address	196 Central Avenue

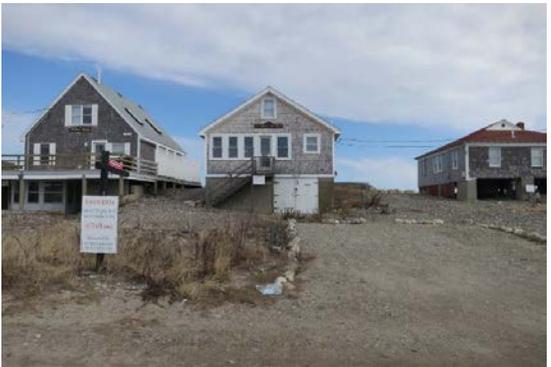
Road Elevation	8.18 feet NAVD88	
Ease of Construction	Acceptable	
Notes	Older home on solid foundation Concrete patio on south side Doors to storage in basement Basement ~2' above road Main floor ~10' above road	
Address	194 Central Avenue

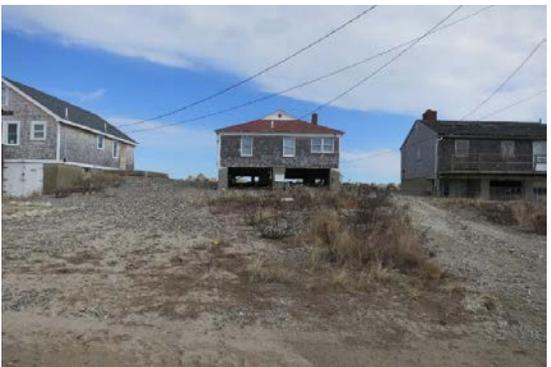
Address	192 Central Avenue

Road Elevation	7.56 feet NAVD88	
Ease of Construction	Good	
Notes	Older home on concrete piers House ~8' above road Unpaved driveway

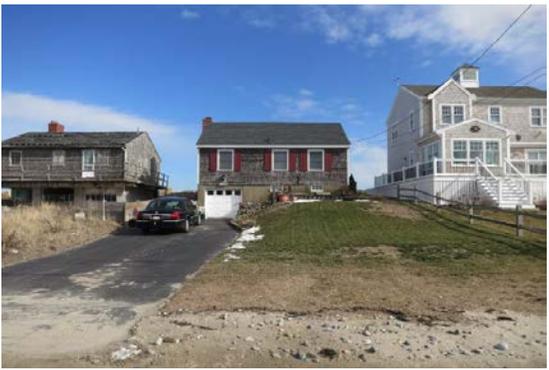
Road Elevation	7.03 feet NAVD88	
Ease of Construction	Acceptable	
Notes	Older home on solid foundation Paved driveway with lawn to south Garage ~1.5' above road	
Address	188 Central Avenue

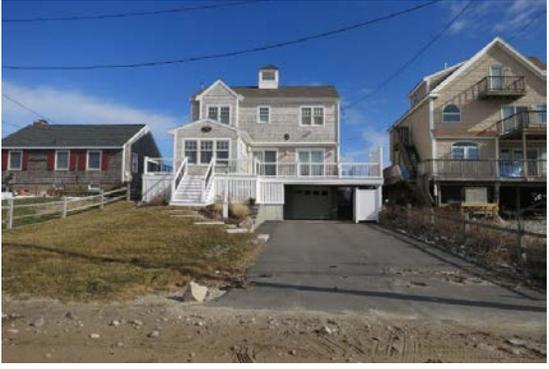
Road Elevation	6.62 feet NAVD88	
Ease of Construction	Acceptable	
Notes	Modern or rehabbed home with solid foundation Garage underneath with ~10' deck overhang Garage on north side Garage level about ~1' above road	
Address	186 Central Avenue

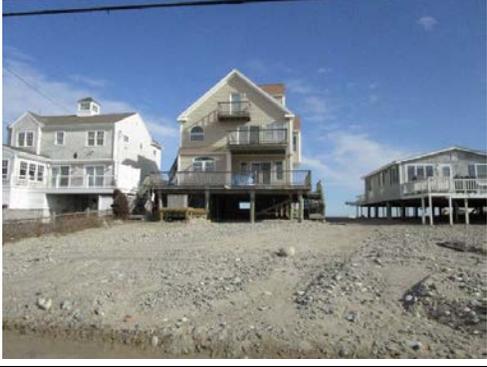
Road Elevation	6.83 feet NAVD88	
Ease of Construction	Good	
Notes	Modern house on piles House ~9' above road Overwash to north Unpaved driveway	
Address	184 Central Avenue

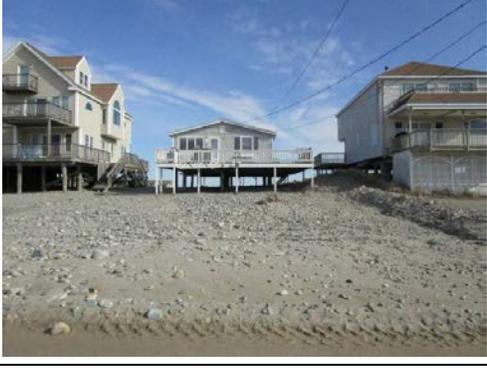
Road Elevation	6.93 feet NAVD88	
Ease of Construction	Good	
Notes	Older single story home on piles Unpaved driveway Signs of overwash to the north House ~9' above road	
Address	182 Central Avenue

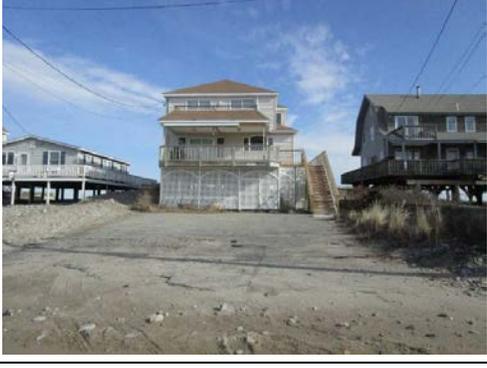
Address	180 Central Avenue

Road Elevation	7.06 feet NAVD88	
Ease of Construction	Good	
Notes	Modern house on piles with wood grating underneath House ~10' above road Paved driveway

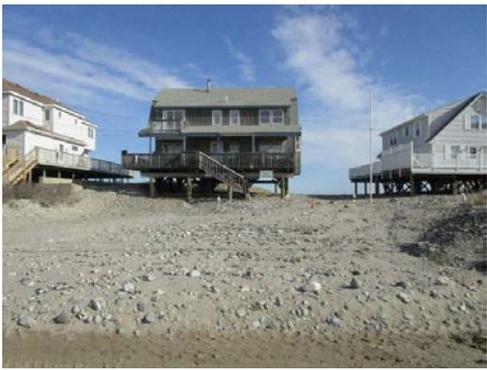
Road Elevation	7.10 feet NAVD88	
Ease of Construction	Good	
Notes	House on piles ~10' above road Signs of overwash south of house Unpaved driveway	
Address	178 Central Avenue

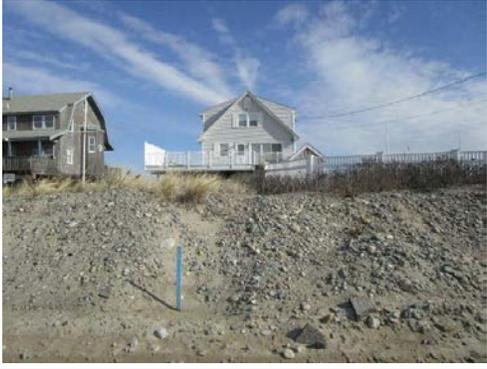
Road Elevation	7.21 feet NAVD88	
Ease of Construction	Good	
Notes	Modern house on piles ~10' above road Driveway off of Seaview Avenue	
Address	176 Central Avenue

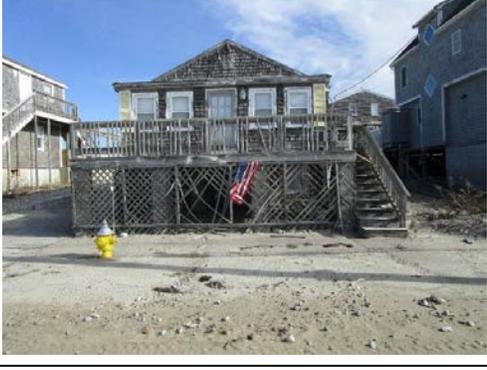
Road Elevation	7.63 feet NAVD88	
Ease of Construction	Acceptable	
Notes	Solid foundation under main house Crawlspace door in solid foundation Approximate 18' of extended deck is on block "piles" Unpaved driveway Floor ~6' above road Yellow fire hydrant in front	
Address	172 Central Avenue

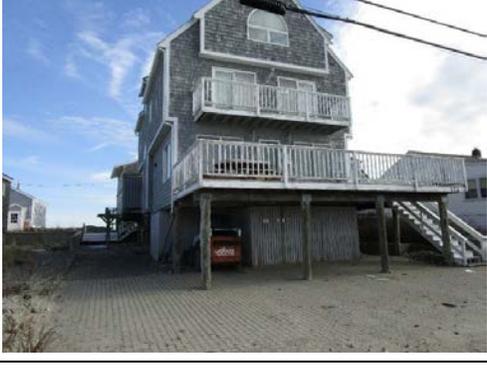
Address	170 Central Avenue

Road Elevation	7.51 feet NAVD88	
Ease of Construction	Good	
Notes	Pile foundation approximately 10-20 years old ~12' deck overhang Paver tile driveway House floor ~8' above road

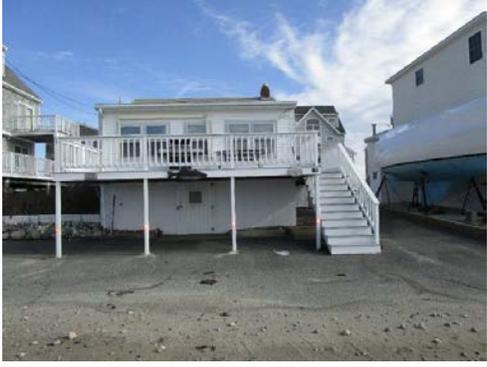
Road Elevation	7.46 feet NAVD88	
Ease of Construction	Challenge	
Notes	Older home on solid foundation Small door in foundation, likely for storage ~10' deck overhang House ~25' back from road Paved driveway	
Address	168 Central Avenue

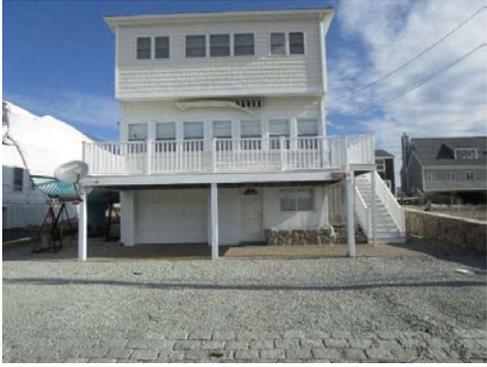
Road Elevation	7.30 feet NAVD88	
Ease of Construction	Challenge	
Notes	Updated older home with solid foundation and garage Garage floor ~1' above road Other door and living space under home ~10' deck overhang Main floor ~8' above road	
Address	164 Central Avenue

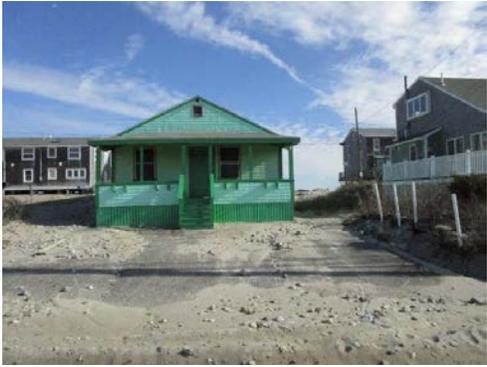
Road Elevation	7.09 feet NAVD88	
Ease of Construction	Good	
Notes	Older home with solid block foundation ~8' covered porch Floor ~3' above road Crawl space under house Overwash channel across street between #164 and #168	
Address	162 Central Avenue

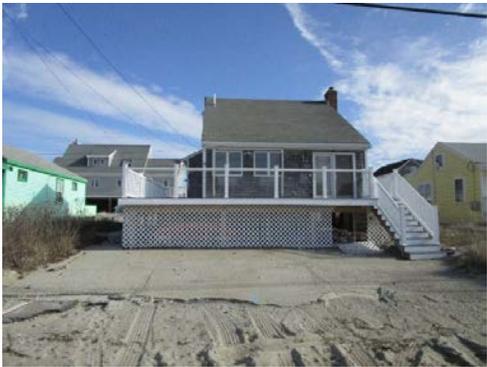
Address	160 Central Avenue

Road Elevation	7.02 feet NAVD88	
Ease of Construction	Good	
Notes	House on cinder block piles Floor ~5' above road ~4.5' deck overhang Paved driveway Signs of flow-induced erosion on concrete driveway

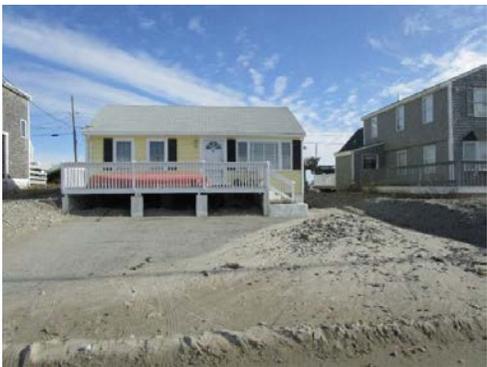
Address	158 Central Avenue

Road Elevation	7.00 feet NAVD88	
Ease of Construction	Good	
Notes	Older house raised on series of shore-perpendicular block strips Signs of overwash from ocean House ~3-4' above road Paved driveway

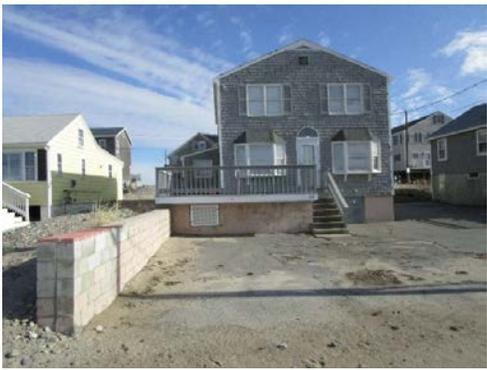
Road Elevation	7.10 feet NAVD88	
Ease of Construction	Good	
Notes	Older home with solid block and concrete foundation Crawl space under house Paved driveway Lots of wrack from high tide in driveway	
Address	156 Central Avenue

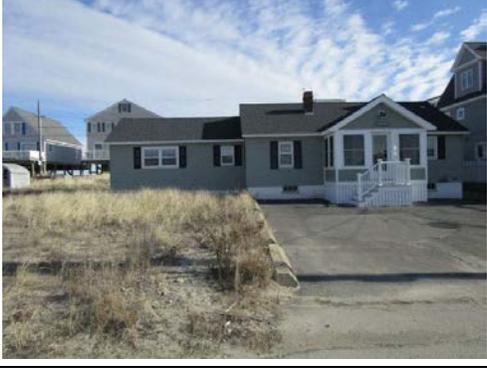
Road Elevation	7.23 feet NAVD88	
Ease of Construction	Challenge	
Notes	Older home with solid concrete foundation Living space in basement ~10' deck overhang Paved driveway Side door on southwest corner	
Address	152 Central Avenue

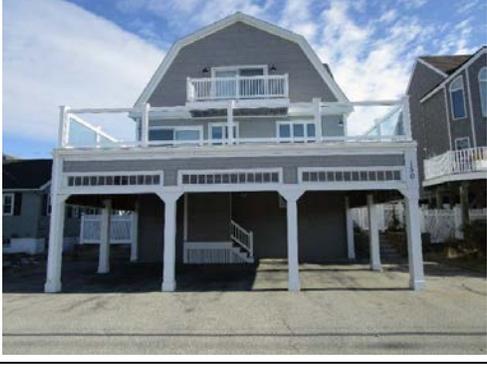
Road Elevation	7.42 feet NAVD88	
Ease of Construction	Challenge	
Notes	Older home on solid block foundation Looks like basement windows Paved driveway House flood ~2-3' above street	
Address	150 Central Avenue

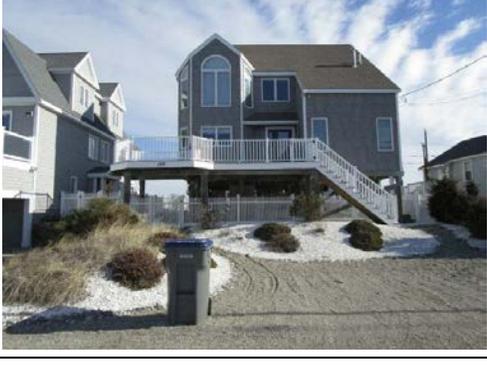
Address	148 Central Avenue

Road Elevation	7.56 feet NAVD88	
Ease of Construction	Challenge/Acceptable	
Notes	Modern house with solid foundation Stairs up from carport Large overhanging carport/deck ~18-20' Challenge due to carport posts but appears okay for fill Floor is ~3' above road

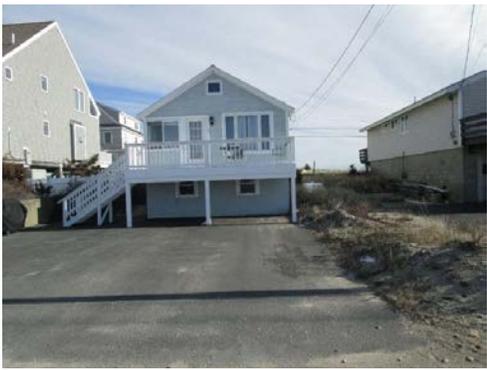
Address	146 Central Avenue

Road Elevation	7.79 feet NAVD88	
Ease of Construction	Good	
Notes	Modern house on good piles with bracing No problem with fill but bush landscaping will be affected

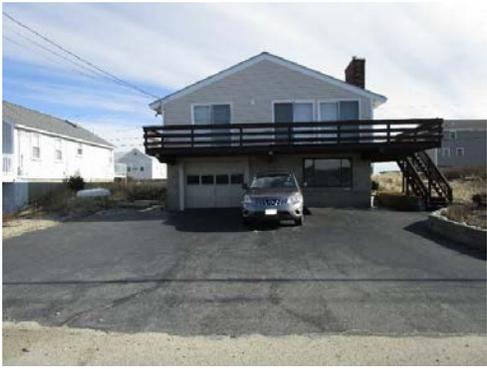
Road Elevation	8.07 feet NAVD88	
Ease of Construction	Challenge	
Notes	House on solid foundation No garage ~8' deck overhang Paved driveway at same elevation as road Should be able to bring fill up ~2 ft against house Side access door could be a challenge	
Address	144 Central Avenue

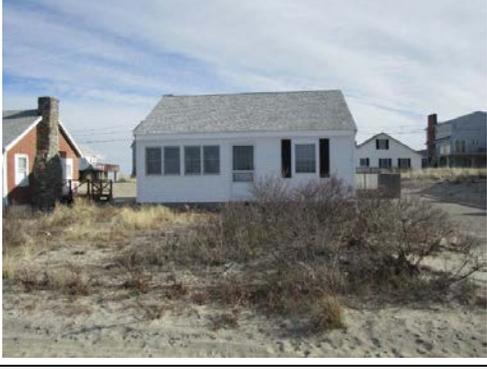
Road Elevation	8.14 feet NAVD88	
Ease of Construction	Problem	
Notes	Small house on block foundation Floor ~2' above road Stone chimney Paved driveway Difficult to raise road more than 2 feet	
Address	138 Central Avenue

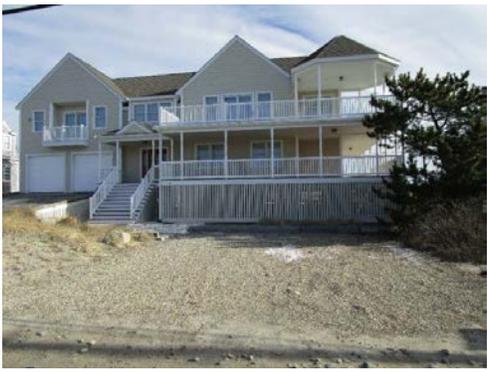
Address	130 Central Avenue

Road Elevation	7.94 feet NAVD88	
Ease of Construction	Challenge	
Notes	House on solid foundation Garage ~0.5-1' above road ~12' deck overhang

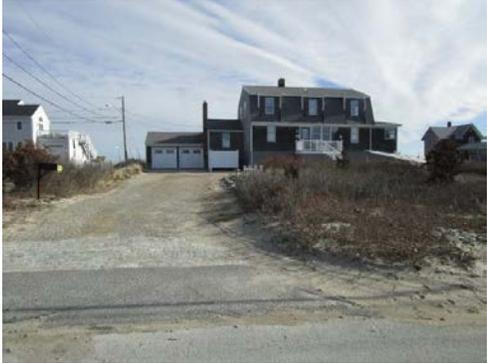
Road Elevation	8.11 feet NAVD88	
Ease of Construction	Good	
Notes	Driveway ~8' above road	
Address	128 Central Avenue
