Due Diligence Study Scituate Town Hall Buildings

CODE EVALUATION & MEP/FP SYSTEMS NARRATIVE

June 3, 2014

**R.W. Sullivan
Engineering**

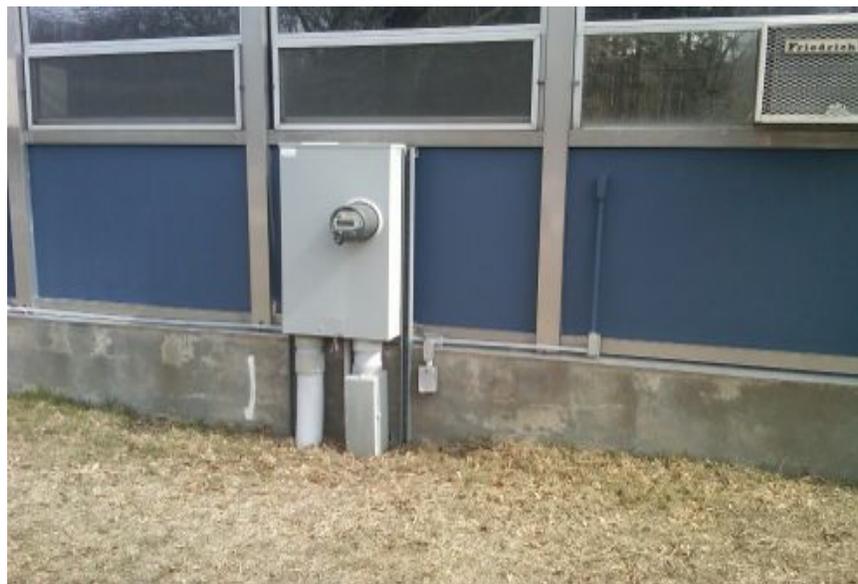
- a. The electric service enters the building at the basement level main electric room and connects to a 400 amp, 208/120V, 3 phase, and 4 wire main switchboard.

Electric Meter at Town Hall

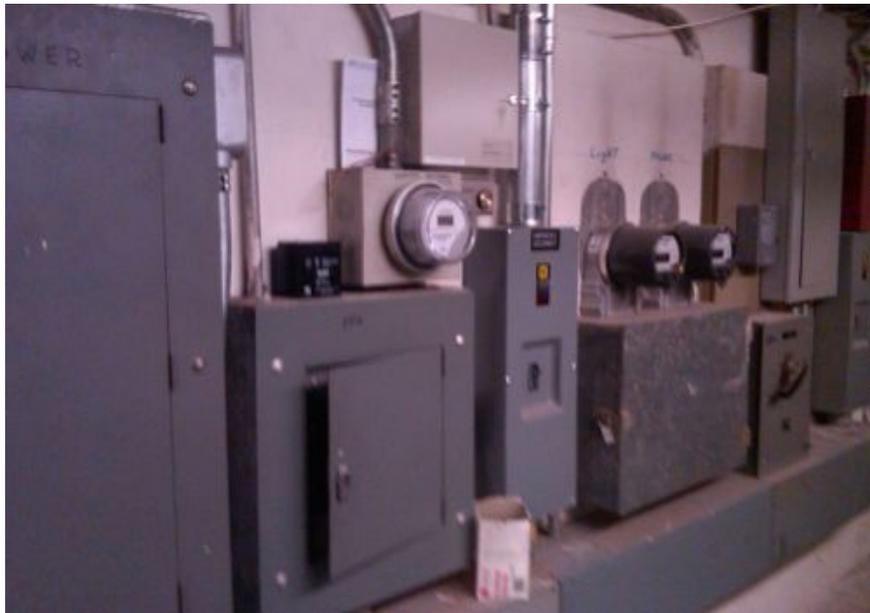
Electric Service
