Existing Conditions Survey & Feasibility Study

Gates Middle School
327 First Parish Road
Scituate, MA

August 7, 2012

DURKEE BROWN
VIVEIROS WERENFELS
ARCHITECTS
111 Chestnut
Street Providence, RI 02903
tel: 401.831.1240
www.durkeebrown.com

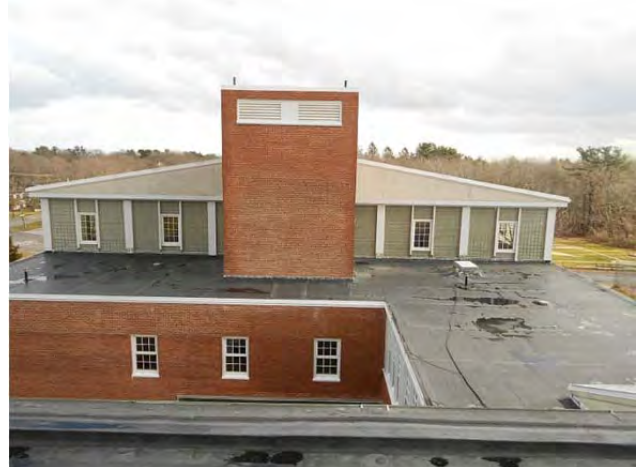
Both the gymnasium flat and low roof portions over the lobby connector have EPDM, aka “rubber” membrane roof systems. The flat roof areas have built-up roof edges and slope towards internal roof drains. Based on ponding observed, it appears that the insulation has formed low spots, often before water reaches the drain itself. The age of the roof was not evident but is assumed to match the “B” wing roof. The seams appear to have been resealed over the years but seam failures were observed in many locations, especially on the high gymnasium roof.

A wing membrane roof showing low pitch and ponding

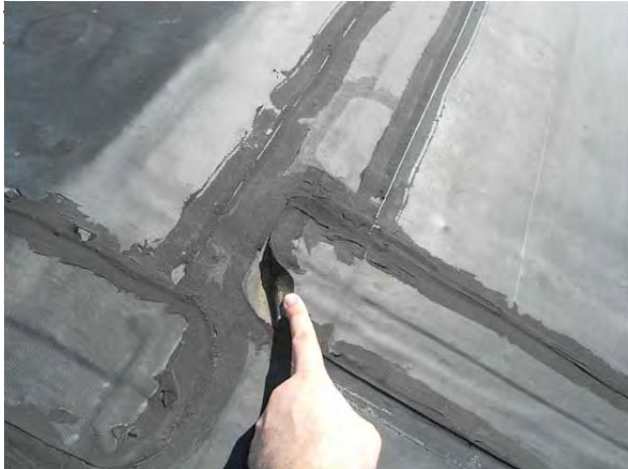
The flashings throughout the roof assembly are extensively weathered. Corrosion and damage was observed around the roof scuttle and along the bottom of the glass block wall panels. The roof flashing was bent and malformed from the last roof installation. The flashing no longer sits flush and tight to the building. This could allow wind-driven rain to enter the substrate. Also, the transitions from the flat roof to the glass block and slope classroom roof are less than the recommended minimum dimension due to a re-roof adding insulation thickness to the lower flat roof. These low transitions may allow water infiltration from snow build-up, which might already be occurring as indicated by the multiple applications of sealant over the entire assembly.

Extensive sealant & missing pilaster at gym

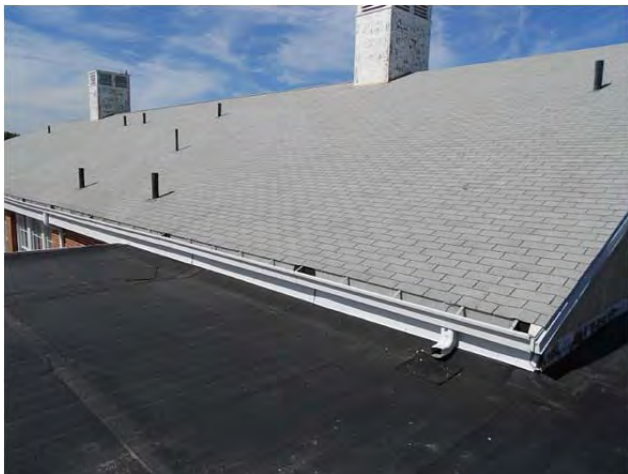
The transition from the asphalt shingle roof to the flat membrane is another area of concern. The gutter is suspended only a few inches above the flat roof. A more seamless transition would be to simply membrane the transition and allow the water to flow directly from one roof to another without the gutter, eliminating additional penetrations from attachments.

A wing transition to classroom wing shingled roof

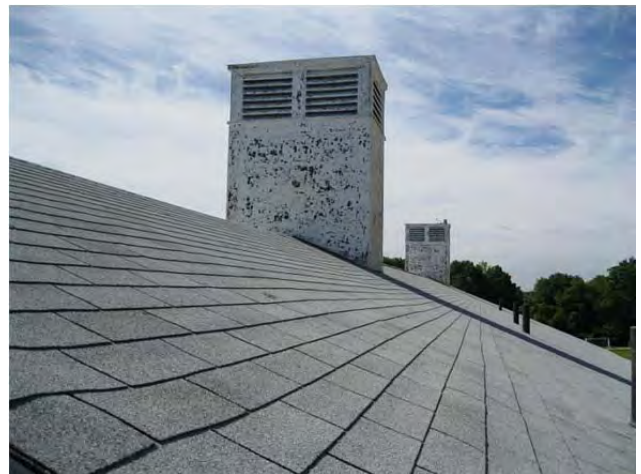
The two ventilation cupolas were not renovated at the same time as the roof replacement. Although there was no evidence of recent leaks or structural deficiencies, the finishes are worn and beyond their useful life. The cupolas should be cleaned and repainted in their entirety. The flat seam copper roofs should be replaced

Classroom wing ventilation cupolas

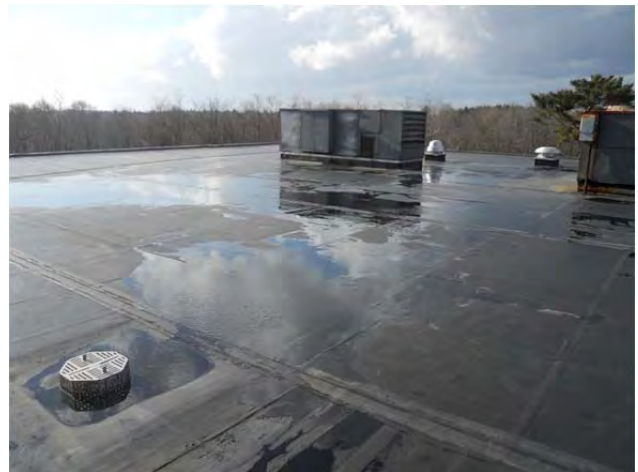
The flat EPDM roof is not in good condition. It has significant ponding at the west wing due to improper pitch towards roof drains. Also, lifting seams and deteriorated sealants in the EPDM appear widespread. Around the perimeter of the roof, there is an existing curb, and the EPDM is not installed in a manner recommended for water tightness. This curb has a metal coping on it, but the EPDM roofing runs over the top of it and terminates in a sealant joint. A more effective detail for water tightness is for the EPDM to extend underneath it. The existing sealant joint is difficult to maintain and may permit water into the masonry wall and ceiling below if it fails.

Ponding of water on the EPDM roof on B wing

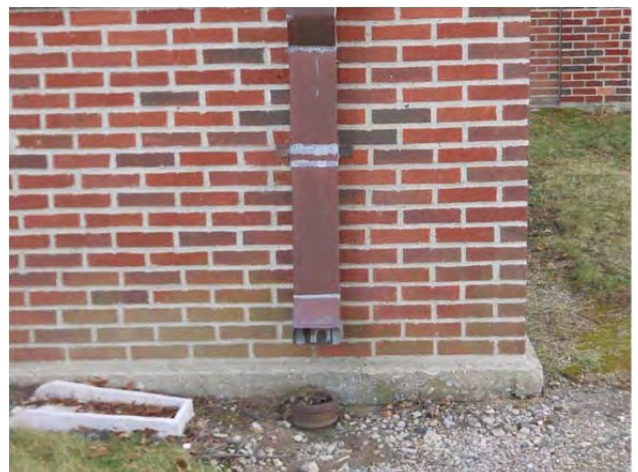
The synthetic slate roof, cupola, gutter and downspouts are in good condition. The downspouts do not connect to an underground storm water system and do not have effective splash blocks. This means that roof run-off from the pitched roof, outlets directly at the building foundation wall. At the south of the slate roof are two metal clad sheds that house equipment for the HVAC system. The flat seam copper roofing is rusted and the sidewall panels are bent.

Downspout at B wing with no connection to an underground system or splash block

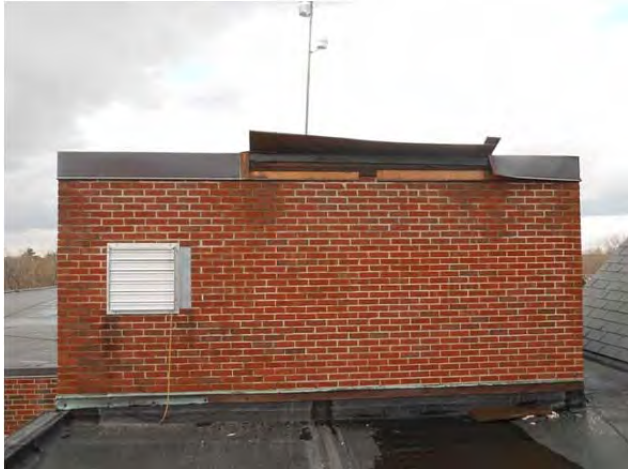
Torn roof flashing at the top of the elevator shaft

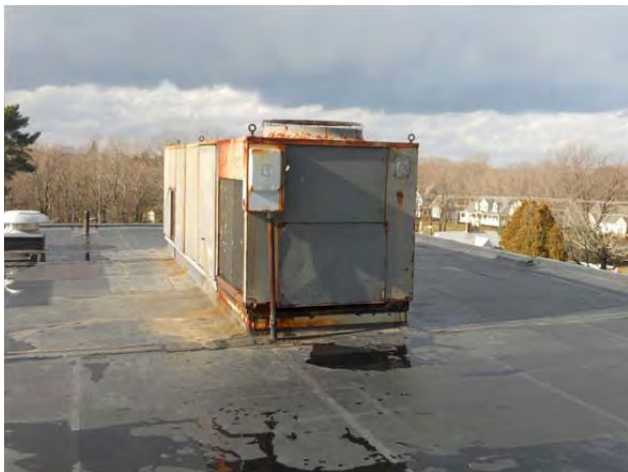
Corroded rooftop equipment dating back to the 1974 renovation

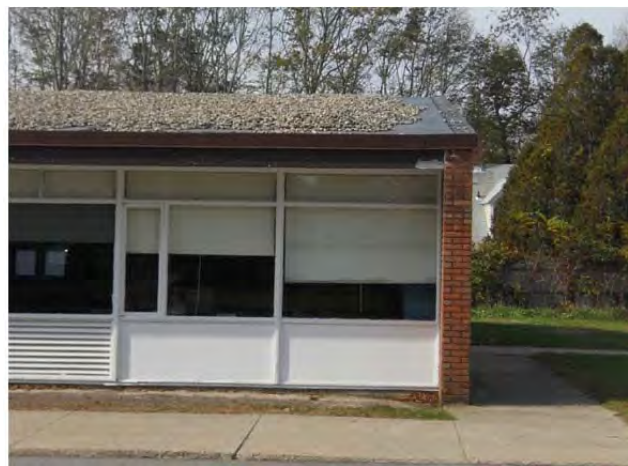
C wing roof showing missing ballast at roof edges

The pitched roof over the classrooms is a very unorthodox installation of loose-laid stone ballast over a pitched membrane (EPDM) roof. Normally, ballasted roofs are left to non-coastal flat roofs. In this installation, the ballast is nearly non-existent for a width of approximately three feet along the eave. The ballast is normally present to protect the membrane from UV exposure and hold it down for better wind resistance. The missing ballast is due to removal by sliding snow, coastal winds, or by efforts to mitigate leaks.

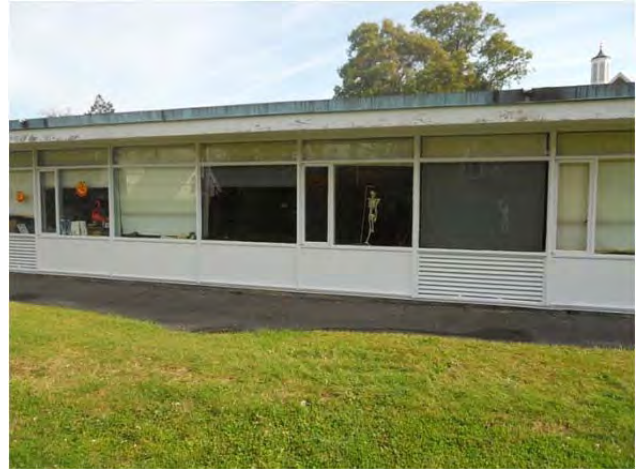
C wing roof edge is bent and failing in many locations

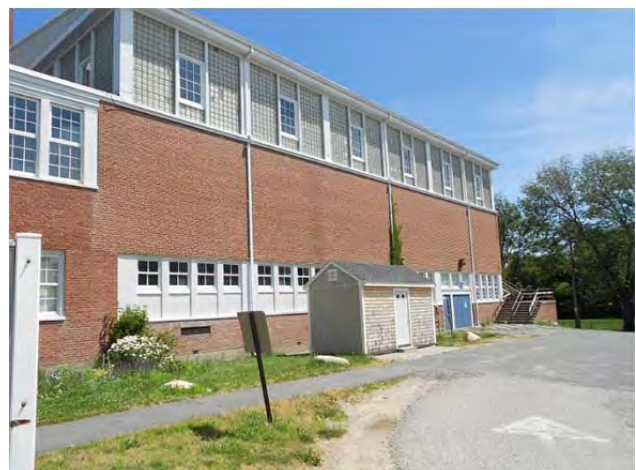
The brick walls consist of veneer face brick with concrete masonry unit (“CMU”) backup wall and glazed block face units on the interior side at corridors and other public areas. Much of the brick areas were repointed as part of the 2006 exterior repairs. Although the color match of the mortar is not identical, the repointing is generally intact and does not appear to be compromised due to any latent or new deficiencies.

A wing brick walls showing recent repointing

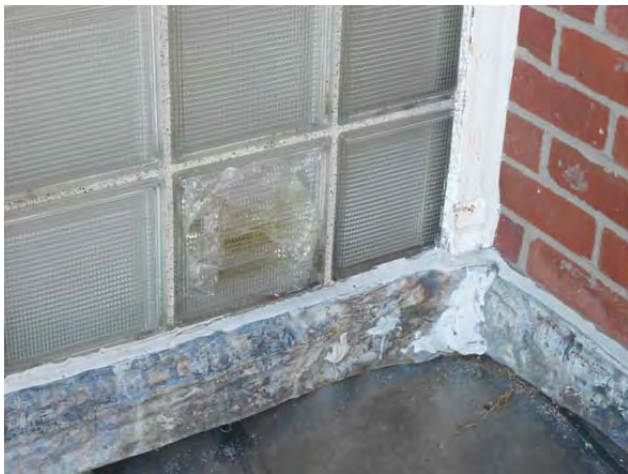
The glass block is located around the entire upper perimeter of the gymnasium. Although subject to damage from projectiles from both inside and out, the glass block is actually failing from other causes. The portland cement mortar joints between the glass block have failed, allowing water penetration to the surrounding steel frames as well as into the glass block units themselves. Years of moisture-induced freeze-thaw, as well as crumbling mortar have caused several blocks in each panel to crack, split, shift, and/or shatter. The glass block in its entirety is beyond repair. Left alone, the mortar joints and glass blocks will experience rapid acceleration of decay and failure. The further the panels decay, the more susceptible the adjacent structural steel components will be to damage.

Exterior face of glass block shattered from freeze-thaw exposure.

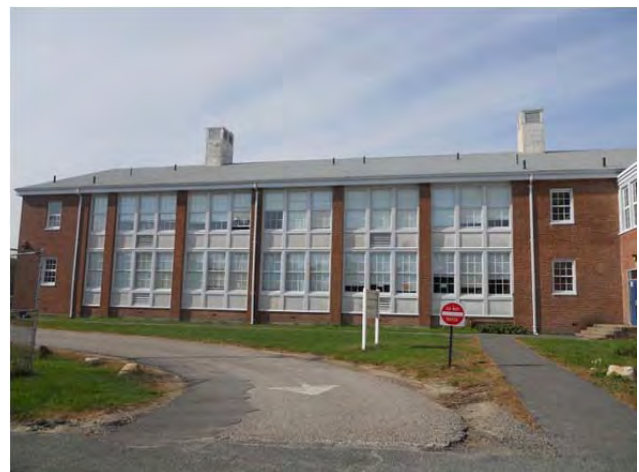
Solid panels, located mostly below windows in the classroom wing and first floor gymnasium horizontal ribbon windows are stucco. The condition of the stucco is equal to or worse than the stucco elsewhere on the building, including failing sealant joints, staining, and possible mold growth.

Original wood "curtainwall" covered with aluminum panning. Solid panels are coated with stucco.

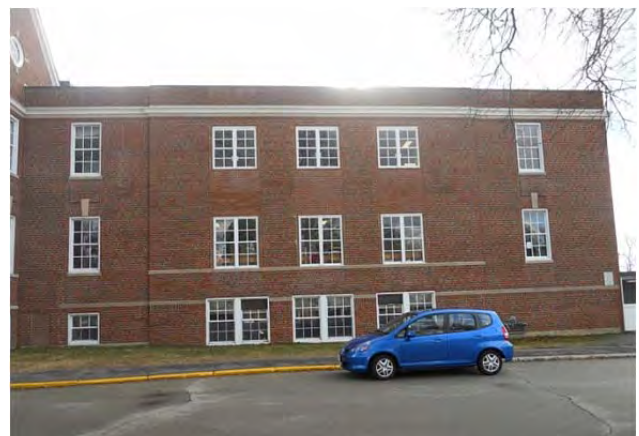
North elevation of B wing with the center bay modified where original spandrel windows were removed

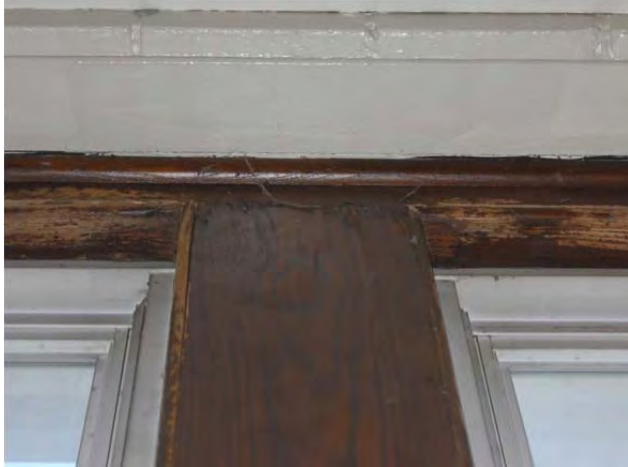
On the exterior, sealants were poorly installed and are covered in mold. On the interior, wood casings, trims and moldings demonstrate signs of peeling paint, water damage and ultra violet degradation.

Wood window trim in B wing with water damage

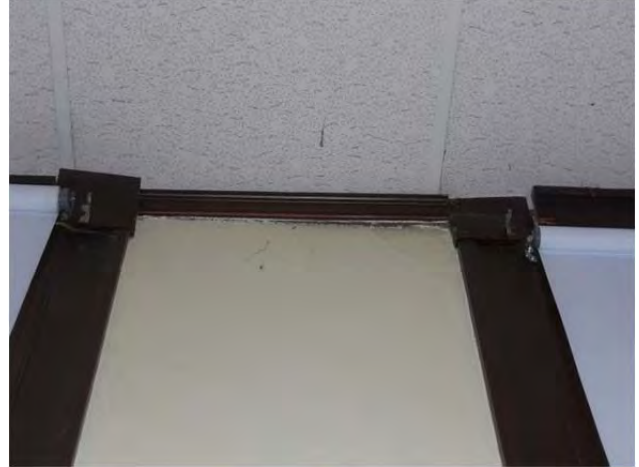
Wood window trim in B wing with water damage

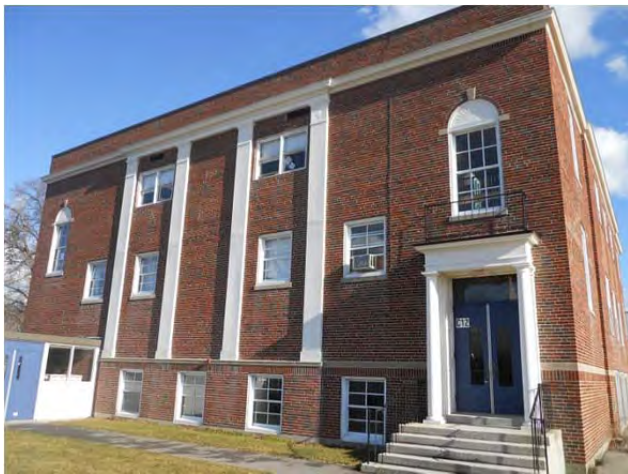
West elevation of B wing heavily modified with non-original windows

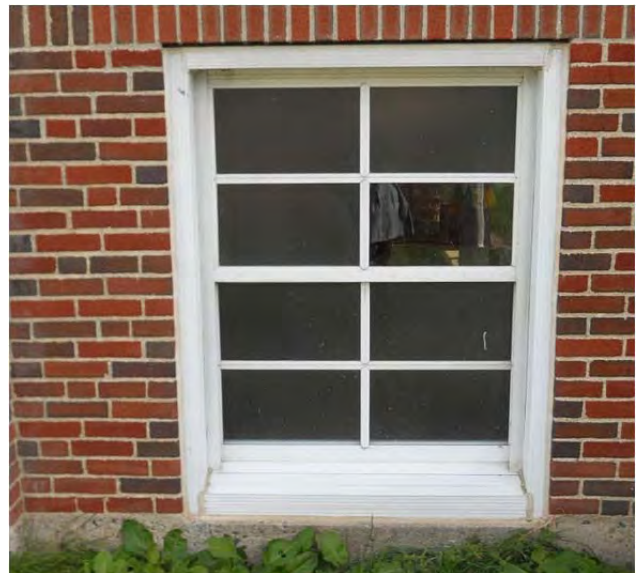
Inappropriate window grid proportions for the style of this building

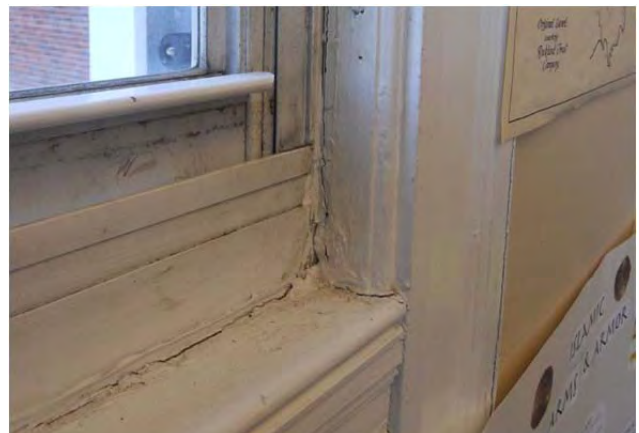
Paint failure at window frame interior in B wing

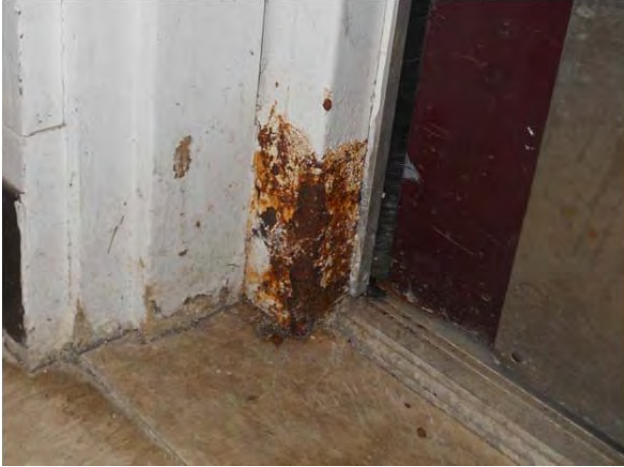
Rusted metal frames are typical conditions at all exterior doors

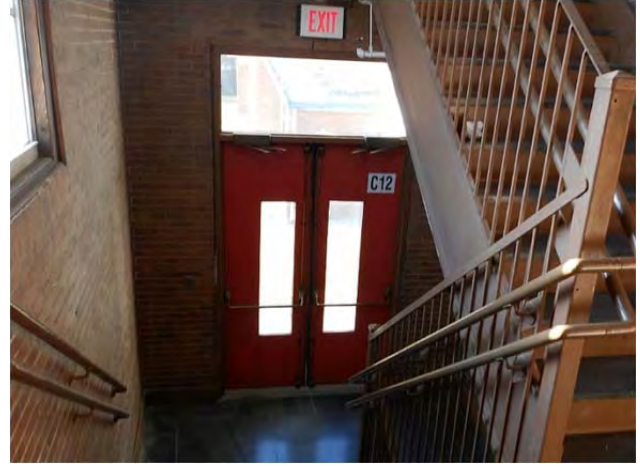
Exterior doors throughout have antiquated hardware

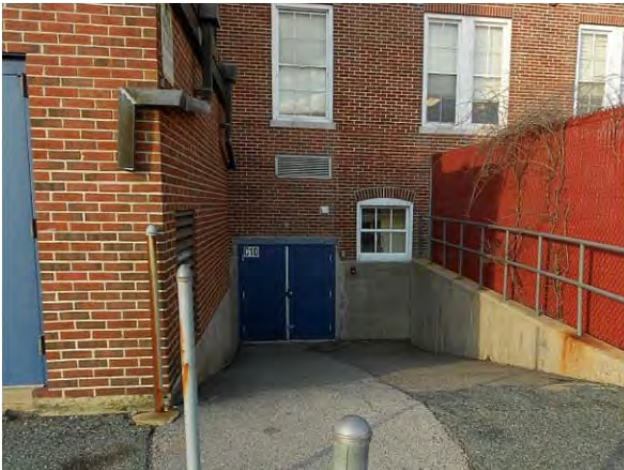
The kitchen loading door has an extreme pitch outside that promotes water infiltration

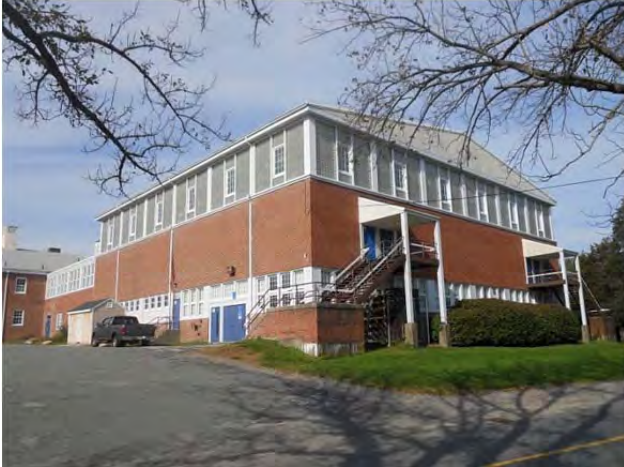
The two elevated gymnasium stairs are in very poor condition. The elevated concrete platform, open grate metal stairs, and handrails are extremely corroded and in some locations, rusted completely through. The lower transitional landing, constructed of concrete and brick, is extensively cracked. The concrete stairs exhibit spalling at corners and edges of the platforms and treads. The handrails do not comply as guardrails for height nor baluster spacing.

Gymnasium exterior egress stairs are beyond repair

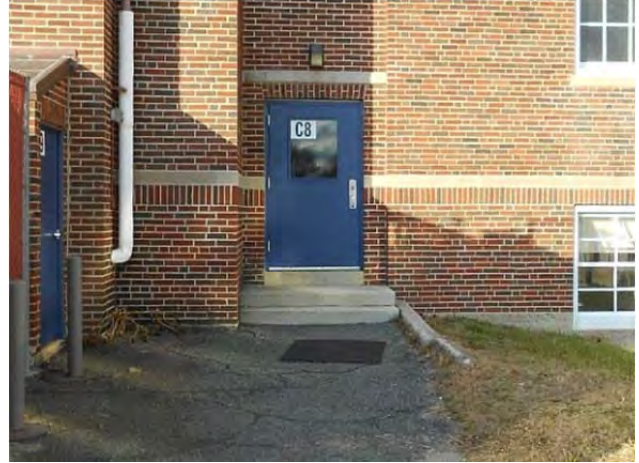
Some exterior stairs have no guard or hand rails.

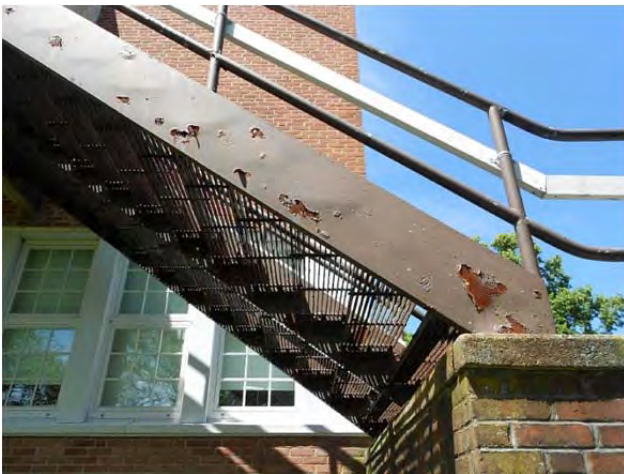
Gymnasium egress stair stringers have rusted completely through and in danger of failure.

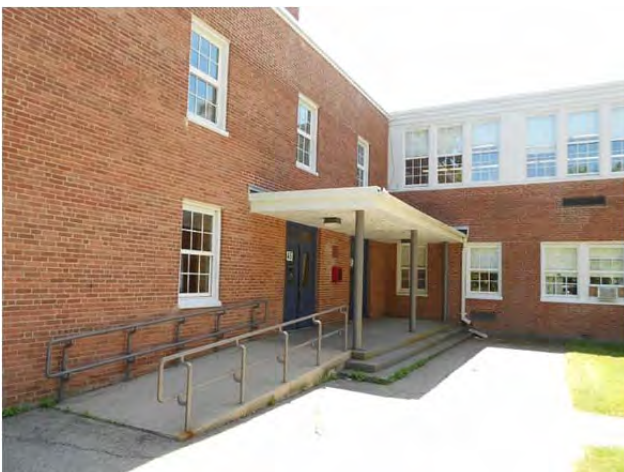
Gymnasium lobby entrance is generally Code compliant except for handrails at the stairs.

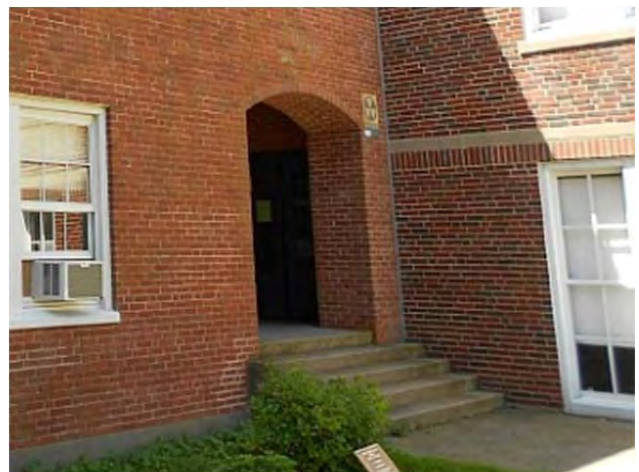
Some exterior stairs have no guard or hand rails.

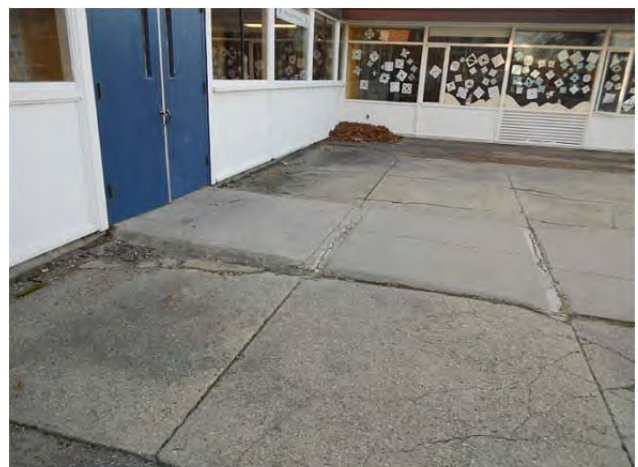
The connector corridor between "C" wing and "B" has two sets of double doors, both of which have flush transitions to sidewalks. However, the sidewalk leading away to the north egress to the handicapped parking is in poor condition. Some concrete sections have heaved while others are severely crumbling. Both conditions have a cumulative effect of making it extremely difficult to traverse the area with a wheelchair.

Although handicapped compliant, the sloped walk is cracked and heaved in several locations.

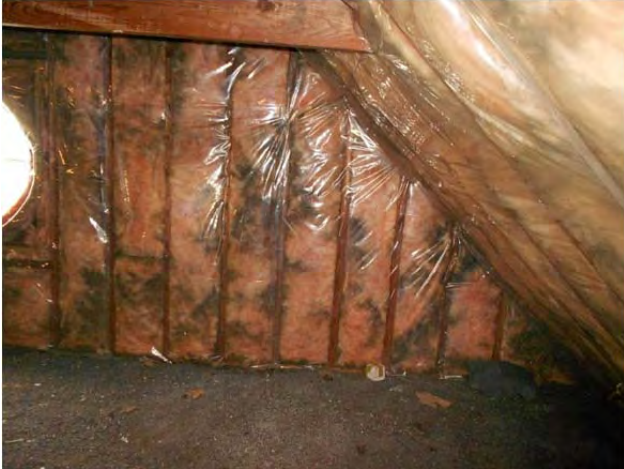
B wing's attic, while well insulated, is heavily compromised by moisture and possible mold.

difficult for those carrying tools. Within the attic, there is widespread staining on batt insulation in both the attic walls and roof rafters.

Please note, the staining on the insulation and framing may be mold. Also, the existing tar and gravel roof may contain hazardous materials. Both should be tested by a licensed testing agency.

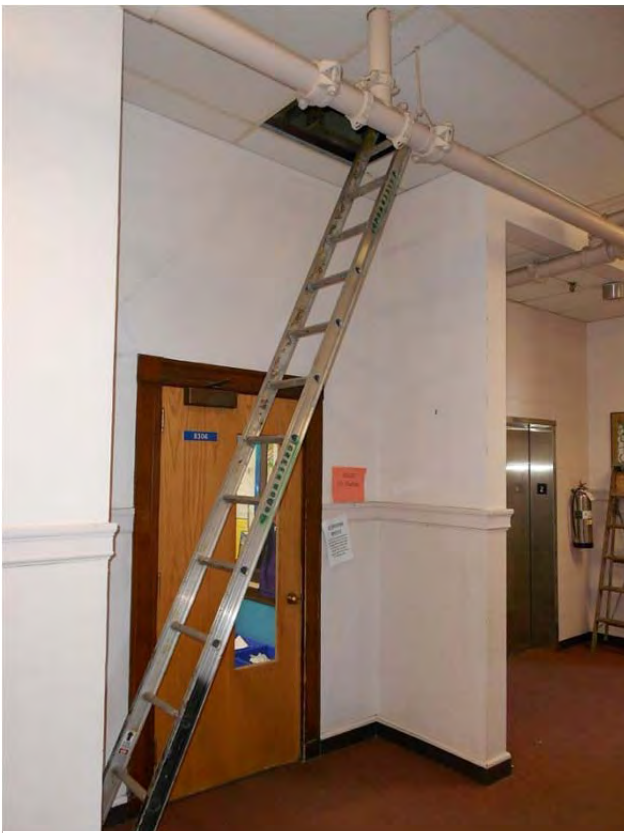
Access to the attic area is by ladder through a ceiling panel in the second floor corridor, directly outside of a classroom door. This access creates an unsafe condition / hazard for maintenance technicians in the attic, technicians on the ladder and occupants of the classroom. The actual scuttle into the attic is small and

Ladder access to B wing's attic is dangerous for both workers and building occupants.

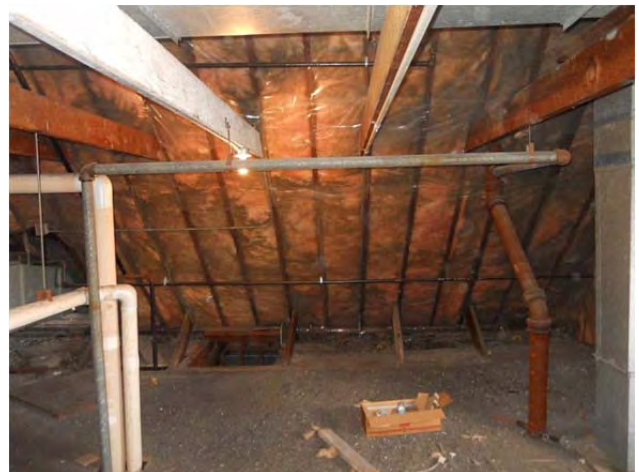
Access to the attic in B wing is located at in the eave space, limiting ease of access.

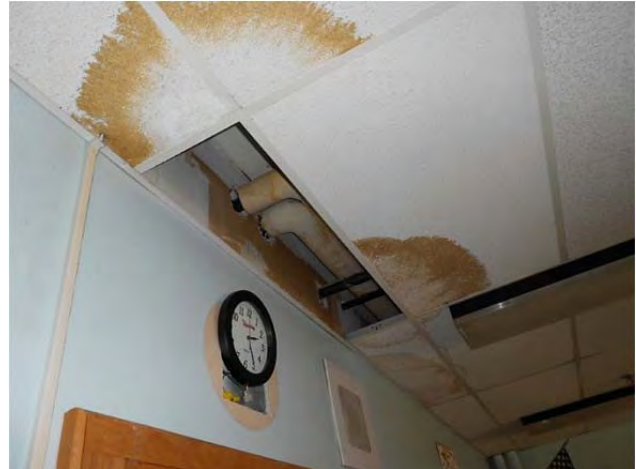
Existing ceilings throughout the building are stained from roof and steam pipe leaks.

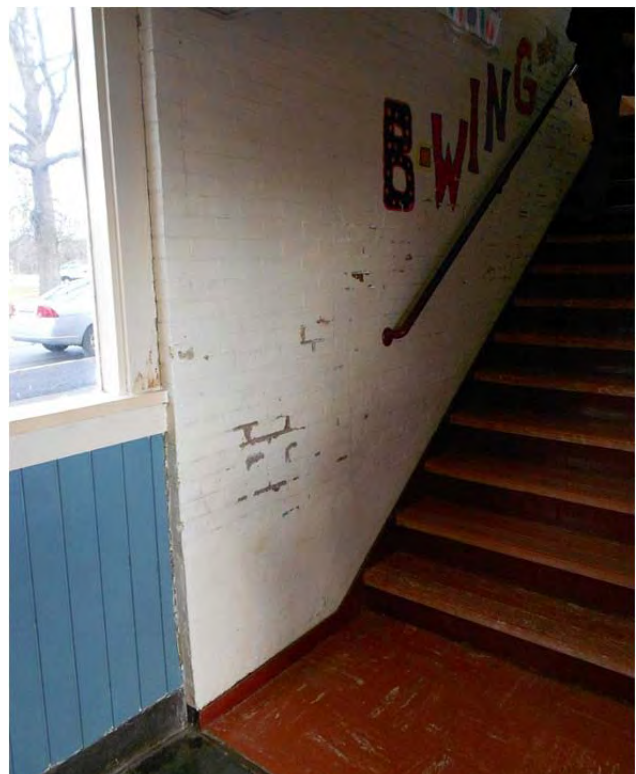
Painted exterior masonry surfaces throughout the building typically have peeling paint.

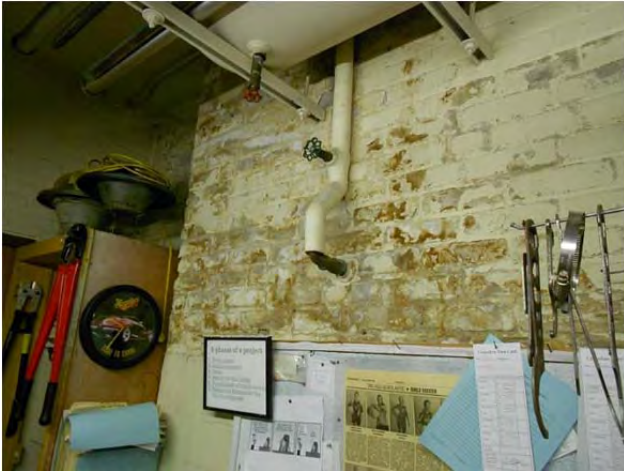
In other areas, paint on masonry walls is in a variety of conditions. In the basement, areas such as corridors and the cafeteria are in fair condition. In basement utility areas, paint is in poor condition.

Painted masonry walls in B wing's utility areas.

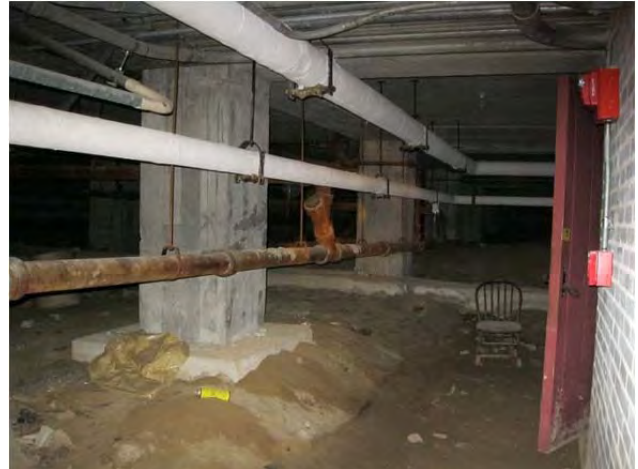
A wing crawlspace

Below the classroom wing, the concrete columns, beams, and floor slab form a modest crawlspace area with a dirt floor. The area was extremely humid at the time of inspection and had some standing water in the sump pit despite there being no rain for days. Ventilation was not perceivable from the small perimeter brick vents.

The extreme moisture and lack of mechanical ventilation have caused pipes, conduits, and other MEP devices to rust on the outside. Also, open electrical boxes were observed. Both conditions should be dealt with promptly to avoid potential damage.

Insulation and pipe elbows that may contain hazardous materials were observed in the crawlspace. Those items should be compared to the existing hazardous material report. Any items not documented in the existing report, including but not limited to the dirt floor of the crawlspace, should be tested by a licensed testing agency

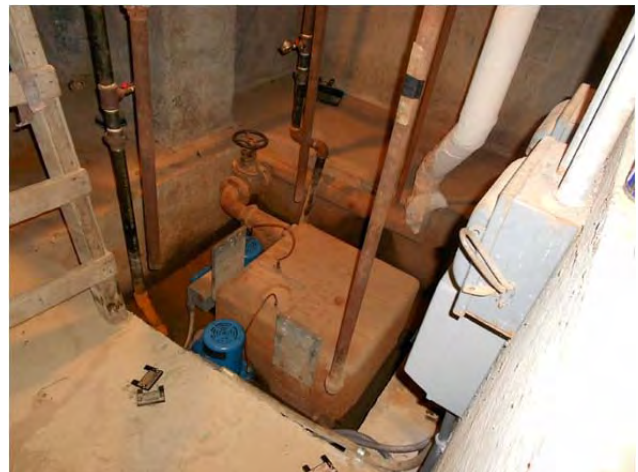
Mechanicals in A wing crawlspace

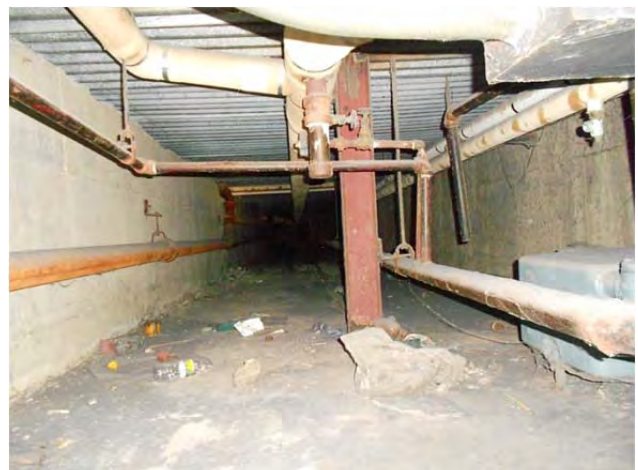
Although the access hatch was open to the B wing environment, the crawlspace was humid. The MEP devices showed similar, if slightly less, rust to those in A wing. As with A wing, insulation and pipe elbows that may contain hazardous materials were observed and should be tested.

C wing crawlspace

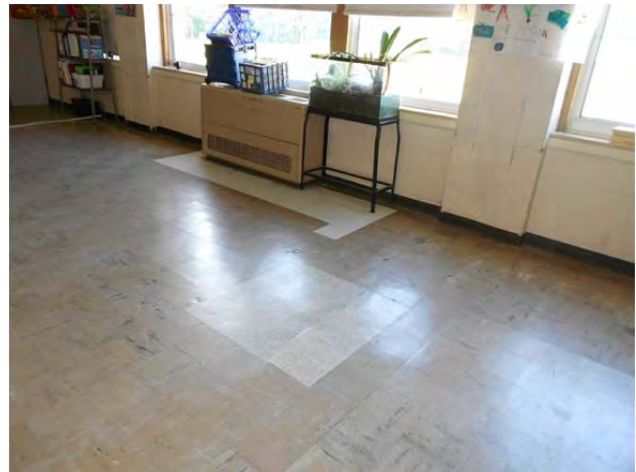
Patched vinyl tile floors are present in all wings

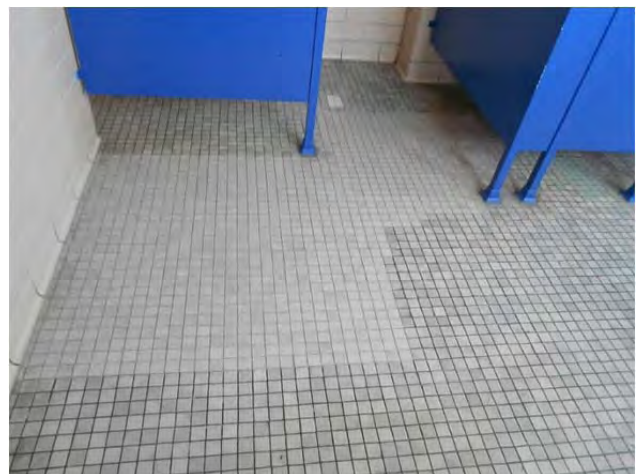
Toilet and janitor areas have ceramic mosaic tile. The tile grout is severely stained and most areas have had non-matching patches at some time.

Patched ceramic tile in a rest room

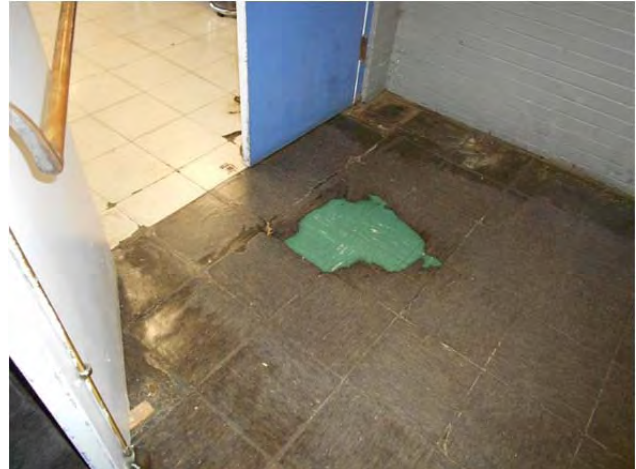
12x12 vinyl patches. Most floors show significant wear across major student circulation paths like doorways and aisles. The condition of the tile is poor at best. The first floor areas show signs of moisture migration around the tile joints from the humid crawlspace below.

Vinyl tile floors are heavily worn and far beyond their useful lives

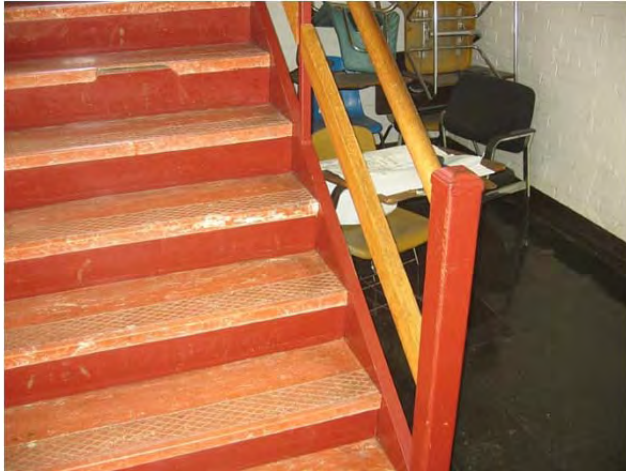
Non-compliant guardrails

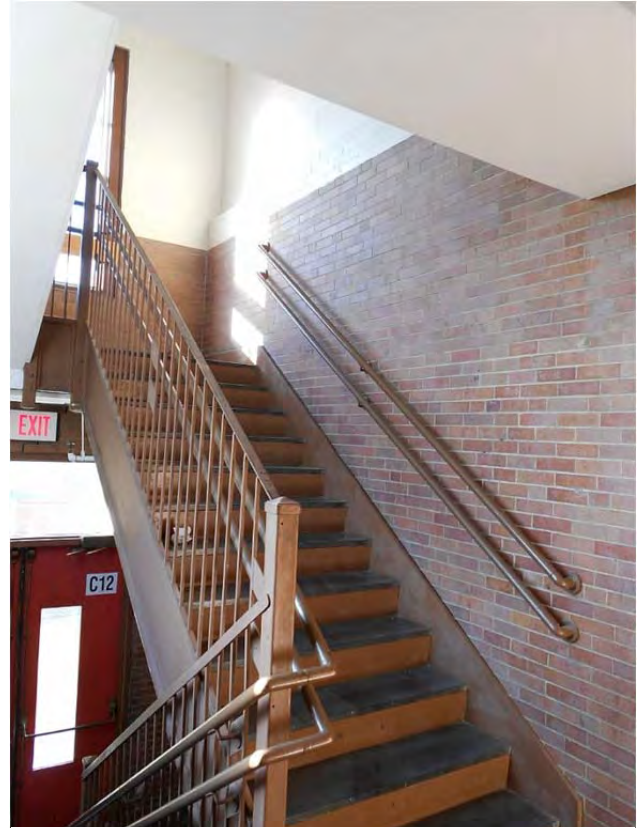
Some stairs are closer to compliance than others. Still, the handrails do not have the proper extensions.

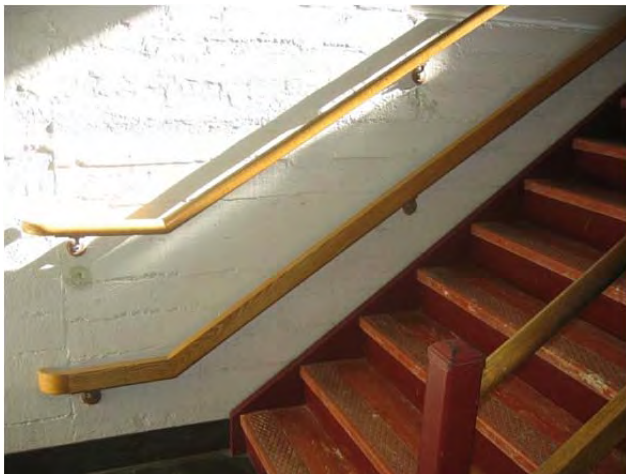
Some wall-mounted handrails are compliant, albeit sporadic. The lower rail is not required nor compliant.

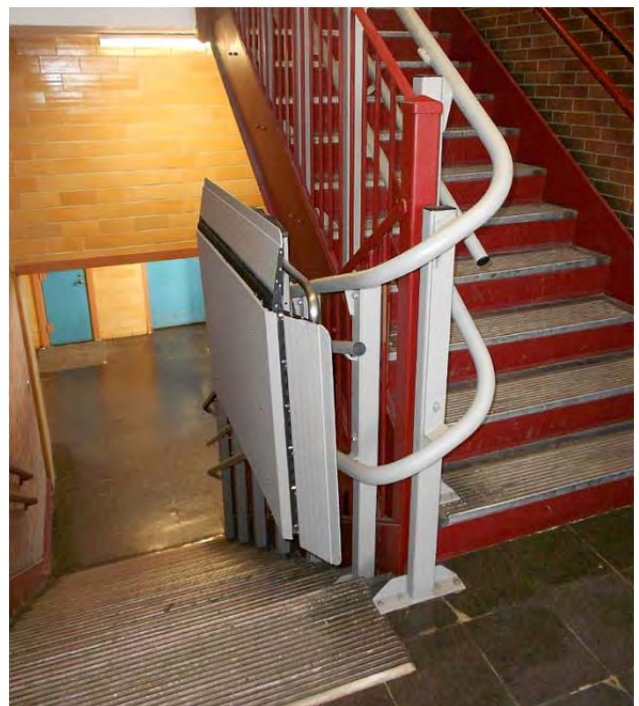
The handicapped lift impedes the stair width

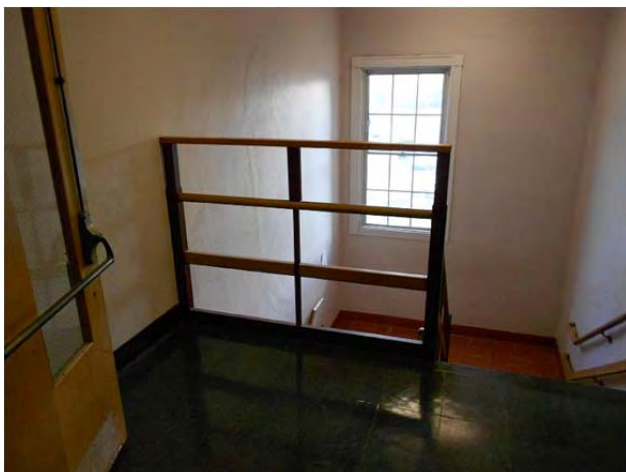
Some existing guardrails have few or no balusters

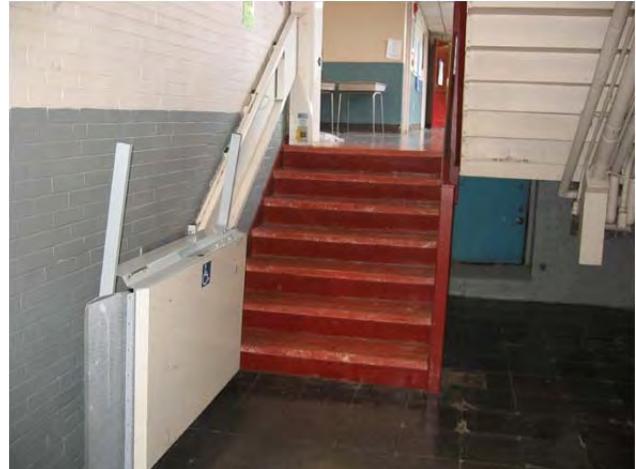
The handicapped lift impedes the stair width

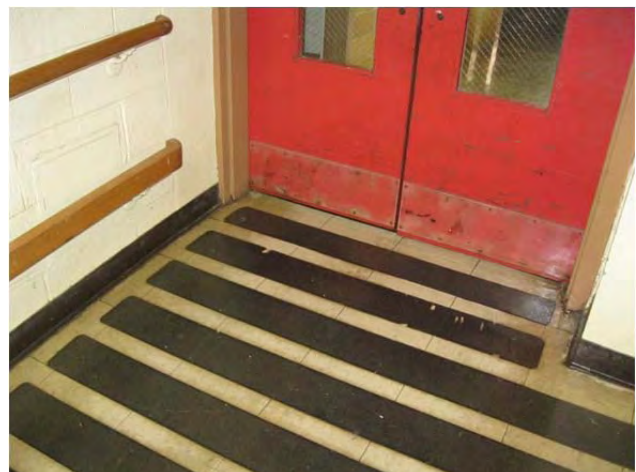
Also in A wing are two newer ramps constructed of plywood and wood framing, one connecting the two levels of the upper level gymnasium lobby and another connecting A wing to B wing on the second floor. The gymnasium ramp appears fully compliant with code. The classroom ramp lacks the proper 60" square landing at a 90 degree turn as required by MAAB.

Ramp in A wing without a landing before the door

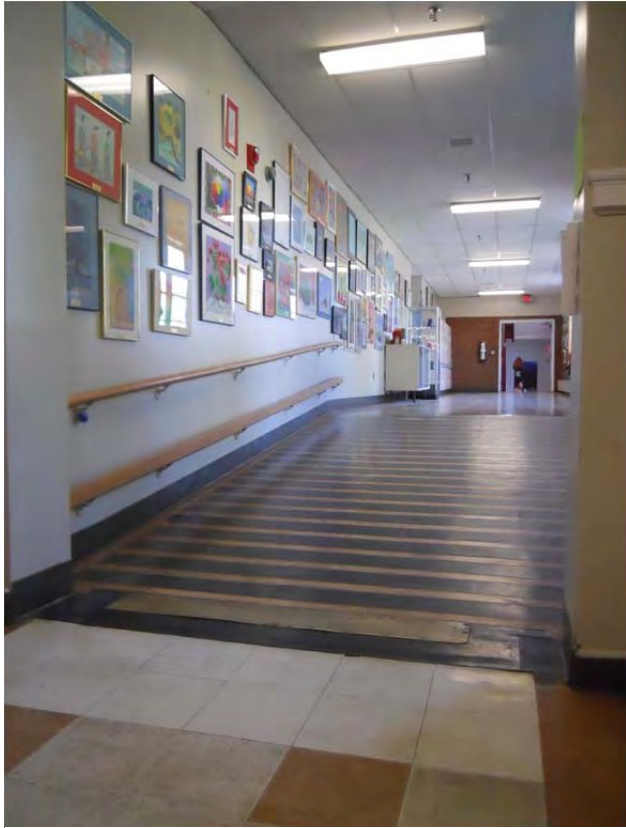
The floors between the original building and the west wing in B wing are connected with ramps on both the main and upper levels. These ramps are not MAAB compliant. The ramps exceed the maximum 1:12 slope and do not have compliant handrails. Also, the ramps extend the full width of the corridor. This presents a problem where the ramp ends abruptly at the adjacent wall thus posing a problem with handicapped individuals.

B wing ramp added in the 1970s is not handicapped compliant

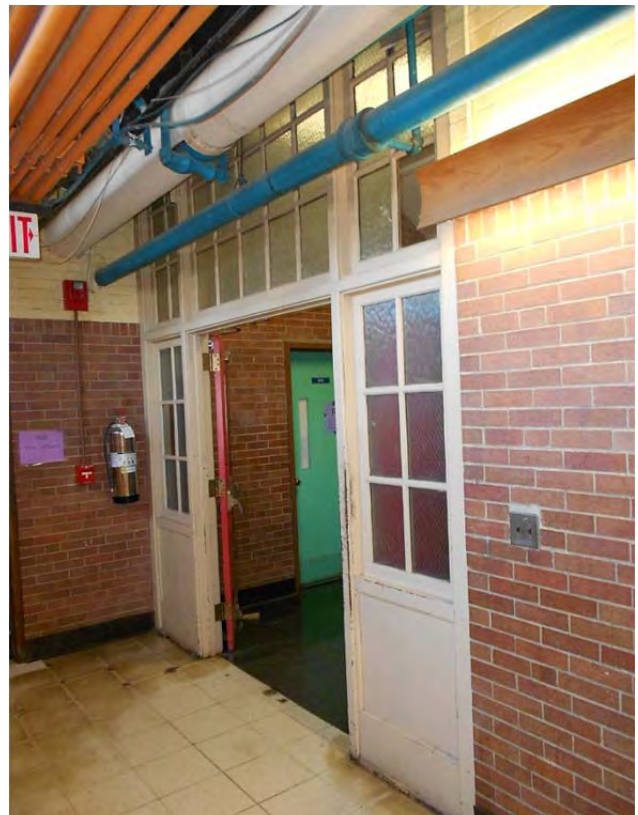
Original unrated stairway frame and glass in B wing

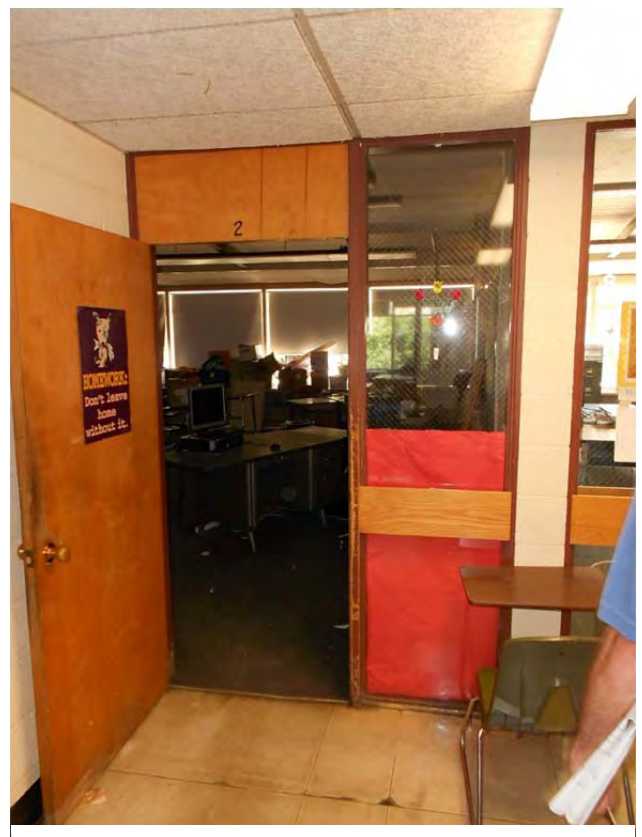
C wing doors, frames, and glass are antiquated

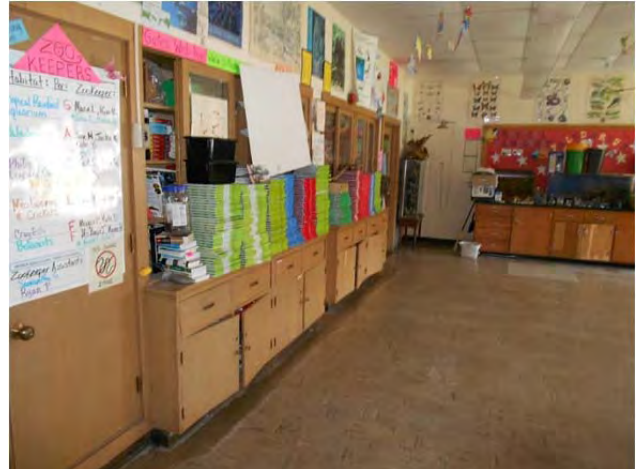
A wing casework is still serviceable but is nearing the end of its useful life

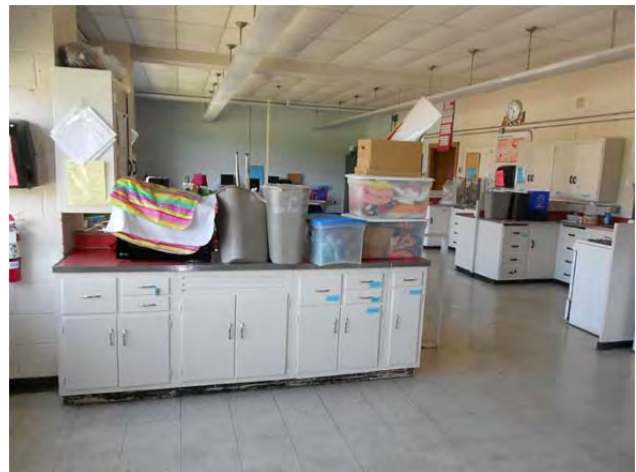
Family and Consumer Sciences casework is old and not handicapped accessible

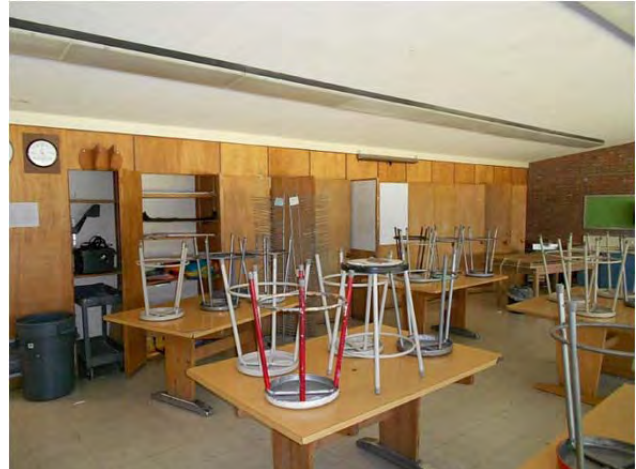
C wing casework is still serviceable but is nearing the end of its useful life

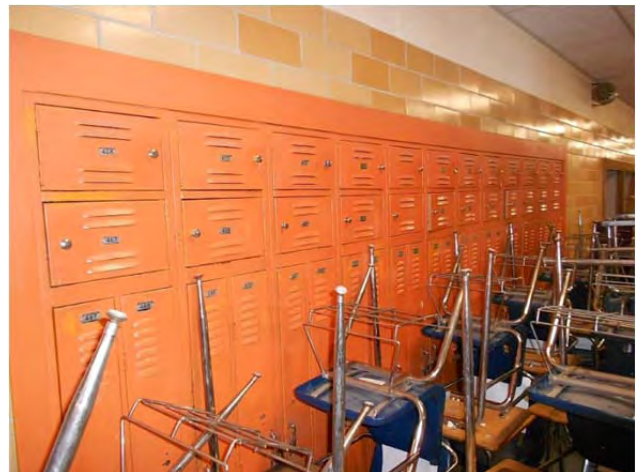
Recess lockers are located in C and A wings. The narrow style lockers do not suit modern needs.

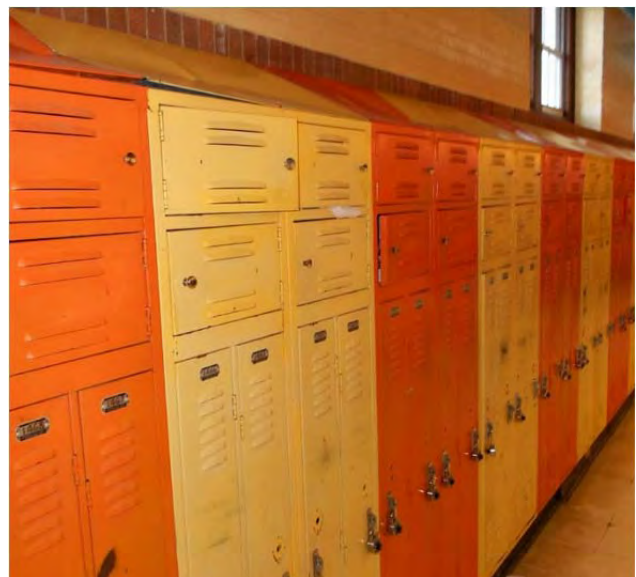
Sloped top lockers are used in B wing but retain the same narrow style as the rest of the facility.

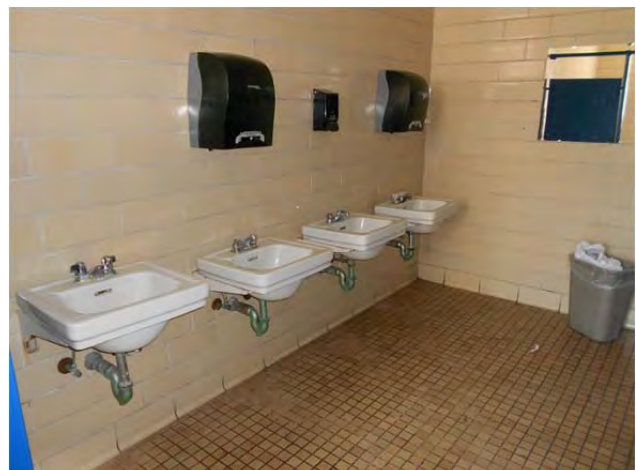
Restrooms have varying levels of handicapped compliance.

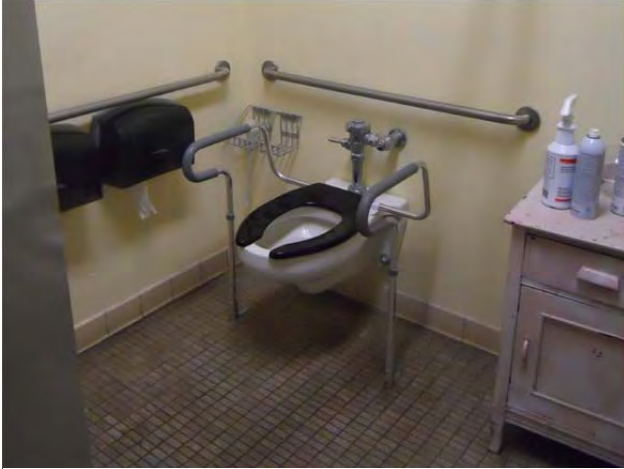
Handicapped compliance has been attempted to be met in non-compliant ways

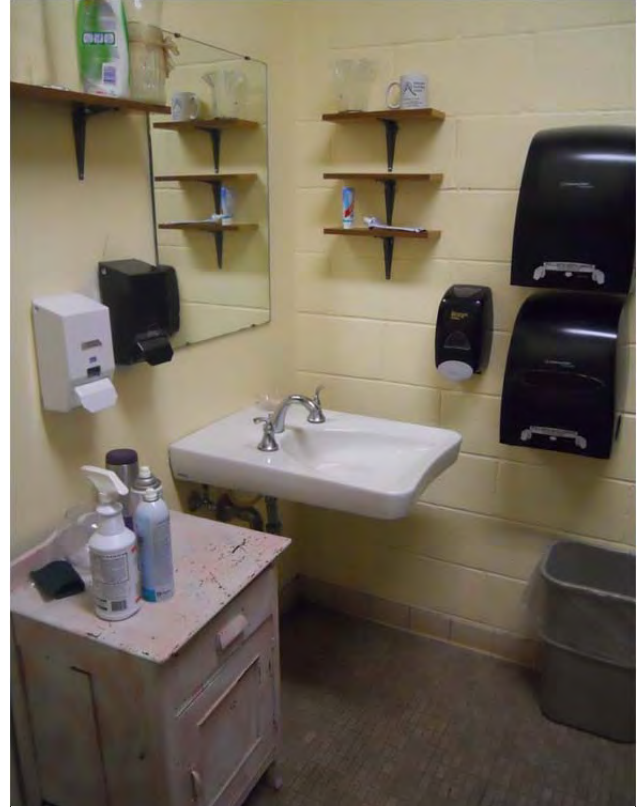
The sink is handicapped compliant but the excess furniture and accessories restrict clear areas.
