Existing Conditions Survey & Feasibility Study

Gates Middle School
327 First Parish Road
Scituate, MA

August 7, 2012

DURKEE BROWN
VIVEIROS WERENFELS
ARCHITECTS
111 Chestnut
Street Providence, RI 02903
tel: 401.831.1240
www.durkeebrown.com

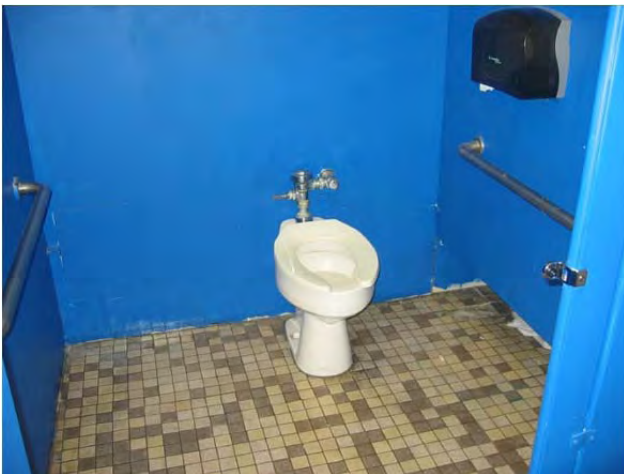
Missing grab bars and too much distance from fixture to the side grab bar make this non-compliant

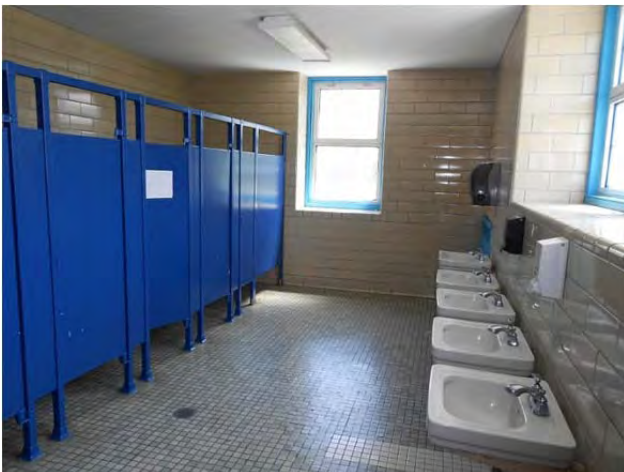
A restroom in A wing that has not been modified to meet handicapped codes.

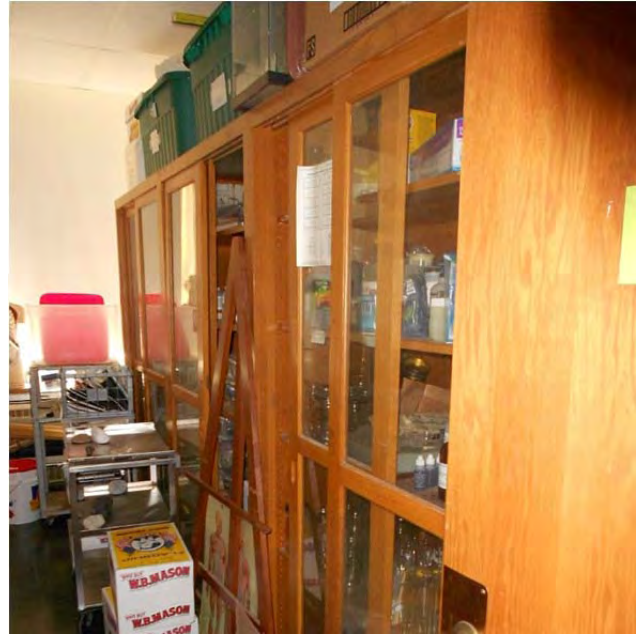
As with any science classroom, storage space is always a need. Storage bins are placed on top of casework and wardrobes up to the ceiling. This is unsafe should the material shift and fall. It is also a potential fire hazard. Even if the building were sprinklered, which it is not, items must stay a minimum of 18" below the ceiling.

Science Prep Room casework with storage to the ceiling

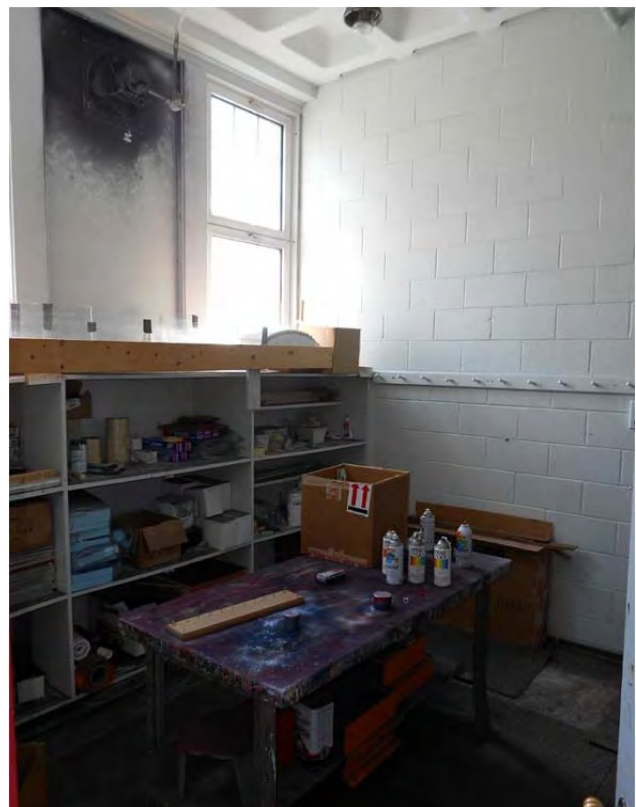
An adjacent storage room is being used as a makeshift spray booth without adequate ventilation. A thru-wall fan located high on the wall was stained with paint spray, along with the floor and equipment around a table in the center of the room. The spray paint cans were stored in an unlabeled cabinet adjacent to combustible materials.

Spray painting without ventilation hood at work area.

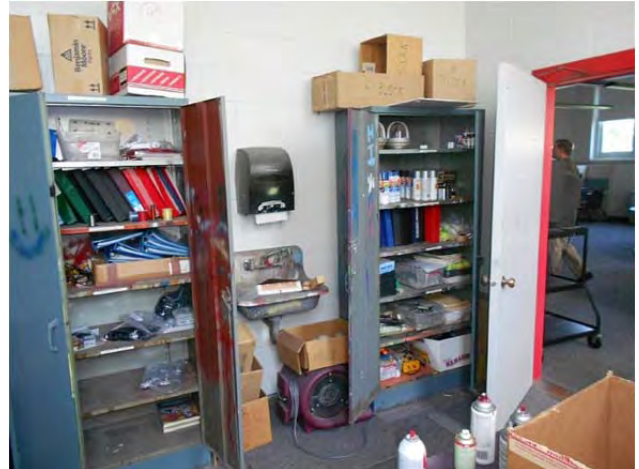
Paint storage should be away from combustibles and stored in approved cabinets.

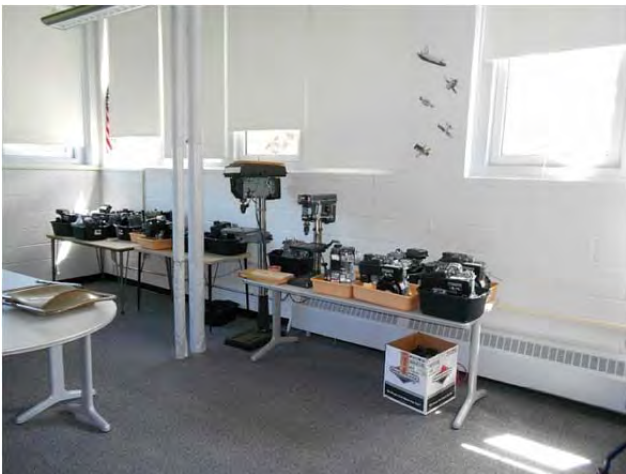
Small engines were observed being stored in one area of the classroom. It did not appear that special provisions for ventilation and fluid containment were in place within the classroom for the small engines. If these engines are run within the space, carpet over wood floors is the worst possible floor finish for fire safety.

Small engine repair within the building adds many specific Code requirements like ventilation.

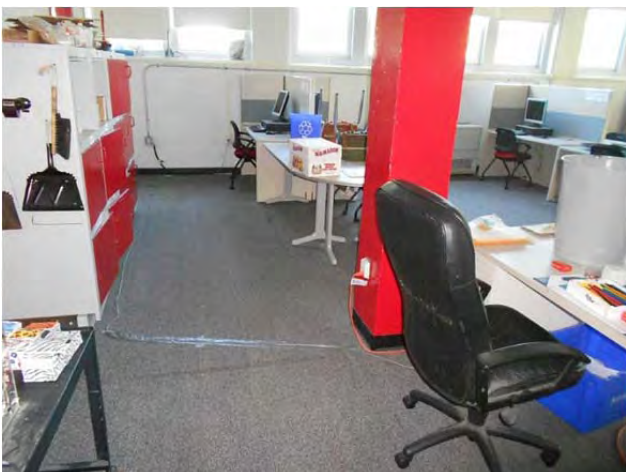
Technology wiring taped across floor in the Mod Tech Lab.

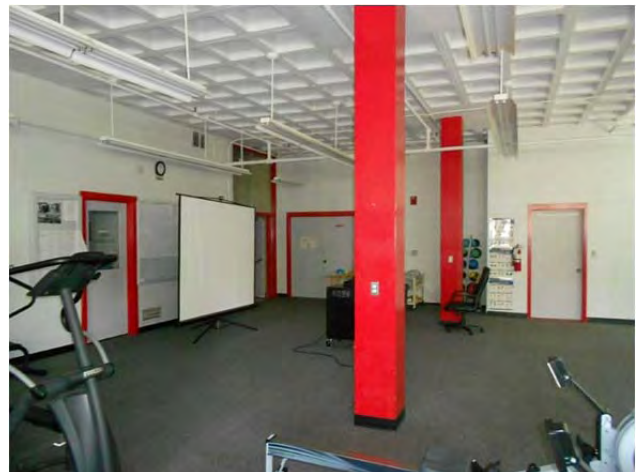
There is limited free space in the exercise room for activities like yoga or aerobics.

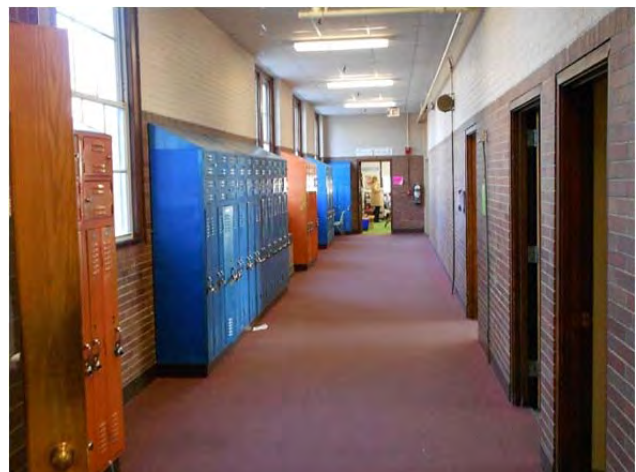
To compound the issue, the corridor within the east wing of B wing is too narrow for the volume of students encountered during class changes. The corridors are nearly 8'-6" wide with 12" deep lockers located along one side. When students are at those lockers, the effective width of the corridor is reduced to around 6'-0", thus limiting circulation to single-file flow in each direction.

Corridor widths are further compromised by adding lockers to one side.

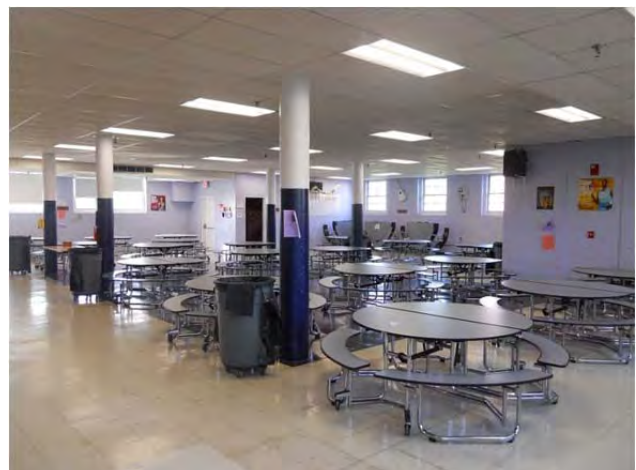
Cafeteria

Aesthetically, this is not very appealing. Although adequate for illumination, the 2x4 lay-in fluorescent light fixtures do not help the aesthetics.

One deficiency to note was rusting and grease-covered ceiling tile near the cooking hood. Another is the severe inclined ramp for deliveries from outside down to the kitchen level, which could be extremely dangerous in wet or icy conditions, or when traversed with large or heavy loads.

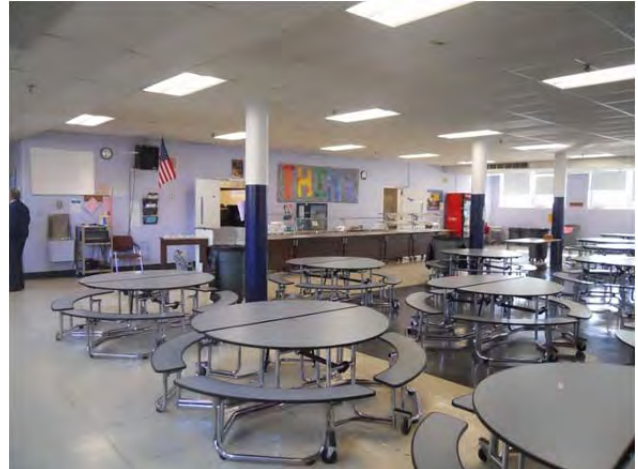
The serving lines are located in the cafeteria space itself. While not an ideal location to protect the equipment from damage, the layout appears to function well. The equipment is clean and appears maintained, as does the kitchen. The kitchen area itself also appeared clean and maintained, even when food prep was occurring during the walk through. Ceramic tile walls and quarry tile floors were well kept.

The serving area is located within the cafeteria space

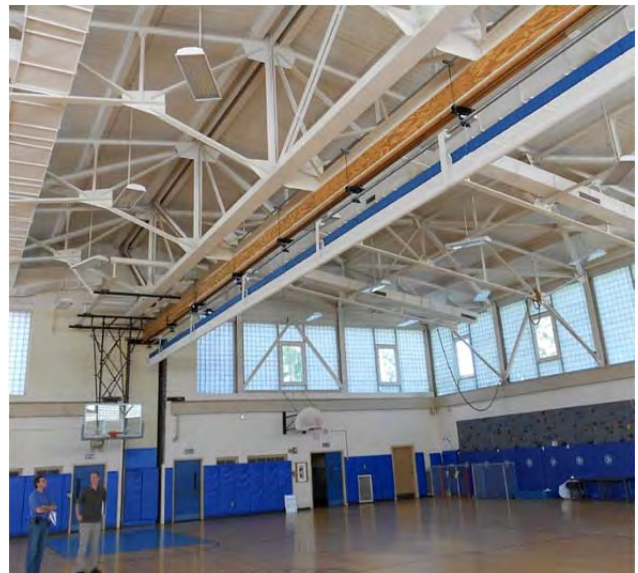
The original gymnasium operable wall has been replaced with a roll up divider curtain.

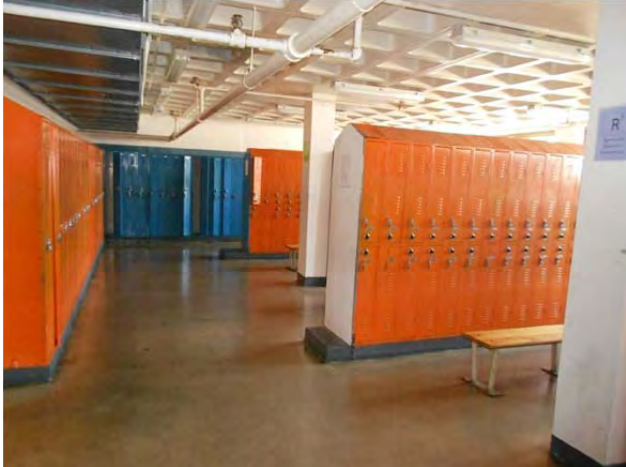
The men's locker room has plenty of room for circulation

CMU walls. The concrete floors in the boys room exhibited extensive hairline cracking from an unknown source. The layout for the boys room allows ample room for circulation and handicapped accessibility. The girls room, due to the changing stalls and showers, is not accessible.

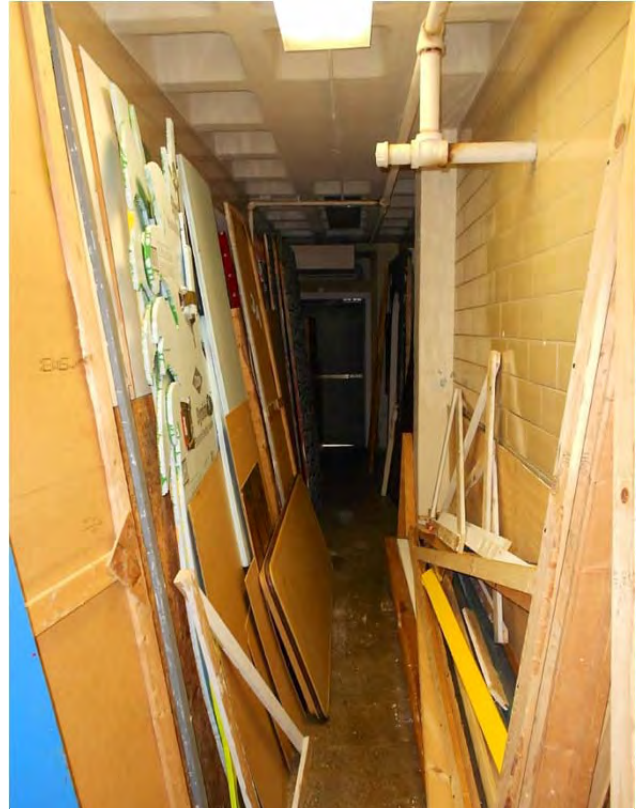
The second means of egress from the men's locker room is nearly blocked with storage.

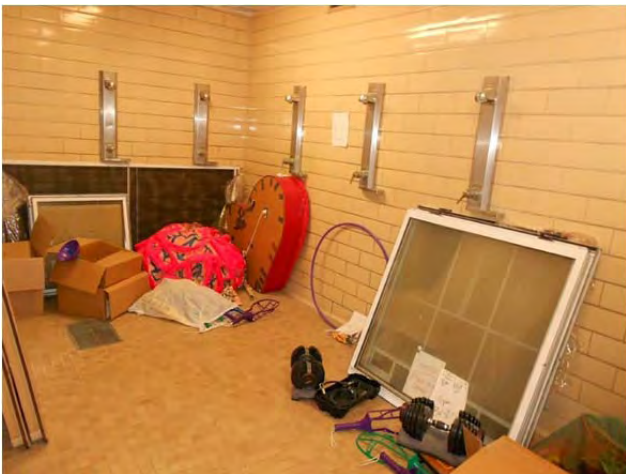
The men's shower area is being used for storage.

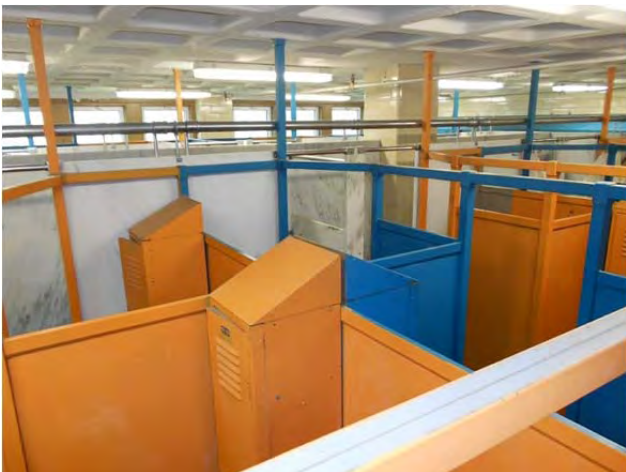
The women's changing booths are dated but serviceable.

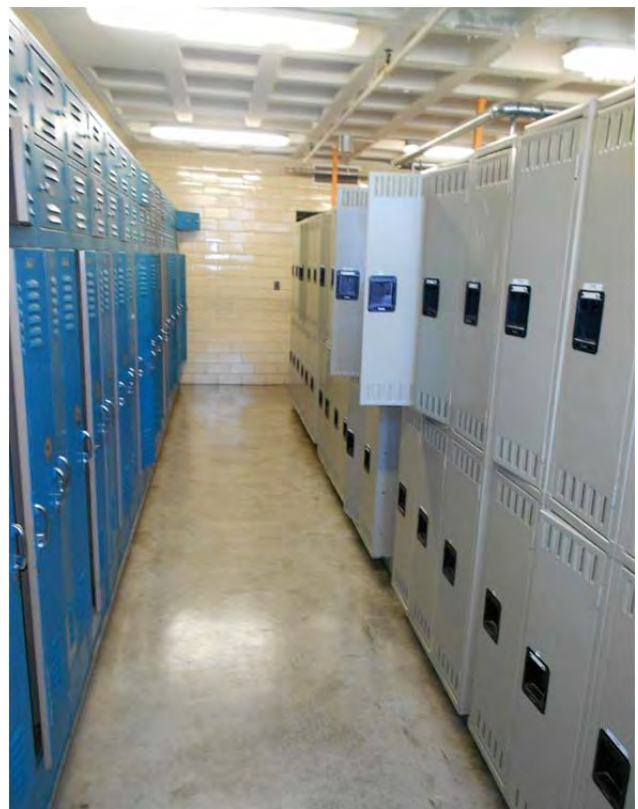
The women's lockers consist of many different styles and eras.

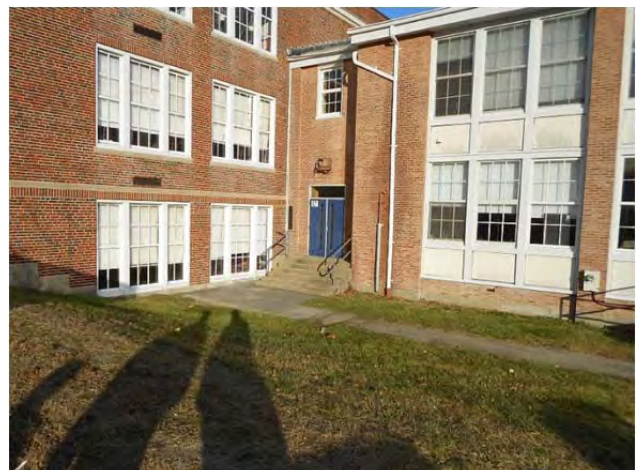
On the south side of the site, in order to have a level play field, fill was used to raise the grade. This causes the grades to slope towards the building, most severely in the corner connection between A and B wings.

Grade slopes towards the building

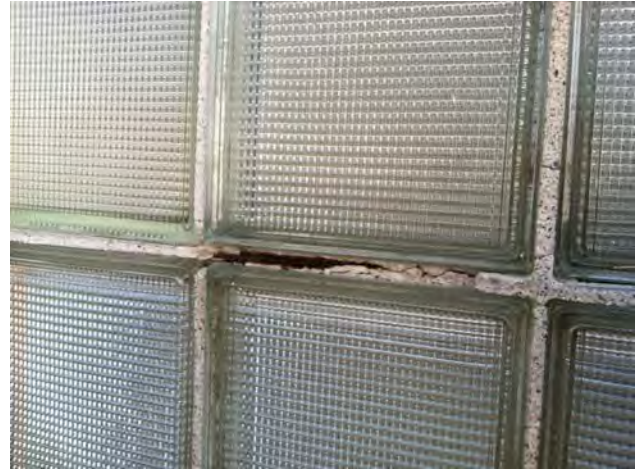
The structural steel that supports the glass block wall construction in the gymnasium is deteriorating. The rust jacking of the steel is beginning to cause localized spalling of the mortar between blocks and will eventually cause damage to the glass block units. The existing glass block needs to be removed and replaced with new glass block and new steel wall framing members, or with a new translucent wall panel system.

Rusting steel supports in glass block mortar joints at upper gymnasium wall (A-Wing)

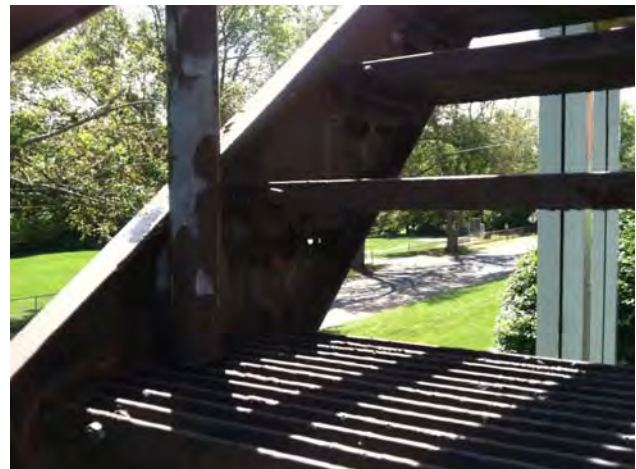
Both exterior egress stairs on the east end of the gymnasium are in very poor condition. The steel stringers, treads, and railings are not galvanized and are deteriorated. In some areas, the deterioration is so severe that it extends through the full thickness of the steel. The existing stairs need to be removed and rebuilt in their entirety.

Deteriorated steel stringers and treads at gymnasium east egress exterior stairs.

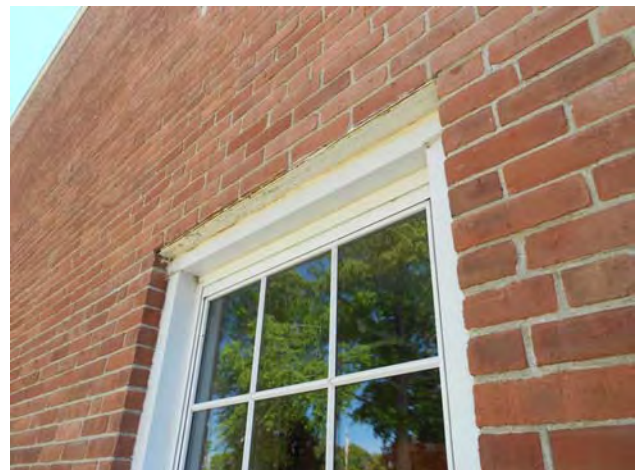
The existing exterior window and door lintels at the gymnasium, classroom wing, and connector are not galvanized and are starting to rust. There were no signs of significant rust jacking and therefore, it is assumed based on visual assessment alone that these lintels can just be cleaned and painted. The existing lintel conditions do not represent an immediate structural deficiency, but something that should be addressed within the next few years.

Peeling paint and rusting lintel at A-Wing.

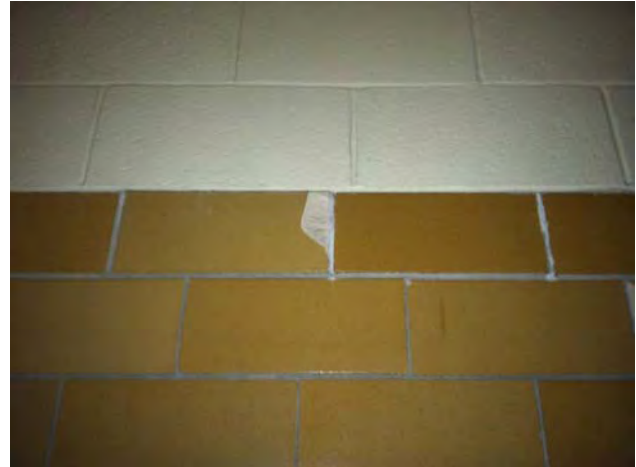
There are numerous areas where there are cracks and spalling of the interior glazed block wall. These walls are not load bearing. The locations observed with spalling at the interior face do not appear to be related to any structural or moisture issue. The spalling occurs randomly and even occurs in areas with very little structural loading (such as under a window). It is my opinion that the spalling is not a structural issue and may be caused by a material flaw.

Random spalling of interior face of glazed block.

None of the cracks that I observed were significant structurally. The spalled areas can be replaced with new units to match the existing. The areas with cracks can be repointed and cracked units replaced with new units to match the existing. In some areas that are the result of thermal stresses, it may be more suitable to repoint with a flexible material between adjacent units.

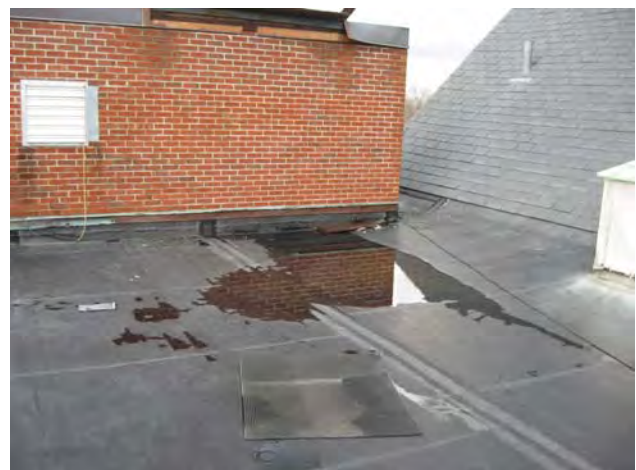
When the gable roof was constructed over the existing flat roof in 1931, it created a significant potential increase for drifting snow load on the adjacent existing flat roof joists on the south side of the building. Along the west edge of this roof there is also a vertical projection created by the elevator mechanical room that was added with the 1974 renovation. This vertical wall also creates the potential for significant localized drifting snow. Based on my observation of existing conditions and my review of the structural drawings for the 1931 and 1974 renovations, the additional drifting caused by these two conditions does not appear to have been addressed. In many cases, older codes did not address drifting conditions at all. Based on the current code, the additional drift potential is approximately 50 pounds per square foot above and beyond the base design snow load requirement of 35 pounds per square foot. This creates an increase in stress on the existing flat roof

Vertical roof projection – added snow drifting.

rafters of nearly twice the allowable in the area immediately adjacent to the mechanical room projection.

This condition is very significant structurally and so it is my recommendation that this portion of the roof framing be reinforced by sistering each of the existing rafters with 2x12 LVL's. This work should be done regardless of any future renovation to the building. Until this work has been completed, the snow should be removed from the lower roof during the winter so that the depth of snow on the existing flat roof never exceeds 12 inches.

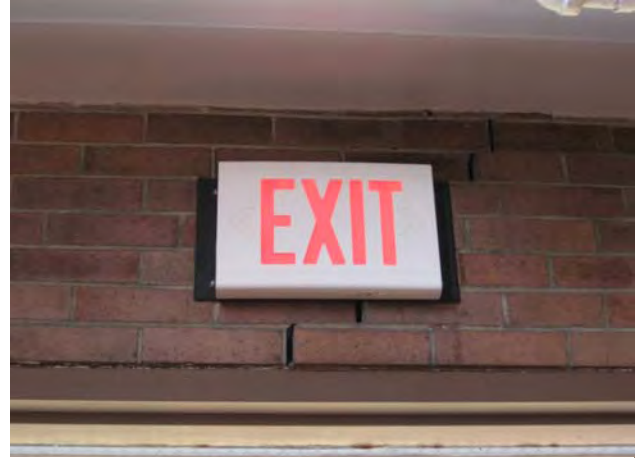
Several significant cracks were observed in the interior masonry walls of the southwest stair. The cracks varied in thickness from hairline to approximately 1/4" in thickness. In some areas, there has been out of plane movement on opposite sides of the crack. There are a couple of possible causes for these types of cracks. The diagonal cracking could be the sign of differential settlement. However, there do not appear to be any other typical indicators that settlement is a problem in the building. Also, settlement typically occurs early in the life of the building and these cracks appear to be much more recent. Settlement cracks also are not typically out of plane. Based on this, it is my opinion that the more likely cause of these cracks is that they are result of water infiltration into the wall. With this type of solid masonry wall, water infiltration can cause severe damage. If the water gets trapped and freezes, it causes the walls to crack and push out resulting in out of plane movement. It appears that the most likely entry point for water getting into the walls was with the original belt course detail near the top of the wall. This was removed and replaced during the most recent façade renovation and so it is likely that previously deteriorated belt course was allowing water into the wall. The cracks above the entry door are most likely related to failure of the flashing over the entry canopy roof which was also repaired during the 2006 façade renovation.

In-plane cracks over door in southwest stair (B-Wing).

It is my recommendation that the masonry walls in this stair be repaired by removing localized portions of the cracked interior face and reconstructing. These existing conditions do not represent a severe structural deficiency, but something that should be addressed within the next couple of years.

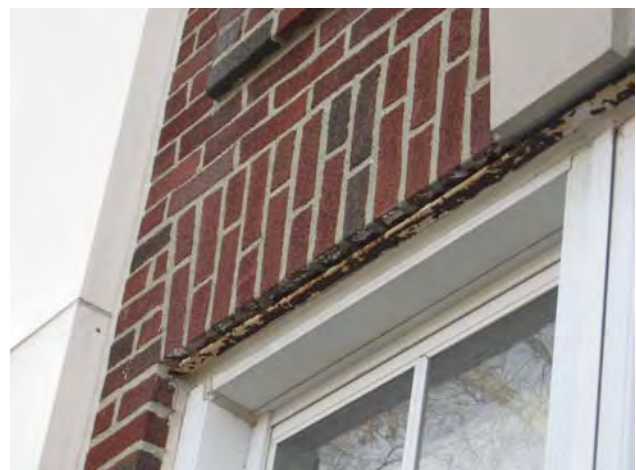
During the 2006 exterior renovations that were made to the building, many of the original exterior lintels over windows were replaced with new galvanized lintels. However, it was noted during my site visit that there were many existing lintels that were not replaced as part

Deteriorating lintel at B-Wing.

of this work. The original lintels are not galvanized nor painted (See photo 2.3). The lintels over these windows are currently exposed bare steel and will deteriorate over time if left unattended.

It is my recommendation that these lintels at the very least be cleaned and painted. Eventually, they will need to be replaced with galvanized steel angles. The existing lintel conditions do not represent an immediate structural deficiency, but something that should be addressed within the next couple of years.

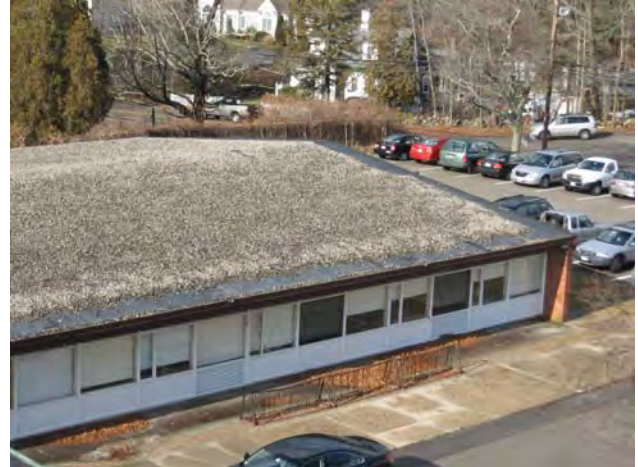
The ballast for the roof membrane has been removed from the edges of the existing roof. The roof edges are the areas with the highest amount of wind uplift. Ballast roof systems are not recommended in high wind areas. The existing roof system should be replaced with a new adhered or mechanically fastened roof system.

Missing roof ballast along roof edges (C-Wing).

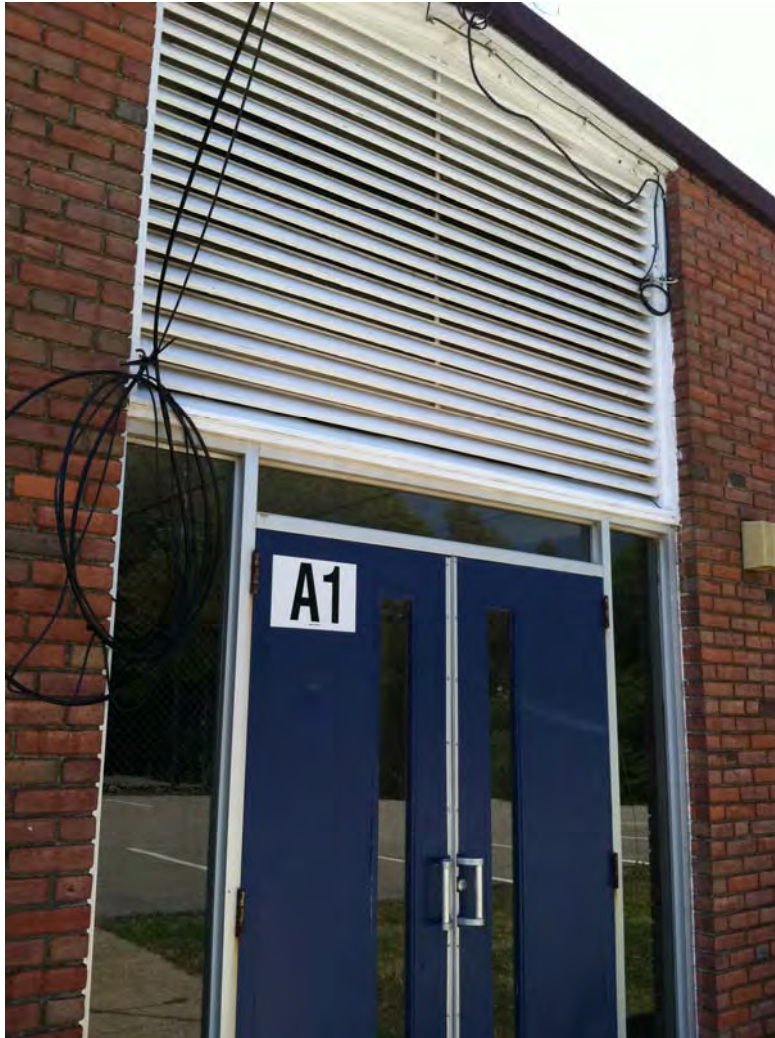
A fan in the attic of the C wing provides exhaust through a gable end louver at the front of the Wing.

The efficiency of the school ventilation system should also be addressed. For instance, based on our visual inspection, the exhaust system exceeded its service life and should be replaced with new more efficient system. A possibility of using energy recovery ventilators should be considered.

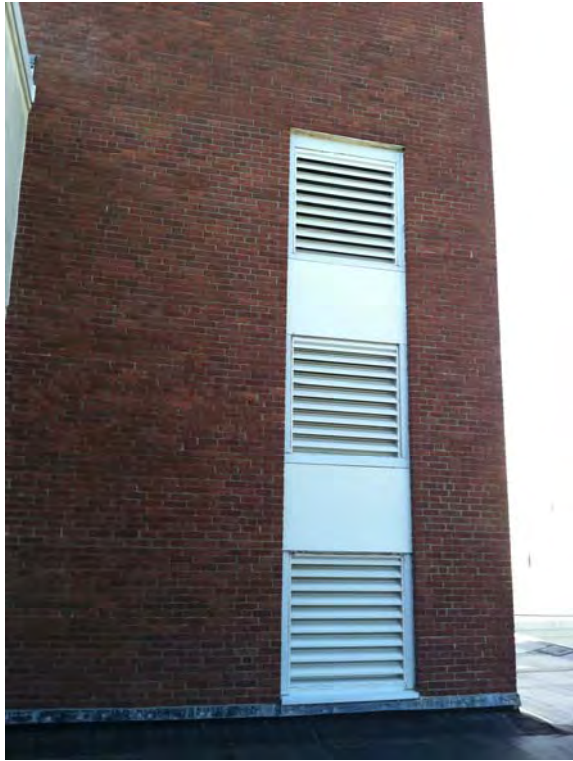
The A Wing gym heating and ventilation system is housed in a tower and the West end of the Gym. Multiple fans and heating coils provide heating ventilation and toilet/locker room exhaust. The ventilation tower has multiple levels and includes louvers and opposite sides for intake and exhaust.

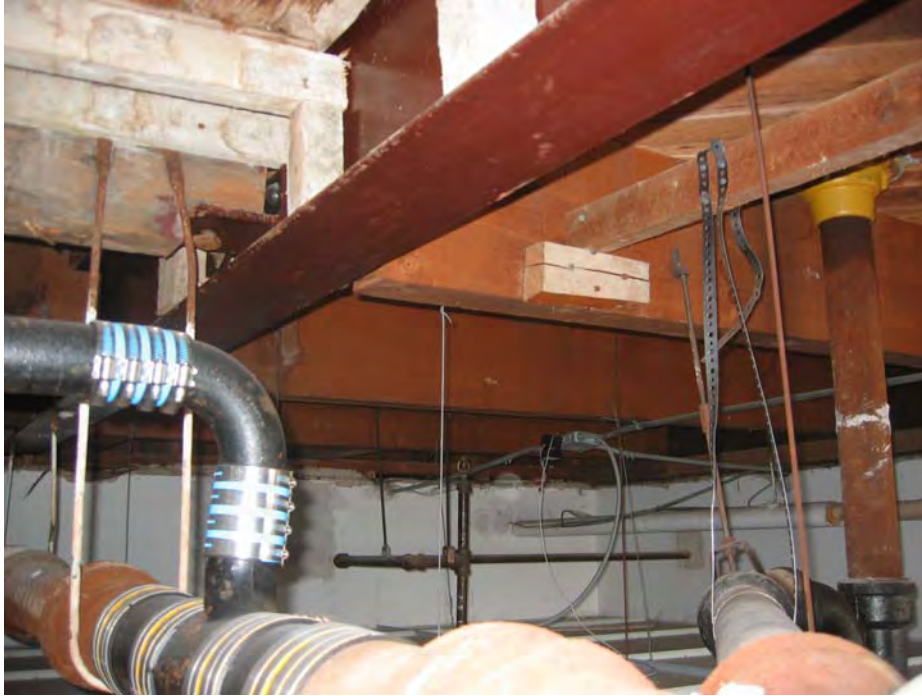
Sanitary piping connects to a municipal sewer system through underground piping on the south and west side of the site. It is possible that sanitary runs under the far west wing based on the drawings furnished by the Town of Scituate.

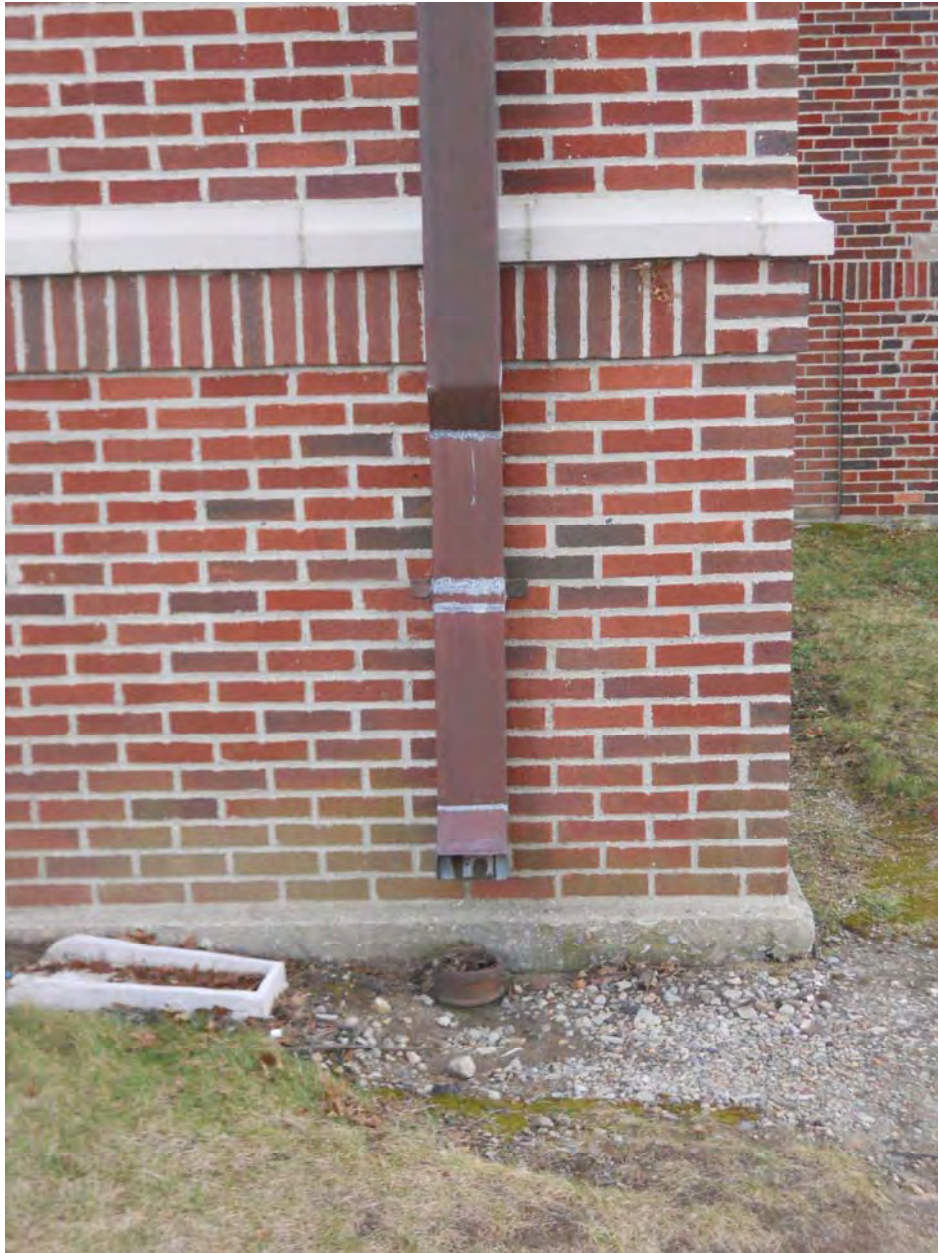
The storm system consists of gutters and downspouts spilling to grade on most of the building sections. Some areas including the Gym and South wing include roof drains and interior rain leaders that extend down through the building and connect to the storm system.

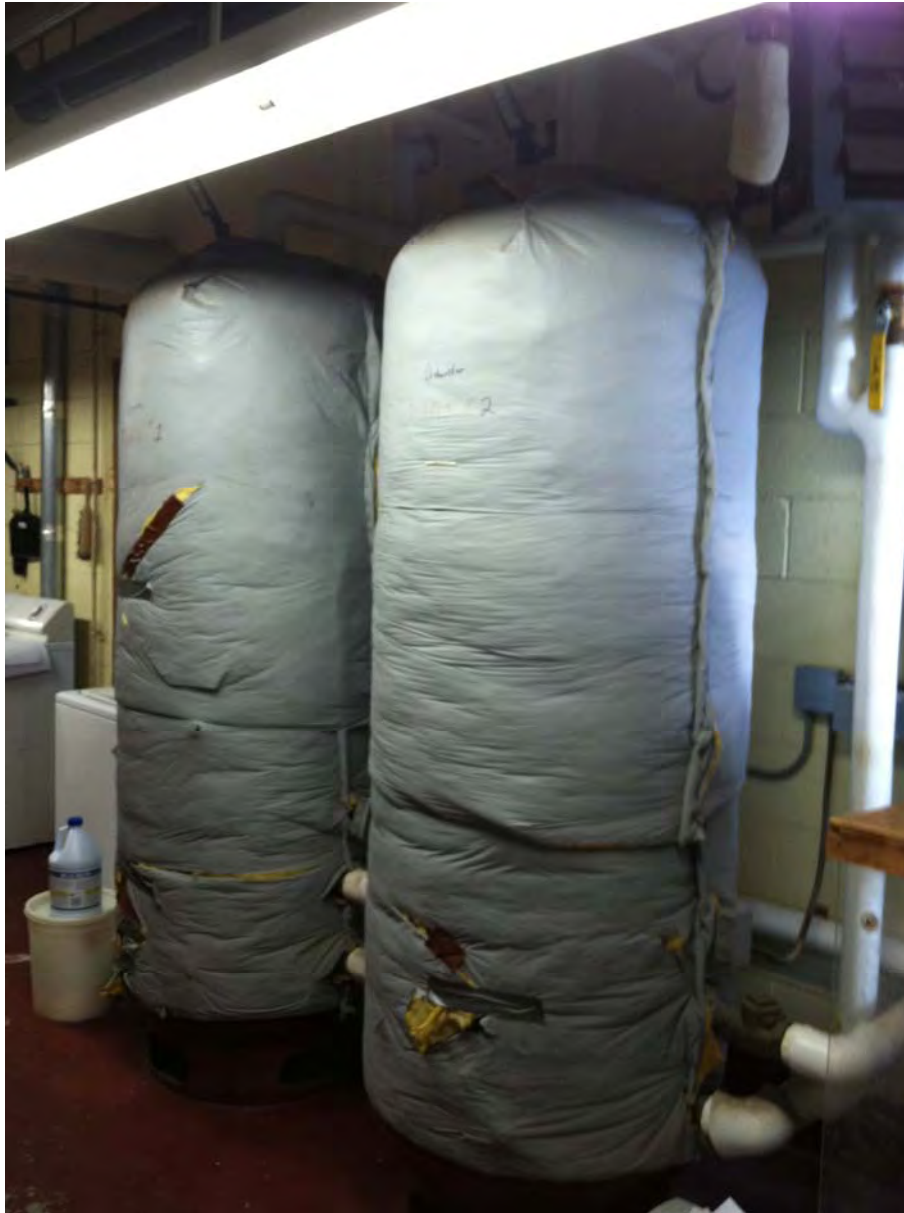
The domestic hot water system was provided to the building from a natural gas fired tank type domestic water heater located within a room adjacent the kitchen. The water heater is an AO smith model BC 670

892 manufactured in 1991. The heater burner is atmospheric and the flue connects directly to the exterior and extends up the outside of the building. There are two insulated storage tanks which store water at 140F for the kitchen and 120F for other use. It could not be determined if the storage tanks have the required ASME stamp. There is hot water recirculation on both systems. Copper distribution piping consisting of non insulated type "L" copper with soldered fittings extends from the boiler room and supplies fixtures throughout the building. Soldered fittings likely include a 50/50 combination of tin and lead.

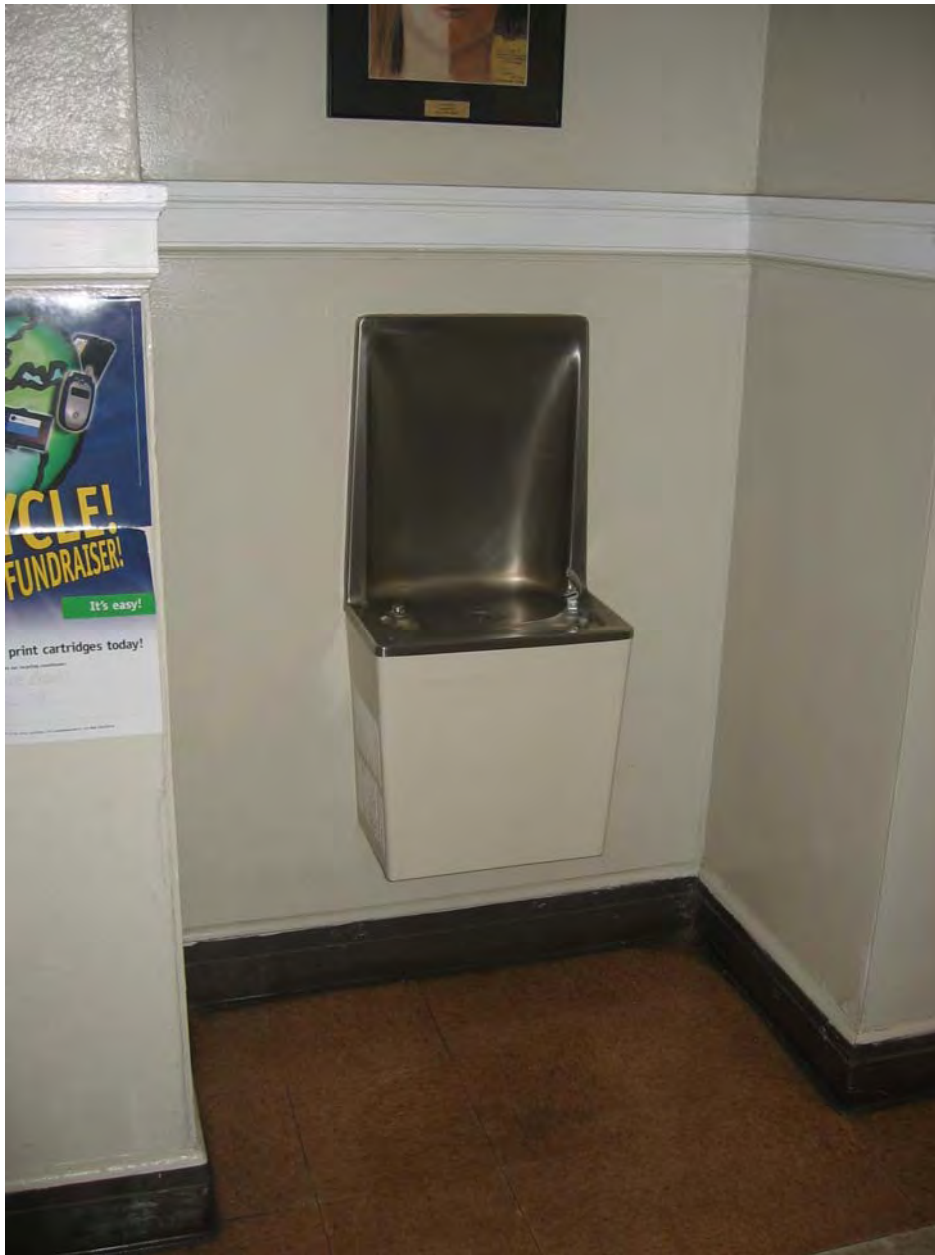
Drinking fountains and water coolers are located throughout the building. Fixtures consist of vitreous china drinking fountains and stainless steel water coolers. The drinking fountains are recessed in walls and the electric water coolers are single level.

Drinking fountains will also need replacement to comply with the current accessibility requirements.

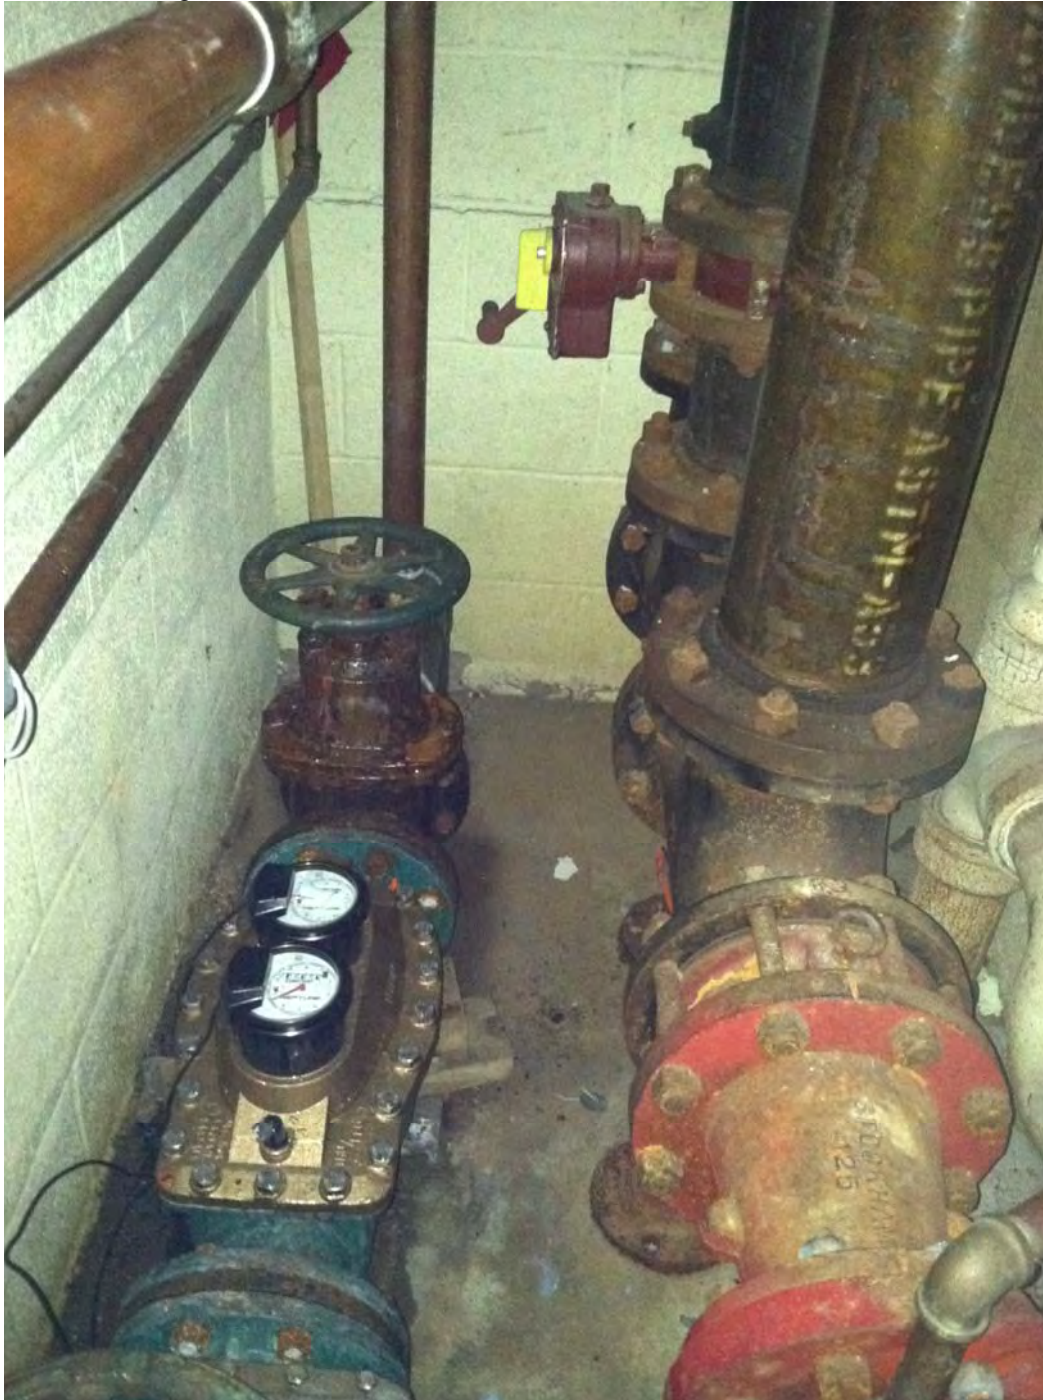
The building is equipped with a fire suppression system in limited areas that include the original building, A Wing attic and locker rooms. The water and fire service room is in the A Wing below the gym. The fire service room includes a vertical fire pump and controller. A double check valve assembly is not installed on the incoming fire service.

The fire protection service will need to be re-located into an area of the building's final configuration. A new fire pump will likely be required as well. All existing sprinkler heads need evaluation for replacement as well. It appears that some of the heads are of a style that is no longer compliant.

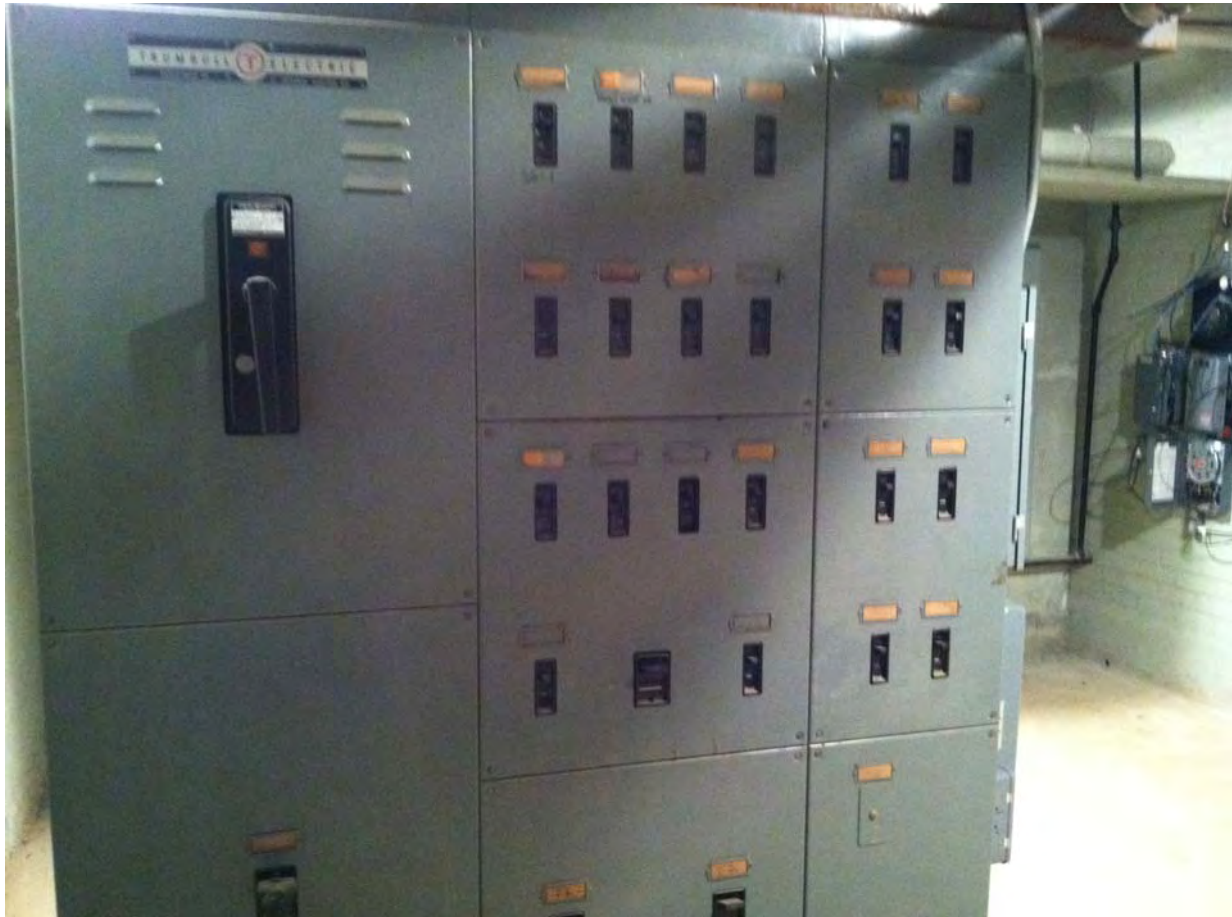
The existing electrical service for the building is located in the A Wing south end basement or crawl space. The service is fed from an adjacent transformer, vault under the building accessible only from and exterior areaway. The primary utility service extends underground from a utility pole on the east side of the site.

A new electrical service will be required if only the original building and adjacent wings are to remain. The majority of the electrical distribution equipment is aged and should be replaced if a new electrical service is installed.

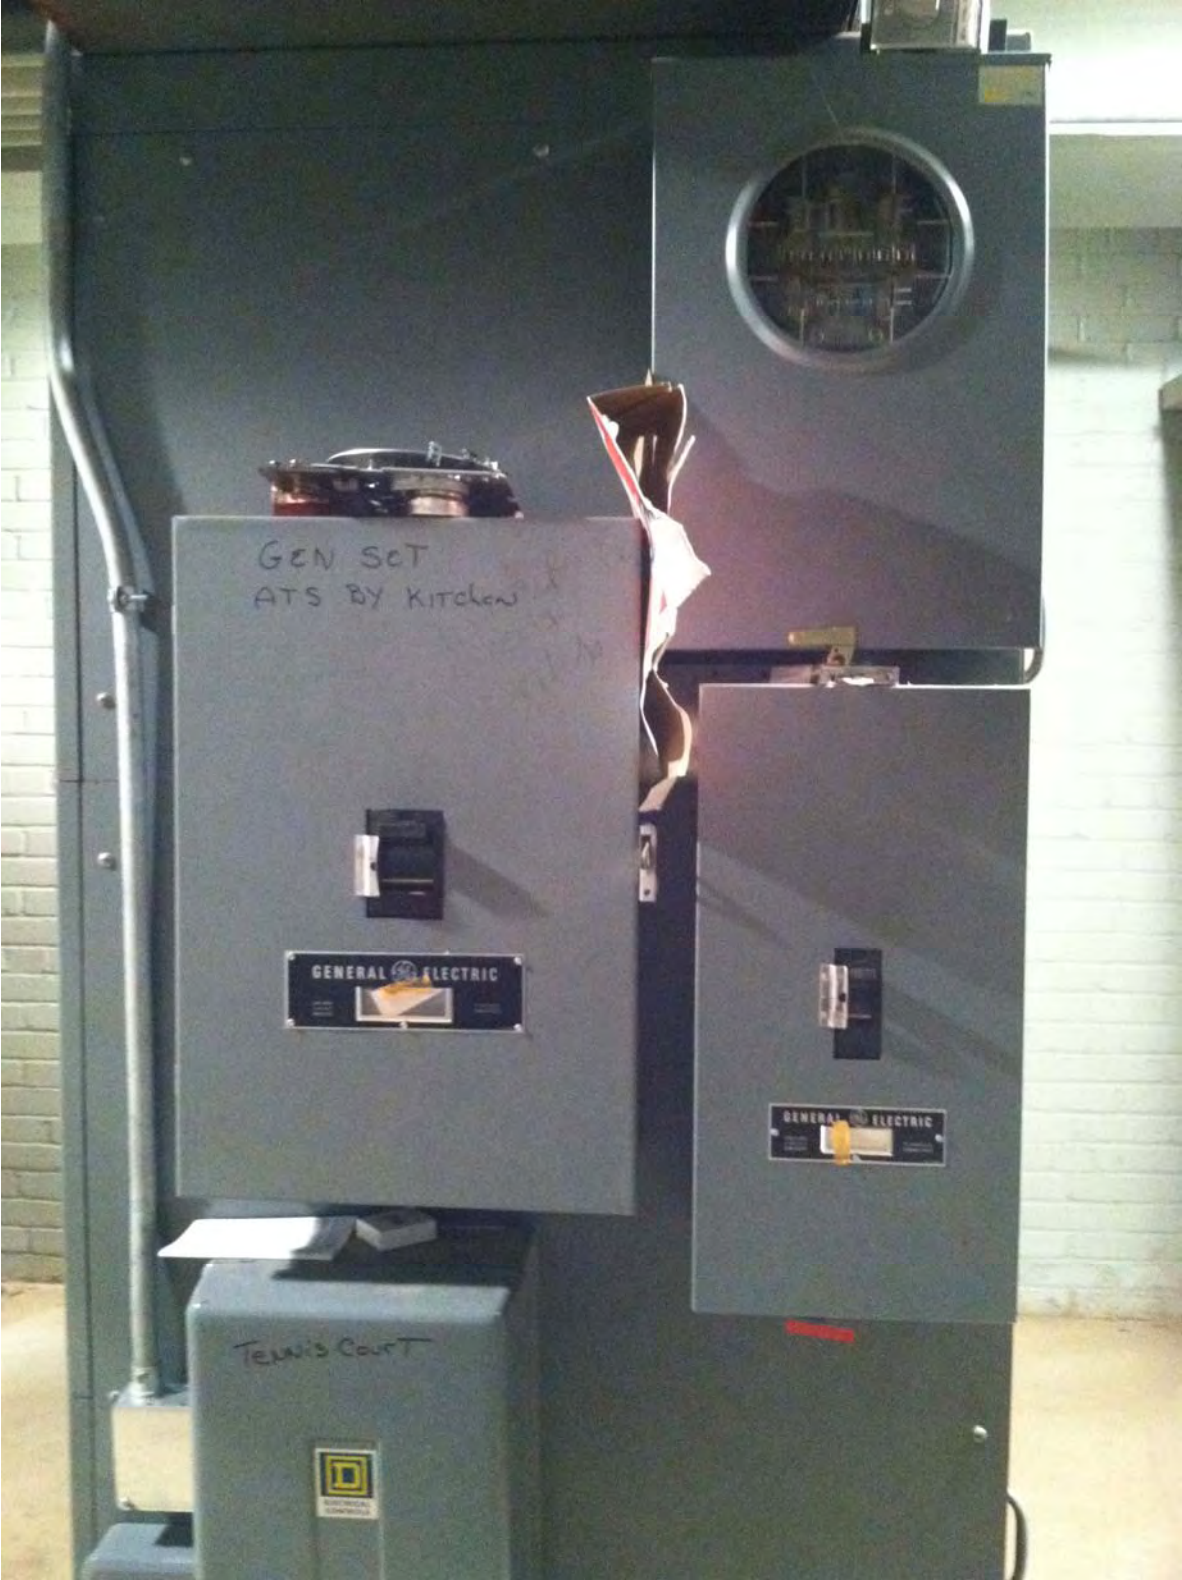
The existing electrical service is 1000A, 120/208V, 3 phase, 4 wire. This service feeds various panels in all other areas of the building. A tap ahead of the main service disconnect feeds the fire pump via the fire pump controller.
