Existing Conditions Survey & Feasibility Study

Gates Middle School
327 First Parish Road
Scituate, MA

August 7, 2012

DURKEE BROWN
VIVEIROS WERENFELS
ARCHITECTS
111 Chestnut
Street Providence, RI 02903
tel: 401.831.1240
www.durkeebrown.com

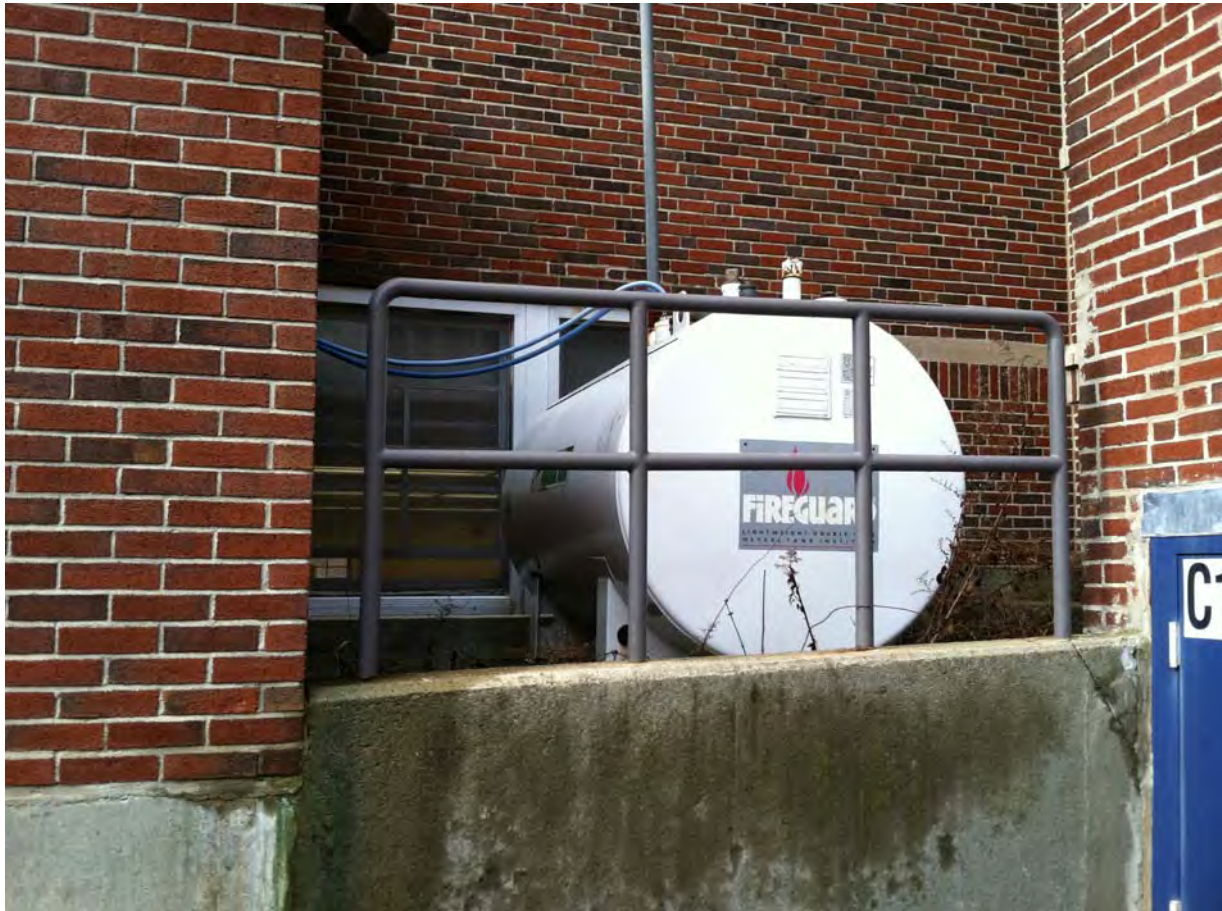
A 125kW Emergency / Standby Generator is located at the rear of the original B Building in a dedicated room accessible from the building exterior. The engine generator is diesel fired and an above grade fuel tank is located adjacent the generator room. The engine generator transfer switch is located in the passage area behind the kitchen. Loads on the generator include kitchen equipment, heating, fire alarm, the elevator and lighting.

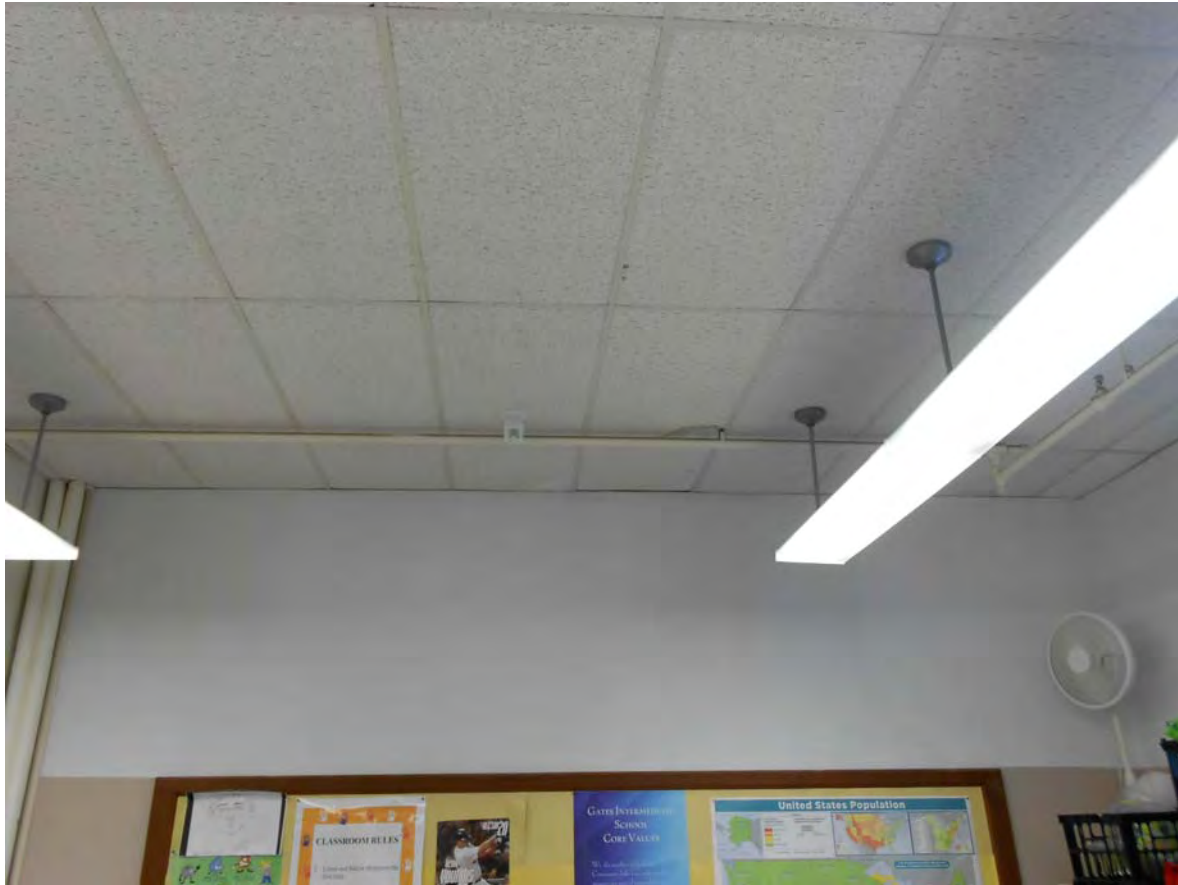
Lighting is generally suspended fluorescent fixtures with recently installed occupancy sensors in B and C Wings for automatic control. The lighting system in the Gym has been retrofitted with multiple T-5 or T-8 lamp fluorescent fixtures.

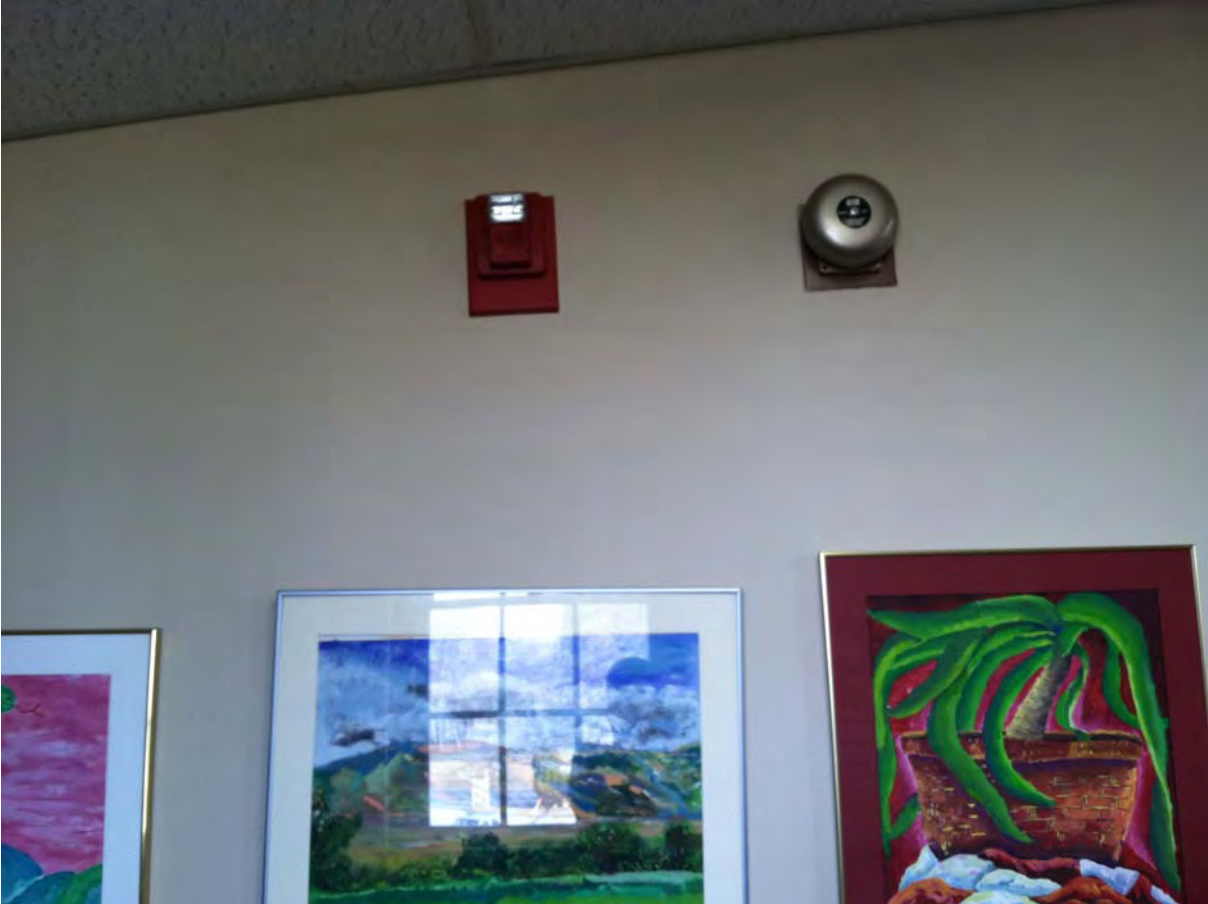
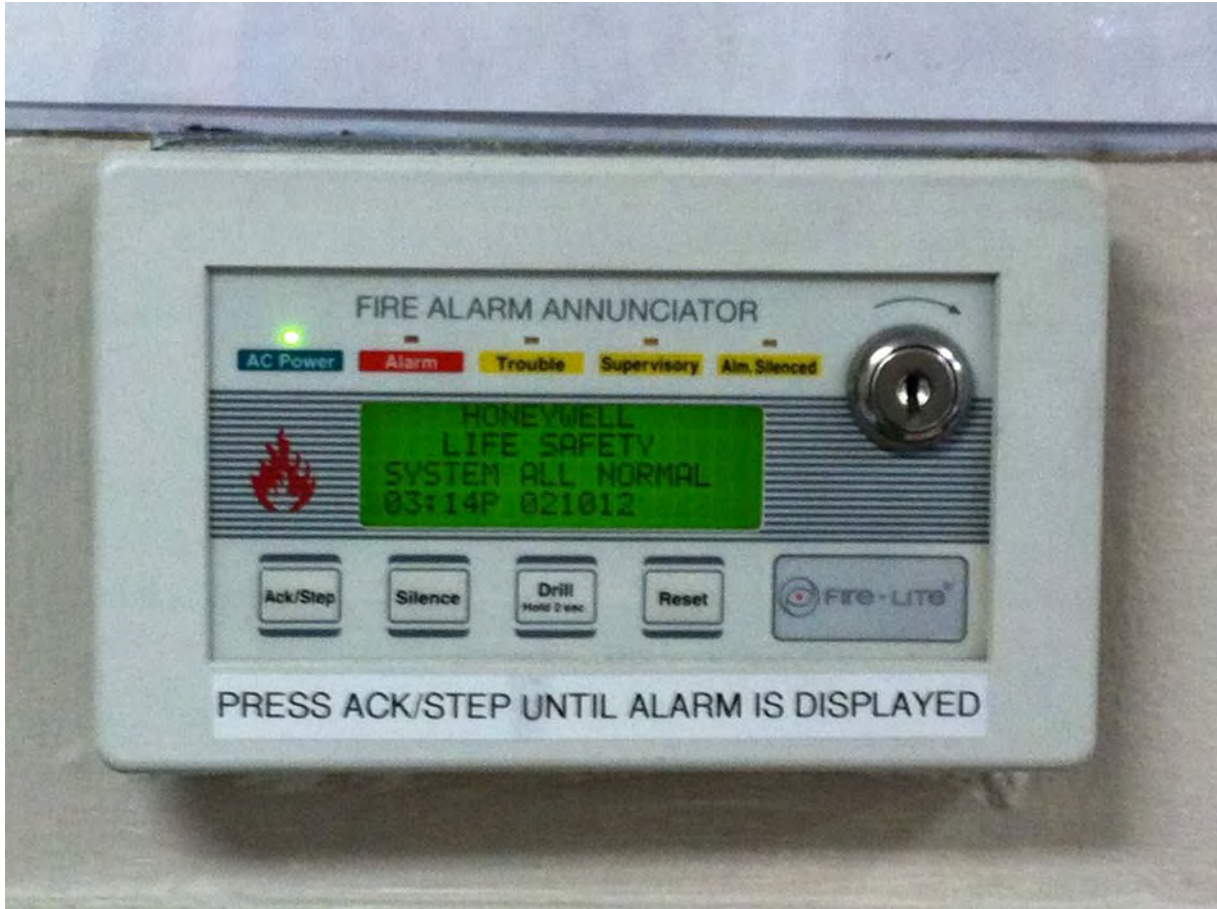
The building is equipped with a hard wired fire detection system. The control panel is located in the B Wing main office with annunciation and drill switches. Another annunciator and Master Box is at the front of the A Wing gym. Notification devices have been upgraded from the original bell system to horn strobe devices in most areas. Many area do not comply with MAAB mounting heights and strobe style. We also assume strobes are not synchronized given the different styles.

The existing fire alarm system does not meet the current building code requirements for Assembly use if community space is programmed. Current code requires emergency voice evacuation which the current system will not support. We recommend a new fire alarm system that provides code required notification.

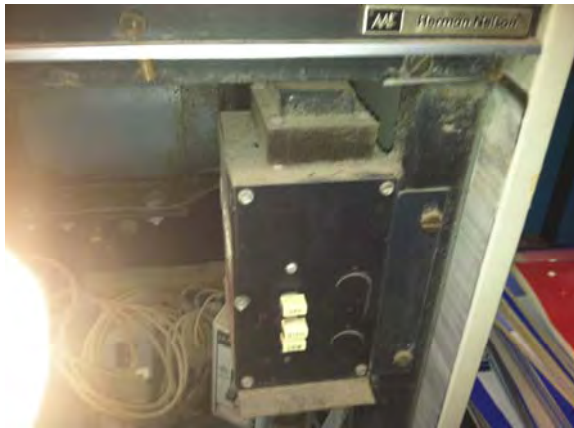
It has been indicated to us that the school maintenance contractor estimated that the majority of the unit ventilators shall be replaced. There are problems unit ventilator dampers operation, unit controls and heat output etc. Some of the units are noisy.

Interior of an AAF Herman Nelson unit ventilator

The boilers should remain. They are fairly new. The piping and the heating devices shall be replaced with new more efficient devices. The existing pneumatic control system shall be replaced with a digital system.

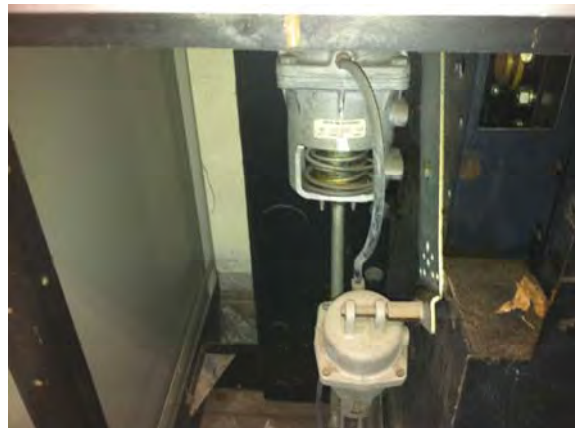
The control system is pneumatic type. It has been indicated to us that the pneumatic piping is leaky. Note that leaky piping does not allow the control system to function properly affecting the terminal unit performance.

Unit ventilator pneumatic controls (unit interior)
