SCITUATE PUBLIC SAFETY

FEASIBILITY STUDY

FINAL REPORT

May 22, 2014

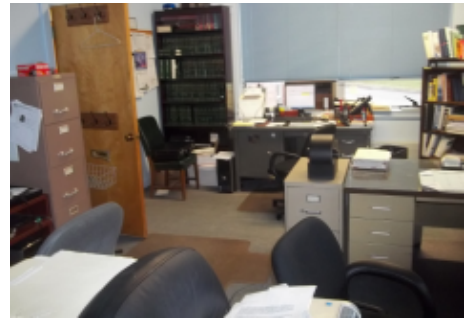
- Majority of Offices are cramped and inadequate
- Storage rooms are overflowing with items
- Some doors have lever hardware. Levers occur mostly in the new addition
- Toilet rooms are not ADA compliant except on the Officer’s Locker Room.
- Rooms with VCT flooring are in decent condition. Floors require waxing and/or re-finishing
- Rooms, with what appears to be 9x9 vinyl asbestos tile (VAT) floors, are in poor condition.
- The Break room is currently being used as an Office and is inadequate
- Juvenile Cell VAT floor in poor condition. It does not contain a penal style suicide prevention toilet.

Overcrowded Office Space

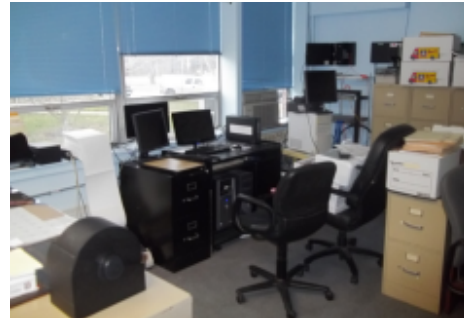
Overcrowded Office Space

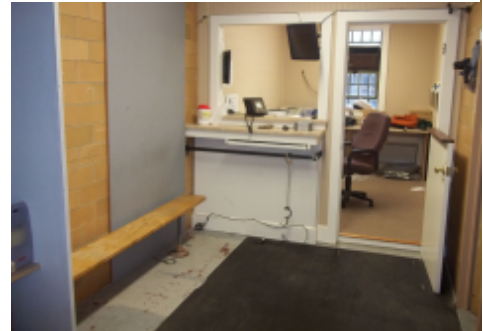
- Inadequate storage
 - All painted floors are peeling and require re-coating
 - There are no ADA compliant toilets
 - Steps should be removed at booking area to reduce accidents

- Cuff rails are inadequate and limit the number of users
 - Ramps up to Booking appear too steep (non-ADA)
 - Railings are not ADA Compliant
- Dispatch
 - Very cramped

Booking Area

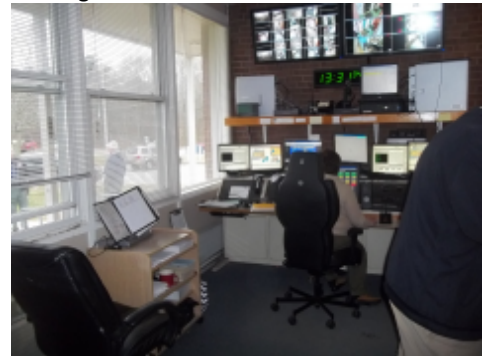
- Dispatch also serves as receptionist which could distract the dispatcher at certain critical times
 - Ceiling at Dispatch requires repair
 - Carpet is worn out

Dispatch

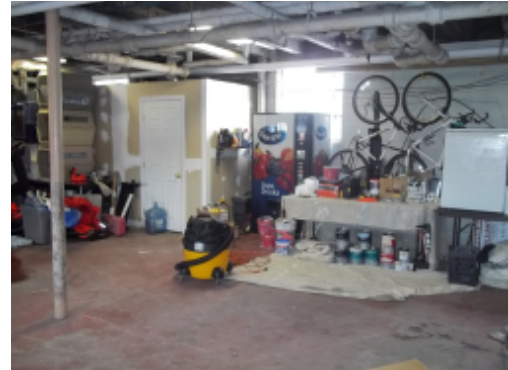
Storage in Vehicle Processing/Sallyport

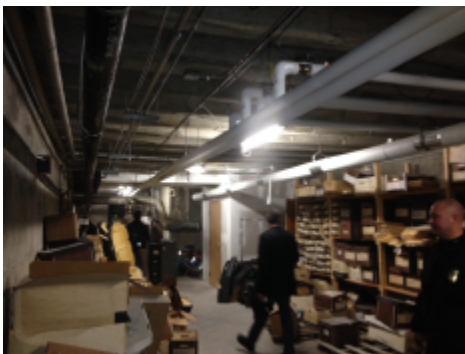
Archive Storage

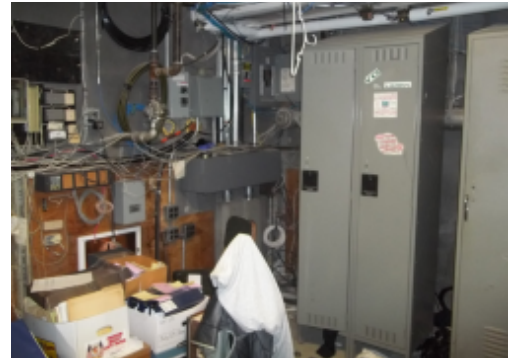
- Lower Level Personnel Locker Room
 - Old smaller style lockers
 - Electrical Distribution and telephone panels should not be located in this area
- Fitness Room
 - Poor Ventilation
 - There is minimal natural light; window opens onto an areaway
 - Lighting is inadequate
 - Carpet is in poor condition and should be replaced
- Archive Storage – not enough room for proper storage of existing files
- The Firing Range was not seen; Space reported to be used for storage not firing range

Personnel Lockers in Electrical Room

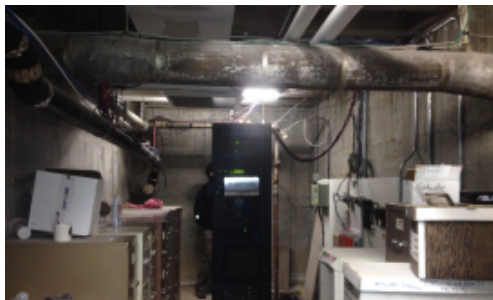
911 Telecomm Rack in non-ventilated Storage Room

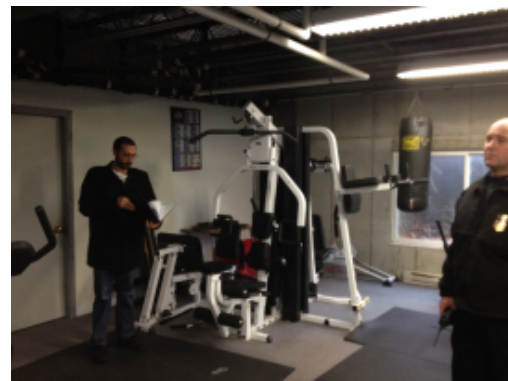
Fitness Room in Basement

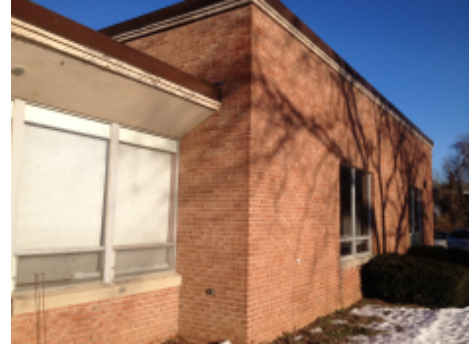
- There are areas with visible efflorescence which indicate moisture in the walls. Re-pointing is required at certain areas
- Precast window sills are stained due to moisture
- Steel lintels showed signs of rust

Exterior Brick Veneer and Windows

- If possible, increase insulation at exterior walls to improve thermal envelope to insulation values of between R11.5 and R13 continuous insulation. This is very difficult with this type of construction
- Repair and re-point brick veneer at locations indicated
- Determine if moisture is seeping into precast sills and make necessary corrections
- Wire brush, clean and paint steel lintels where rusting

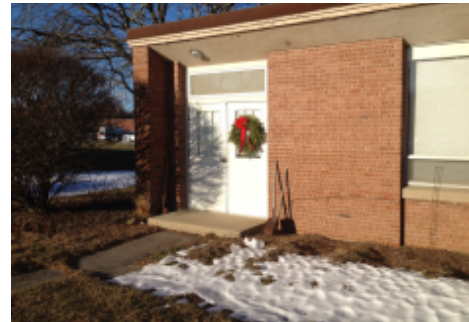
Entrance into Day Room

- Exterior doors appear to be non-insulated hollow metal doors. They seem to function properly but are not energy efficient.
- The Keypad lock into the station does not appear to function well
- Doors are not ADA compliant
- Overhead doors appear to be in good condition

- Replace all other doors with insulated energy compliant doors
- Replace keypad type locks for access into the building

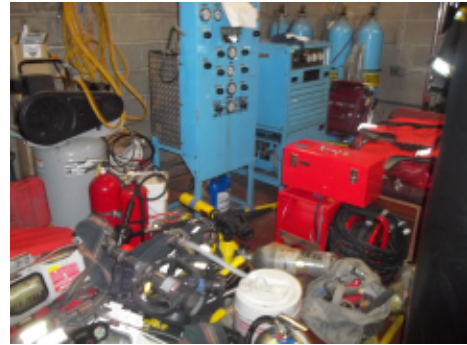
- Most spaces are cramped and inadequate
- Storage rooms are overflowing with items
- Some doors have lever hardware, but not all.
- Toilet and shower rooms are not ADA compliant.
- Apparatus Bays are cramped with equipment including Turn Out Gear and SCBA and Fitness equipment. These items should not be located there.
- Apparatus Bays do not have adequate space along the exterior walls mostly due to personnel lockers which should not be located in the Bays.
- Turn Out Gear should not be stored in Apparatus Bays due to increased deterioration from ultra violet light and soot and smoke from the trucks.
- The Kitchen is also used as the station’s office. The Kitchen is overly cramped.
- The office area is inadequate.
- The Sleeping Quarters are overcrowded and does not have adequate space for storage of personnel items.

SCBA Equipment in App Bays

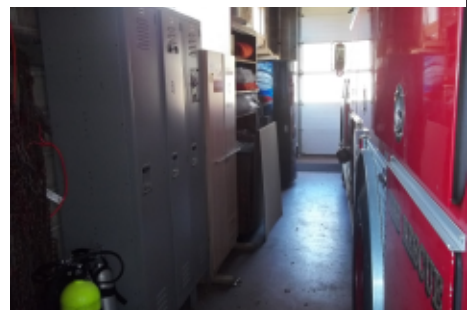
Personnel Lockers in App Bays

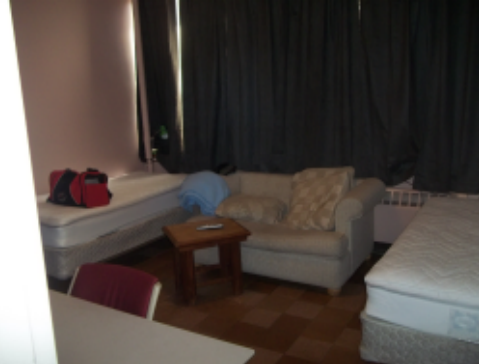
Dorm Room

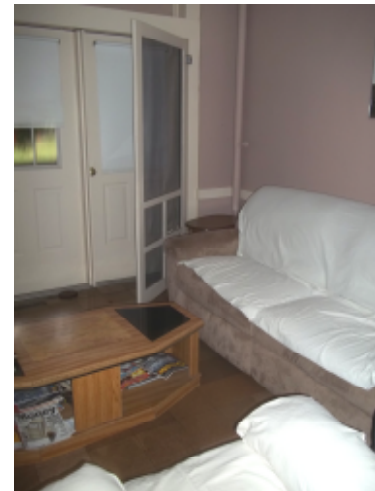
- The Day room does not provide adequate room for the number of fire fighters on the shift.
- There is a step between the Apparatus Bays and the rest of the facility. This can be a potential tripping hazard especially when there is a call.

Day Room

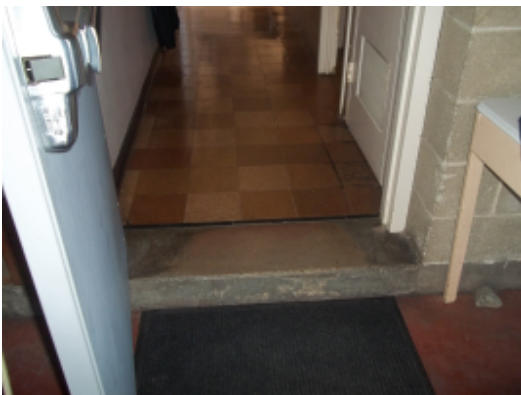
Step between App Bays and Living Quarters

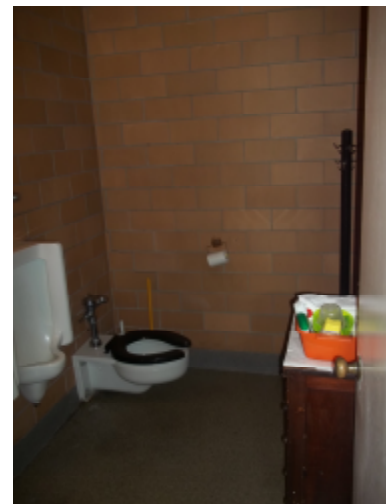
Toilet Shower

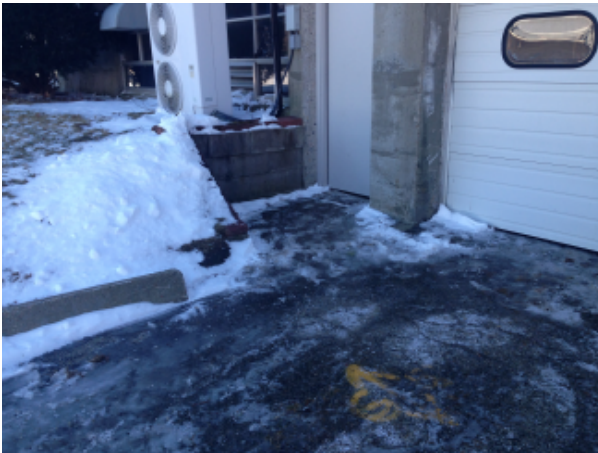
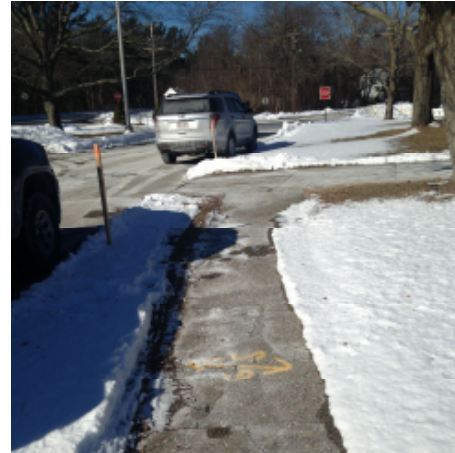
Paint observed in a walkway south of the Police Station and in a driveway north of the Town Hall indicates gas service is provided to the buildings. Gas meters were observed along the south face of the Police Station and the north face of the Town Hall.

Figures 1 & 2: Paint within driveway north of Town Hall and walkway south of Police Station indicating gas services

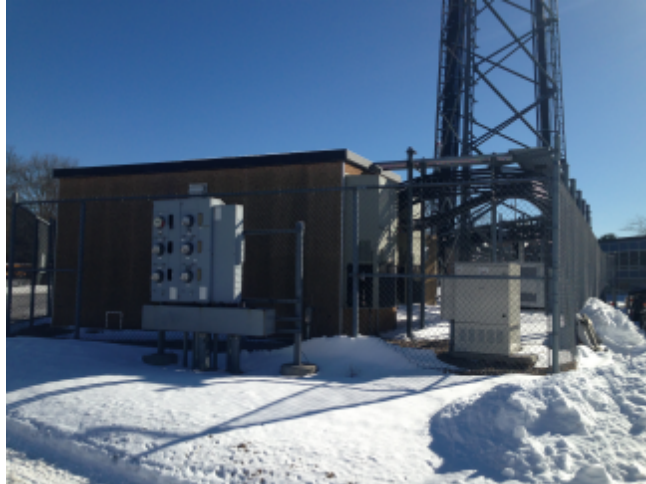
A cellular tower was observed just north of the Police Station. Sean McCarthy noted there are police and fire communications mounted to the cell tower. Electrical and generator equipment were also observed in this location.

Figure 3: Cell tower and electrical and generator equipment north of the Police station

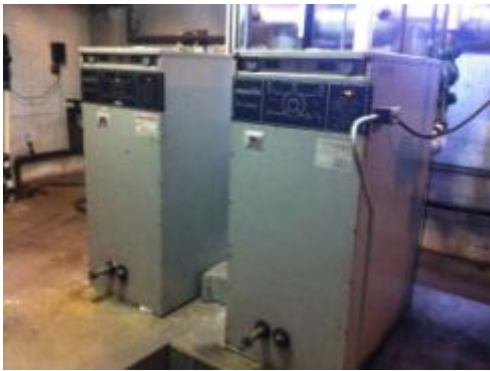
Gas Fired Boilers

The central boiler plant which supplies heating hot water to the Police Station, Fire Station and Town Hall resides in the lower level of the Town Hall. The central plant is comprised of two gas fired Lochinvar Power Fin boiler, three base mounted pumps, breaching, combustion air, and accessories.

Each boiler is paired with a dedicated boiler pump. Each boiler has a rated input of 750 MBH with an estimated output of 660 MBH.

Upgrade boiler system to high efficiency condensing boilers. If system remains as a central plant provide additional boiler for redundancy backup in event of boiler failure.

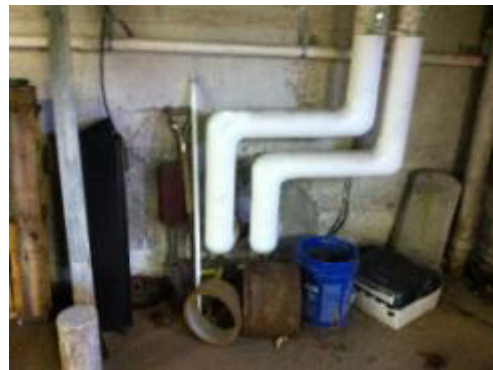
Piping Runs to Police Station

Each building is served by a single dedicated base mounted pump located in the Town Hall boiler room. The pumping system did not appear to have backup or redundancy. If a pump fails the building serviced by the pump will lose its heating hot water. Heating hot water is pumped to the Police Station and Fire Station via buried piping. The condition of the underground piping is unknown.

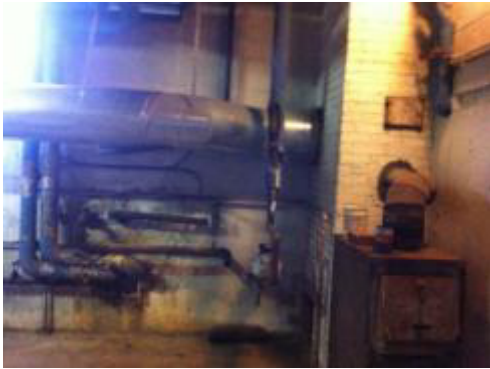
Breeching

Flue gas is discharged to the outside via un-insulated sheet metal breeching into a brick masonry chimney. Combustion air is provided by high wall louvers without dampers. The breeching does not meet code required high and low combustion air openings.

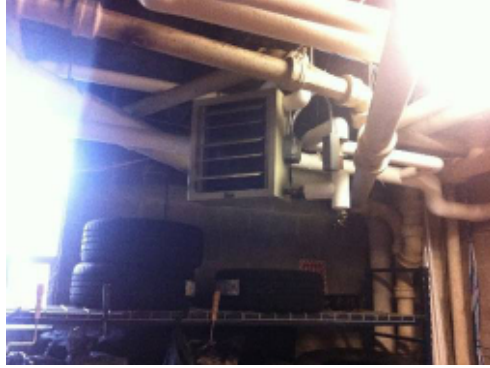
Hot Water Unit Heater

The 3-bay sally port is heated by hot water unit heat mounted at the ceiling. The sally port is not equipped with an exhaust system or means to detect vehicle combustion.

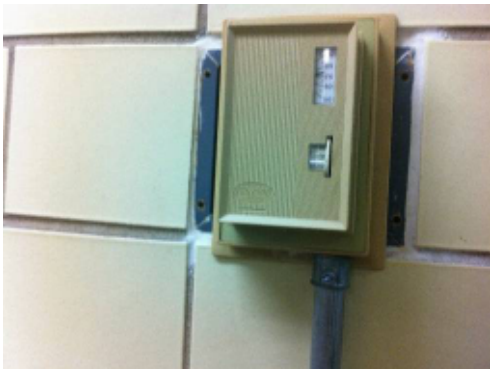
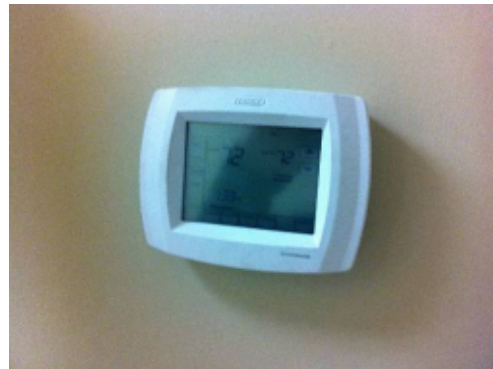
Pneumatic and Programmable Thermostats

The building HVAC systems and heating plant are controlled by a pneumatic automatic temperature control system as well as standalone programmable thermostats. The existing ATC system is generally antiquated in comparison to direct digital control (DDC) systems available today.

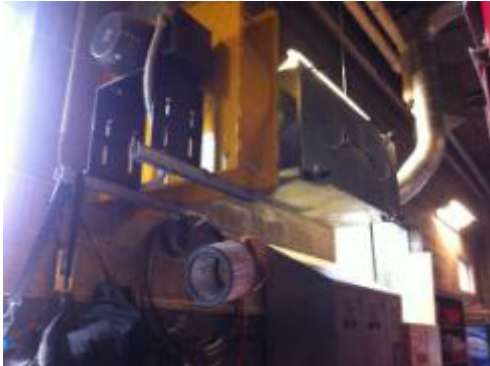
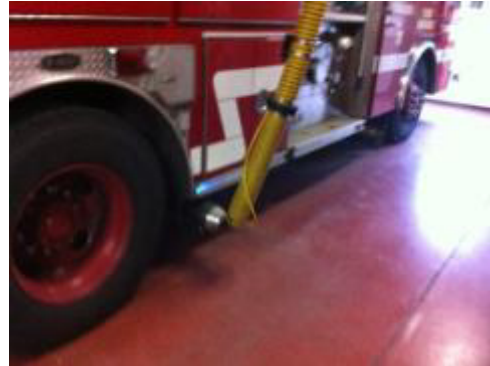
Vehicle Emission Capture System

The apparatus bay is equipped with a vehicle emission capture system. The apparatus bay does not appear to have an emergency vehicle combustion exhaust system or detection system.

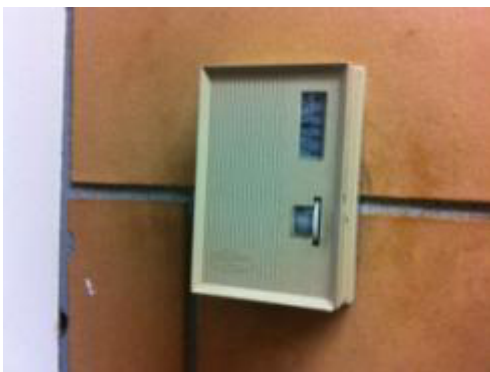
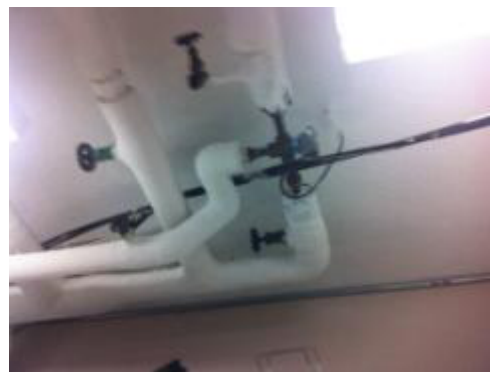
Pneumatic Thermostat and Pneumatic Control Valve

The building HVAC system and heating plant are controlled by a pneumatic automatic temperature control system. The existing ATC system is generally antiquated in comparison to direct digital control (DDC) systems available today.

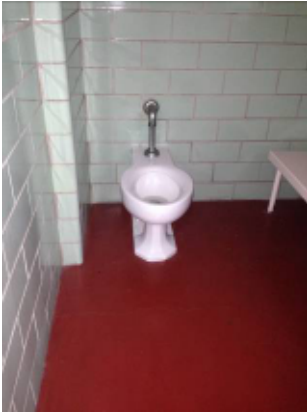
Cell fixture

Cell fixtures are vitreous china floor mounted. Fixture are not anti-suicide, and are not accessible.

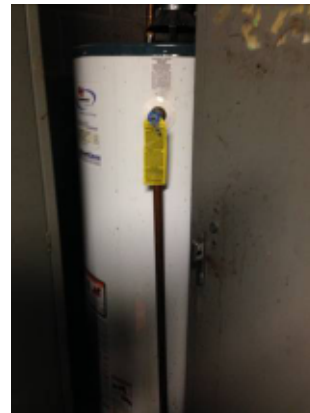
Domestic Water Heater

The hot water is generated through a standard efficiency, natural gas fired, tank type water heater, with an input of 40,000 BTUH and 50 gallons of water storage. Water heater was manufactured in 2005 and appears in good condition. The system does not have a mixing valve and there is no expansion tank.

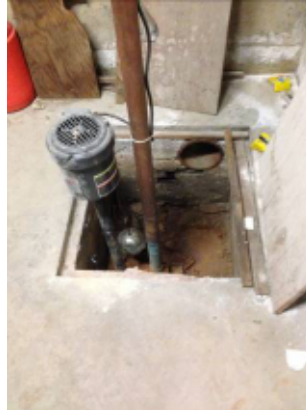
Sump Pit

There is an open sump pit in the basement with a single pump. Sump appears to collect a sub-soil drainage system. Pump discharges to the storm drainage system.

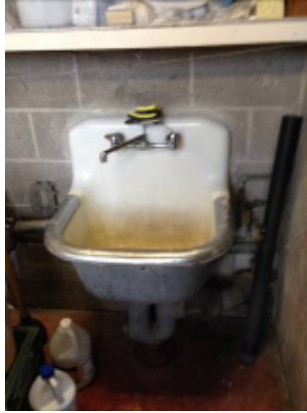
Service Sink

Janitor's sinks are cast enamel trap standard with back mounted faucet with no vacuum breaker.

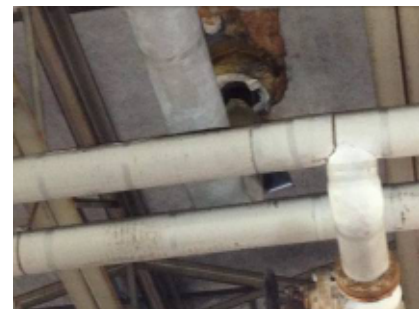
Roof Drain

Building has flat roof with interior roof drains. There is evidence of leaks at the roof drains in the Apparatus Garage. Storm drainage piping is generally cast iron bell and spigot.

In general existing cast iron drainage piping can be re-used if sized appropriately. We recommend video inspection of existing drains to confirm integrity.

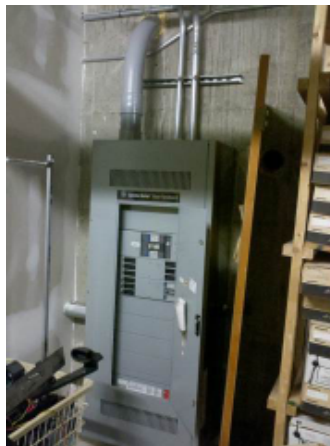
Main Distribution Panel

A 400 ampere main circuit breaker distribution panel is located in the basement. The panel appears to have been installed during construction of the addition and feeds one 100 A/3P for Panel "PB" in fitness area and one 200A/3P for the automatic transfer switch. Other remote panels exist throughout the facility including panels of original vintage, some of which are fusible. The service does not have a critical operations power system "COPS" or emergency power system.

The switchgear installed during construction of the addition is approximately 15-years-old and is in good condition. It was manufactured by General Electric.

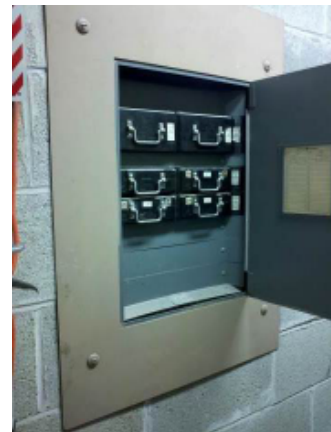
Original Fusible Panel

The original building switchgear is in poor condition.

The original building switchgear should be replaced. New panelboards should be provided and existing circuits reconnected.

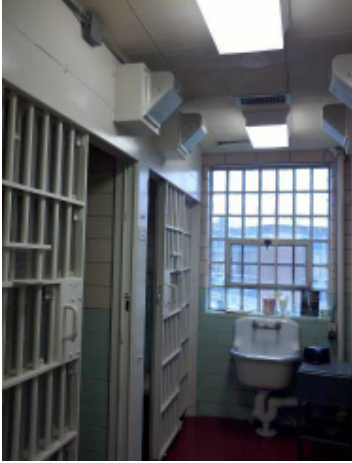
Detention Hall Lights

Detention hallways have surface wraparound fixtures. Cell fixtures consist of 12" square corner-mounted security fixtures with incandescent bulbs. Cell fixtures provide inadequate light output to

Cellblock lighting fixtures should be replaced with fluorescent security rated fixtures. Light fixtures within cells to have extended speaker housing.

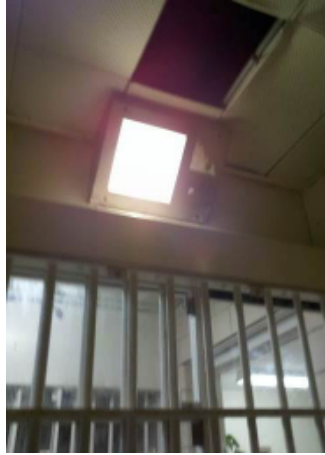
Cell Light

monitor the cell. Booking lights consist of surface ceiling wraparound fixtures and portable plug-in RLM residential grade flood lights.

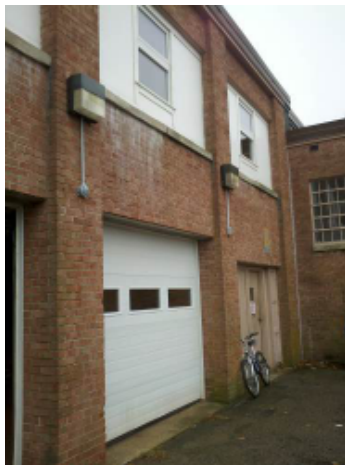
Building Wall Packs

Exterior lighting consists of HID wall packs at the rear of the building. The front canopy has halogen par lamps surface mounted to the underside of the canopy as well as recessed lensed down lights. Roadways and parking areas lack adequate lighting. Existing fixtures are not dark sky compliant.

Exterior wall sconces should be replaced with LED sconces. Pole-mounted LED fixtures should be provided for parking areas. All fixtures should be dark sky compliant.

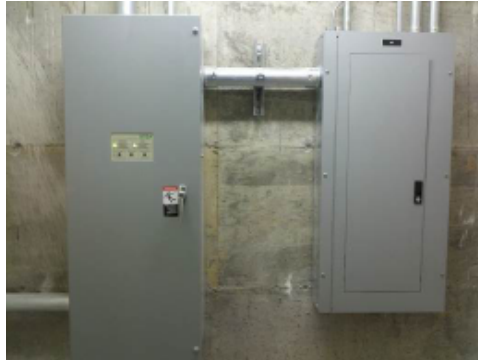
Automatic Transfer Switch & Panel

The police station has one 200 ampere, 120/208V, 3 phase, 4w ASCO automatic transfer switch and panel located in a dedicated closet in the basement. The transfer switch and panel are in good condition.

The facility's emergency lighting and exit sign system is not compliant with current code which requires a separate transfer switch and emergency panel in a fire-rated closet, fed with fire-rated feeders.

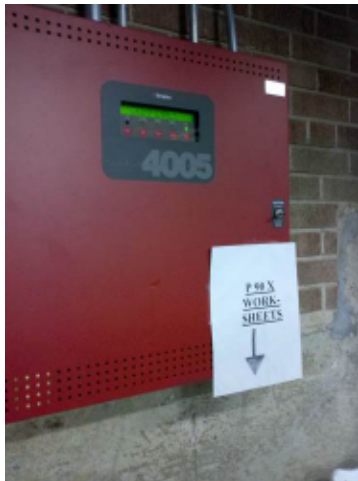
Fire Alarm Panel

The fire alarm system consists of a Simplex 4005 addressable control panel located in the basement. The horn/strobes are ADA compliant but only cover part of the facility's new addition.

The existing fire alarm system only offers partial coverage, and therefore, is not code compliant. Additional devices should be added or the entire system replaced with a current code compliant system with full coverage.

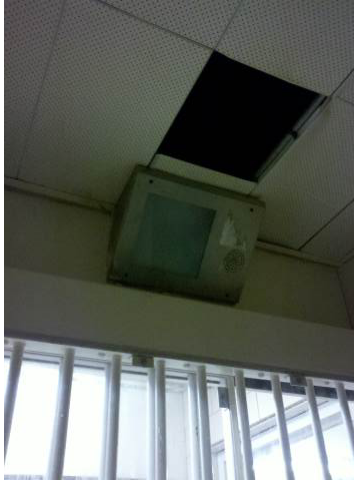
Cell Light with Speaker Housing

The facility does not have a paging system. Paging is performed through the telephones. The cell block does not have a functional audio threshold system to communicate between cells and dispatch. The existing cell light fixture has an integral speaker housing but the speaker does not function.

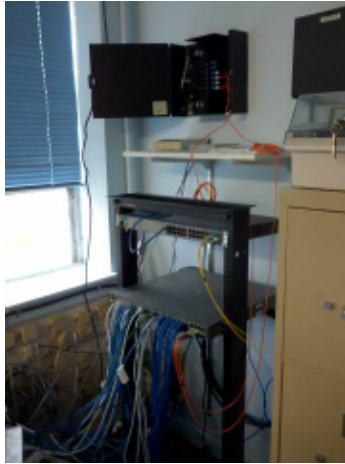
Communications Rack

The E911 UPS system and communication rack are located in the basement adjacent to the sump pump. Heating water pipes run over the emergency communications rack.

Violations should be corrected by rerouting foreign piping that runs over electrical equipment or the equipment should be relocated. Drain pans should be provided over equipment located below water and/or heating pipes.

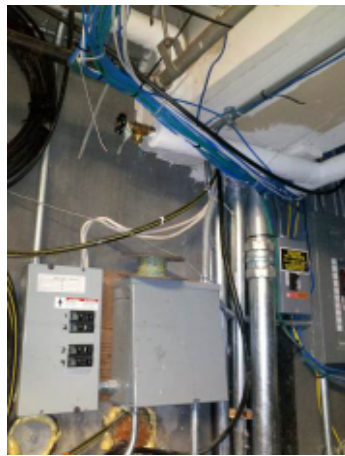
Tel/Data Wiring Bundle

The telephone, cable TV and fiber run in one 4" underground conduit plus one 4" spare between utility poles and electric room. CAT 5 tel/data cabling are generally improperly supported from other trade's utility pipes.

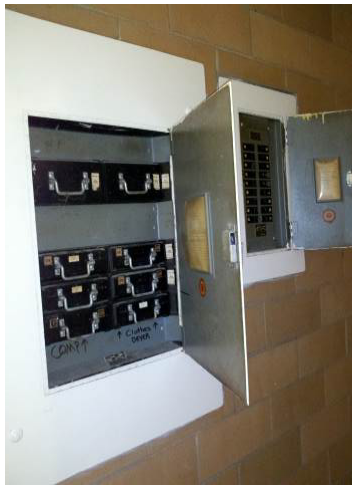
Flush Main Panel

The electrical distribution system consists of a flush-mounted 200 ampere, 120/208v, 3 phase, 4w fusible panel located in the kitchen area corridor. The panel service feeder is fed underground from the Town Hall's normal/emergency distribution panel.

The panel is full and is in poor condition. A 40A/2P NEMA 1 breaker has been tapped from the panel for the plymovent system. An adjacent 100 ampere, 20 pole, breaker type flush panel also exists and is also full.

The panelboards, manufactured by GE, are original to the building. They are in poor condition and have no room for expansion.

A new electric service should be provided directly from the utility company. The existing panels should be replaced.

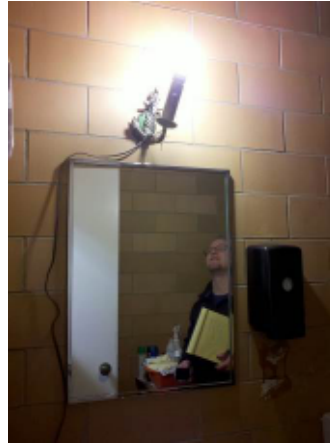
Light Over Vanity

Toilet rooms have a loosely supported wall sconce with a plug-in cord located over the vanity.

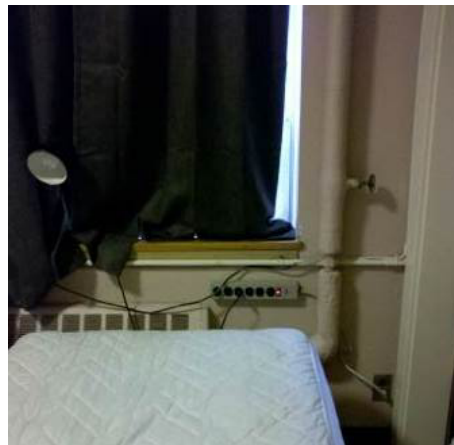
Bunk Outlets

Bunk dorm receptacles are not arc fault protected. Plug-in strips and extension cords are used due to lack of wall outlets.
