Facility Analysis and Assessment Plan

Gates Middle School
327 First Parish Road
Scituate, MA

February 22, 2012

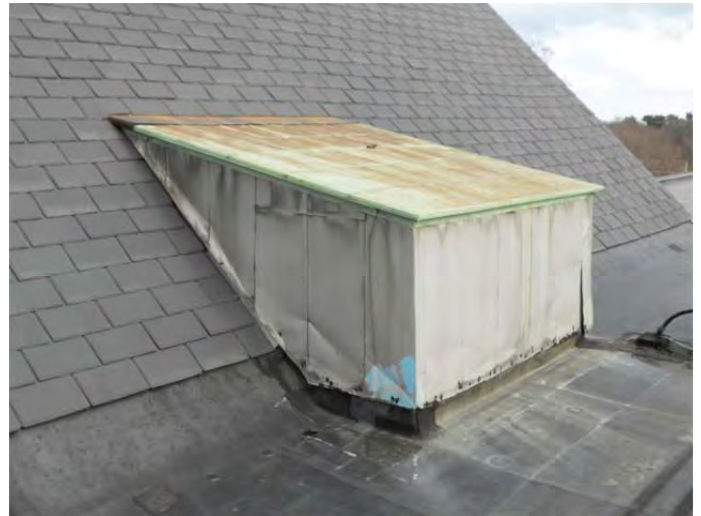
Shed at south side of original building housing HVAC equipment.

Replace metal sheds housing mechanical equipment. **PRIORITY A**

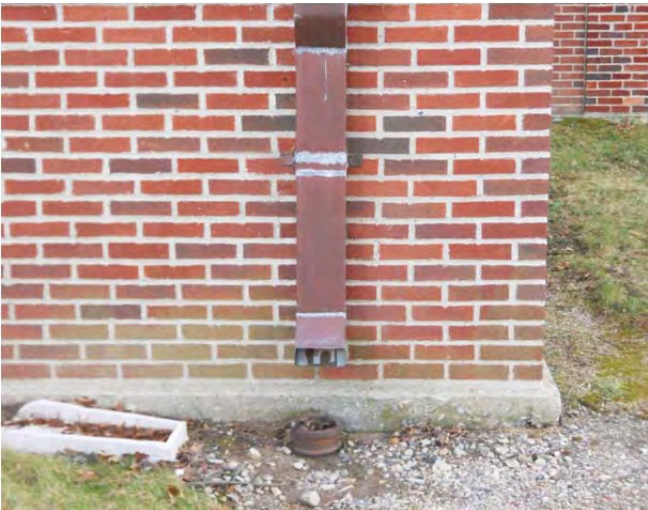
The synthetic slate roof, cupola, gutter and downspouts are in good condition. The downspouts do not connect to an underground storm water system and do not have effective splash blocks. This means that roof run-off from the pitched roof, outlets directly at the building foundation wall. At the south of the slate roof are two metal clad sheds that house equipment for the HVAC system. The flat seam copper roofing is rusted and the sidewall panels are bent.

Downspout with no connection to underground system or splash block.

Connect downspouts to a system that directs water away from the foundation wall. **PRIORITY A**

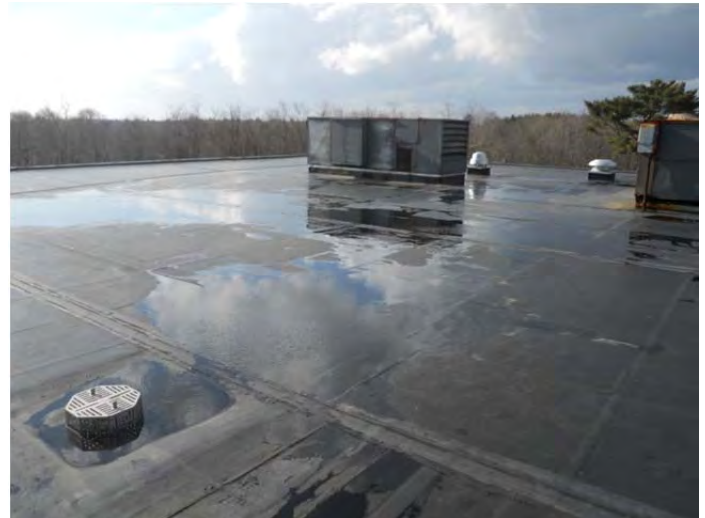
The flat EPDM roof is not in good condition. It has significant ponding at the west wing due to improper pitch towards roof drains. Also, lifting seams and deteriorated sealants in the EPDM appear widespread. Around the perimeter of the roof, there is an existing curb, and the EPDM is not installed in a manner recommended for water tightness. This curb has a metal coping on it, but the EPDM roofing runs over the top of it and terminates in a sealant joint. A more effective detail for water tightness is for the EPDM to extend underneath it. The existing sealant joint is difficult to maintain and may permit water into the masonry wall and ceiling below if it fails.

Ponding of water at EPDM roof at west wing.

Replace existing EPDM at flat roof and all associated flashings, including the perimeter coping. New EPDM roofing should be extended underneath the coping. Install new tapered insulation to direct water to roof drains and install crickets behind elevator over-run to prevent ponding. Install walkway pads from the roof hatch to equipment areas. **PRIORITY A**

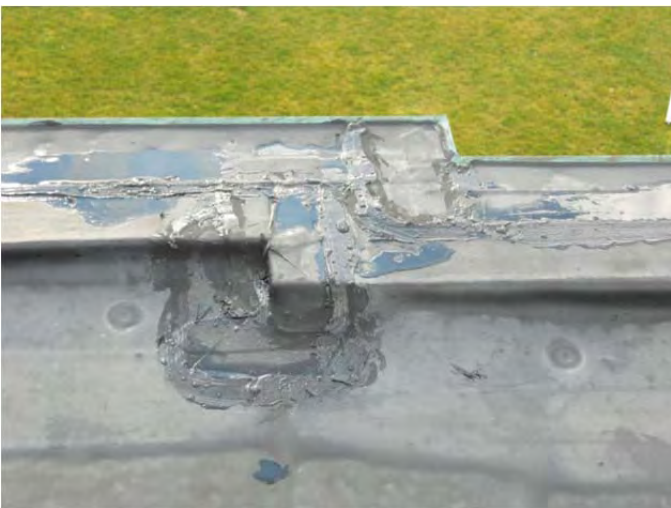
Coping at flat roof with EPDM seam on top of metal coping and demonstrating much past maintenance.

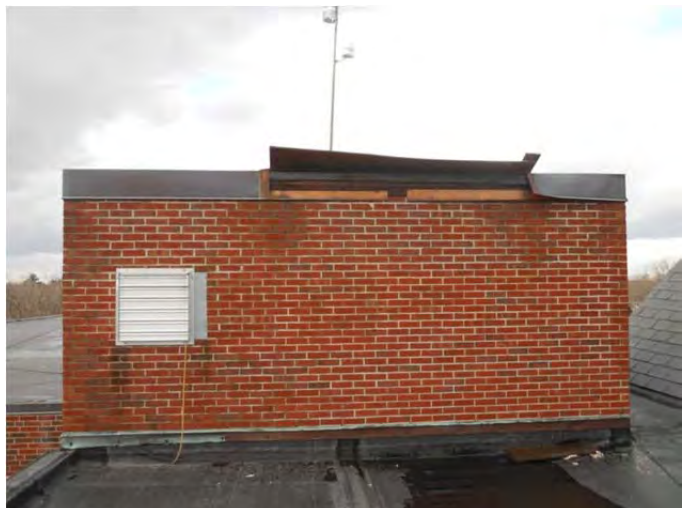
At other locations of the EPDM roof, there are isolated areas of wet insulation and decking, particularly near the over-run for the elevator. There are also lifted flashings around the roof of the elevator. In general, counter flashings remaining from original and past roofing campaigns are beyond their life expectancies.

Torn roof flashing at top of elevator.

Repair areas of torn roof flashing. **PRIORITY A**

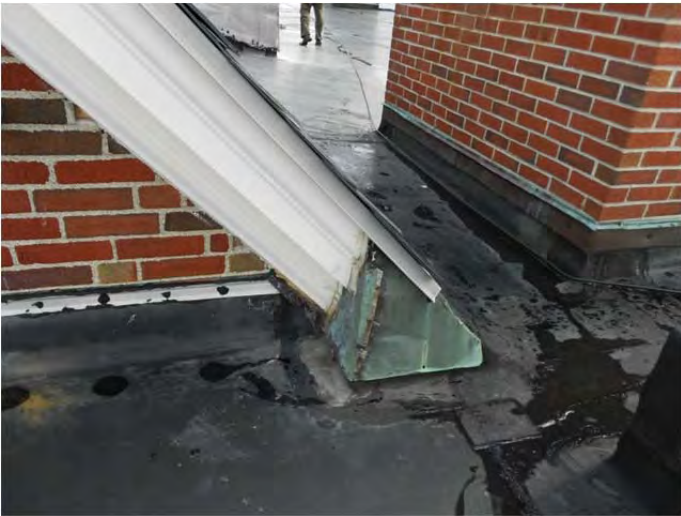
Remaining original copper flashing. Area near elevator over run with wet insulation beneath roof.

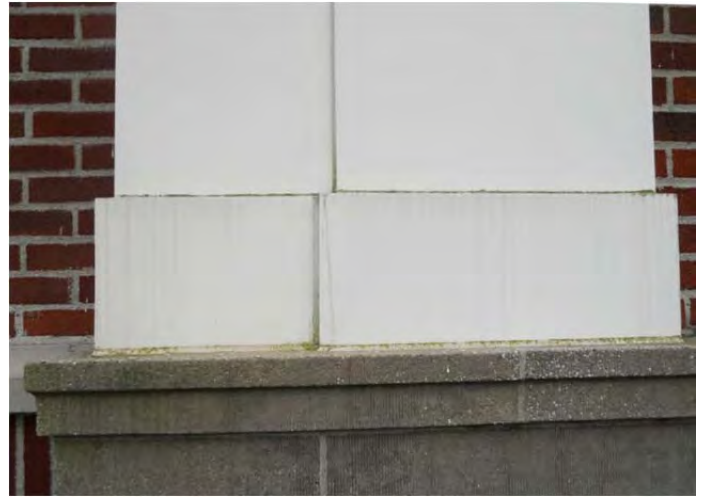
Overall, the GFRP appears to be in good condition. The sealants in between the joints of this product need maintenance however due to mold and joint size. At the north elevation in particular mold is accumulating in the joints. It also appears that when the GFRP was installed at the raking eave edges, butt joints were used as opposed to overlapped joints. Some of these butt joints are greater than 1/2" establishing gaps in the material that are relying on sealant only for water tightness. These larger butt joints may be more susceptible to failure.

Sealant joints at GFRP with vegetation and mold growth.

Beginning in 2014, re-seal all exposed joints and seams every seven years by cutting out and removing all existing deteriorated, loose, and mold covered sealants and replacing with new sealant.

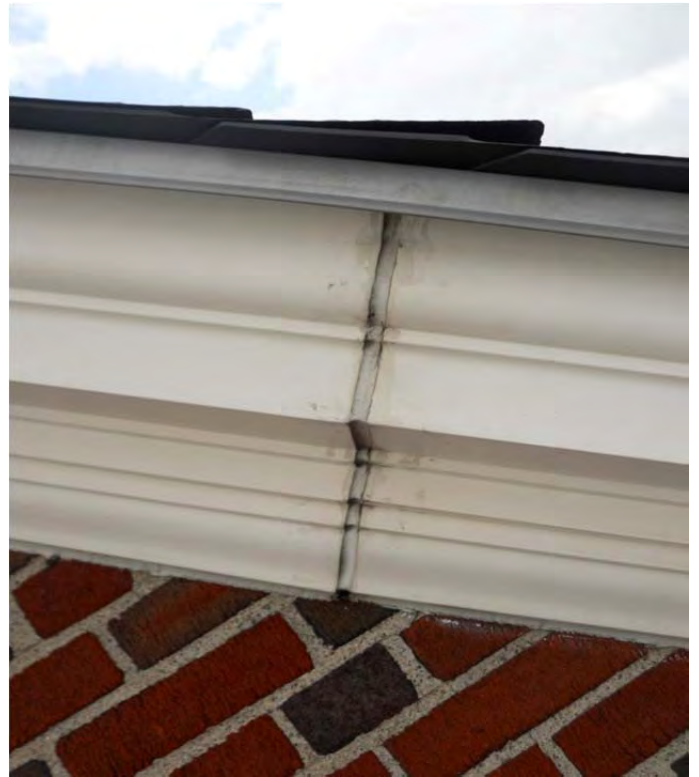
Large sealant joint at butt seam of GFRP raking eave.

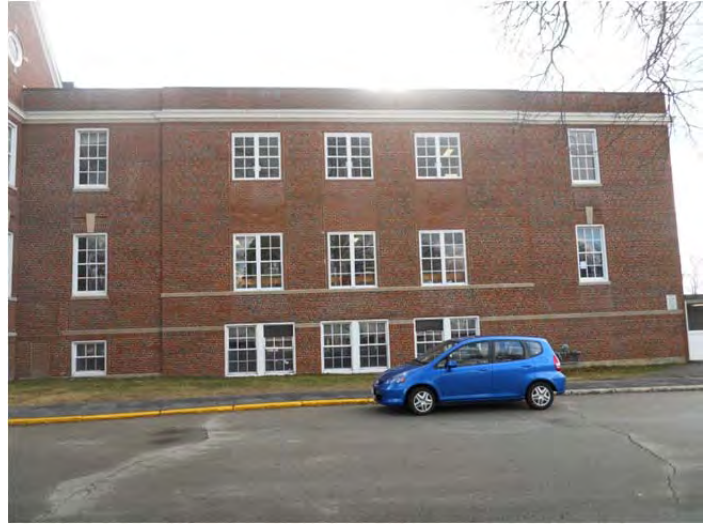
North elevation of west wing with center bay heavily modified where original spandrel windows were removed.

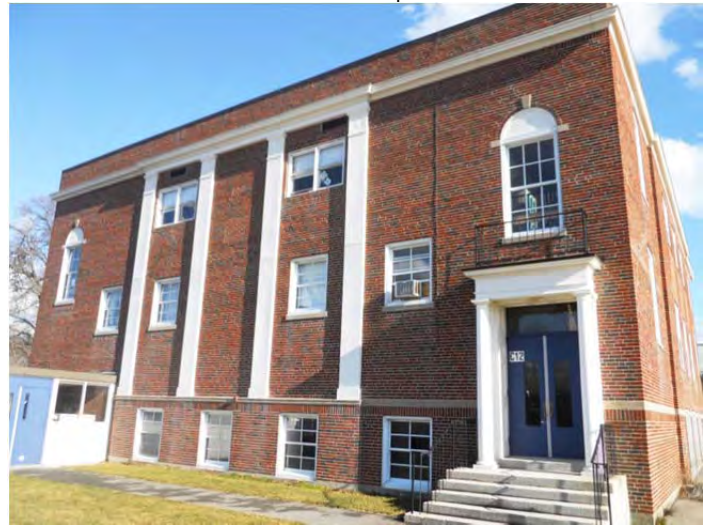
West elevation of west wing heavily modified with non-original window openings.

At west elevation of west wing, change window configuration of all 4/4 windows to 3/3 windows for grid proportions more in keeping with this building style.

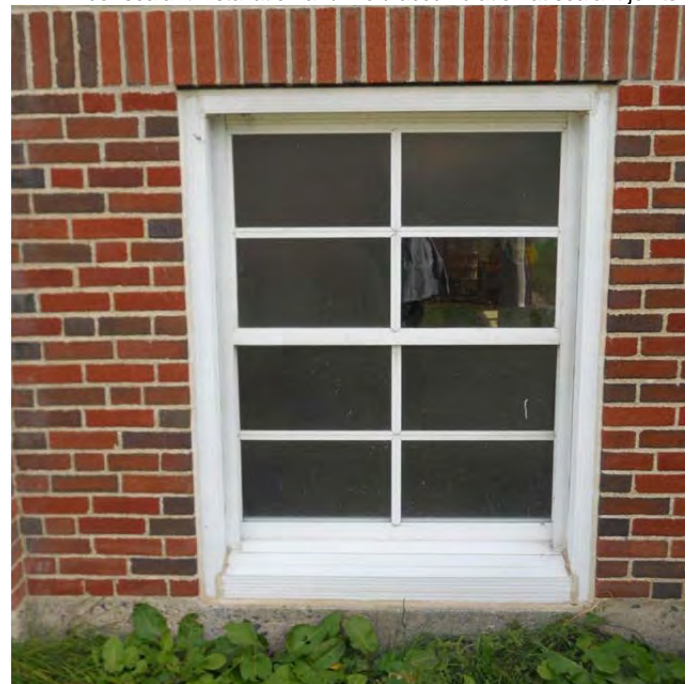
Inappropriate window grid proportions for the style of this building.

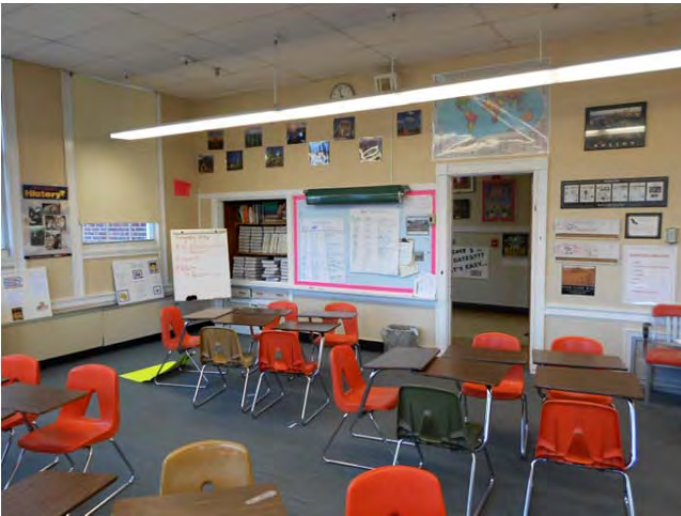
The plaster and GWB walls in the upper floors, are in fair condition. Paint on these walls is also in fair condition with many layers built-up on the plaster walls.

Painted plaster walls in the original building.

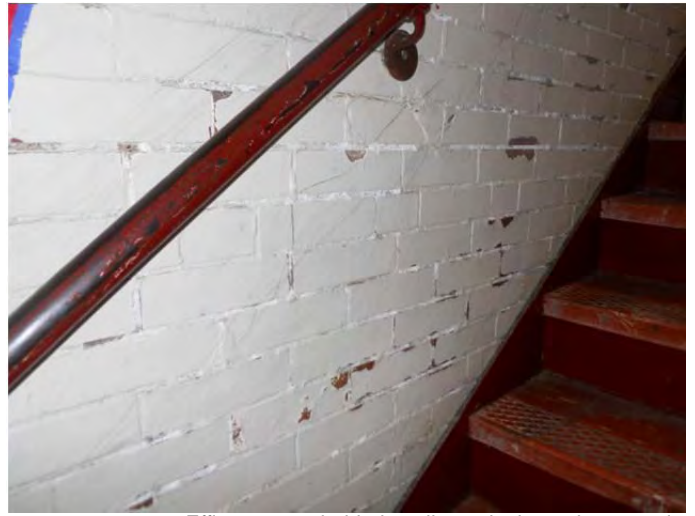
At the southwest egress stair, masonry cracks exist above the exterior door head, at the intersection of a CMU and brick wall, and at a brick intersection in the southeast corner. At the northwest stair, significant efflorescence exists behind the paint. Efflorescence indicates that there is or once was water in the masonry wall. The paint is peeling off the wall in these areas and the efflorescence sheds piles of white dust on the floor on a continuous basis.

Efflorescence behind peeling paint in northwest stair.

Repair cracks in masonry walls. **PRIORITY A**

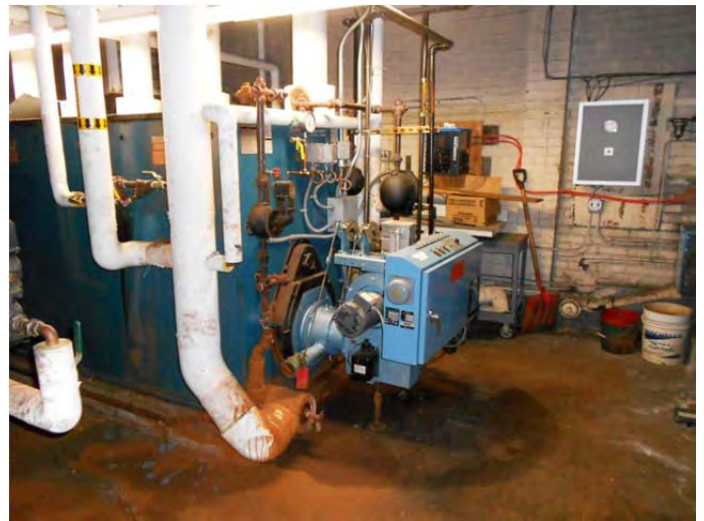
Floor finishes throughout the building are worn and are beyond their life expectancies, with the exception of newer carpet in the administrative area of the first floor.

Painted concrete floor in the basement boiler room.

Replace all existing floor finishes new resilient flooring.

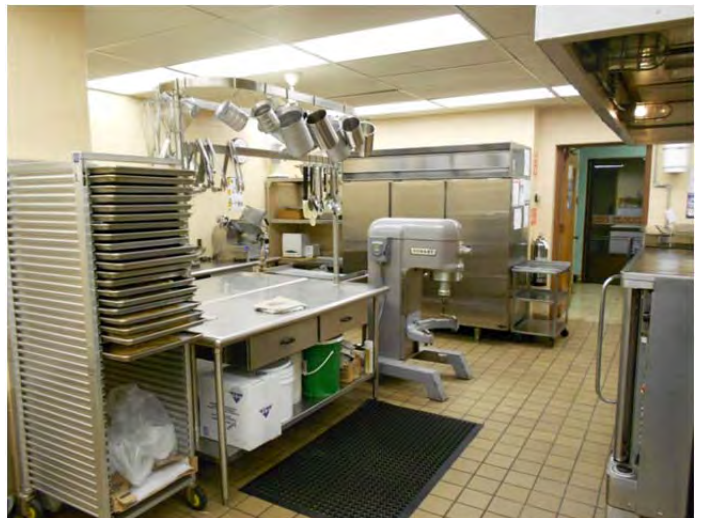
Ceramic tile floor in the basement kitchen area.

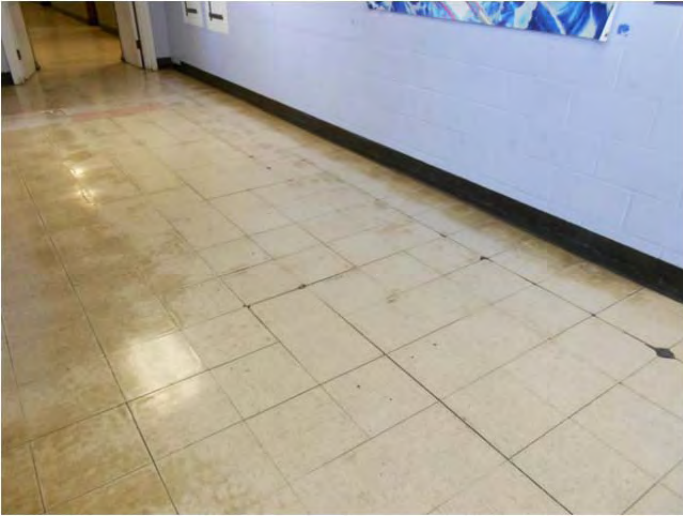
Typical VCT floor throughout corridors and cafeteria area.

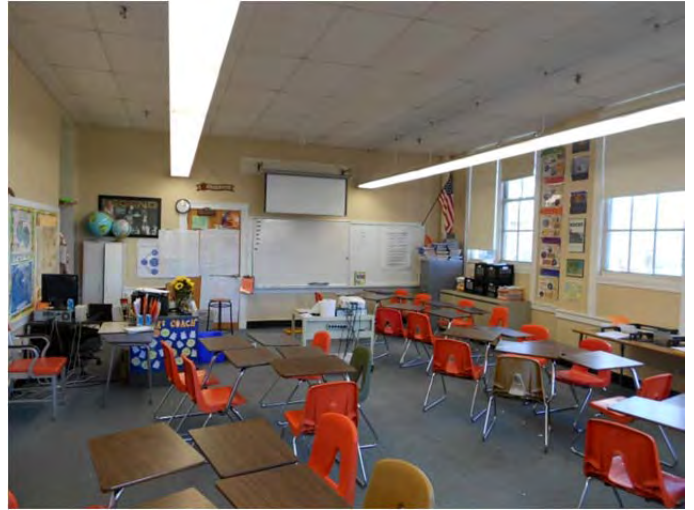
Carpet at a first floor classroom.

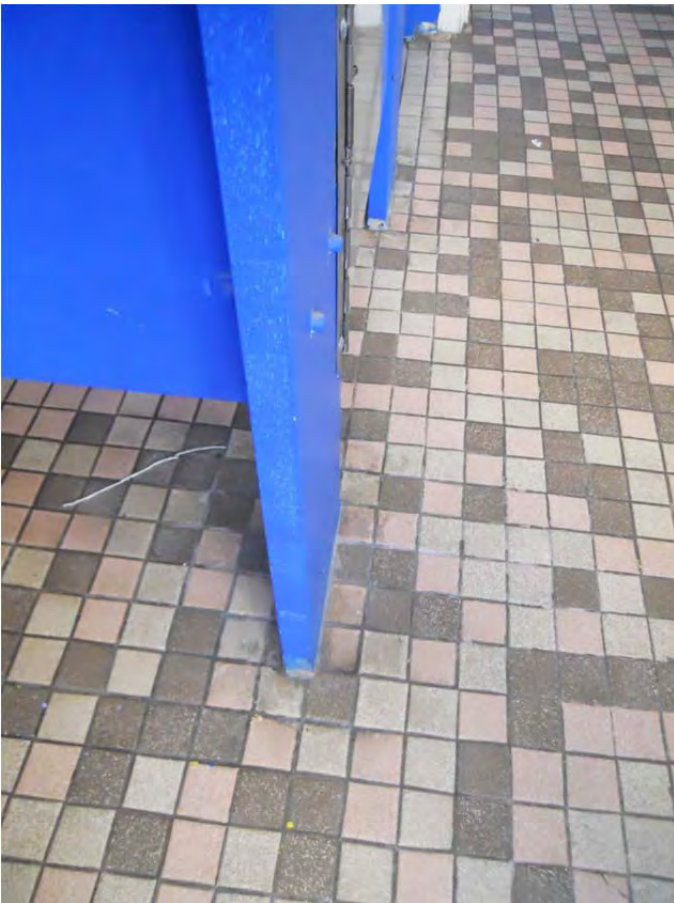
Typical ceramic tile floor in restroom areas.

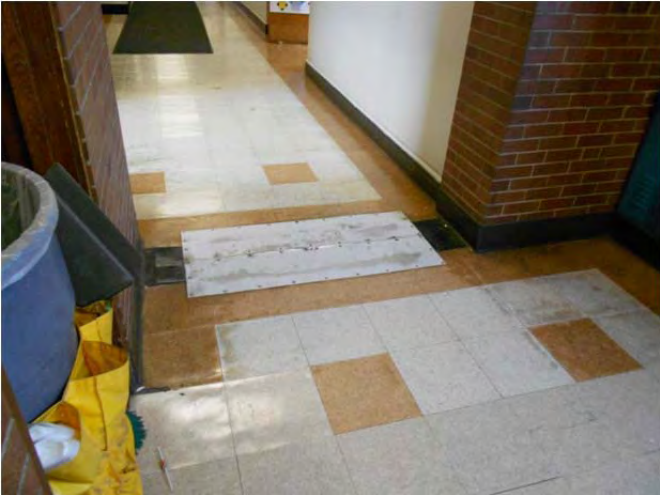
Corridor floor transition between original building and XXXX wing.

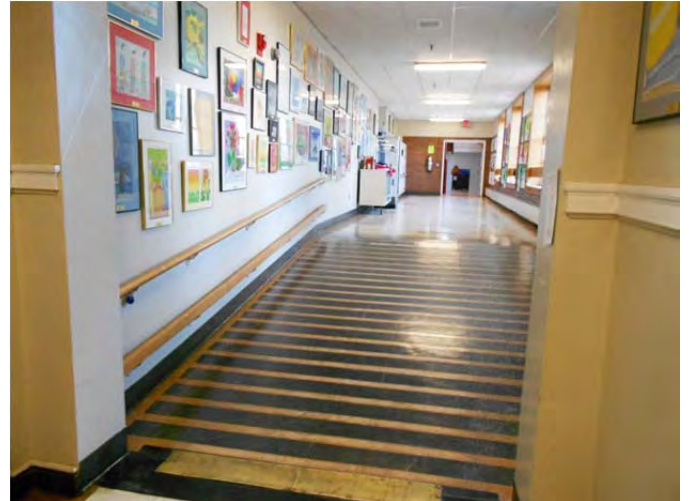
Ramp transition between original building and west wing at first floor.

Replace existing ramp between the original building and the west wing, with new code compliant ramp. **PRIORITY A**

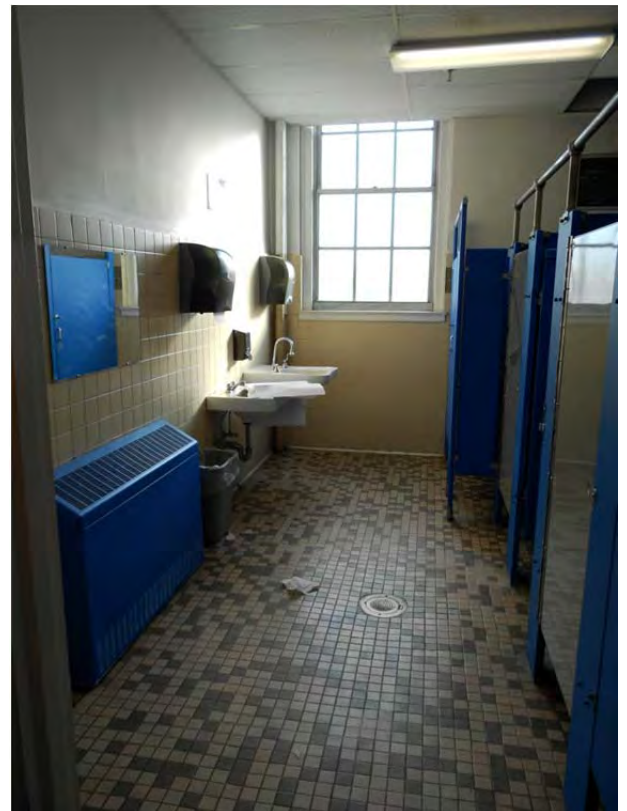
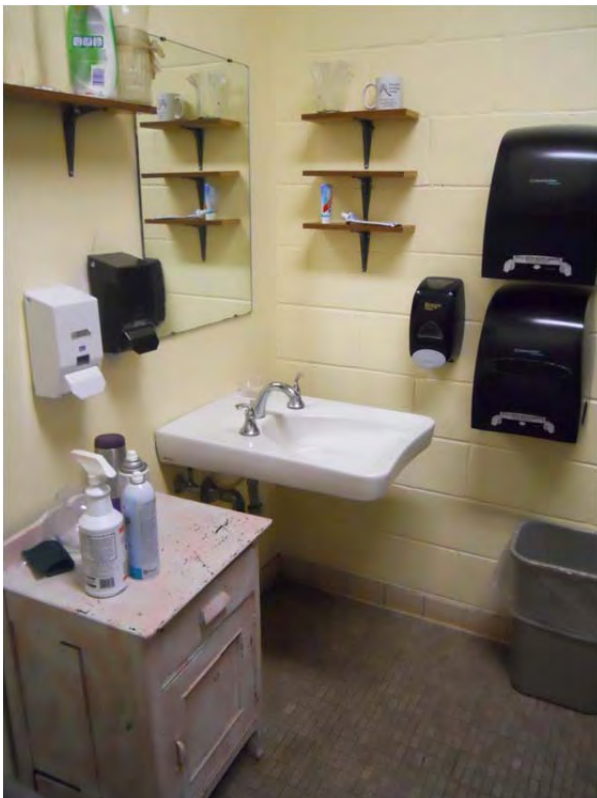
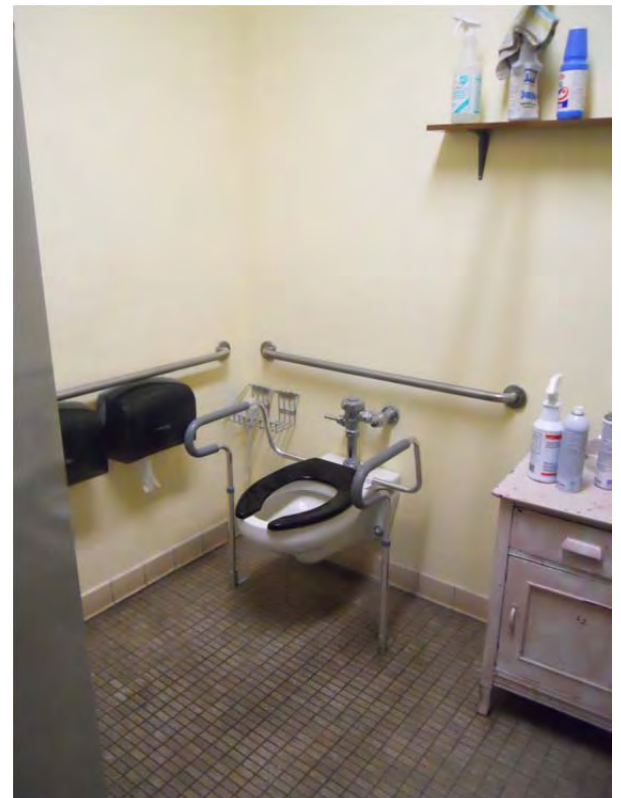
Typical multi-stall restroom.

Individual restroom.

Replace all interior finishes, partitions, fixtures and accessories. **PRIORITY A**

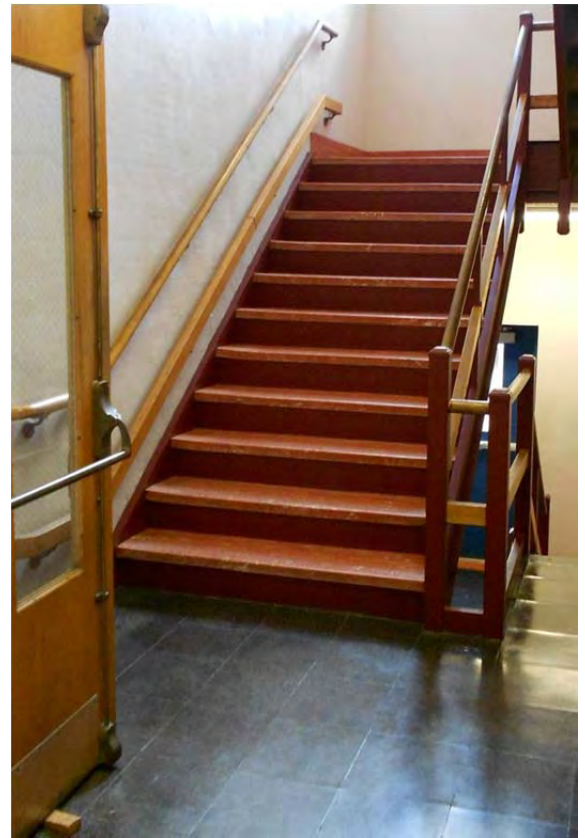
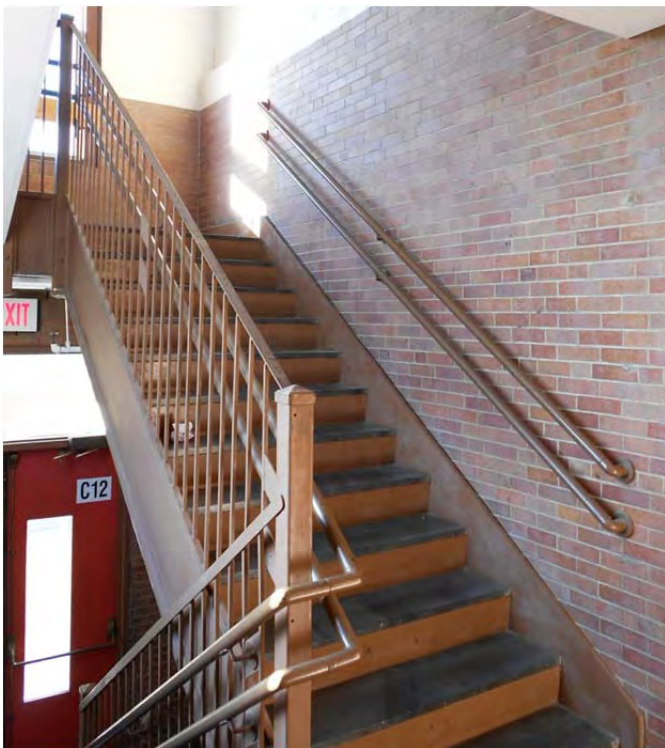
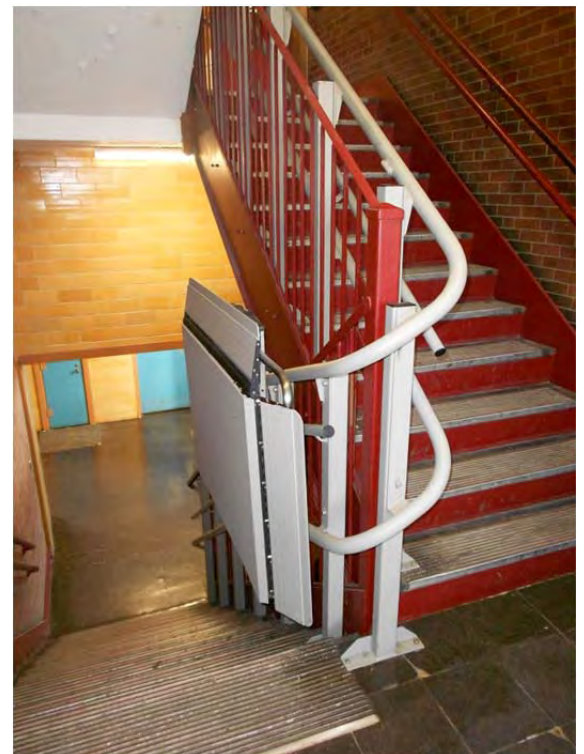
The stairs and treads are in fair condition but they exhibit many code violations.

Exit stair at original building

Exit stair at southwest corner of the west wing.

Exit stair at the east wing.

Keep all stairs, re-do hand and guardrails. **PRIORITY A**

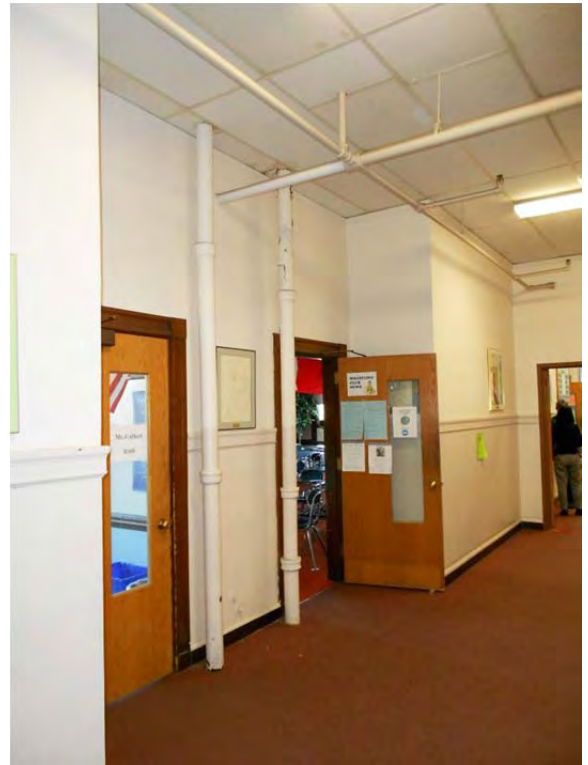
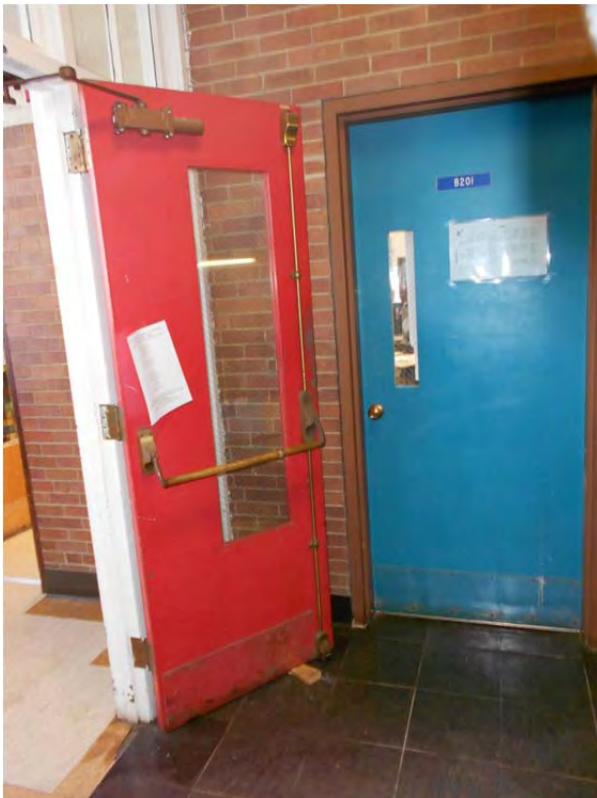
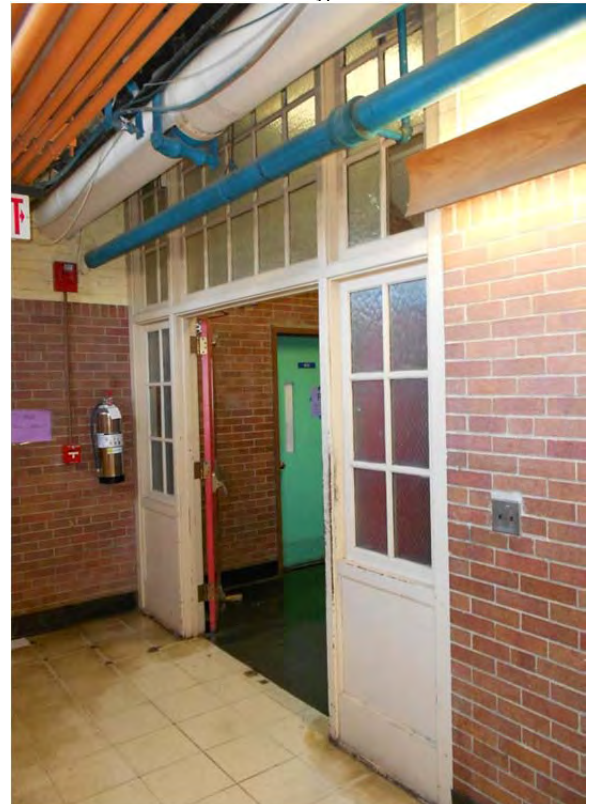
Typical wood classroom door.

Typical metal door at exit stair.

Typical historic frame with transom and sidelights at exit stair.

Replace all wood and metal doors with new and install new Code compliant hardware. See Code section of this report for additional information. **PRIORITY A**

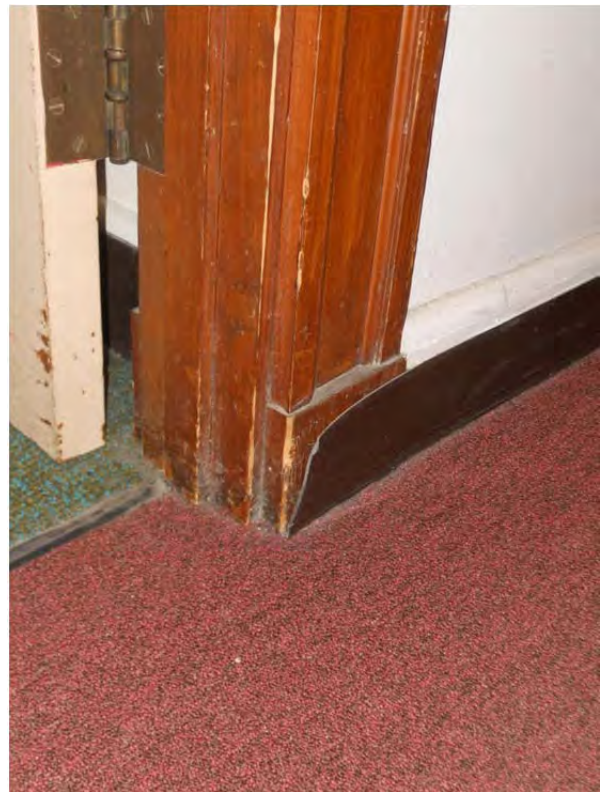
The original wood trim and casework in the original building is worn, but original profiles are discernible throughout. Paint and stained finishes are scuffed. Vinyl base has been installed over original wood base and door casings, but the original material remains beneath the modern modification.

Original door frame and wood base covered with vinyl.

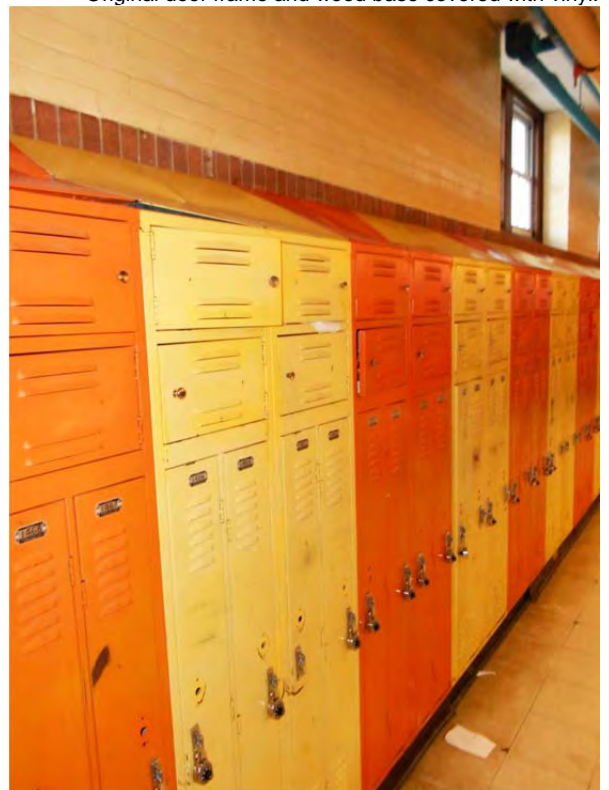
The lockers are bent, rusty and generally in poor condition due to heavy use.

Typical hallway lockers.

Replace existing lockers with new lockers.

PRIORITY B

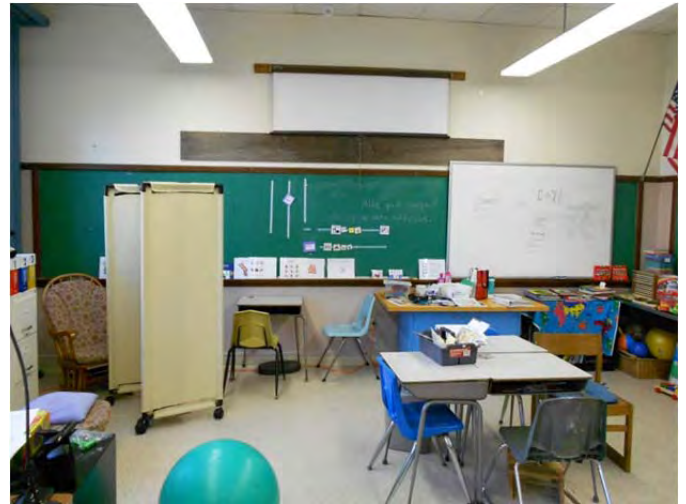
Chalkboards and whiteboards are in fair condition.

Existing chalkboard

Due to the possibility of allergic reaction to dust from chalkboards and where dust sensitive equipment such as computers exists, it is recommended that chalkboards be removed? **PRIORITY B**

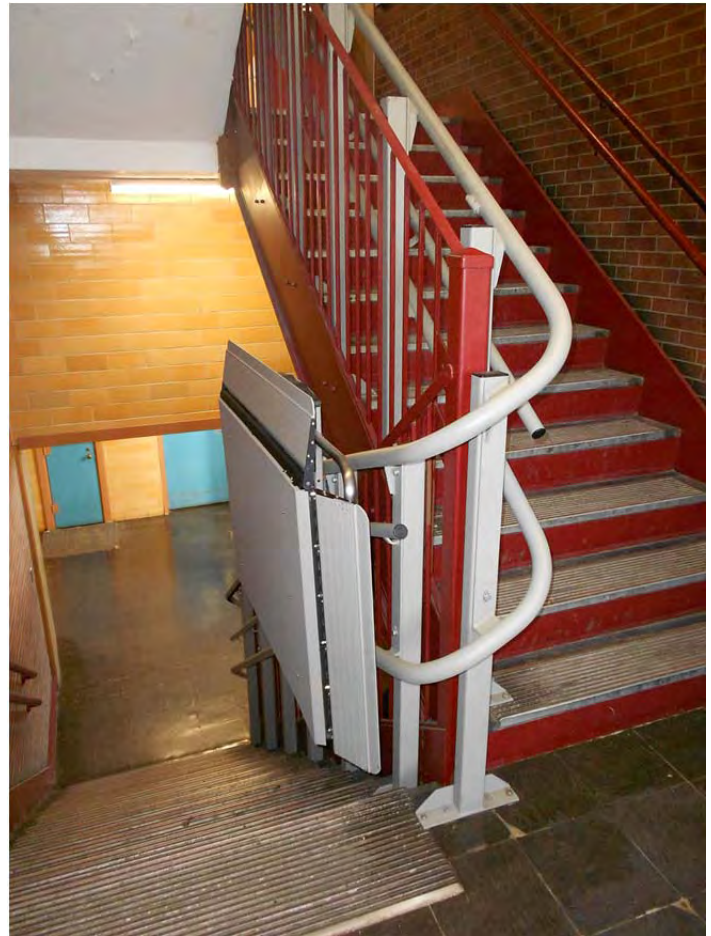
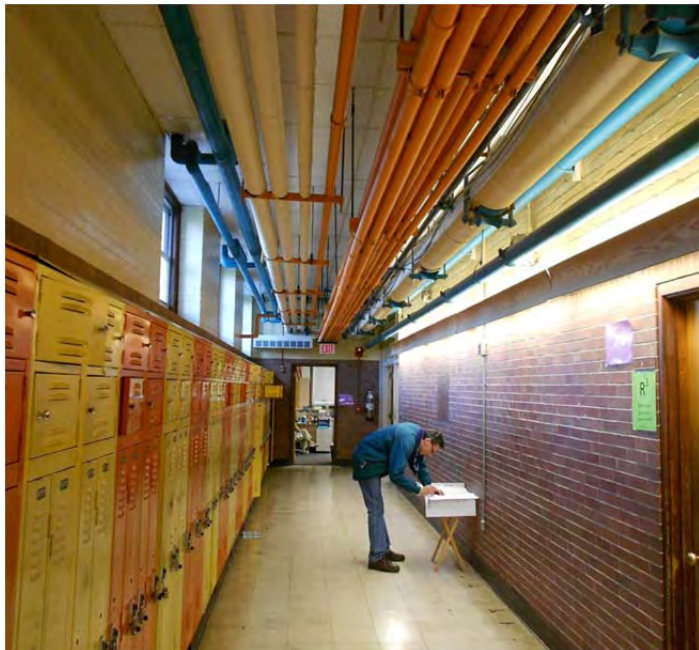
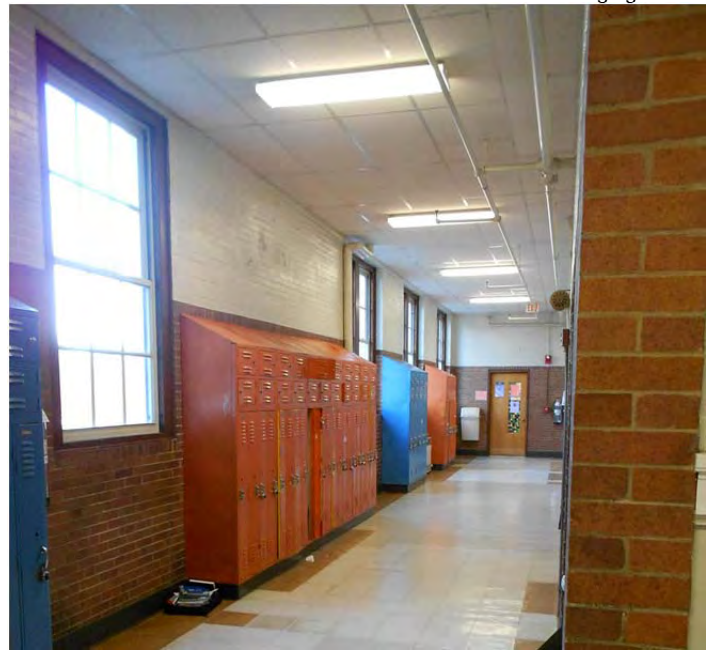
To compound the issue, the corridor within the east wing that connects to the main east wing stair is too narrow for the volume of students encountered during class changes. Although nearly 8'-6" wide, 12" deep lockers are located along one side. When students are at those lockers, the effective width of the corridor is reduced to around 6'-0", thus limiting circulation to single-file flow in each direction.

Narrow stair width for the volume of students changing classes.

The amount of lockers and adjacent classrooms create congestion.

Effective width of corridor reduced by lockers & large student volume.

Relocating the lockers out of the east wing corridor will greatly improve student flow, as will increasing the width of the stair connecting the east wing, gym wing, and south wing. In other corridors and stairs, remove obstructions and furniture to maximize available width.

Another alternative for the east wing stair and corridor include designating different stairs for travel upstairs and others for downstairs travel unless there is an emergency. Once the students adjust to this traffic pattern, crossing and congestion could be reduced.

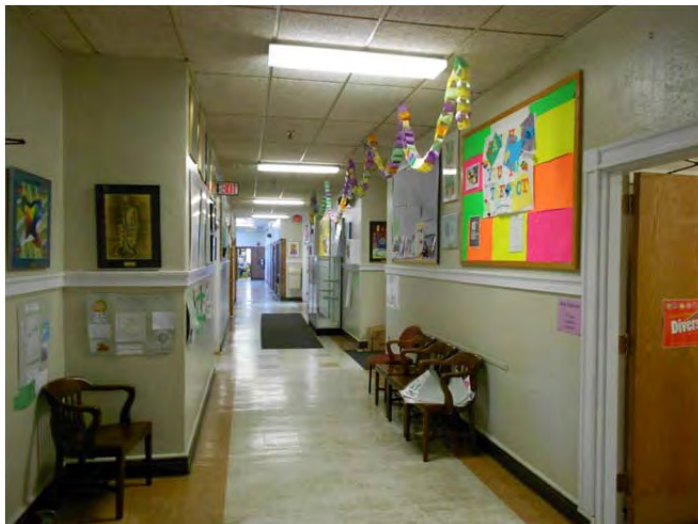
The main level corridor is impeded by furniture and display cases.

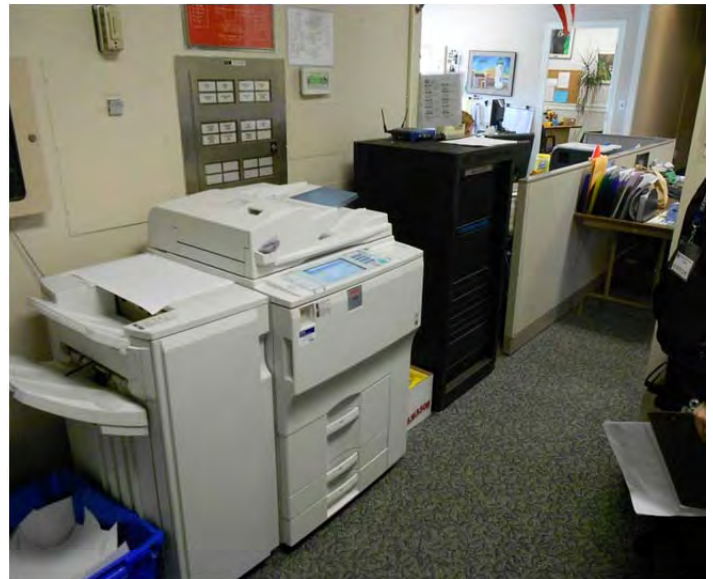
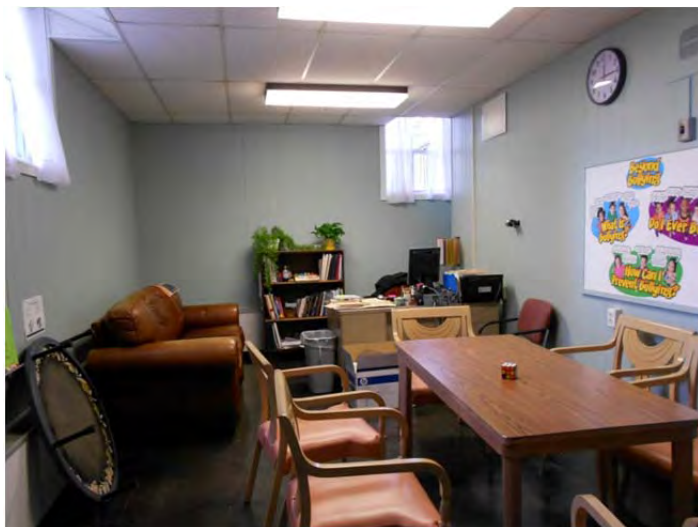
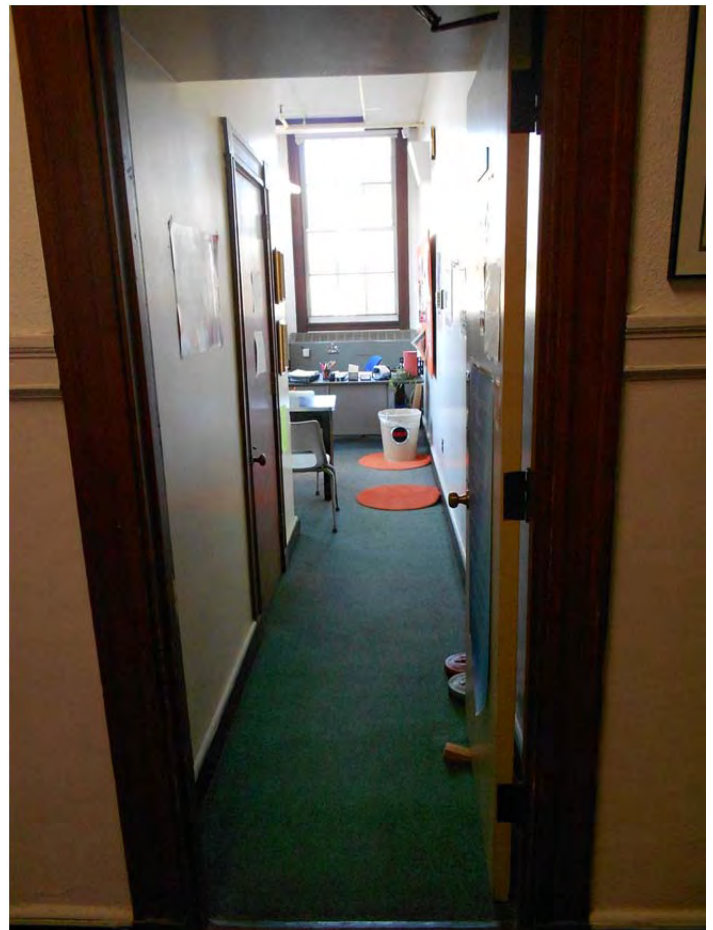
The main administration is cluttered, cramped, and

A lower level special education area not utilized well due to furniture.

An upper level office area restricted by an old bathroom core.

The office areas have definitely sacrificed functionality and size for the sake of the educational spaces. That being said, the administration must be able to function well so the school can function well. Rooms must be adequately sized for the program they contain.

Should there be an opportunity for renovation, office areas should be evaluated for potential improvements if existing non-required infrastructure is removed, like old PA system panels, teacher bathroom cores, etc.

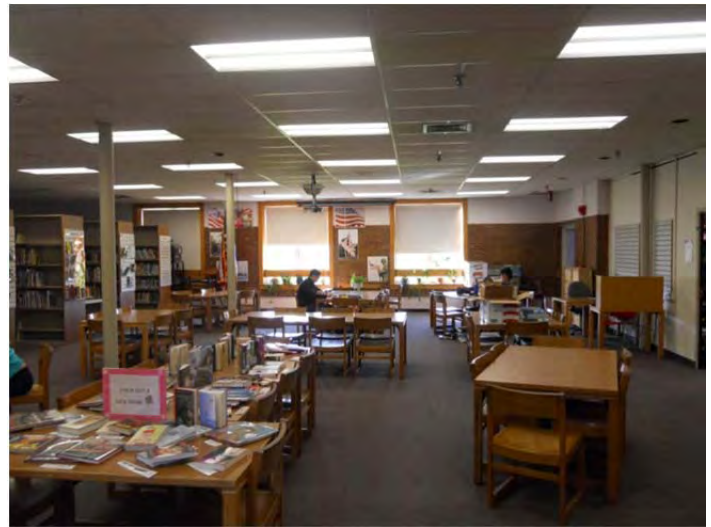
Despite the library space having windows and relatively high ceilings, due to the size of the space, it appears very flat and confining. This is further enhanced by the tall stacks that obscure the view to the computer lab, making the library seem smaller. Also, the library computer lab should be separated acoustically from the rest of the library so instruction can happen in two areas without interference.

The media center does not have non-computer teaching area.

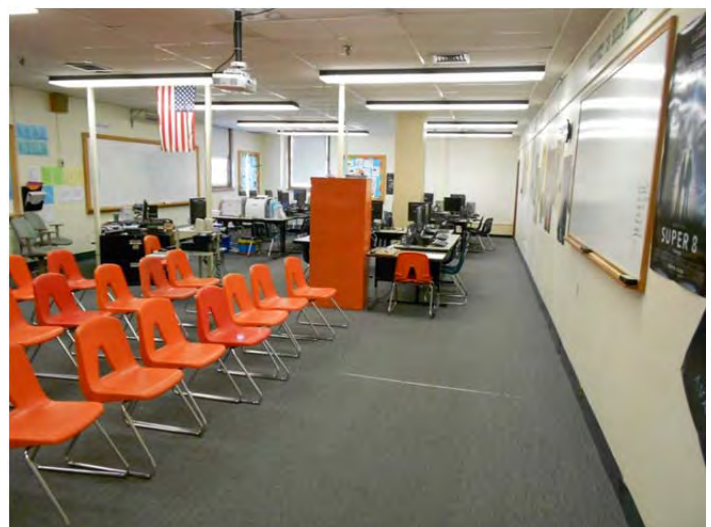
The resource room is separated into lecture and computer areas.

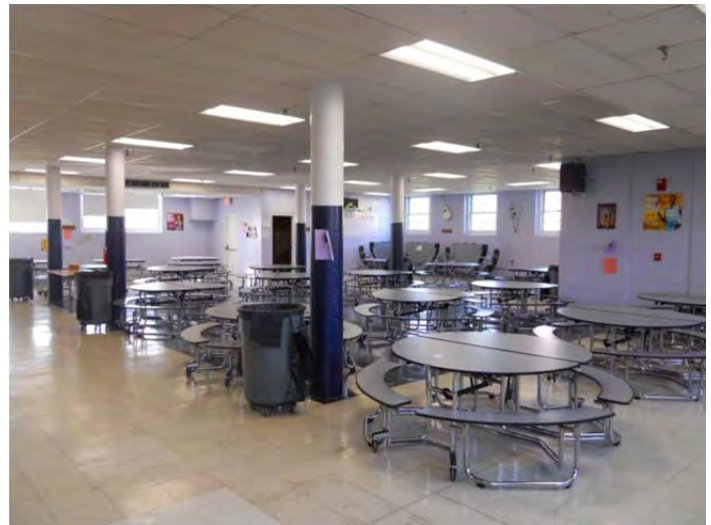
The cafeteria functions adequately for its size and student load.

Although the cafeteria functions well, aesthetically it could use improvement. A new ceiling, possibly with additional height, and lights would improve this, along with a new ceiling in the kitchen.

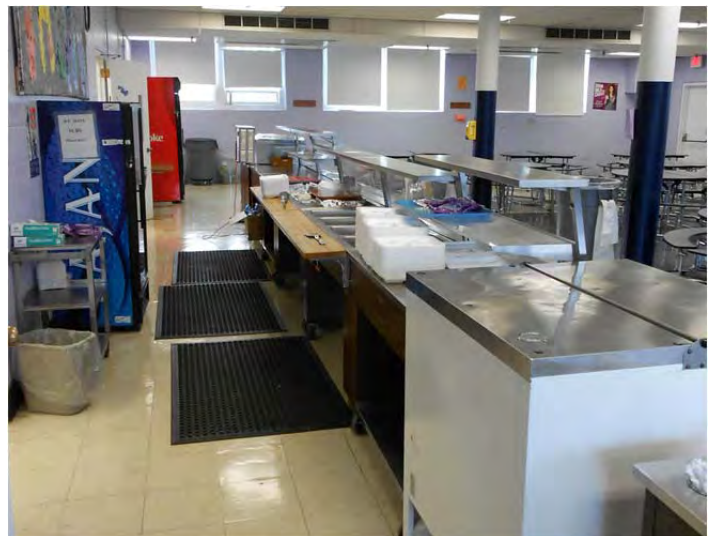
The serving equipment is located outside in the kitchen in the cafeteria.

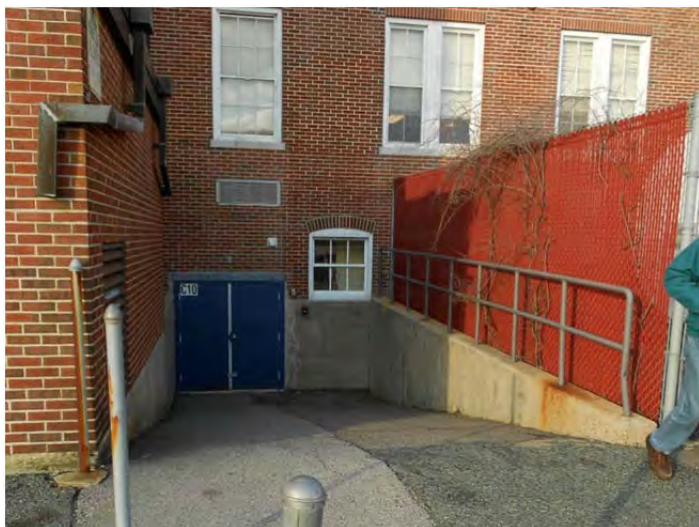
One deficiency to note was rusting ceiling tile near the cooking hood. Another is the severe inclined ramp for deliveries from outside down to the kitchen level, which could be extremely dangerous in wet or icy conditions, or when traversed with large or heavy loads.

Ramp access outside to the kitchen is extremely steep.

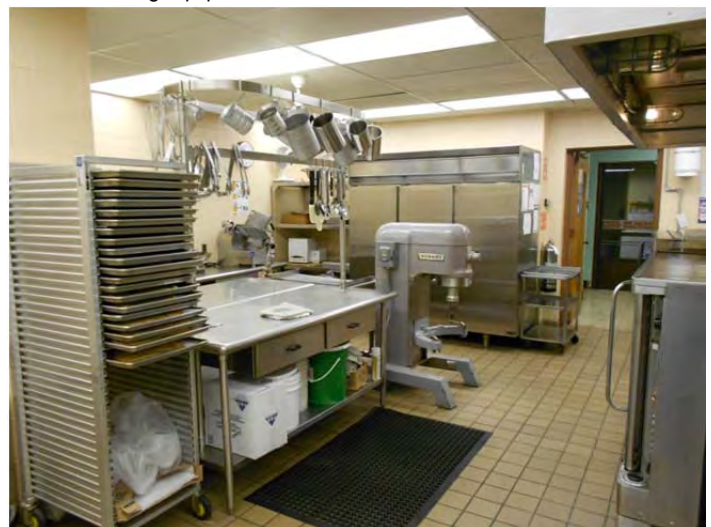
The kitchen is in very good condition despite its age.

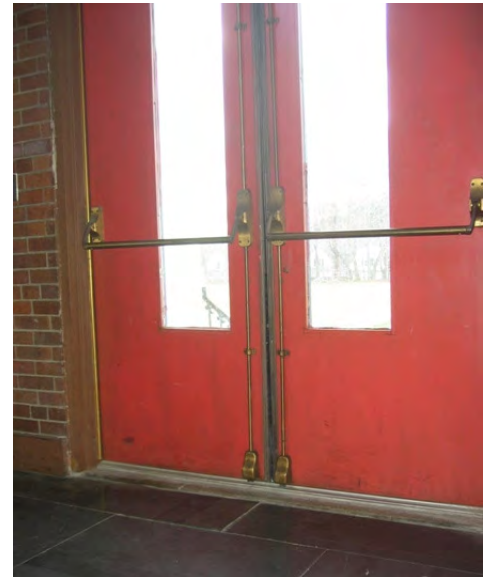
All exterior doors and frames are in poor condition. Door hardware consists of older style exit devices with vertical rods. On the date of inspection, numerous security devices were seen effectively locking exterior doors. Thresholds are aluminum and in poor condition. Door widths vary.

Exterior doors from corner stair.

Remove all existing doors and frames and restore the original masonry openings. Replace the doors with new smooth FRP clad or 70% Kynar painted aluminum and/or aluminum/glass doors in new aluminum frames. Provide new compliant exit devices and continuous hinges on all doors. Coordinate exterior hardware requirements with town. Elimination of levers on exit only doors and a new grand master key system is recommended for increased security. Door widths must be coordinated with egress loads. Existing frames less 72" wide should be provided with unequal leaves; one 36" wide and another +/-24" wide.

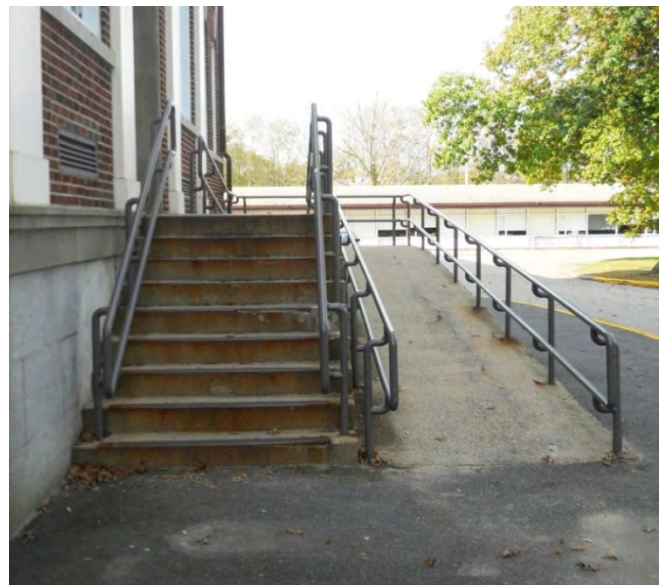
At the main entrance, the concrete ramp, stairs and railings are in poor condition. The ramp is 48" wide, with a slope of greater than 1:12. However, it is not fully MAAB compliant. It has a vertical rise of greater than 30 inches, lacks edge protection and does not have the required 60 inch turning radius at the area in front of the main entry. Also, the guardrails do not meet current building code requirements. The top of the guard is only 2'-9" high and does not have any provisions for fall protection.

Main entry ramp and stairs.

Remove and rebuild the main entry stairs and ramp. Construct new cast in place concrete stairs and ramp. Provide new, 42" high, "Colorgalv" metal guards with solid balusters at 4" o.c. on each side. At the ramp, include double handrails mounted at 18" and 34" above the ramp. Edge protection at the ramp to be provided via continuous bottom rail mounted 2" above the ramp. The other exterior stairs may remain; but new guard/handrails will be required. A variance request could be pursued for the exterior steps and landings.
