Facility Analysis and Assessment Plan

Gates Middle School
327 First Parish Road
Scituate, MA

February 22, 2012

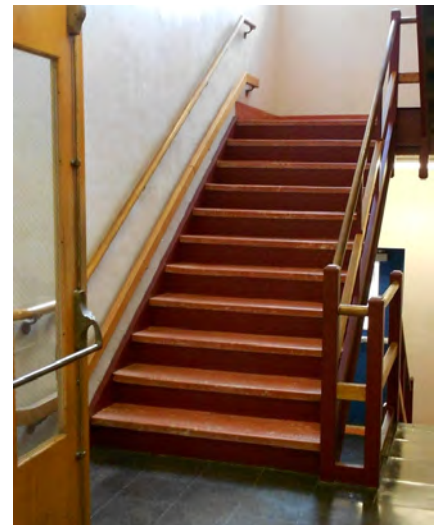
Exit stair in original building

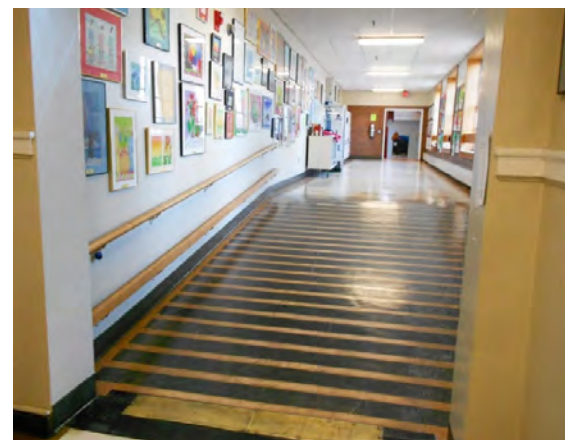
Ramp between original building and west wing

Ramps: Remove the ramps, re-structure the surrounding floor construction and reconstruct new 1:12 sloped ramps with fully compliant double handrails. Post mounted rails must be used to limit the ramp width to the existing opening.

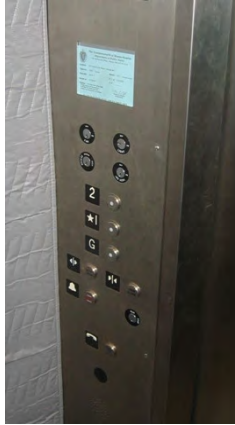
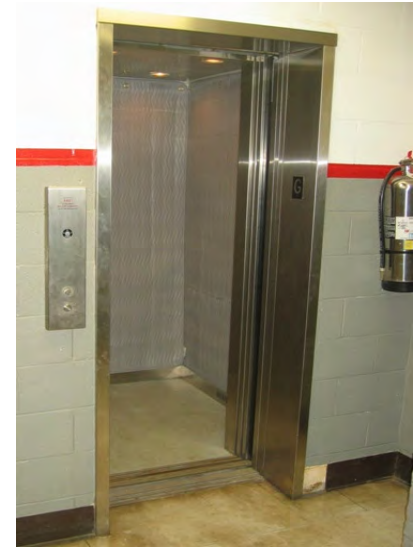
Elevator

The existing elevator is located in the original stair tower of the 1917 building. This was converted during the 1974 renovations. This elevator currently serves the three floors located in the 1917 building and the 1930 additions. The elevator cab and controls appear to have been recently renovated. The elevator entrance is 34 inches wide. The inside cab measures 47 1/2" by 49 1/2". It is not MAAB compliant. However, the controls appear to be MAAB compliant. The elevator is currently operated via key switch. It is unknown if any variances exist for the present installation.

Verify if any MAAB variances are in place. If none exist, remove the existing elevator and provide a new fully compliant holeless hydraulic elevator in a new 8" nominal CMU load-bearing hoistway. A new more central location would be recommended.

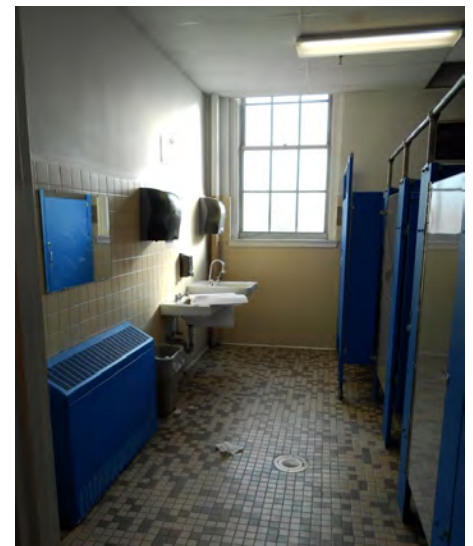
Typical gang toilet room.

Re-design all existing restrooms as part of an overall renovation scope. Increase the number of fixtures at the lower level to adequately serve the assembly load in the cafeteria. Replace interior finishes, partitions, fixtures and accessories. **PRIORITY A**

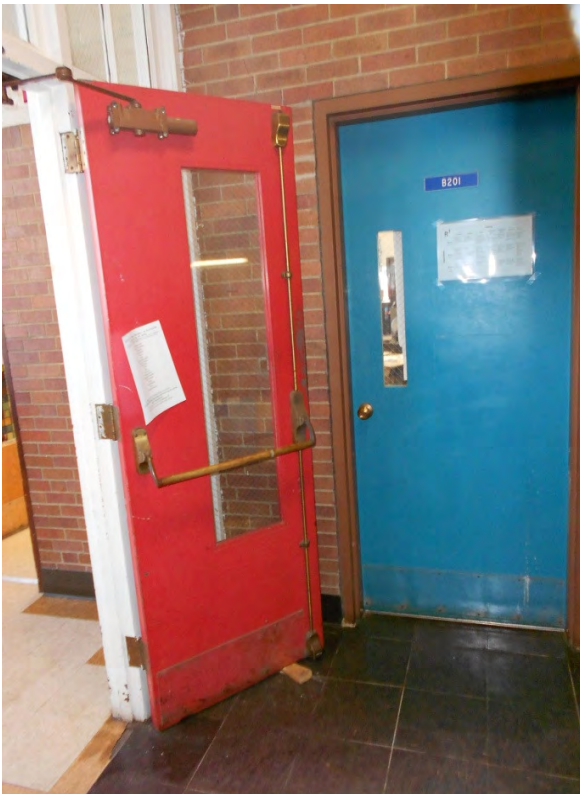
In general, the stair doors replaced in the 1970's bear the required UL labels. However, the glazing is not code compliant.

Typical metal door at exit stair.

Replace all interior fire rated doors. Replace all door glazing with 1/4" thick fully tempered glass. Fire doors shall receive wired tempered glazing. Replace all door hardware with new mortise type lever handle locksets. Egress doors and stair doors shall receive new compliant exit devices.

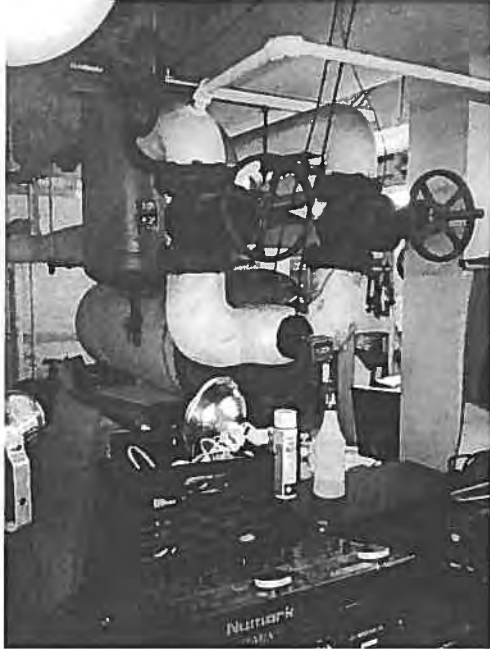
Steam-to-hot water heat exchanger

Portion of the building complex is heated by hot water heating system. There is a steam to hot water converter serving the Original and West Buildings.

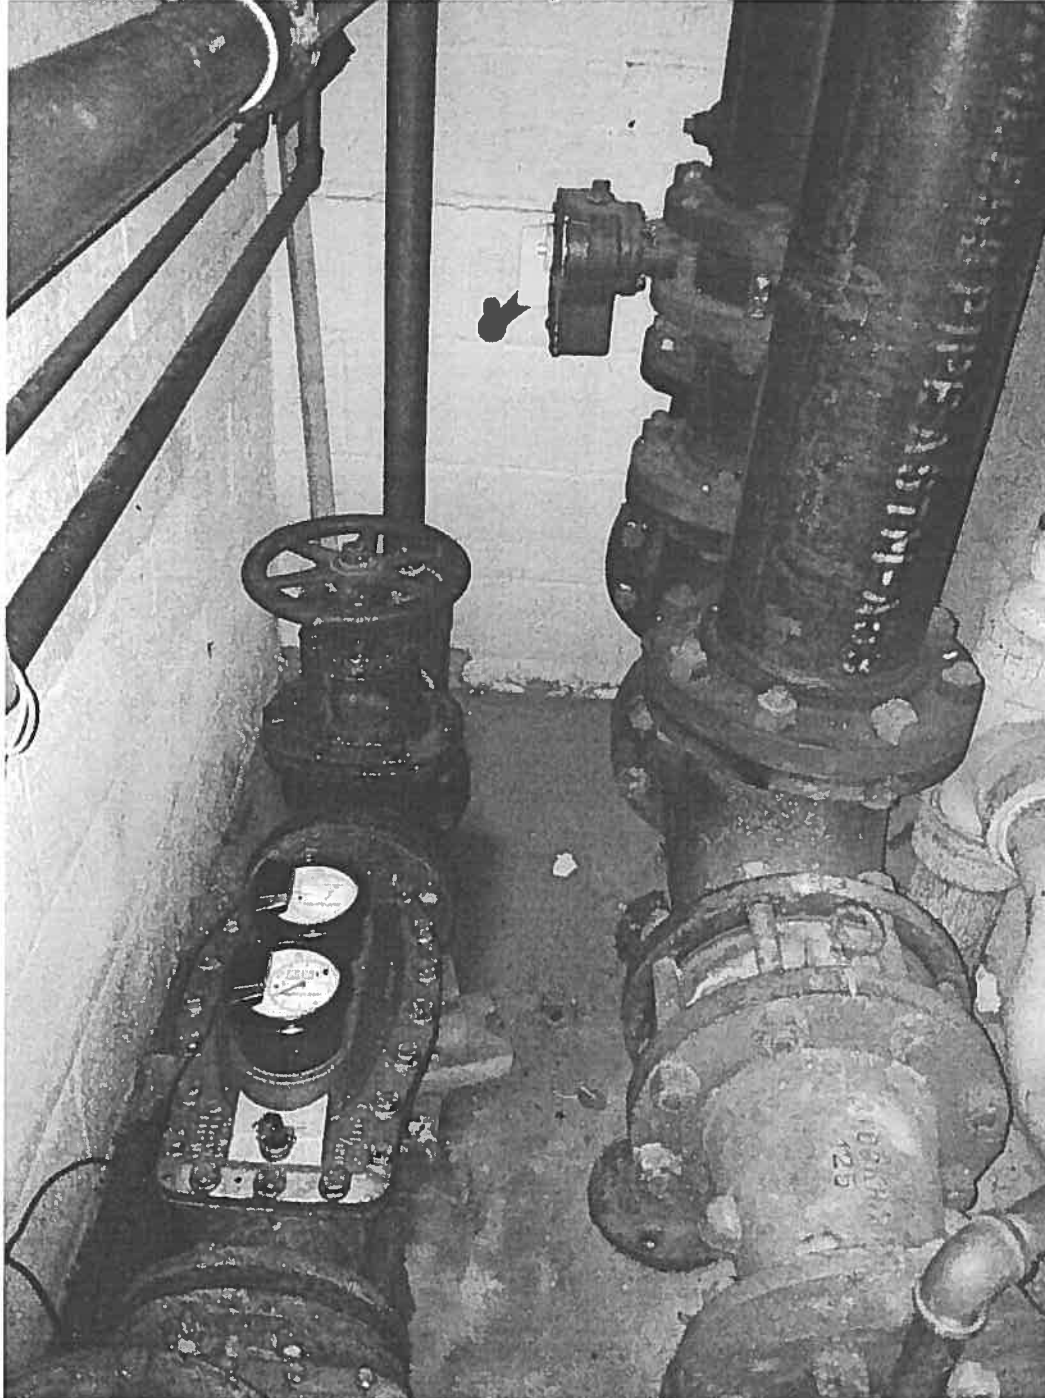
The building is equipped with a fire suppression system in most areas. The water and fire service room is in the far gym wing. The fire service room includes a vertical fire pump and controller. A double check valve assembly is not installed on the incoming fire service.

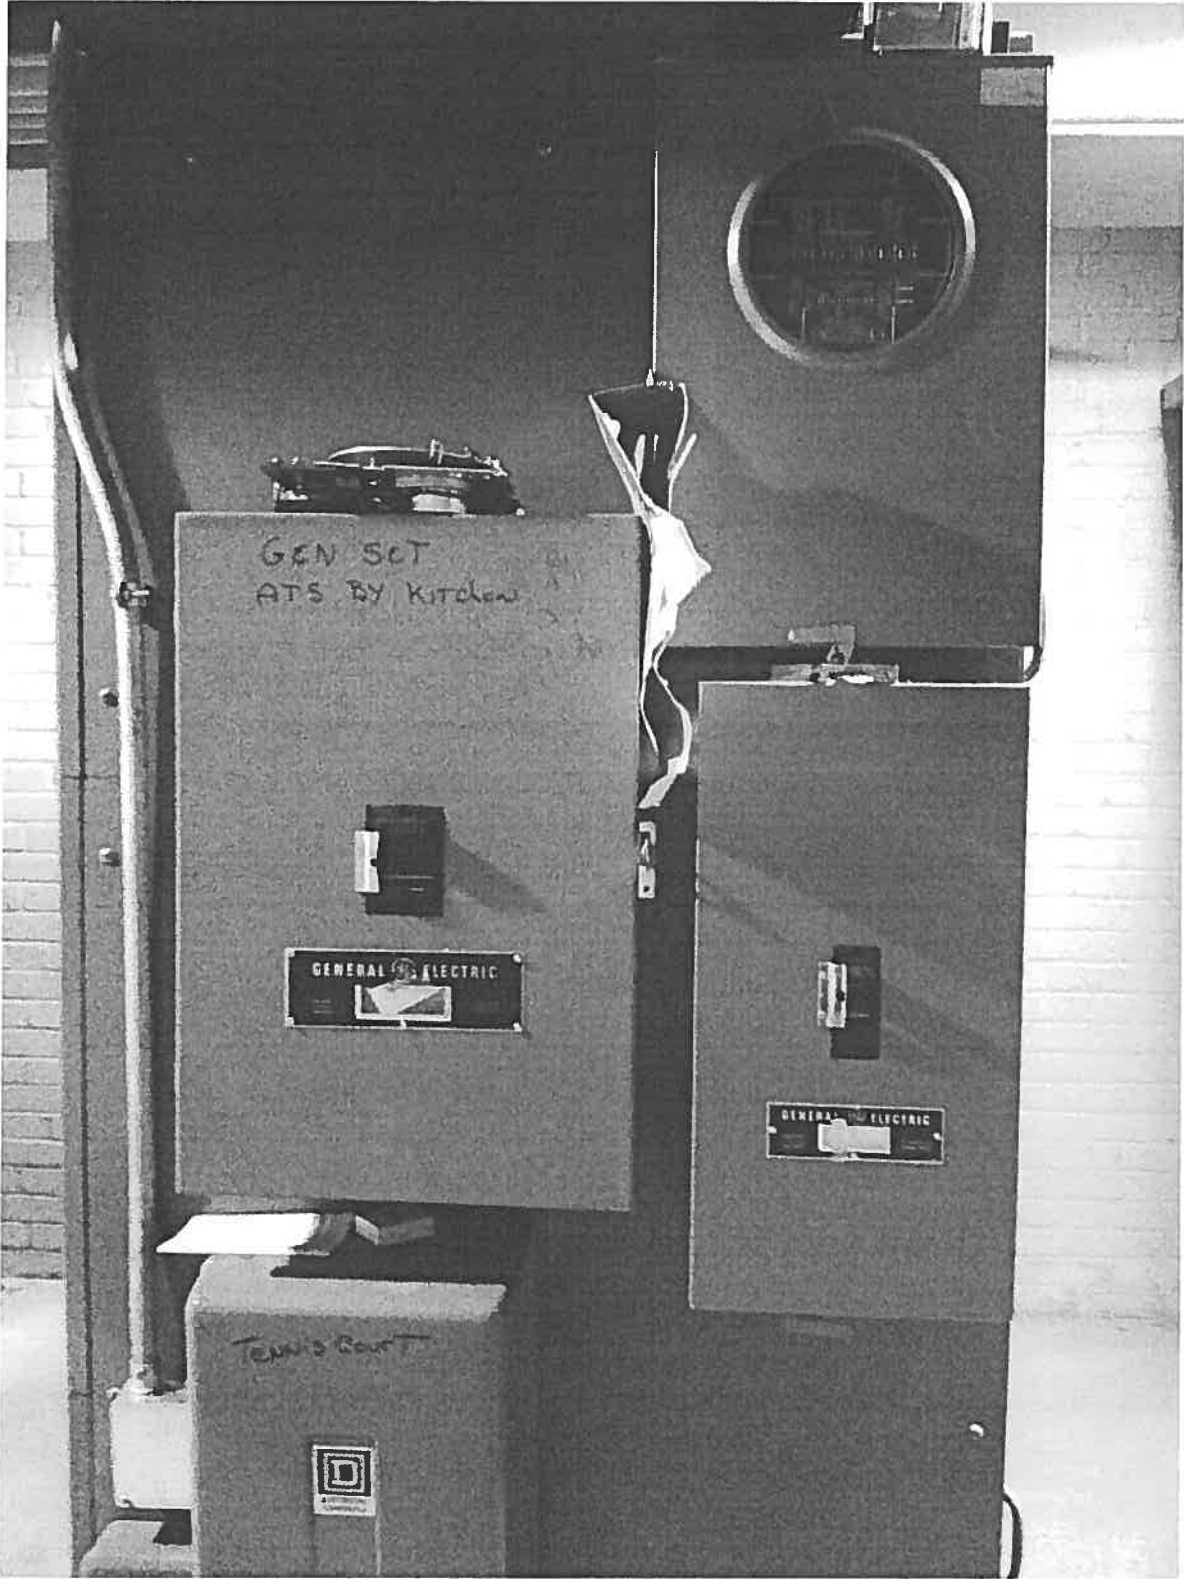
The existing electrical service is 1000A, 120/208V, 3 phase, 4 wire. This service feeds various panels in other areas of the building. A tap ahead of the main service disconnect feeds the fire pump via the fire pump controller.

A new electrical service will be required if only the original building and adjacent wings are to remain. The majority of the electrical distribution equipment is aged and should be replaced if a new electrical service is installed.

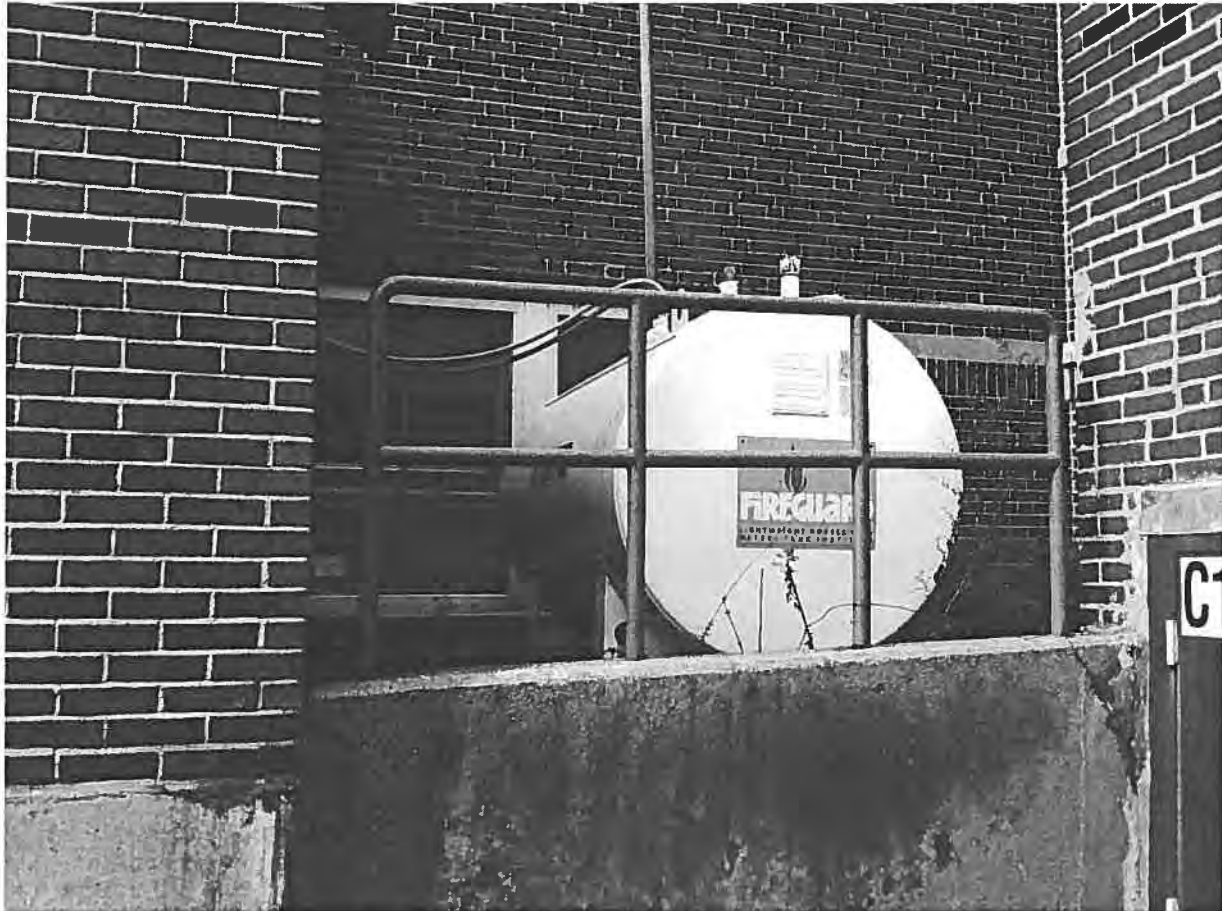
A 125kW Emergency / Standby Generator is located at the rear of the original building in a dedicated room accessible from the building exterior. The engine generator is diesel fired and an above grade fuel tank is located adjacent the generator room. The engine generator transfer switch is located in the passage area behind the kitchen. Loads on the generator include kitchen equipment, heating, fire alarm, the elevator and lighting.

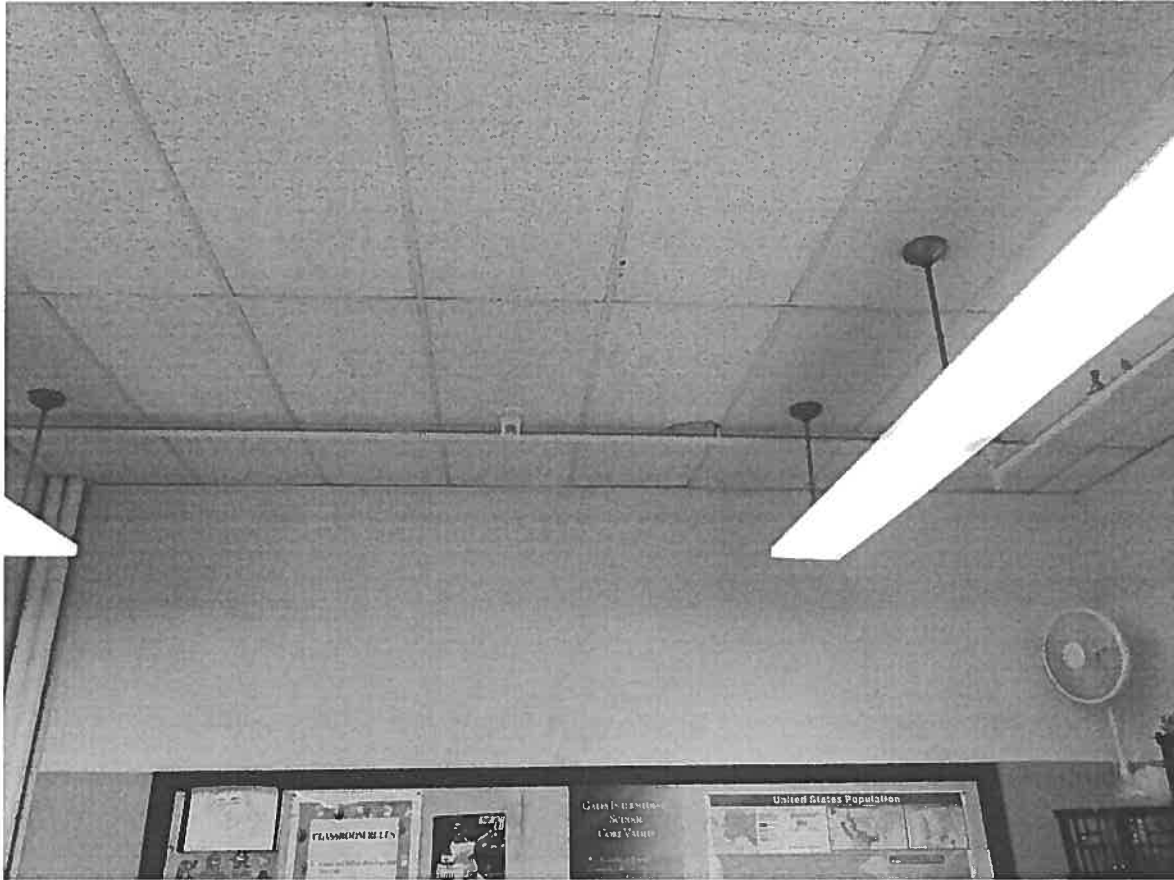
Lighting is generally suspended fluorescent fixtures with recently installed occupancy sensors for automatic control.

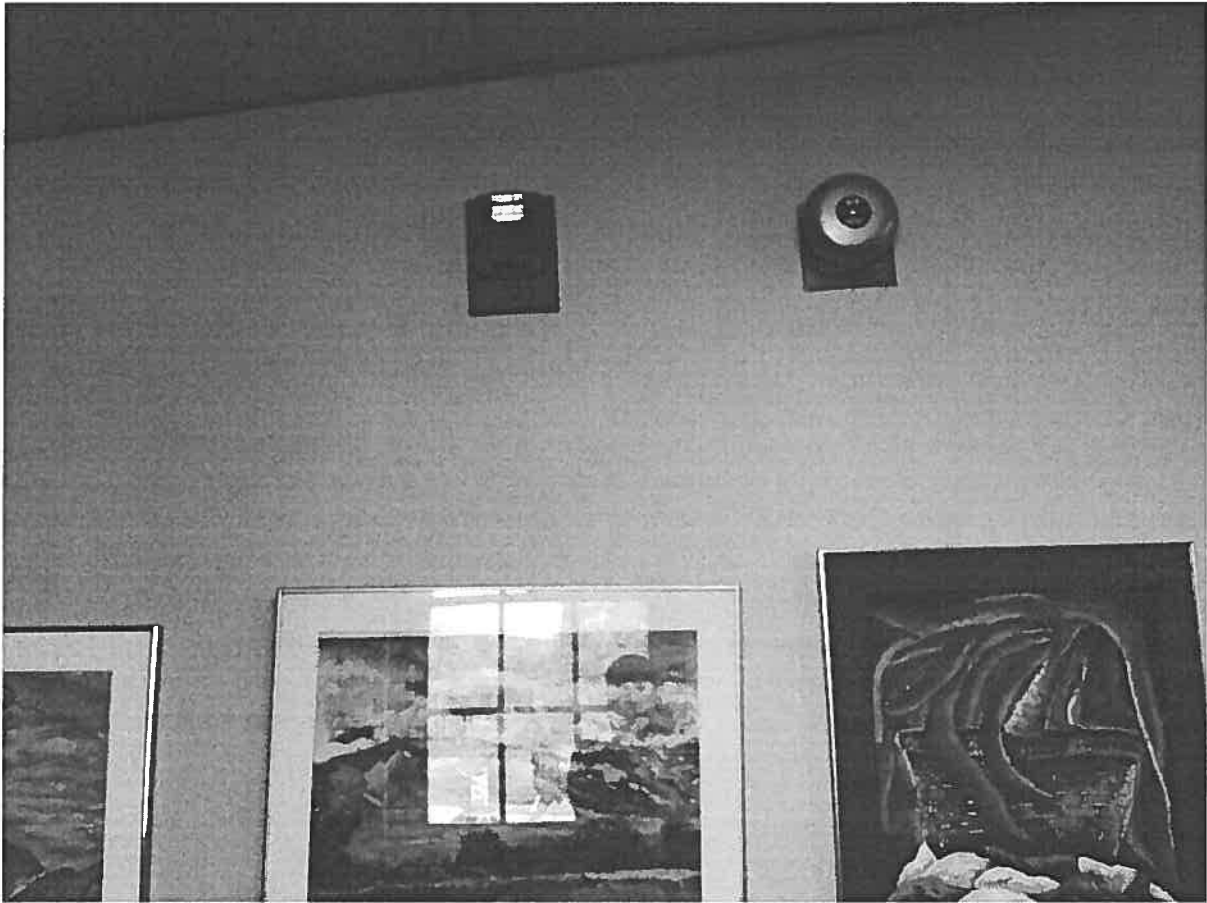
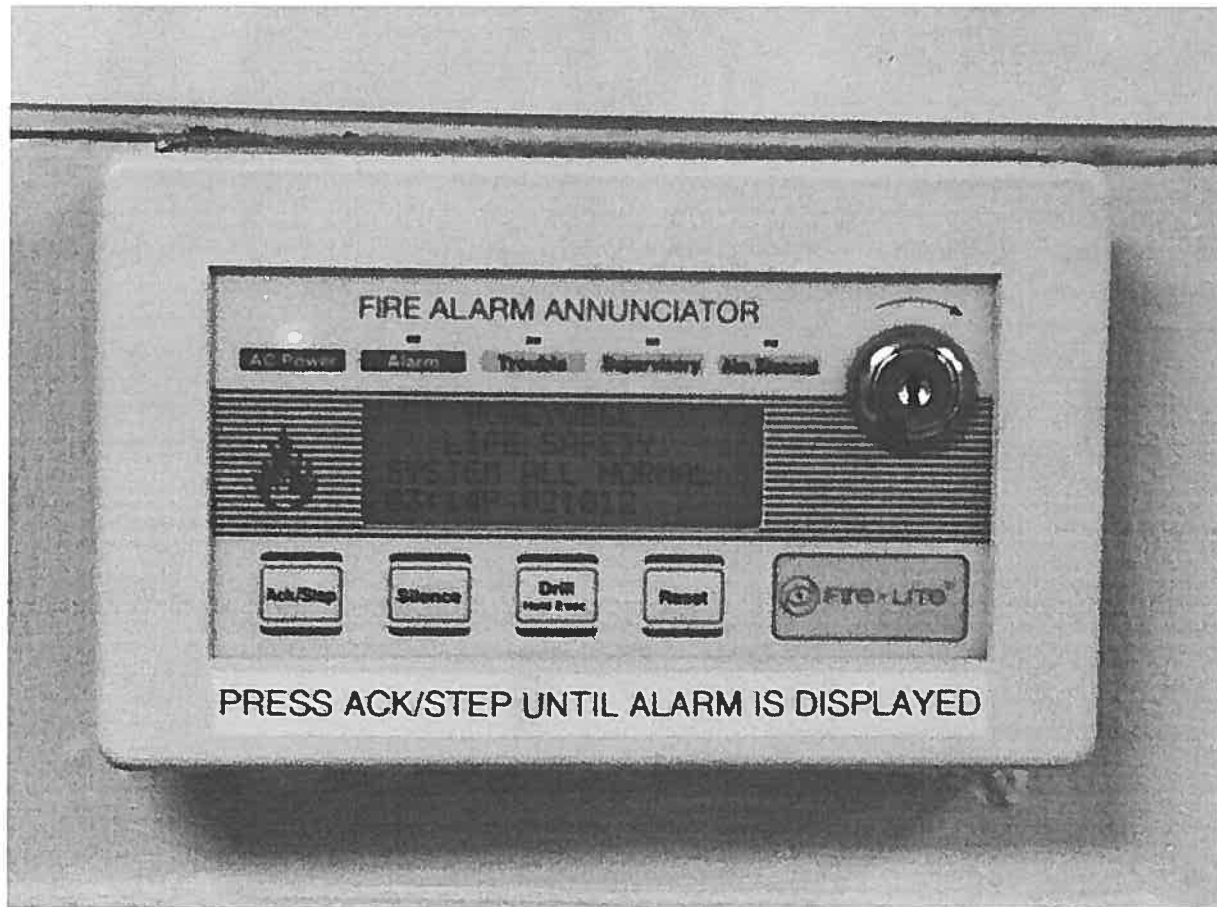
The building is equipped with a hard wired fire detection system. The control panel is located in the main office with annunciation and drill switches. Another annunciator and Master Box is at the front of the gym wing. Notification devices have been upgraded from the original bell system to horn strobe devices.

The existing fire alarm system does not meet the current building code requirements for Educational use. Current code requires emergency voice evacuation which the current system will not support. We recommend a new fire alarm system that provides code required notification.

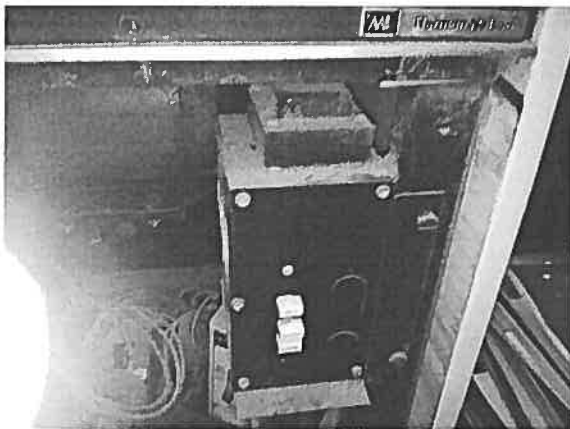
It has been indicated to us that the school maintenance contractor estimated that the majority of the unit ventilators shall be replaced. There are problems unit ventilator dampers operation, unit controls and heat output etc. Some of the units are noisy.

Interior of an AAF Herman Nelson unit ventilator

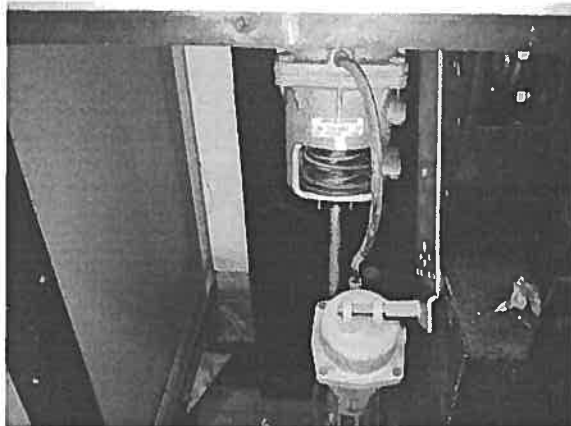
The control system is pneumatic type. It has been indicated to us that the pneumatic piping is leaky. Note that leaky piping does not allow the control system to function properly affecting the terminal unit performance.

Unit ventilator pneumatic controls (unit interior)

The boilers should remain. They are fairly new. The piping and the heating devices shall be replaced with new more efficient devices. The existing pneumatic control system shall be replaced with a digital system.
