# Assessing Coastal Erosion, Sediment Transport, and Prioritization Management Strategy for Shoreline Protection

Town of Scituate

Public Meeting #1  
April 28, 2016

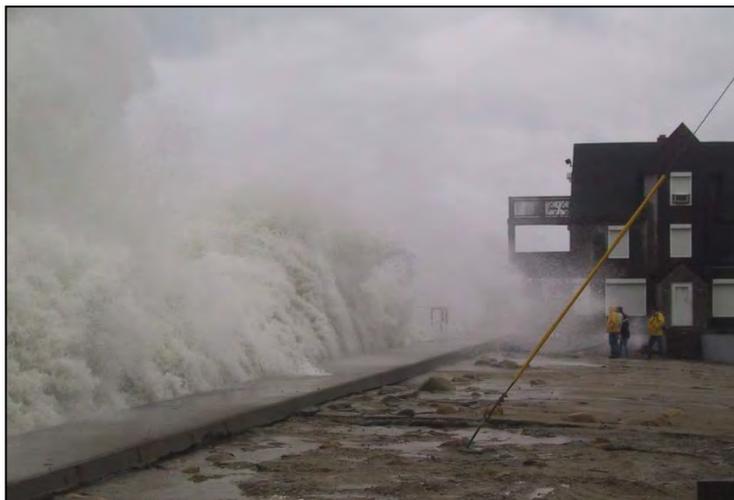
Waves overtopping seawall – Marshfield, MA  
(photo from MCZM)

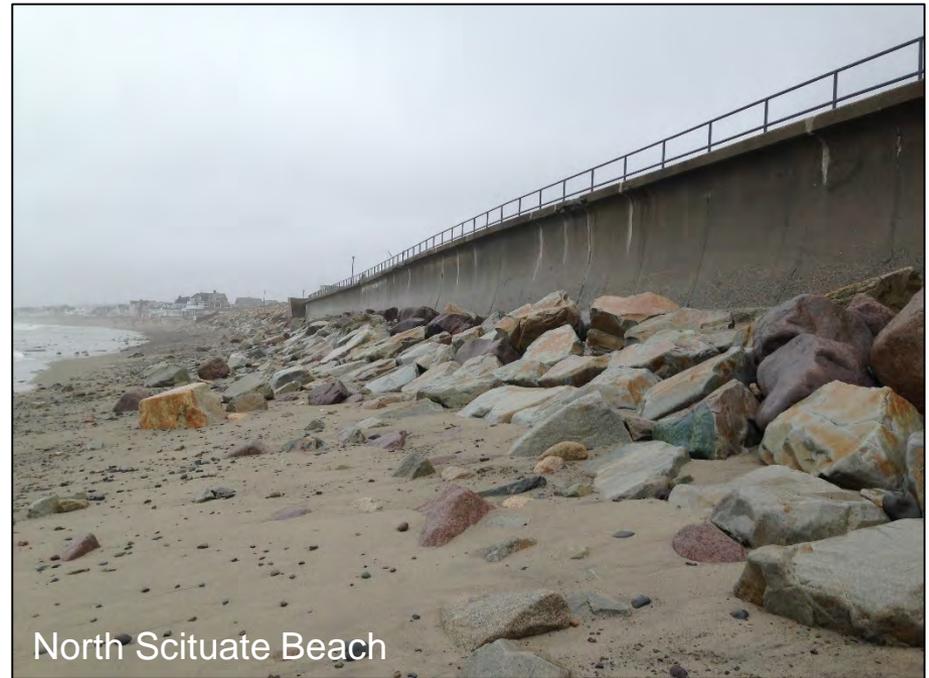
North Scituate Beach

- Shoreline change is minimal along stretches of shoreline where coastal structures have been built.
- The heavily armored Scituate shoreline leaves several areas where the beach is not limited by seawalls and revetments: Mann Hill Beach, Peggotty Beach, and Humarock Beach.
- High water shorelines were obtained from 1950/1952 NOAA T-Sheets and 2008 USGS aerial photographs.
- Cross-shore profiles were extracted from 2000, 2010, 2011, and 2014 LiDAR (Light Detection And Ranging) datasets.

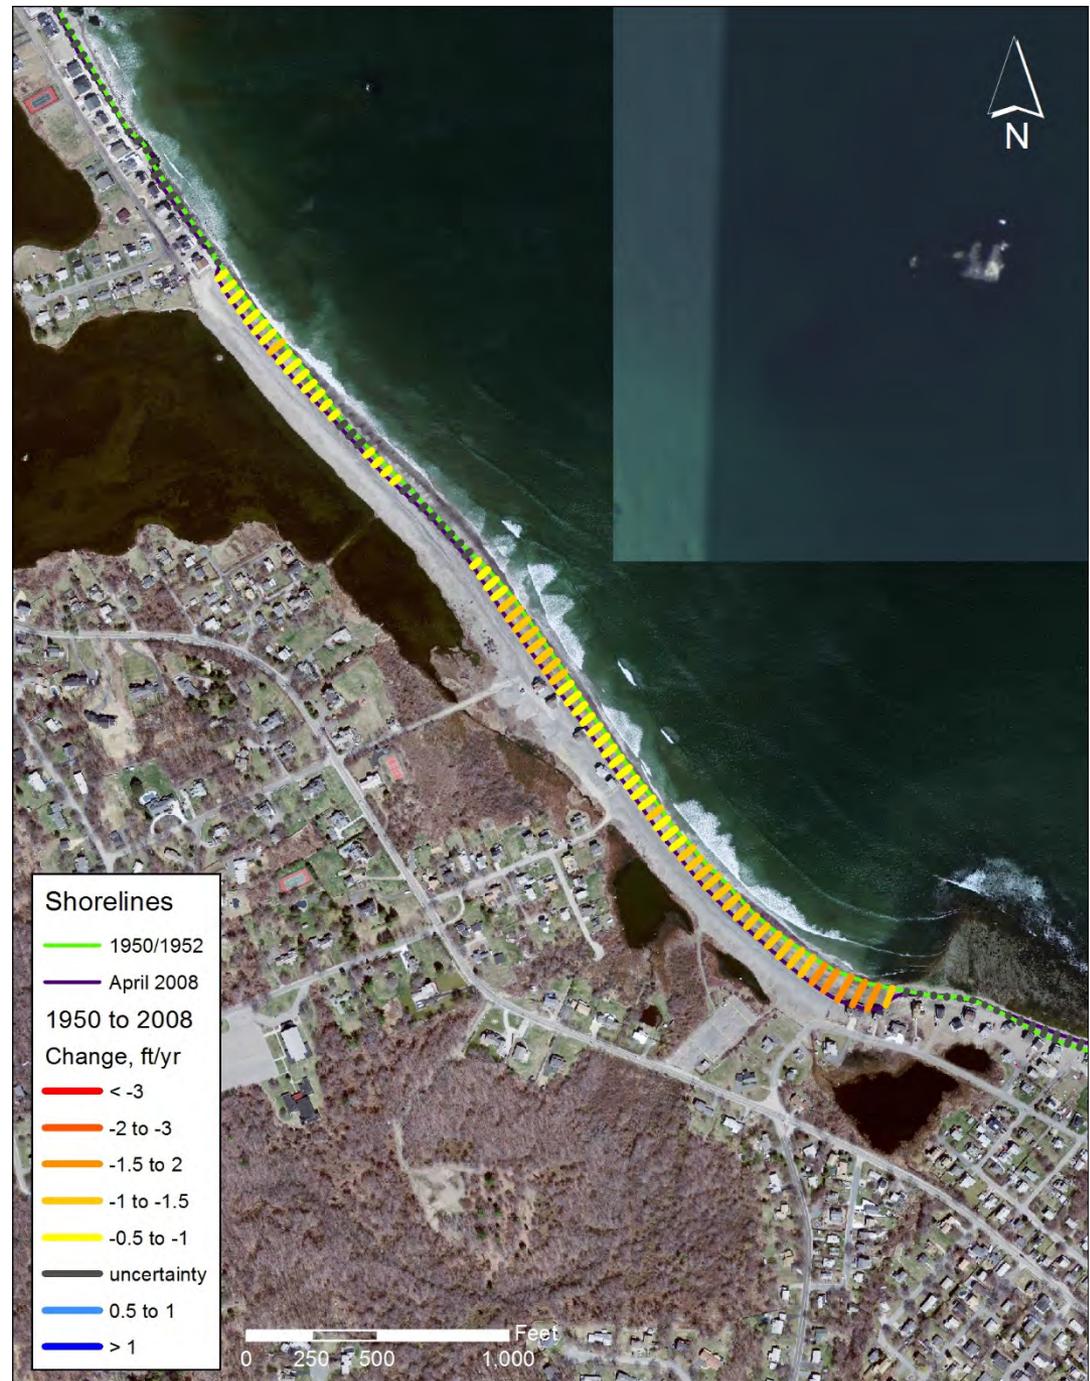
# Mann Hill Beach Shoreline Change

The beach berm at the north end gets repaired after major storms to control the overtopping of water into Mushquashcut Pond.

The 2008 high water line approaches the five homes on Stanton Lane.

Adjacent areas show nearly no shoreline change over the 58 year period due to armoring of the shoreline and seawalls.

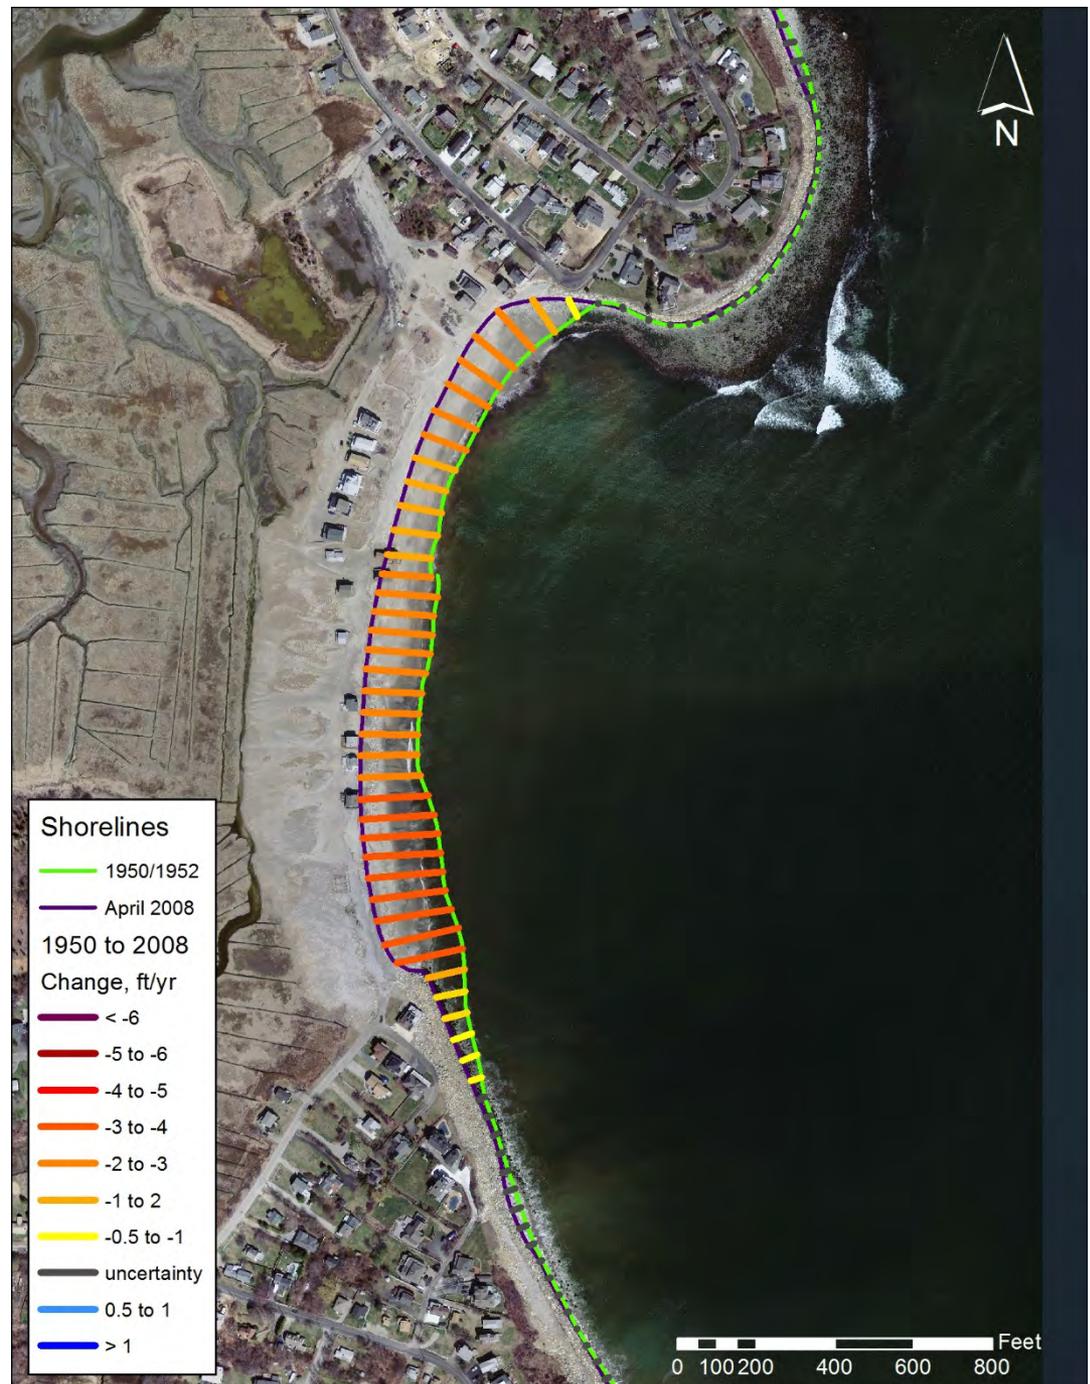
# Peggotty Beach Shoreline Change

The 2008 high water line is shown to reach the seaward face of the first row of homes on Town Way Extension.

The adjacent cliffs have been armored and show no long-term erosion.

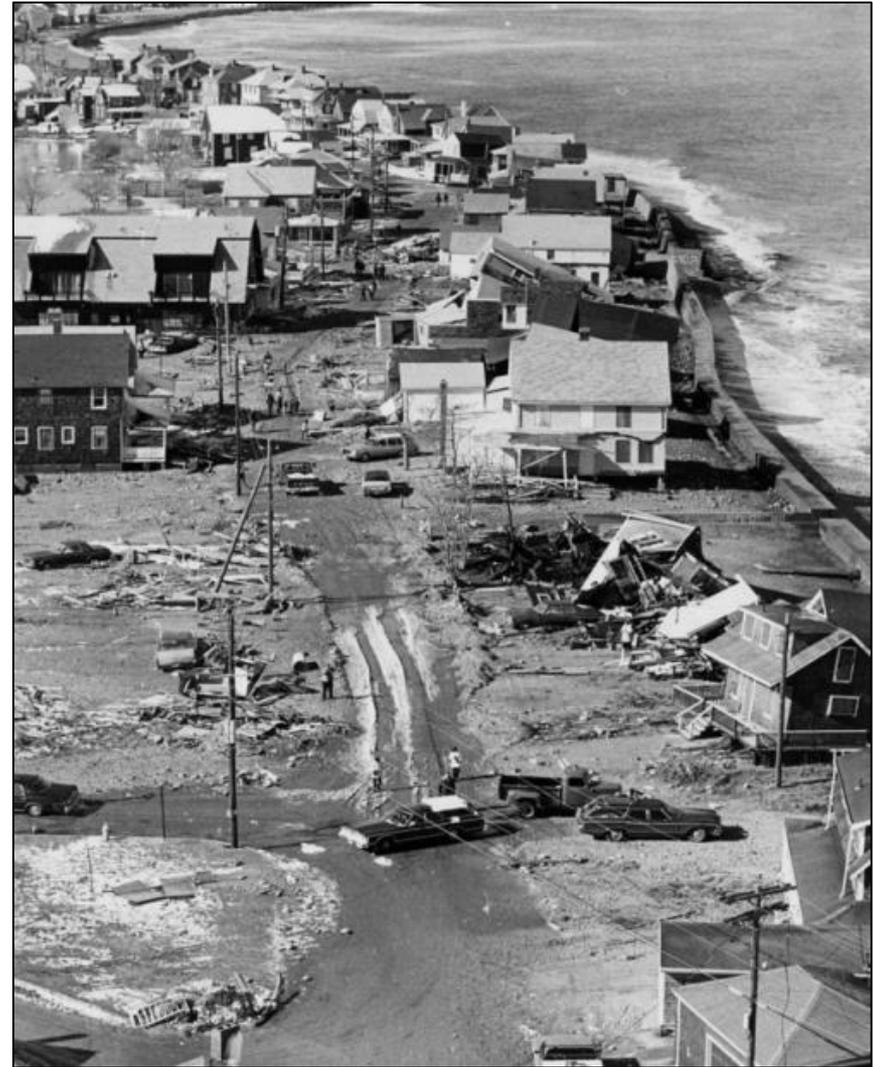
# Blizzard of 1978

158-year return period

Storm Duration: 74 hours

Maximum Surge: 4.4 feet

Maximum Water Elevation: 9.5 feet NAVD88

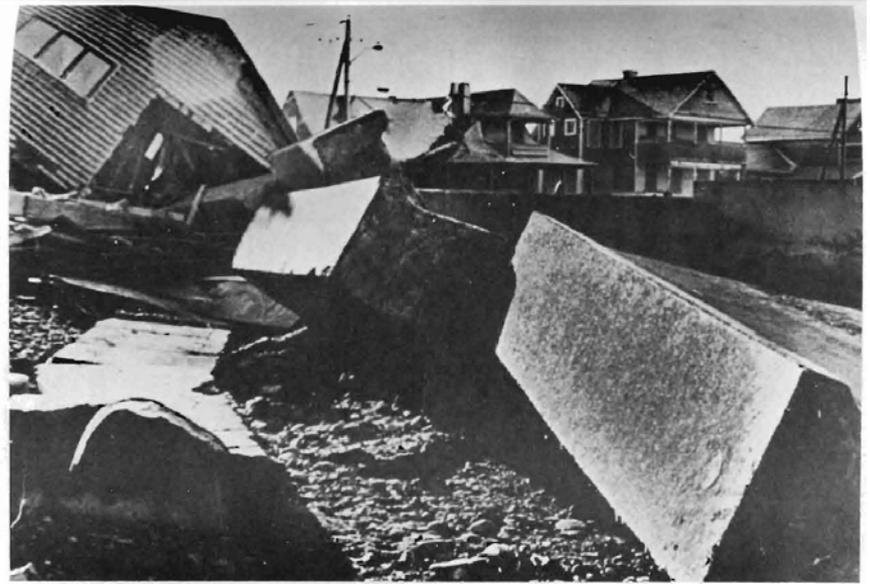
Figure 2.—Portions of the North Scituate Beach seawall in Massachusetts were destroyed by pounding surf (photograph courtesy of The Boston Globe)

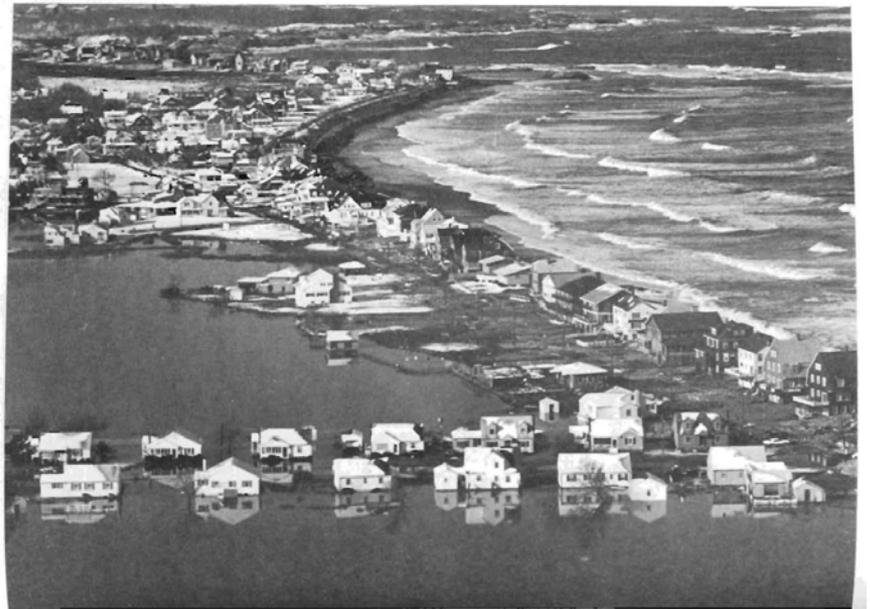
Figure 5.—Floodwaters overtopped the seawall and rock barrier in North Scituate, Mass., and raised the level of Muskeget Pond, resulting in inundation of houses along Muskeget Circle in the unprocessed photograph by Kevin Cole, Boston Herald/American (2003)

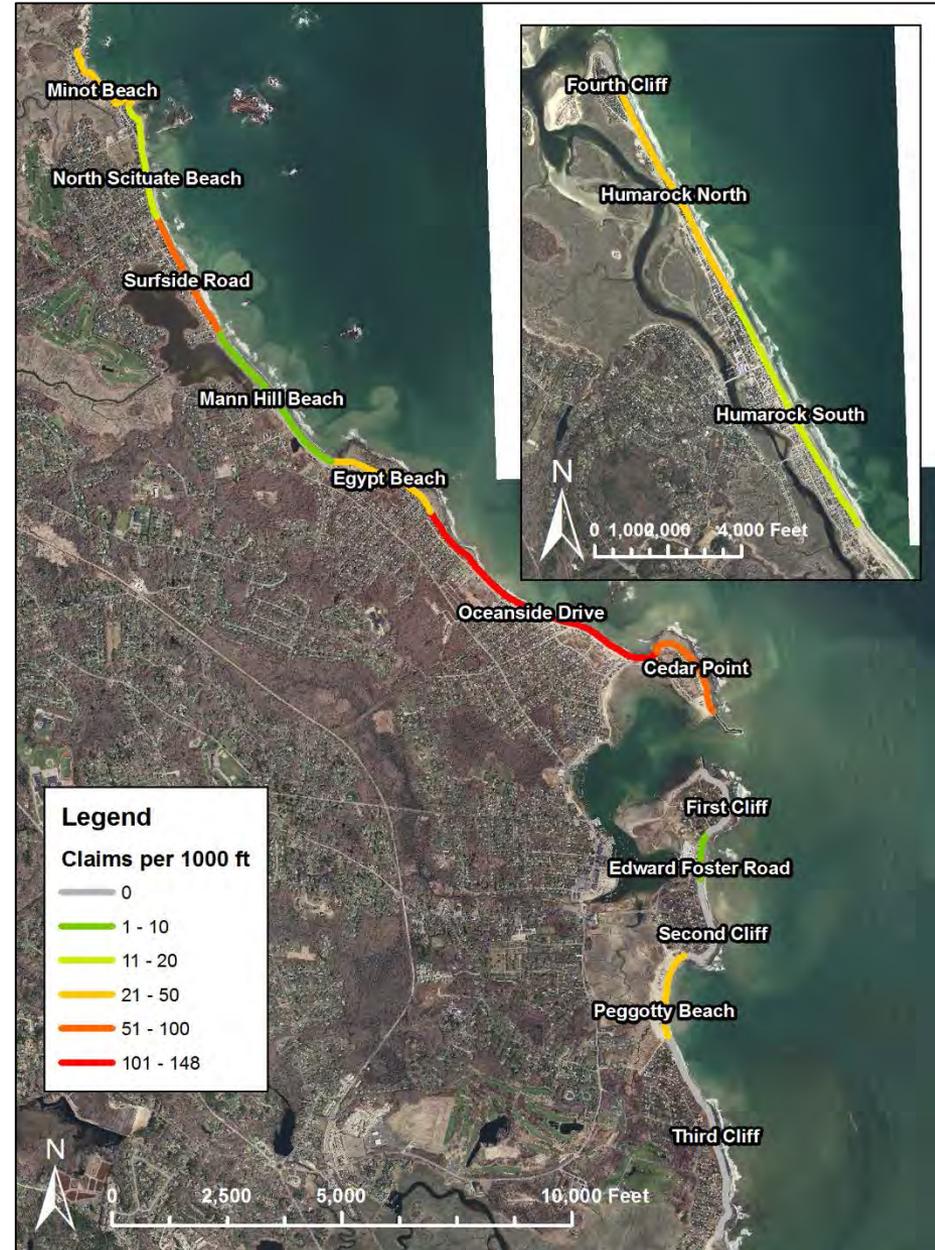
# Criteria #1: Damage Susceptibility of Private Properties

Significant number of damage claims, claim amounts, and high number of claims per property

Low number of damage claims, claim amounts, and low number of claims per property

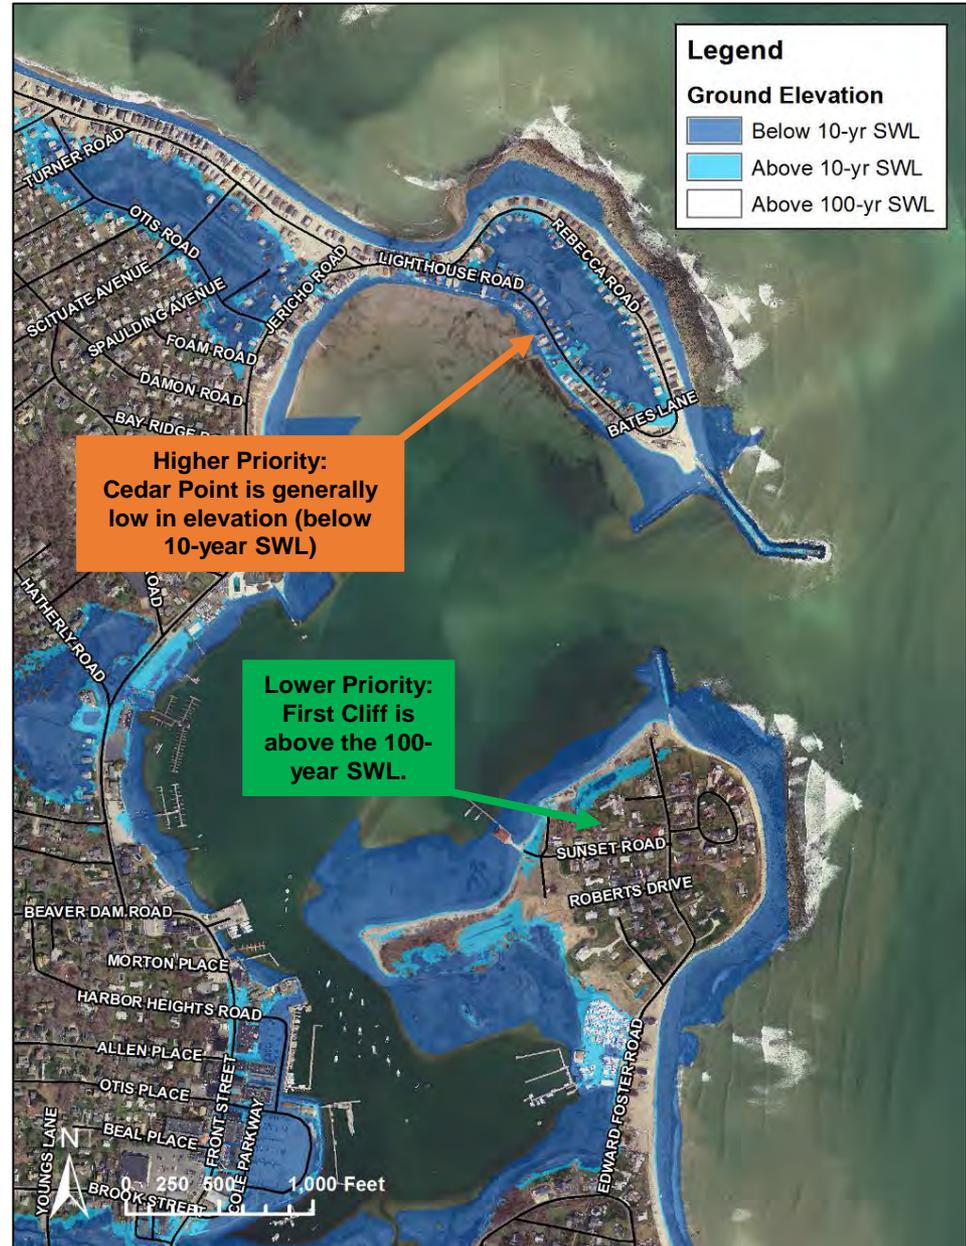
# Criteria #2: Landform Elevation

Low elevation areas are easily flooded and impacted by waves

High elevation areas are less prone to flooding and wave damage

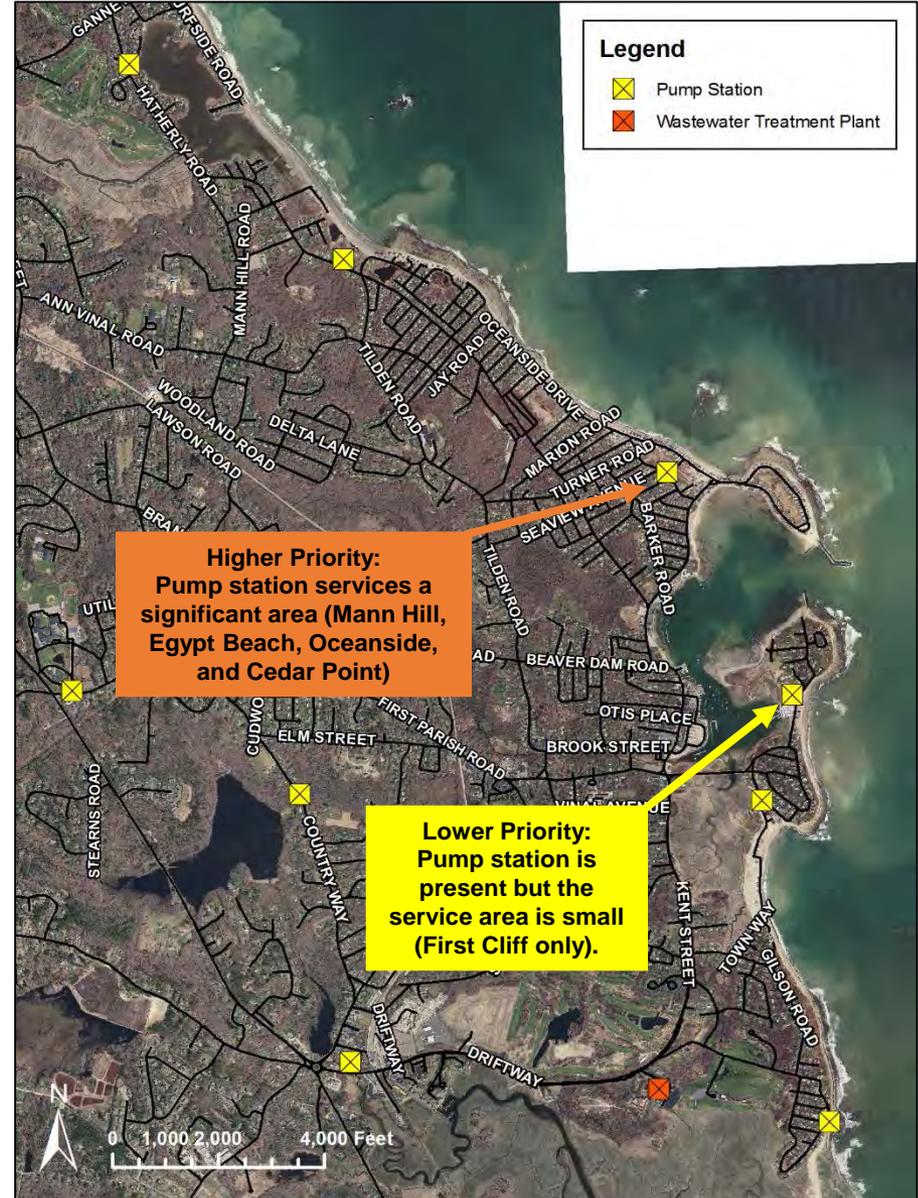
# Criteria #3b: Damage Susceptibility of Public Utilities – Pump Stations

Pump station present in a significant service area

Pumps station present

No pump station present

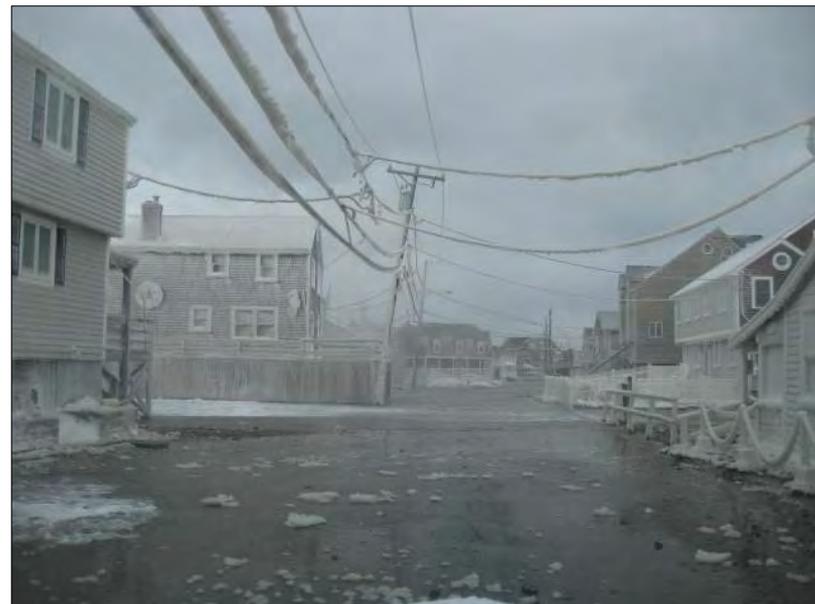
Higher Priority:  
Above-ground electrical lines lean and freeze during a storm on Cedar Point.

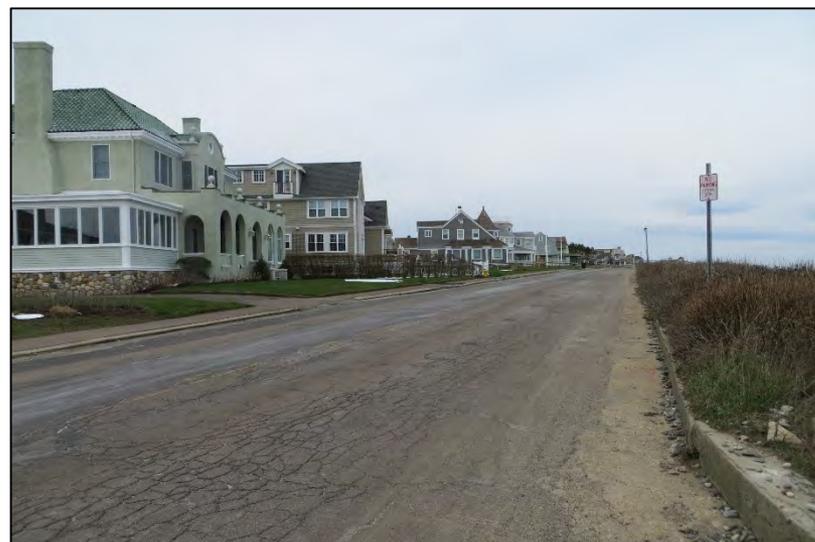
Lower Priority:  
Buried electrical lines on Glades Road (south of Bailey's Causeway)

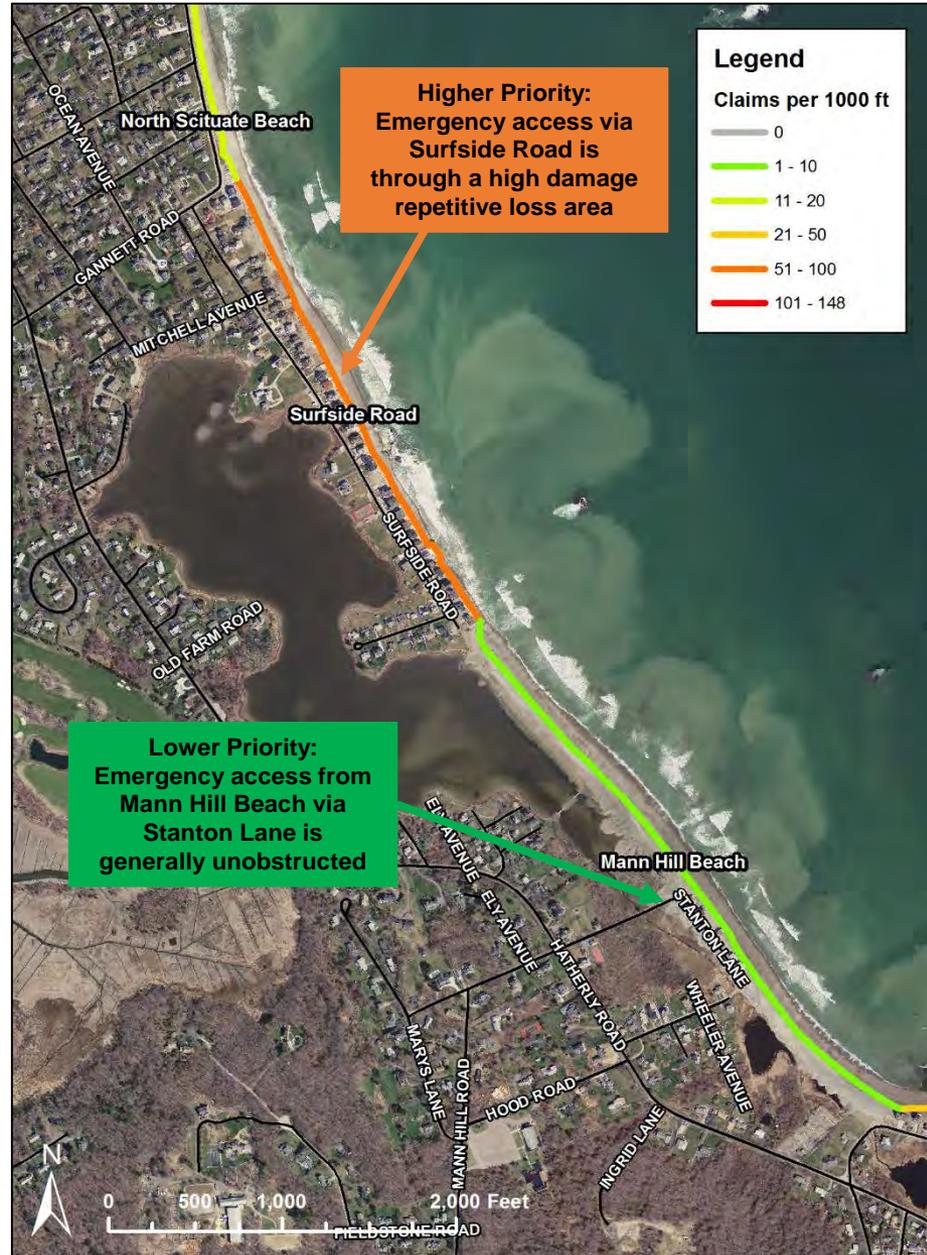
# Criteria #4: Emergency Egress

Access is through a high damage repetitive loss area

Access is through a historically flooded area

Generally unobstructed access

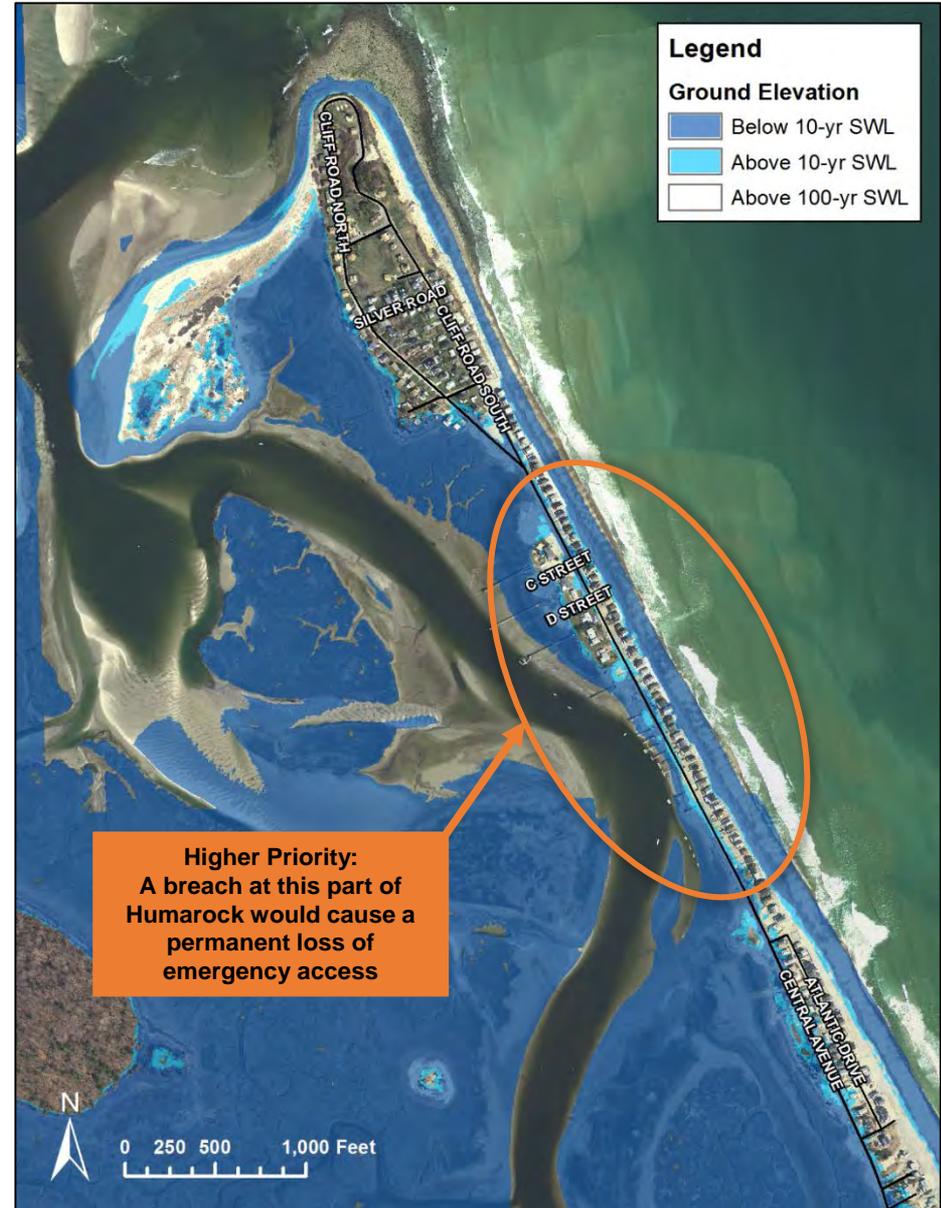
# Criteria #5: Breach Susceptibility

Potential for breach (no fronting coastal structure)

Potential for breach (fronting area reinforced with coastal structure)

No potential for breach

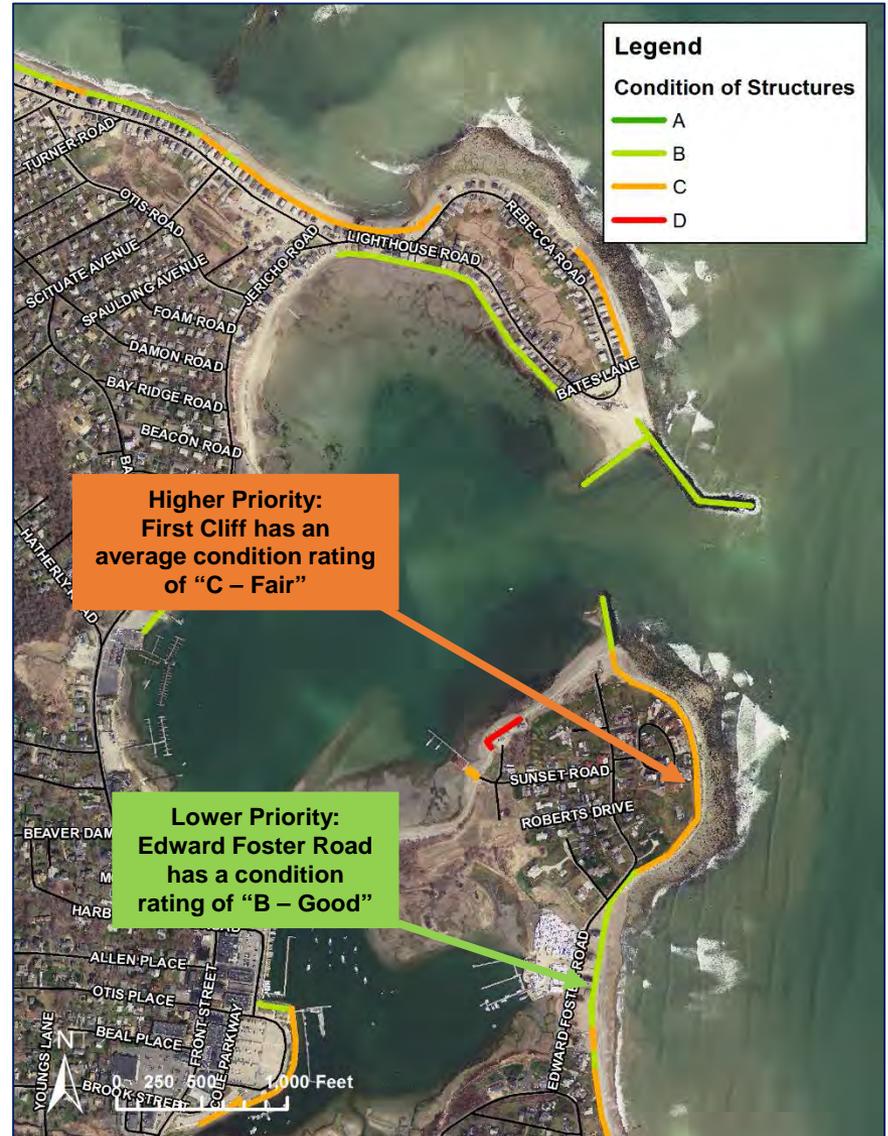
# Criteria #6: Coastal Engineering Structure Condition

“D - Poor” structure condition  
(needs to be removed and  
rebuilt)

“C - Fair” structure condition  
(major repairs required)

“B - Good” structure  
condition (minor repairs  
required)

“A - Excellent” structure  
condition (little to no repairs  
required)
