**FEASIBILITY REPORT
RESERVOIR DAM MODIFICATIONS
FOR HIGHER POND LEVELS
FIRST HERRING BROOK FISH PASSAGE IMPROVEMENTS**

26 June 2013
EA Project No. 62651.02

June 2013
Version: DRAFT
EA Project No. 62651.02

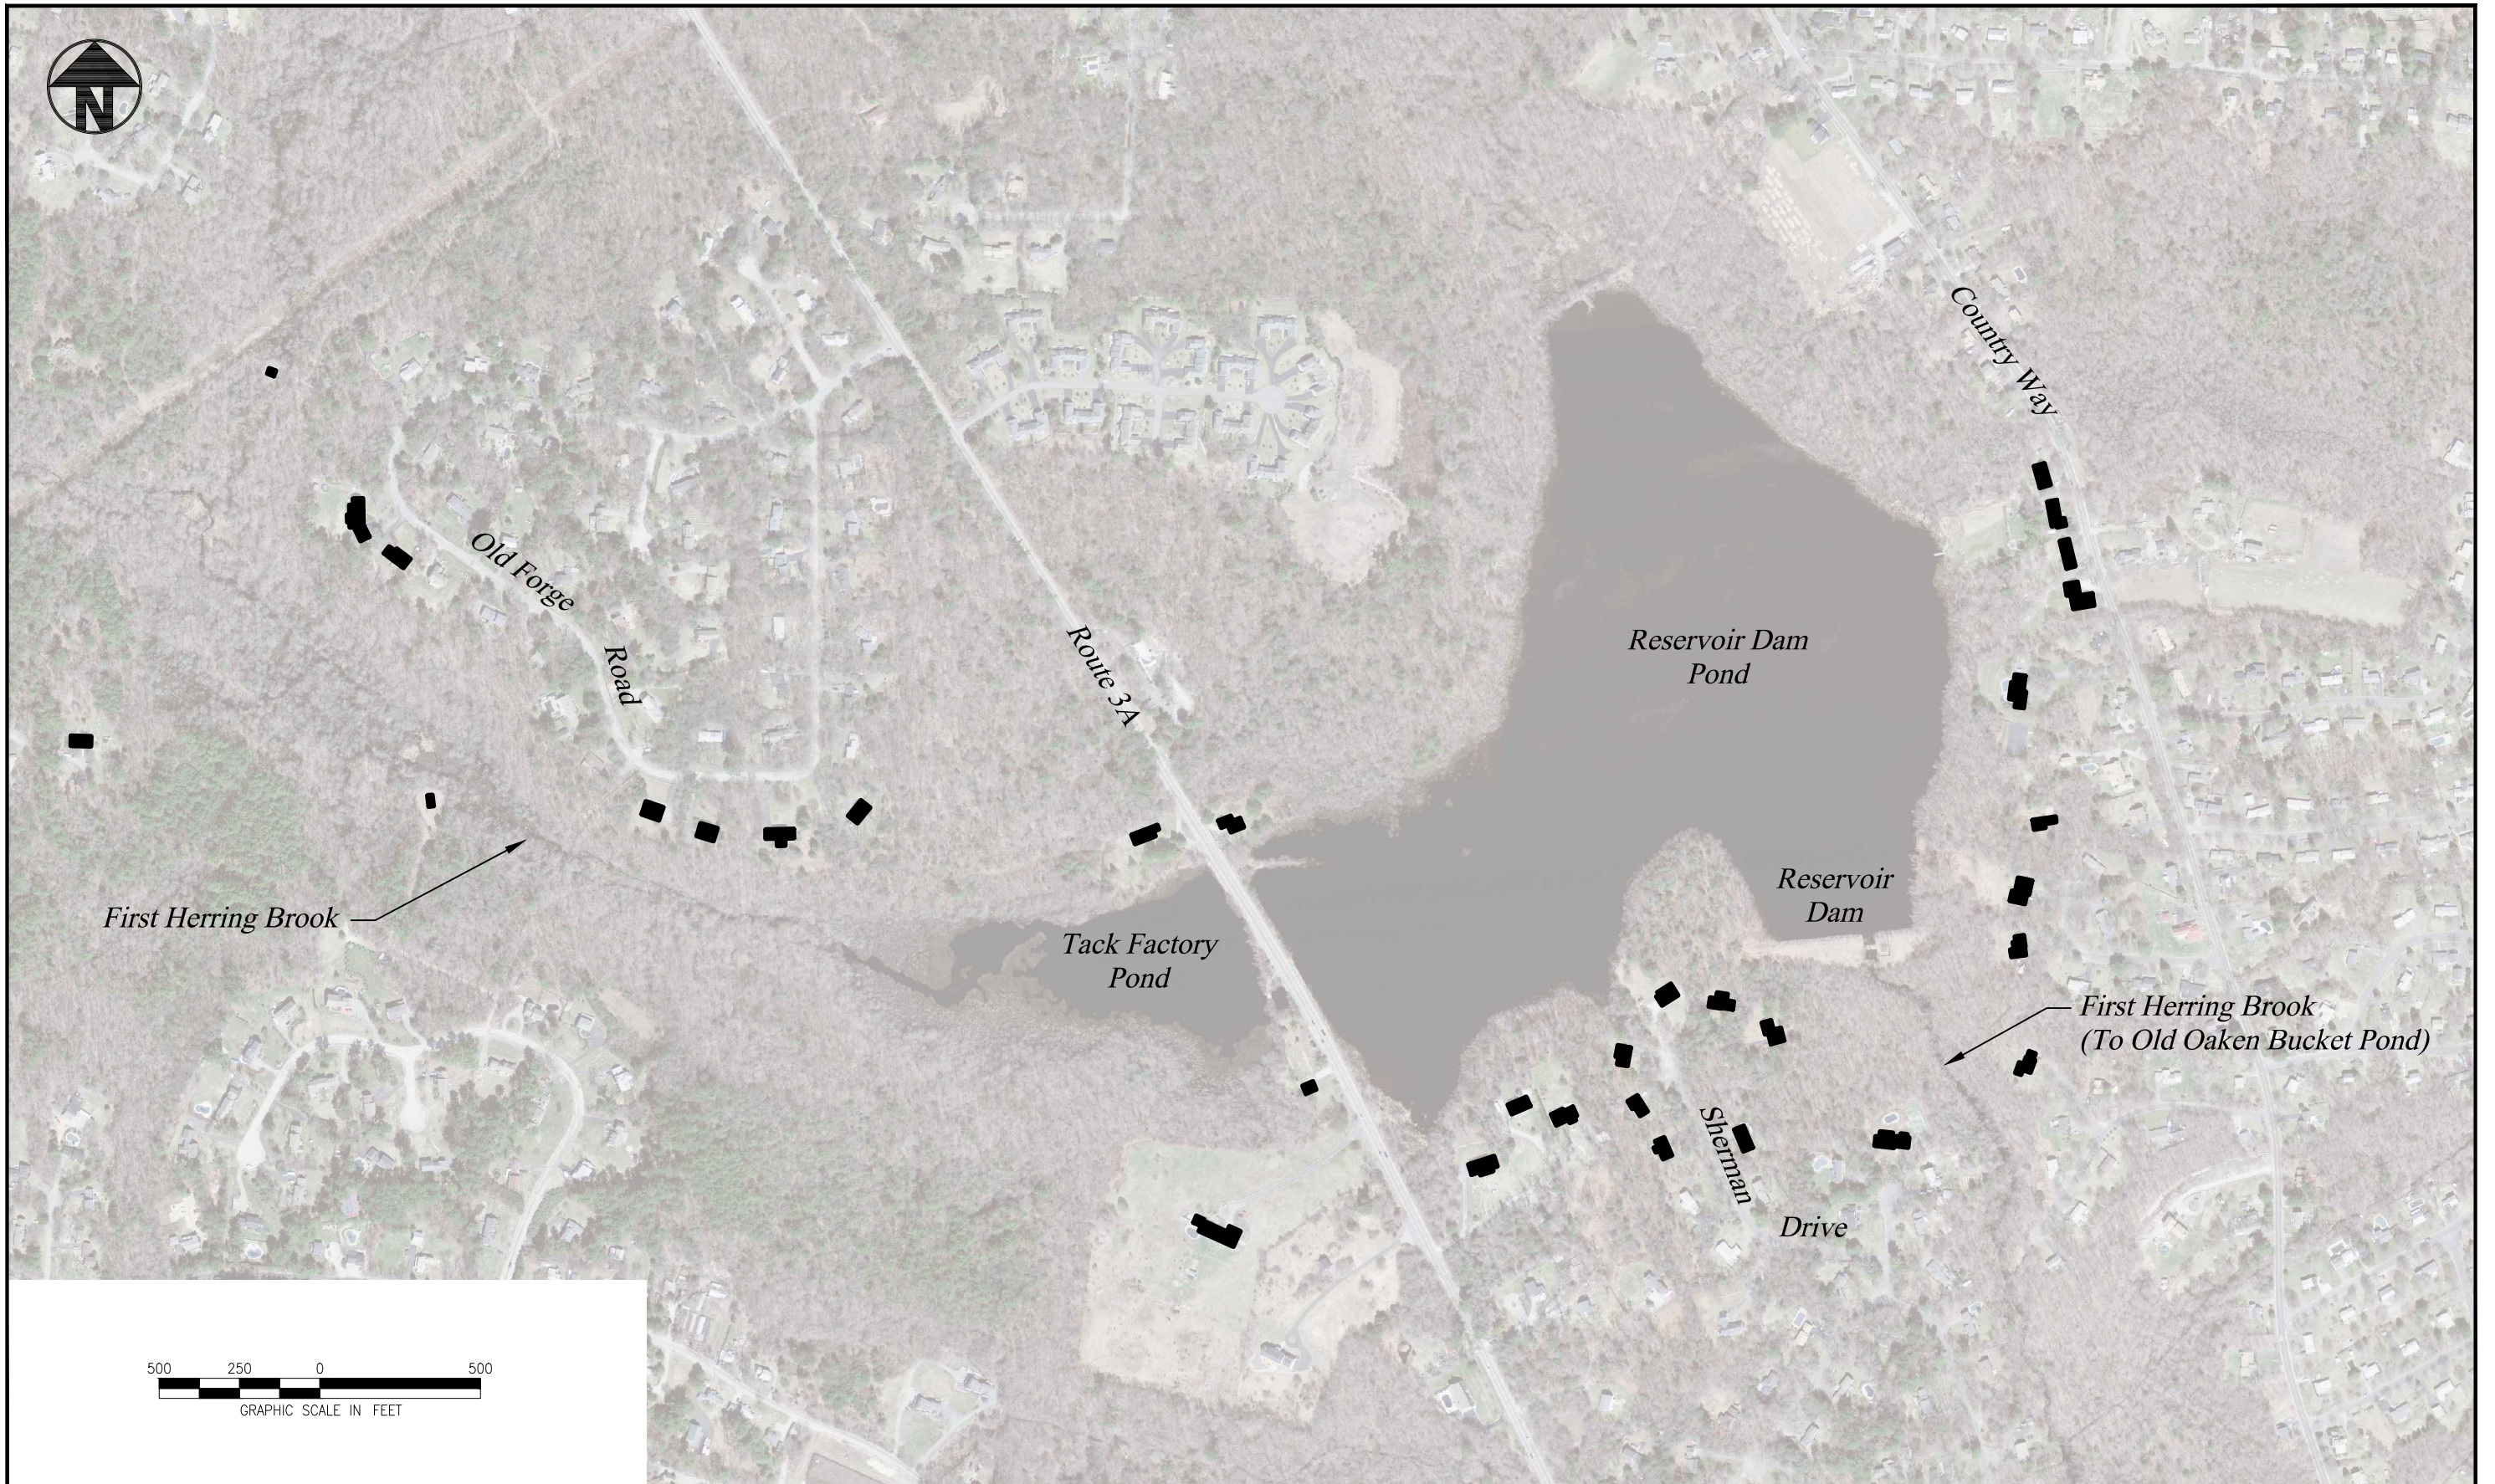
RESERVOIR DAM GENERAL ARRANGEMENT
FIGURE 1

The Scituate DPW is currently implementing an Interim Operational Plan (IOP) recommended by the NSRWA and its partners. The IOP utilizes reservoir storage below the spillway crest (El. 40.0 ft) to meet water supply demands and environmental flow releases needed to maintain the habitat in First Herring Brook between Reservoir Dam and Old Oaken Bucket Pond, as shown on Figure 1, and downstream of Old Oaken Bucket Dam.

There are three (3) houses off from Route 3A that are very close to the Reservoir and Tack Factory Pond (See Figure 1). Ground level around these houses is generally at El. 43.0 ft to El. 45.0 ft. Higher pond levels could increase groundwater level and the yards for these houses may have to be raised to provide some dry yard area for the owners.

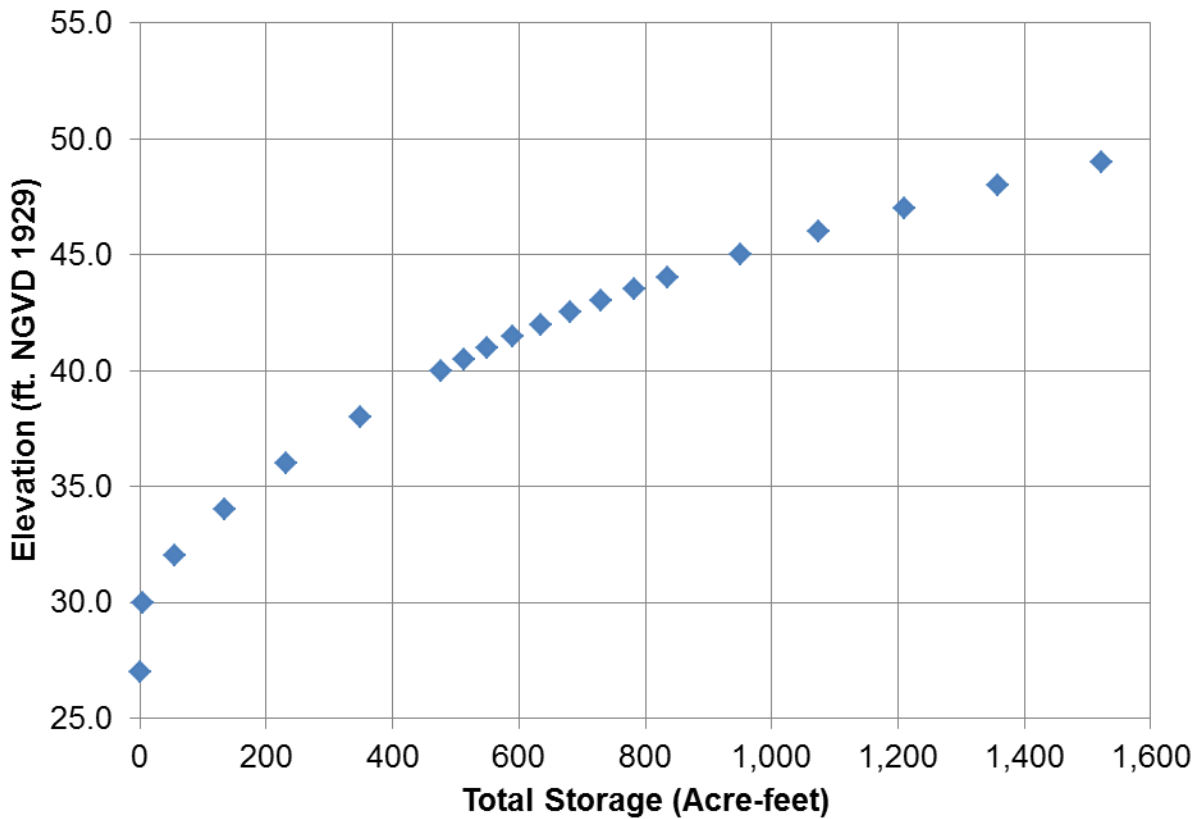
Figure 2 Reservoir Dam Storage Rating Curve

The storage rating curve for Reservoir Dam is presented in Table 1 and illustrated in Figure 2.

For pond levels at El. 40.0 ft and lower, EA used the reservoir storage rating curve presented in the 2003 Town of Scituate Drinking Water Supply and Demand Analysis (CEI 2003). This storage rating curve was also used for the 2012 Water Evaluation and Planning (WEAP) model (Kearns 2012).

Reservoir Dam has a storage volume of 476.6 ac-ft at the spillway crest El. 40.0 ft according to these data. The LIDAR data indicates that Reservoir Dam has a surface area of approximately 69.5 acres. Raising normal pond to El. 41.0 ft would increase the storage volume by 73.3 ac-ft to 549.9 ac-ft. Similarly, raising the storage elevation to EL 43.0 ft would increase the storage volume by 254.6 ac-ft (53%) to 730.2 ac-ft.

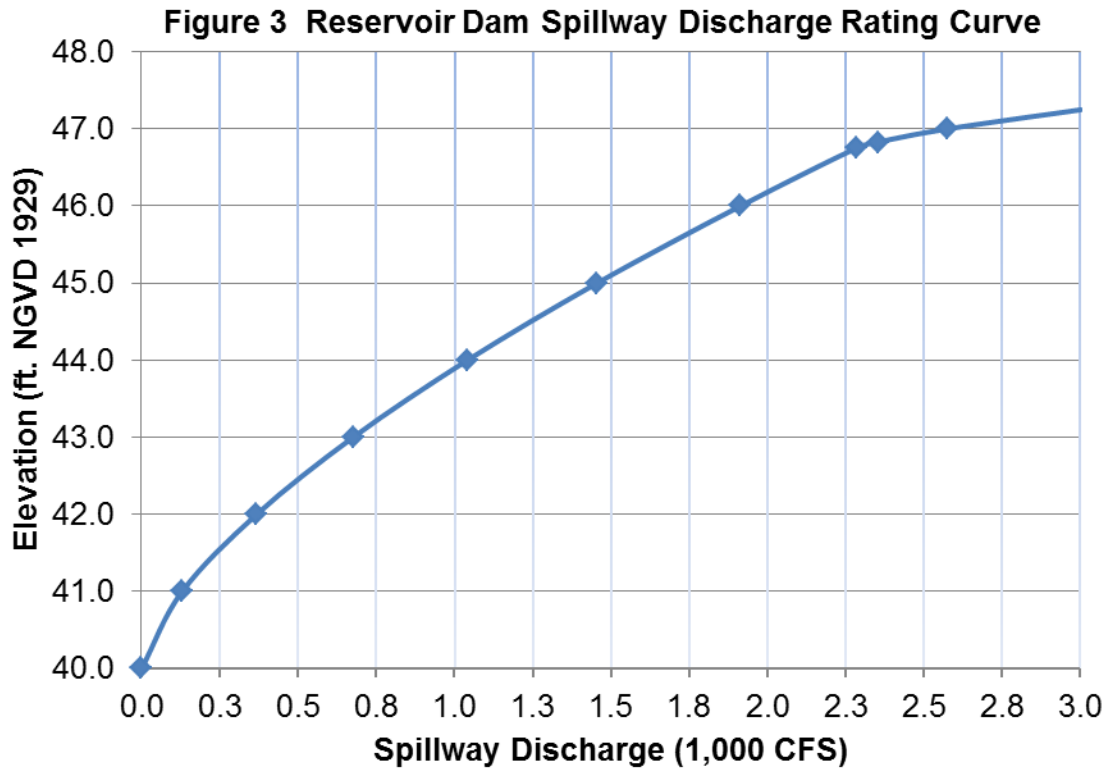
Table 2 Reservoir Dam Spillway Discharge Rating Curve Data
