CEMETERY CLAPP FAMILY

BURIAL SITES SURVEY

CUDWORTH CEMETERY

GROVELAND

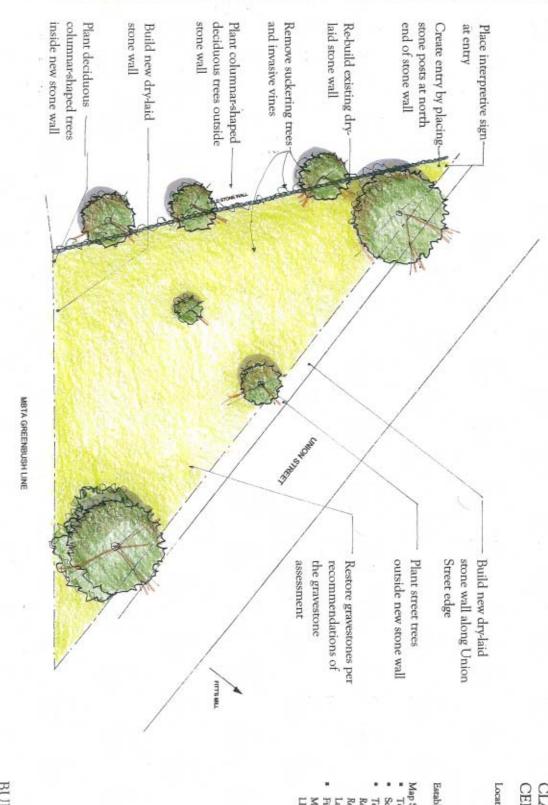
Location: Union Street (south side of Union Street, east of

Established: c. 1774

Remove shrubs; institute a "no shrub policy"

Preserve gravestones per recommendations of the Gravestone Assessment

Restore stone wall

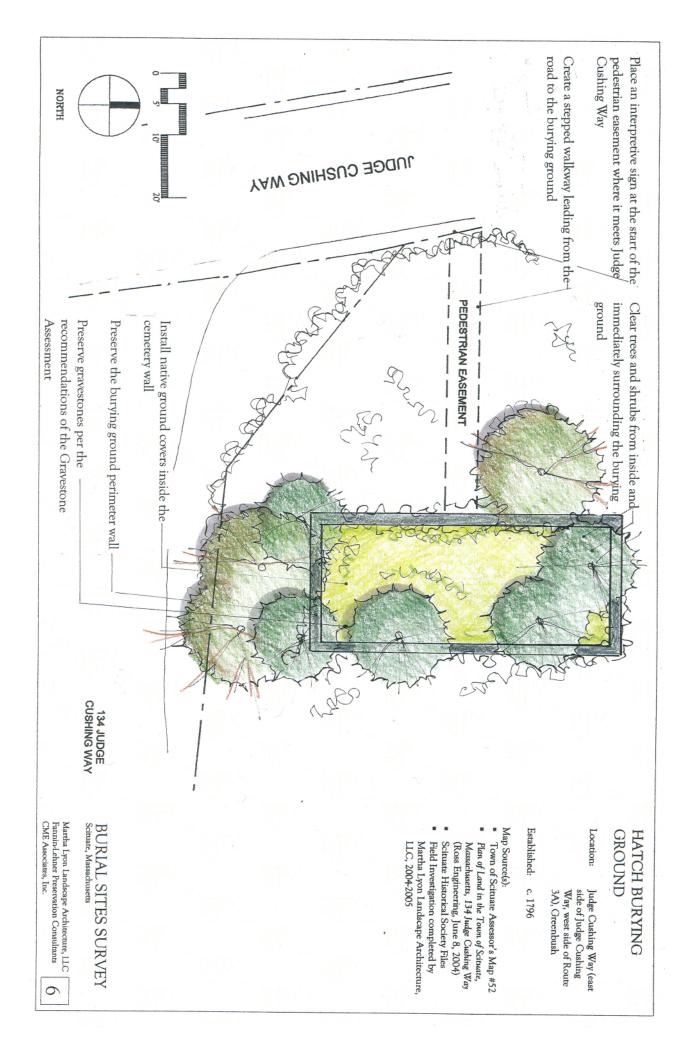
CEMETERY JAMES-CLAPP

Location: Driftway (south of the Driftway, west of Ladd's

Established: c. 1797

- Place new granite posts at north and east corners; install steel chain to connect posts
- Preserve the perimeter wall per the recommendations of the Engineering Assessment
- Assessment
- Plant native ground covers on the cemetery floor
- Place an interpretive sign along the Driftway, alerting visitors to the cemetery's

Preserve the monuments and markers per the recommendations of the Gravestone

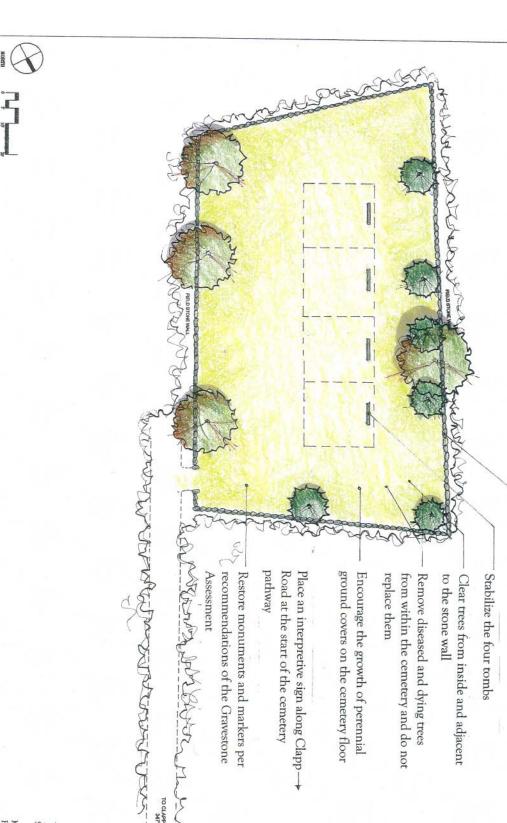
MERRITT CEMETERY

Location: Clapp Road (north side of Clapp Road, west of Mann Lot Road), North

Established: c. 1811

Preserve the dry-laid stone perimeter pathway to the cemetery Clapp Road at the start of the Create a pull-off parking area along
