**FINAL**  
**PRELIMINARY DESIGN MEMORANDUM**  
**FOR**  
**RESERVOIR DAM FISH PASSAGE PROJECT**

**JUNE 2014**

*PREPARED FOR*  
**TOWN OF SCITUATE**

# PRELIMINARY DESIGN MEMORANDUM RESERVOIR DAM FISH PASSAGE PROJECT

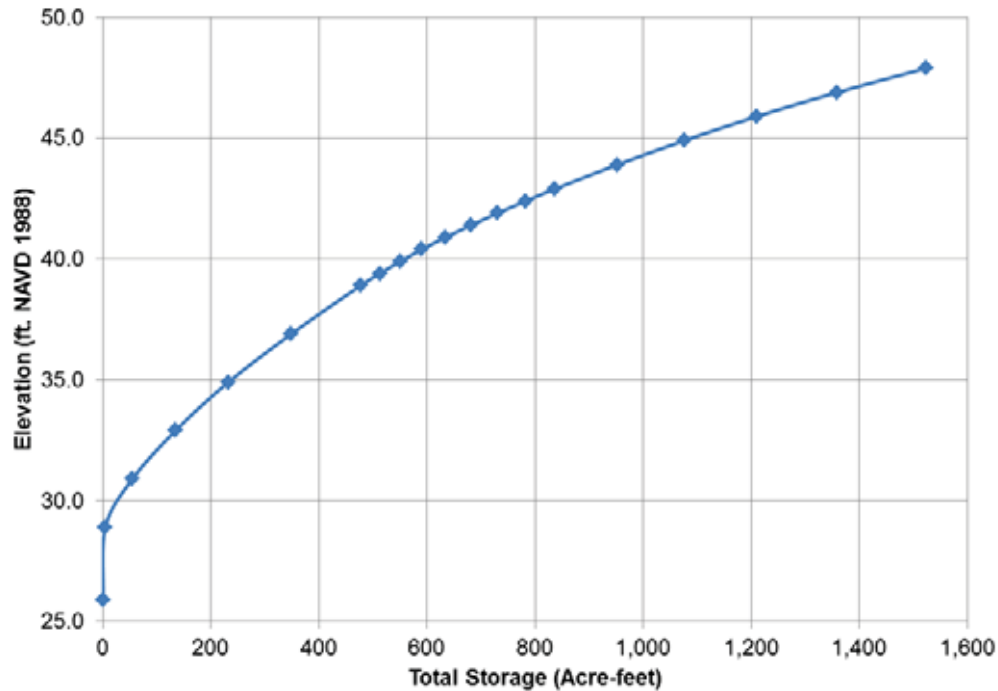
Figure 4-2 Reservoir Dam Rating Storage Curve

The storage rating curve for Reservoir Dam is presented in Table 4-2 and illustrated on Figure 4-2. There are 422.1 ac-ft of useable storage between the existing normal pool (El. 38.9 ft) and the low level at which the current streamflow guidelines are discontinued (El. 30.9 ft).

**Table 4-2  
Reservoir Dam Storage Rating Curve Data**

Reservoir Level (ft. NAVD 1988)	Total Storage (Acre-ft)	Reservoir Level (ft. NGVD 1988)	Total Storage (Acre-ft)
26.9	0.0	39.9	549.9
28.9	4.5	40.4	585.4
30.9	54.5	40.9	634.1
32.9	134.3	41.4	680.9
34.9	231.9	41.9	730.2
36.9	348.6	42.4	782.0
38.9	476.6	42.9	836.2
39.4	512.3	43.9	951.6

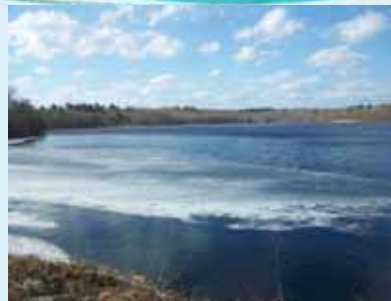
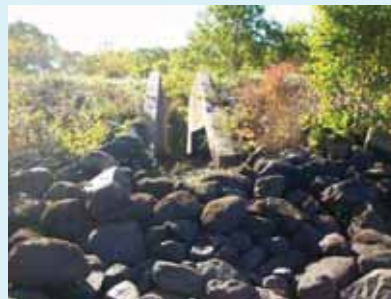
*Water supply and environmental releases from Reservoir Dam through the low-level outlet during summer lower impoundment water levels below the fishway exit channel and spillway crest.*

*River herring juvenile out-migrants cannot find the low-level outlet and the low-level outlet does not provide effective downstream passage.*

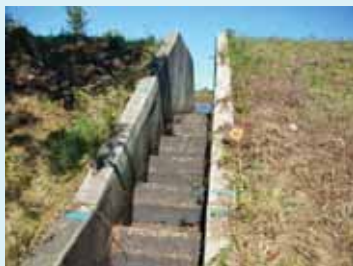
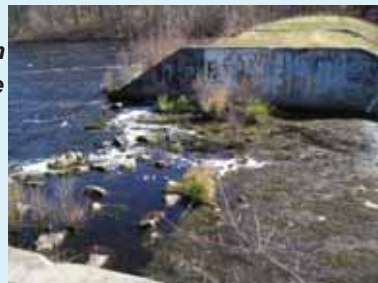
*Increase reservoir storage capacity with installation of spillway crest gate*
